**Railway Accident
Investigation Unit
Ireland**

INVESTIGATION REPORT

Broken rail, Newbridge, Kildare, 23rd February 2023

RAIU Investigation Report No: 2024-R001

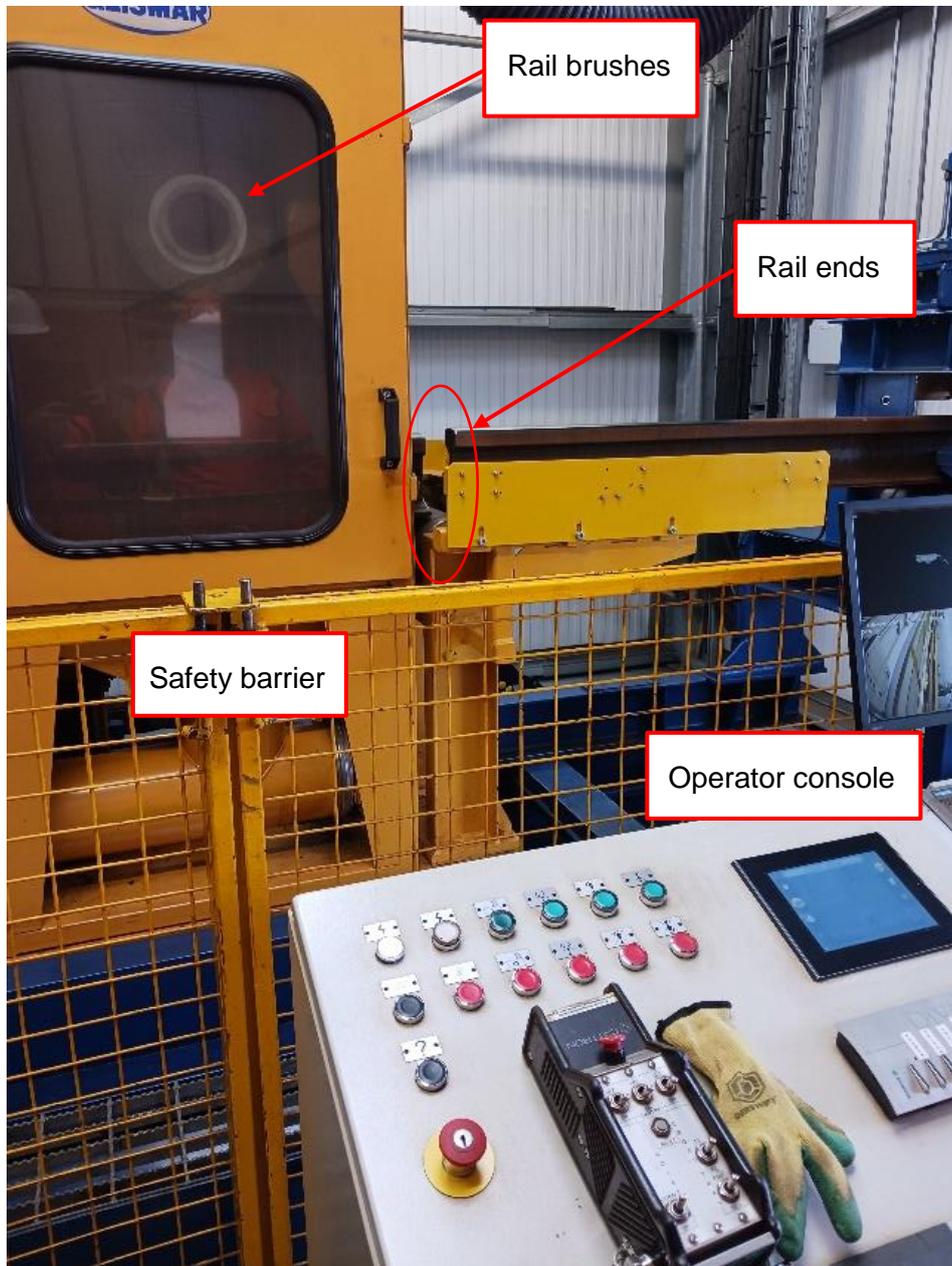
Figure 6 – The Rail Cleaner/ Brush from the operating position

- 64 It is noted that IÉ-IM have undertaken multiple risk assessments covering the rail welding plant and machines, however, these appear to be restricted to occupational health and safety. The risk assessments do not consider risks arising from the production process (e.g. contamination of the rail ends causing weld defects) which may impact the safe running of trains; and as such control measures to address these risks have not been identified.

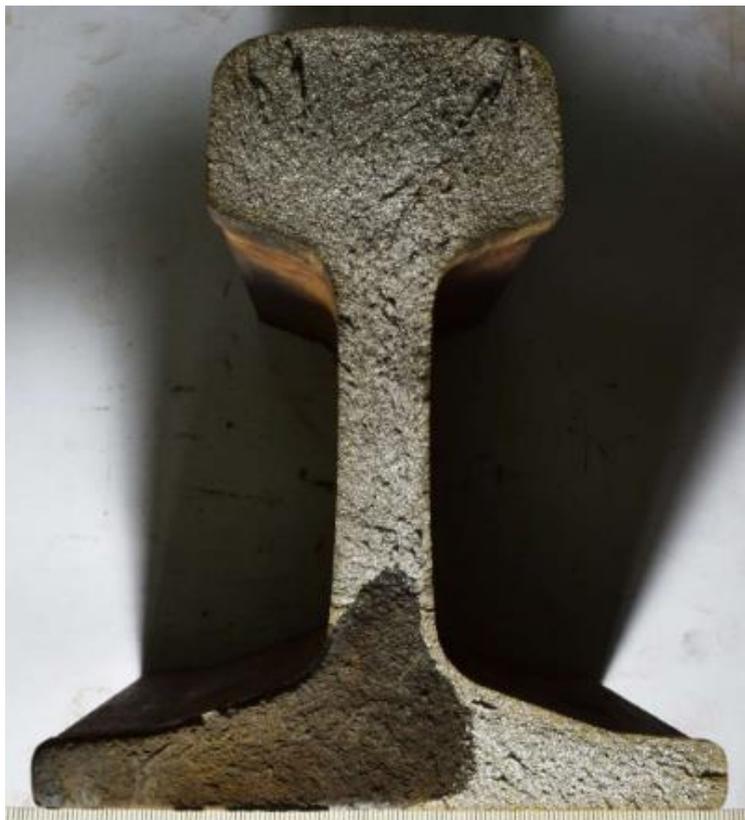
- 81 Serco conducted a visual examination of the broken rail ends. This revealed a darkly corroded transverse crack at the foot of the rail, which further chemical analysis determined a "small number of days exposure". The remainder of the fracture face was not corroded and was typical of recent rapid overload (see Figure 9). The "overload" refers to the stresses acting on the remaining un-cracked cross-section, rather than the bulk stress on the rail as a whole. The presence of the initial crack would have resulted in a very significant degree of stress concentration at the tip of the crack. This would have been many times greater than the bulk stress applied to the rail.

Figure 9 – Complete fracture face showing rail foot crack

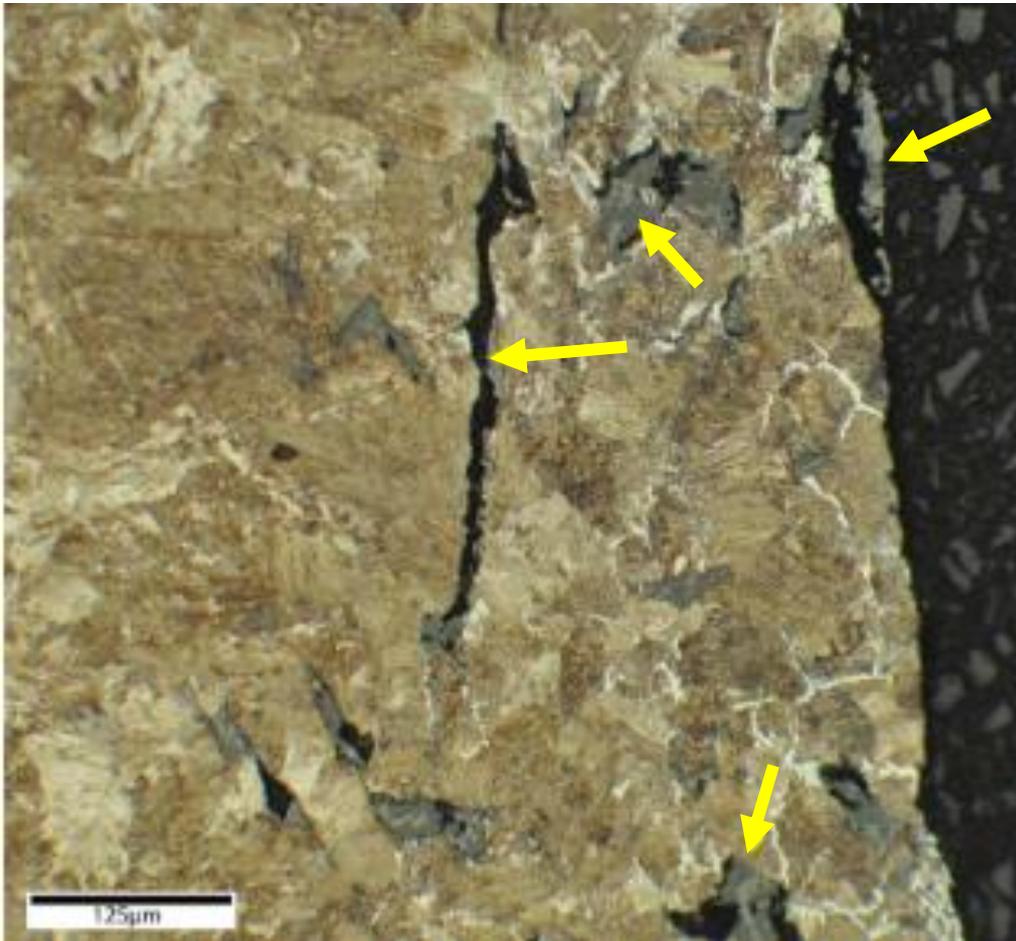
82 Serco’s metallographic examination found “conclusive evidence of a lack of fusion along the surface including decarburisation, fissures and slag inclusions” (see yellow arrowed sections in Figure 10).

Figure 10 – Slag inclusions and slag filled voids indicated by the yellow arrows

- 89 The consultant engaged by the RAIU to review the Serco Report and other evidence, confirmed the source and mode of the failure.
- 90 Also noting the alignment of the slag inclusions in the metal indicated these were likely to have originated from the flash butt welding process⁸.

- 91 These slag inclusions may have originated from residual contaminants (e.g. corrosion, paint, etc) not removed by the rail end cleaner being included or these residues preventing effective flashing and causing oxidation of the molten metals to form slag which was not expelled from the joint.

128 Insufficient cleaning of the rail ends was identified as a possible cause of slag inclusion and lack of fusion. The RAIU makes the following safety recommendation to address CaF-02 (paragraph 122) to achieve greater assurance that rail cleaning has been achieved to the required standard:

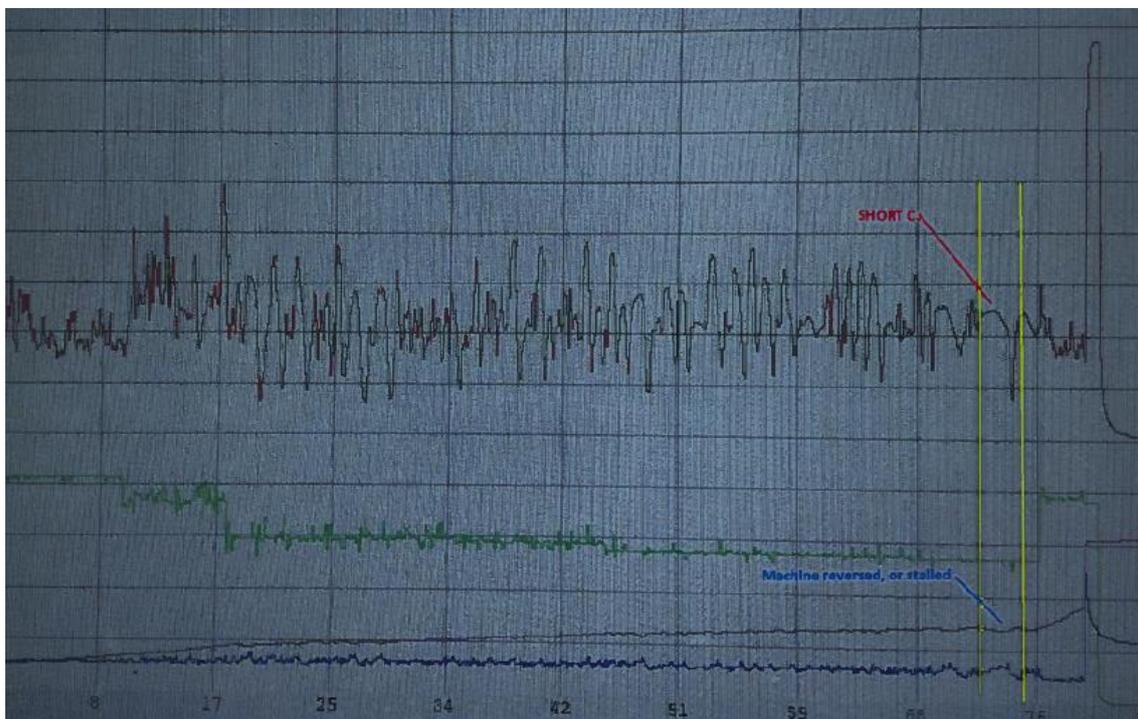
87 At the time of welding for the affected broken rail, Geismar identified a possible “short circuiting” event (identified by “Short C” red text in Figure 12) in the welding sequence, which resulted in the welding machine reversing or stalling (identified by “machine reversed, or stalled” blue text in Figure 12) to the flashing process. However, this was not sufficient to trigger the machine to identify the weld as a “Fail” on the operator display (as described in Footnote 4).

Figure 12 – Welding graphical output from welder

88 Geismar speculated that a small piece of the rail foot appeared to be missing or chipped prior to the rail welding procedure. Consequently they stated that “during the welding process in the area with the missing /chipped location would not have reached the required fusion temperature, thus generating a lack of upsetting material.... slag inclusions could be explained as there would have been insufficient quantity of material to be expelled in the upsetting sequence”.

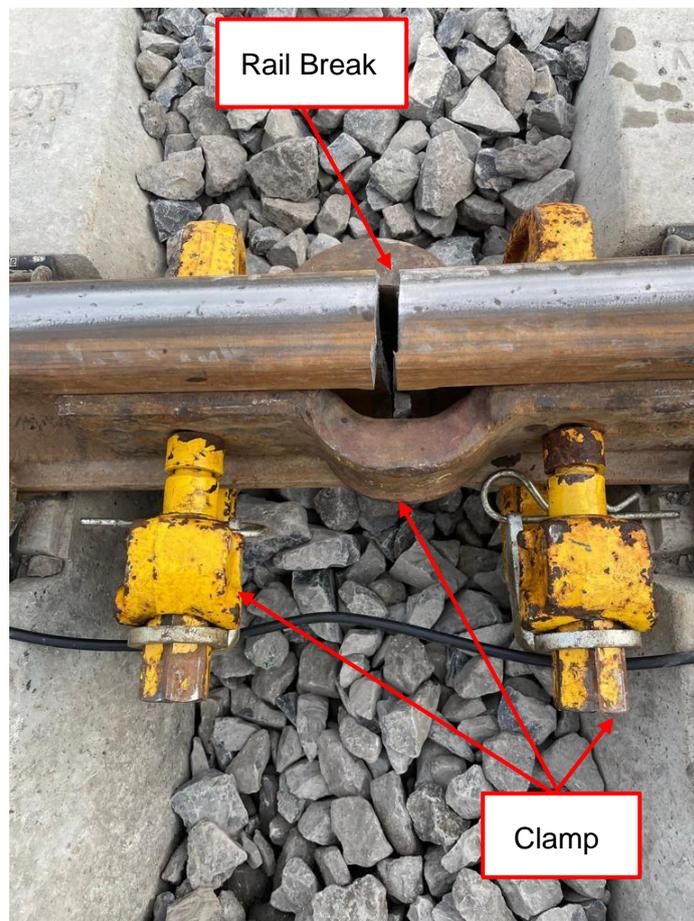
Figure 13 – Broken rail held by temporary rail clamps

107 A PWI attended with support staff and attached a clamp (see Figure 13) to the rail to hold it in vertical and horizontal alignment.

- 109 The first train to proceed over the temporarily repaired rail was advised to proceed at caution with CCE staff in attendance to observe the movement.
- 110 During a subsequent T3 Possession a 9 m section of rail was cut out and removed from site for analysis with a replacement section welded in.
- 111 Additionally, eighteen welds were tested either side of the broken rail using hand trolley mounted ultrasonic testing equipment which permitted testing of the full height of the rail profile. No defects were found.
