# **Railway Accident Investigation Unit Ireland**

## **INVESTIGATION REPORT**

### **Derailment of DART passenger service, at Points DL115, Dun Laoghaire, 13<sup>th</sup> September 2017**

**RAIU Report No: R2018 – 001  
Published: 15<sup>th</sup> August 2018**

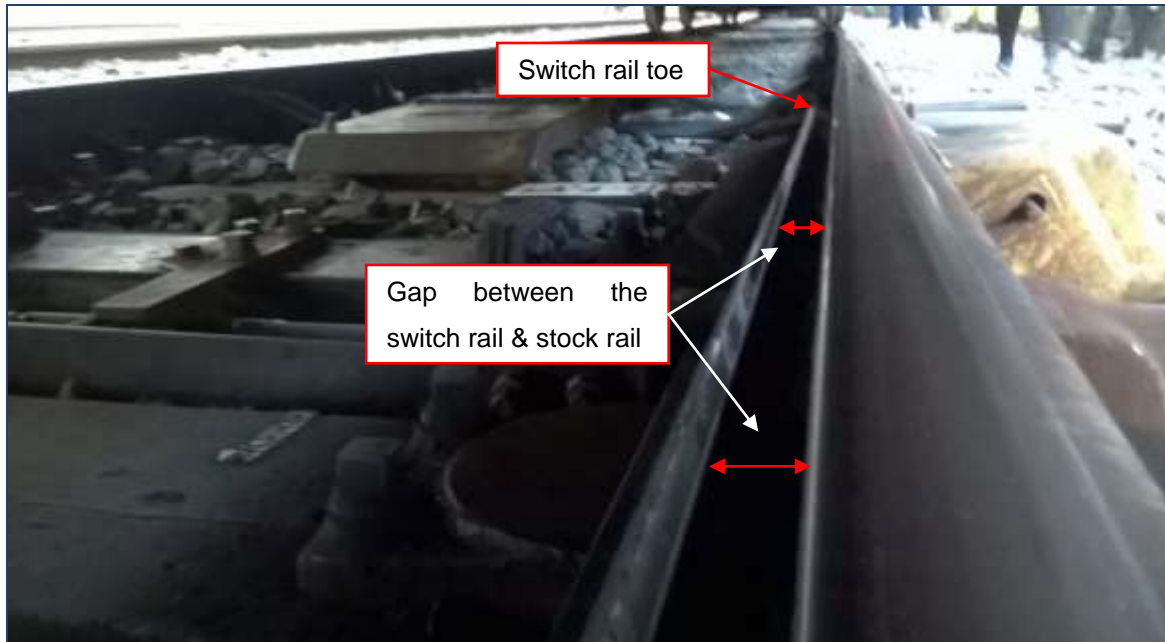
- 57 The post derailment inspection of Points DL115 identified that the power supply had not been taken from the points before fitting the clip and scotch.
- 58 There was a gap between the toe of the switch rail toe and the stock rail, see Figure 8.

**Figure 8 – Gap between the toe of the switch rail toe and the stock rail**

136 The immediate cause of Train E222 derailing was as a result of Train E222 travelling over failed Points DL115 which had been incorrectly secured by the Points Operator by leaving a gap between the stock and switch rails.

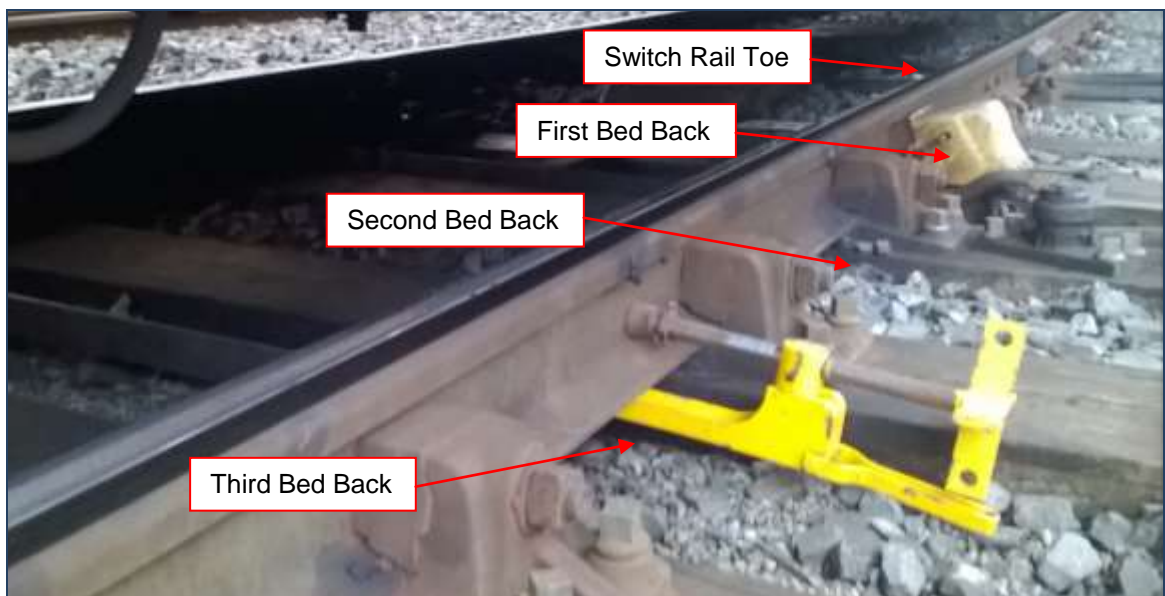
- 59 The points clip was applied in the third bed back from the toe of the switch rail. The points clip collar, which restricts the loosening of the clip, had not been applied; and the points clip had not been locked with a padlock, see Figure 9.

**Figure 9 – Placement of the Points Clip**

- Ensure that the clip fully clamped the points, this was as a result of the Points Operator placing the clip too far away from the toe of the points (paragraph 92), although it should be noted that the IÉ Rule Book or General Appendix does not identify where the clip should be placed (paragraph 54);

- Apply the padlock to the clip (paragraphs 49, 51, 89); meaning that there was potential for interference by a third party if left unattended, or, loosening of the clip from vibration in the event of movement of trains over the points;

147 The IÉ Rule Book and the General Appendix does not specify where the points clip should be fitted (AO-02); as a result the RAIU make the following safety recommendation:

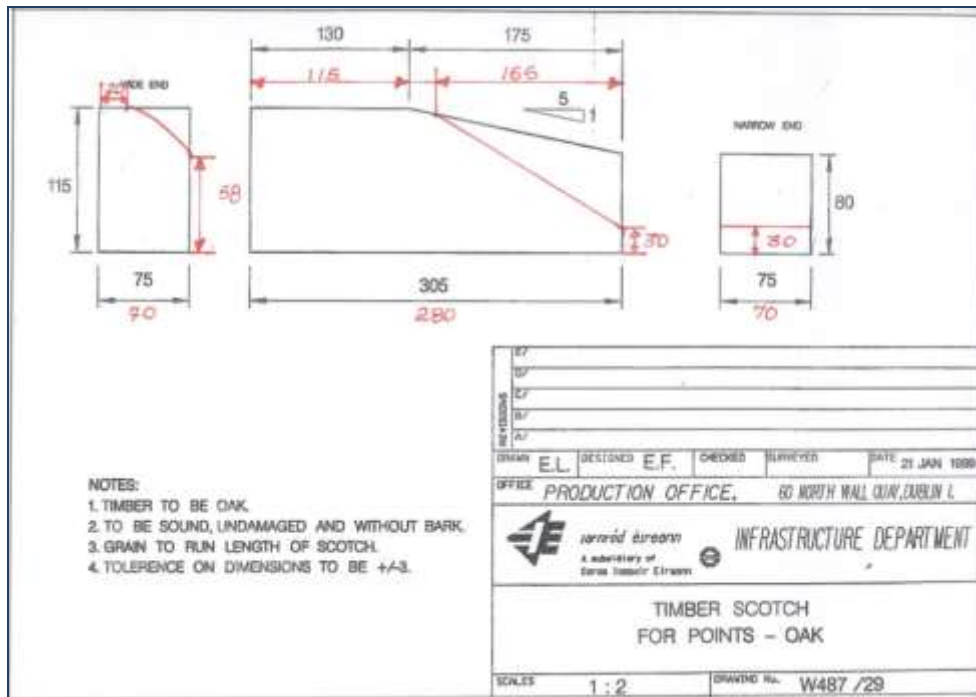
60 The scotch was not manufactured to the dimensions set out in IÉ Drawing No. W487 / 29, 'Timber Scotch for Points – Oak'. Figure 10 illustrates the required dimensions (in black) of the timber scotch under drawings number W487/29 in comparison with the actual dimensions of the timber scotch used on the day of the accident (in red). It should be noted, that the incorrect dimensions did not contribute to the accident.

Figure 10 – Required (black) versus actual (red) dimensions of Timber Scotch

149 The scotch used at points DL115 was not manufactured to Infrastructure department drawing W487/29 (AO-04); as a result the RAIU make the following safety recommendation:

- IÉ IM should review the drawing and specification requirements for points scotches and ensure only scotches manufactured to the required drawing and specification are made available to points operators;

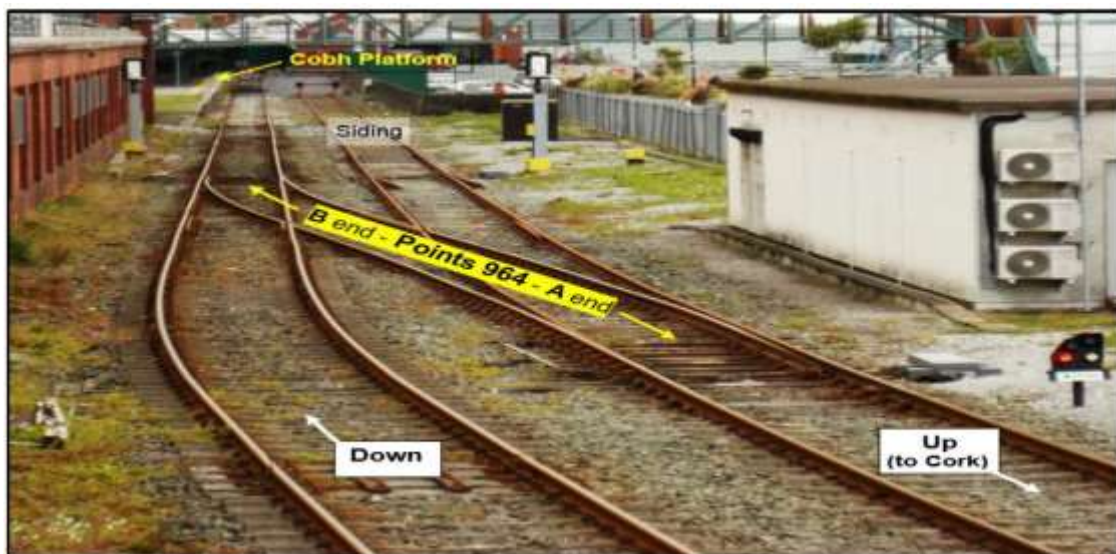
108 The CSC contacted POC and requested Points 964 (see Figure 11) to be scotched and clipped in the reverse position; POC carried out the instruction.

109 POC then proceeded to Points 964A where he observed the points were in the reverse position. POC did not take control of the Points 964B but placed a scotch in the points in the reverse position and advised CSC. CSC authorised the movement of Train P238 (09:00 hrs Cobh to Cork).

**Figure 11 – Points 964 set to the normal position**

112 POC contacted CSC and confirmed to him that Points 964 were scotched and clipped in the reverse position. CSC then authorised Train P239 (09:00 Cobh to Cork) to depart Cobh. The driver of Train P239 departed Cobh and observed Points 964B were correct but heard an unusual noise coming from underneath the train and brought the train to a stop. On examination the driver identified that Points 964A (trailing end) were not correctly set for the direction of travel.

113 As a result of the incident the following recommendation was issued by IÉ: The Head of Health and Safety IM should conduct a review of the assessment documentation used for Points Operators. The review should focus, but not be confined to, include a more robust practical / operationally realistic element to the assessment process.
