REPORT OF THE INVESTIGATION

THE ACCIDENT ON THE CIE RAILWAY

BUTTEVANT, CO. CORK,

1st AUGUST, 1980.

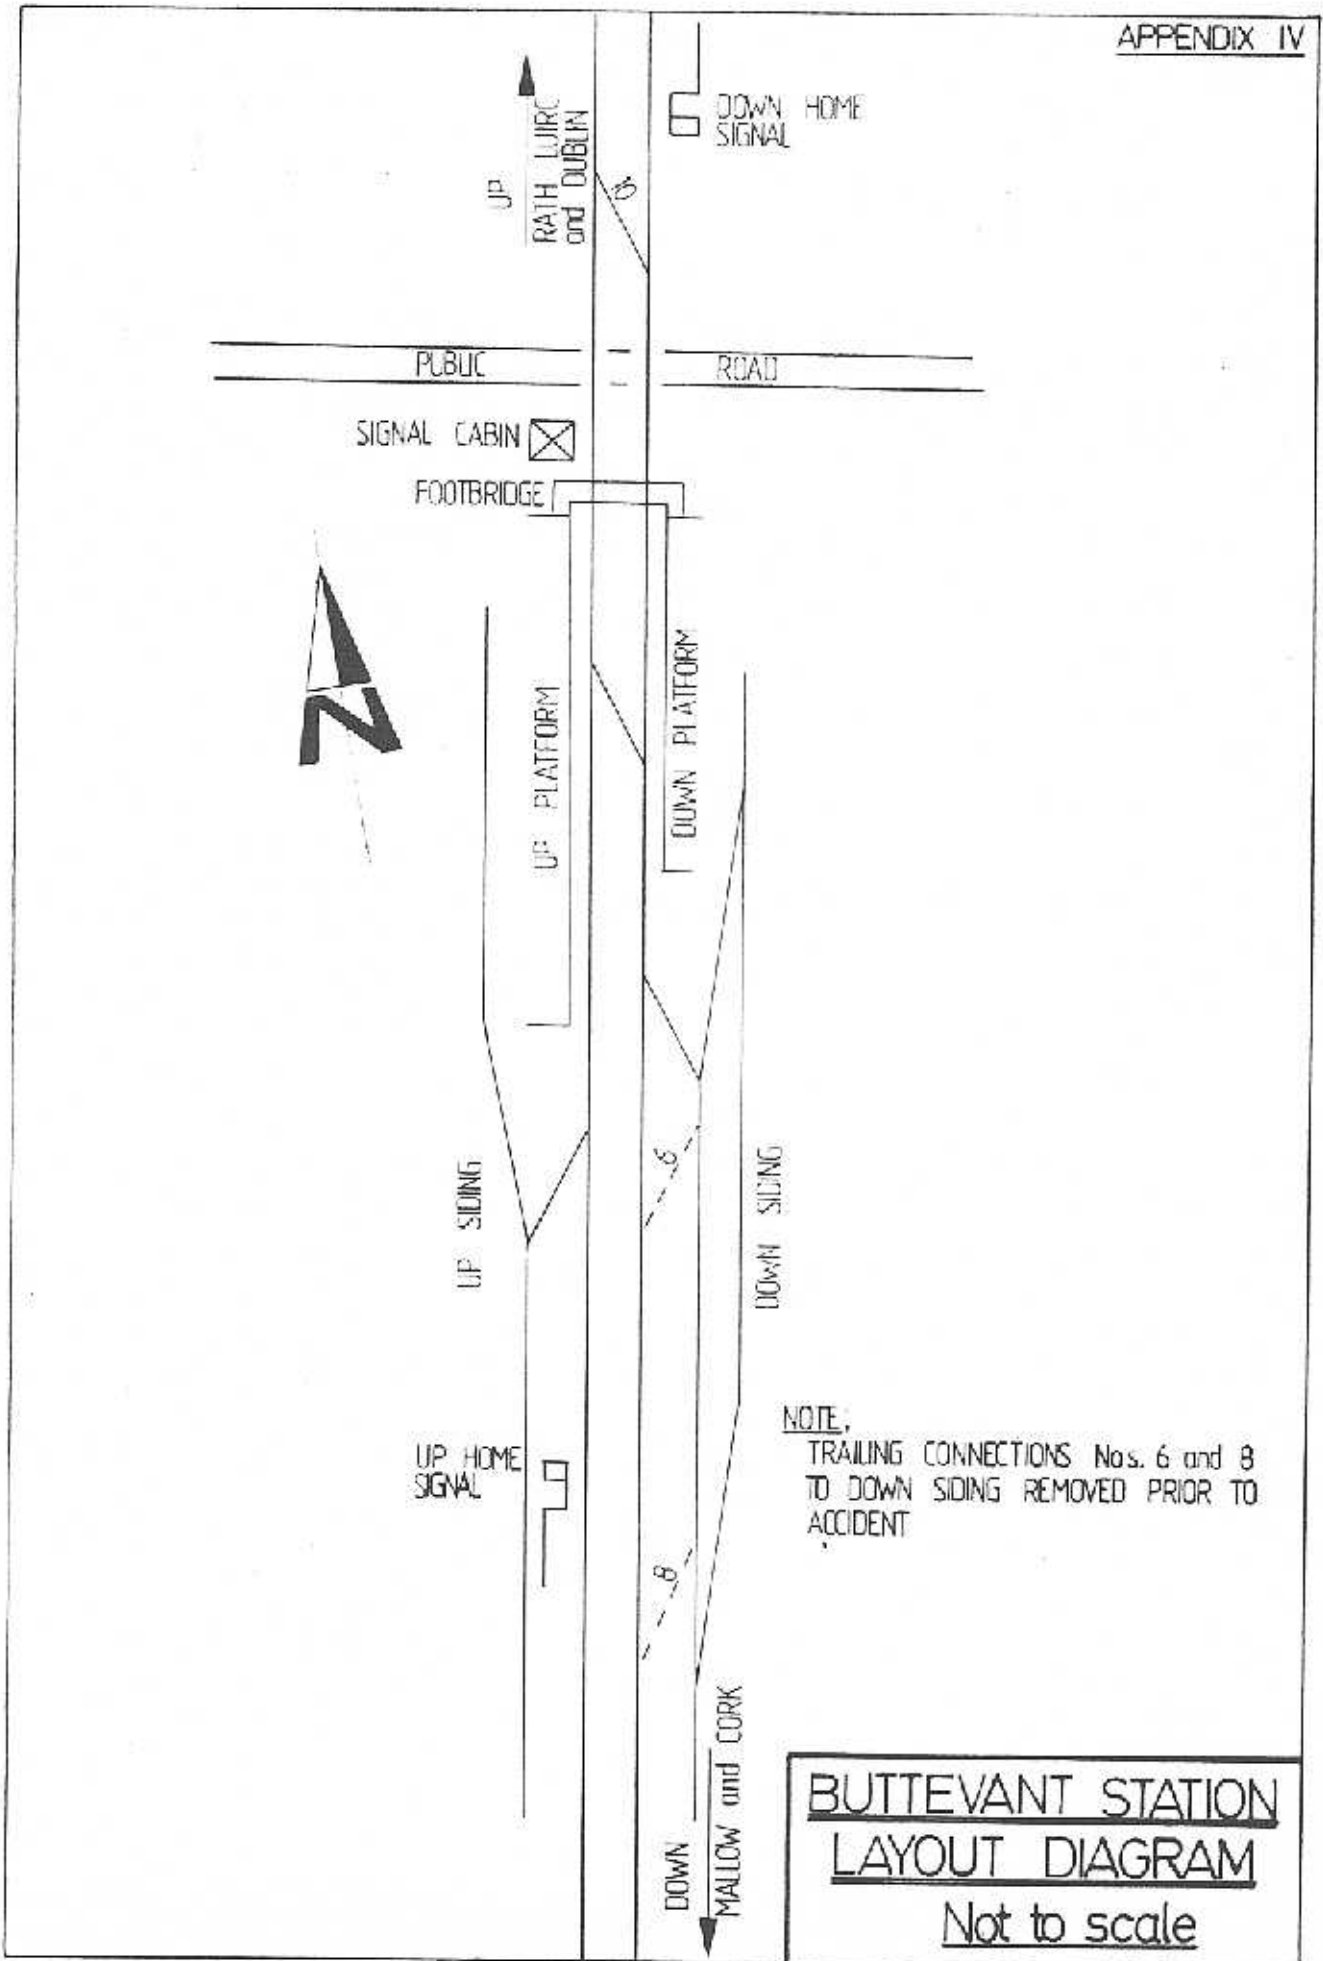
BUTTEVANT STATION
LAYOUT DIAGRAM
 Not to scale

NOTE:
 TRAILING CONNECTIONS Nos. 6 and 8
 TO DOWN SIDING REMOVED PRIOR TO
 ACCIDENT
