Railway Accident Investigation Unit

INVESTIGATION REPORT

Difflin Light Rail Passenger Fall, Co. Donegal

17th December 2016
RAIU Report No: 2017 -001
Published: 7th November 2017

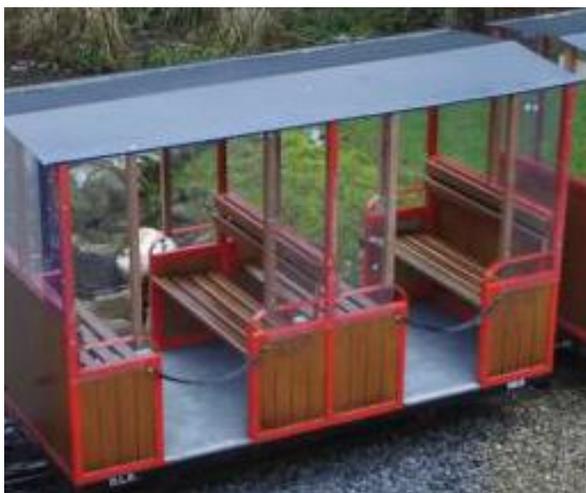
Figure 3 – Open carriage with chains

18 The locomotive can pull a combination of carriages, consisting of various types of carriages: open carriages where chains secure the access and egress point of the train (Figure 3); enclosed carriages (Figure 4) which have doors that close to form a fully enclosed carriage; and, freight wagons.

121 Open carriages are common in the heritage market and it was noted that a chain over the door was added to the carriage post manufacture (paragraph 46). This was in this instance too low to restrain a seated person from falling out.

DLR should review the physical and procedural safeguards for the operation of their trains, to prevent small children whose feet do not touch the ground in a seated position, from falling from open carriages.

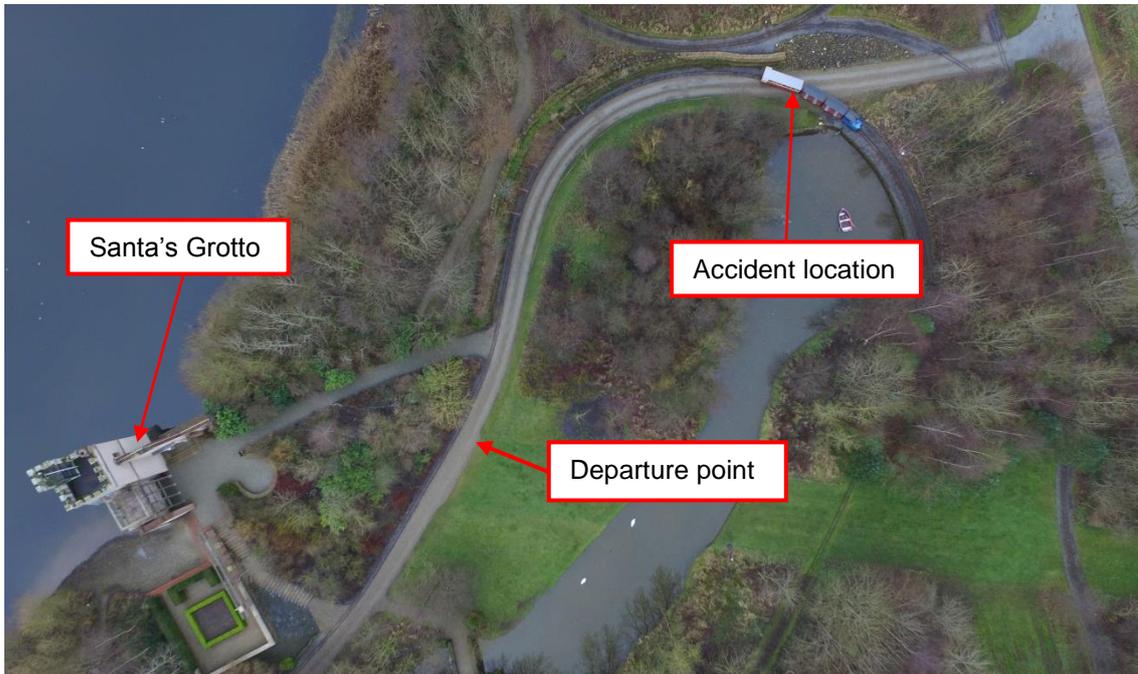
Figure 6 - Overhead view of right hand hairpin curve around Trout Lake

38 The accident occurred whilst negotiating a right hand curve in an area known as 'Trout Lake'. The train in its stopped position, after the accident, can be seen below in Figure 6. (reconstruction)

Figure 8 – Gravel pathway from designated drop-off/pick-up point to Santa's Grotto

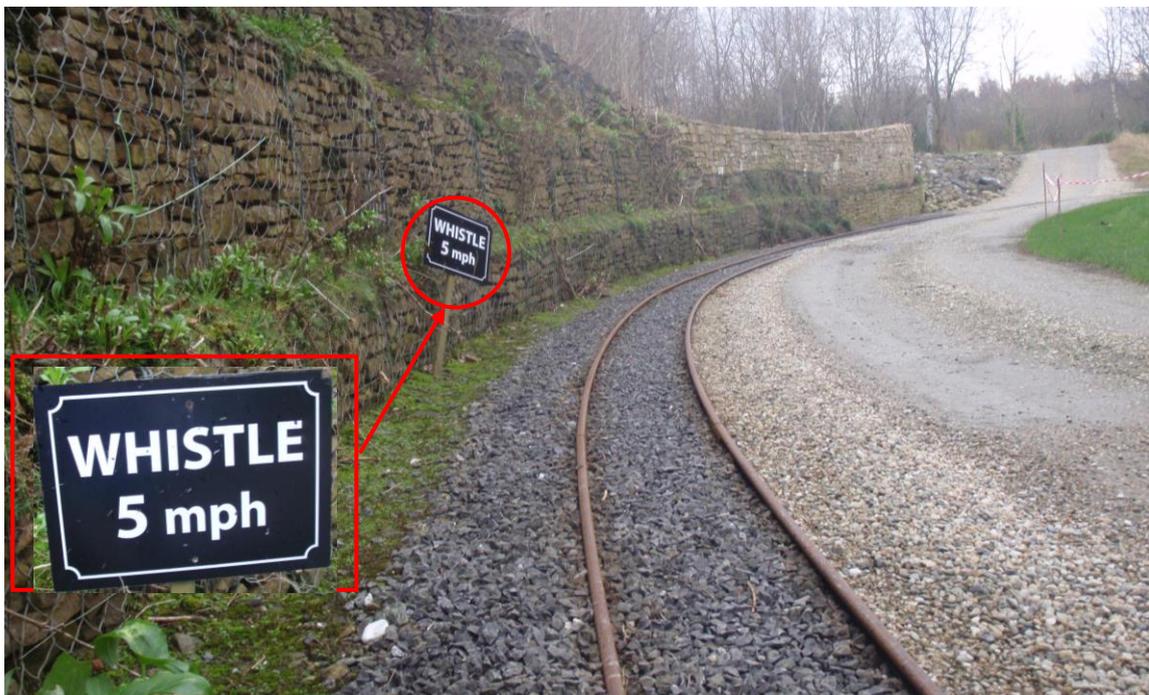
Figure 7 – Speed board on approach to Trout Lake Hairpin

39 Trout Lake Curve has a speed restriction of 5 mph (8km/h). The signage on the approach to the curve can be seen in Figure 7.

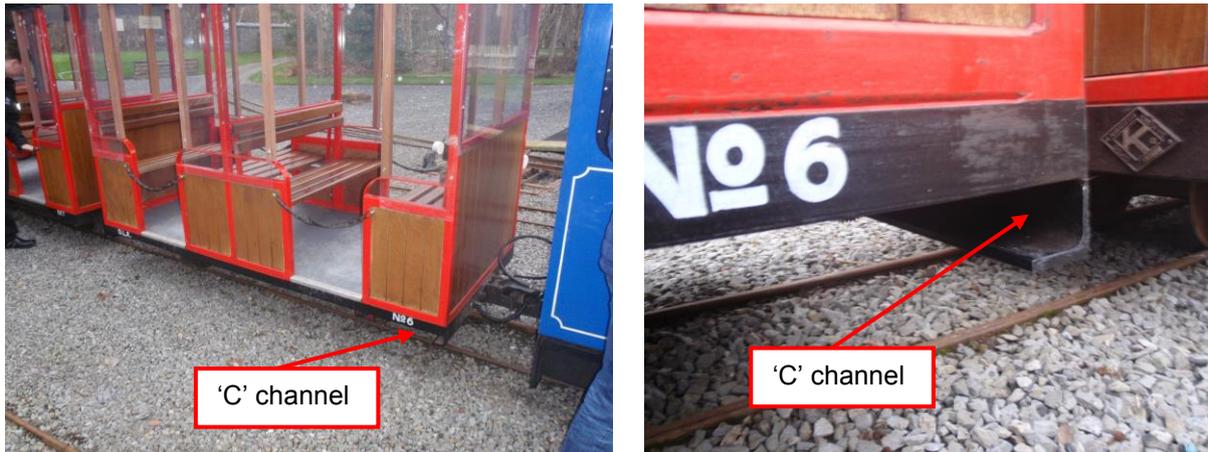
Figure 9 – Open Carriage with 'C' channel

- 43 The rolling stock is well presented and appears to be in good condition. There was no sign of visual corrosion and inter carriage couplers showed little sign of wear and were well lubricated. The open carriages have a 'C' channel structural steel making up the core of the carriage chassis, see Figure 9.
- 44 The rolling stock was in date for the manufacturers prescribed maintenance schedule's.

122 The condition of the rolling stock is not thought to have directly contributed to the accident; however, the fact that the carriage was an open type carriage allowed Girl A to fall out of the train. In addition, the presence of the ‘C’ channel (paragraph 43) may have further contributed to her injuries given the fact that Girl A became entangled and was dragged along the gravel path (paragraph 111).

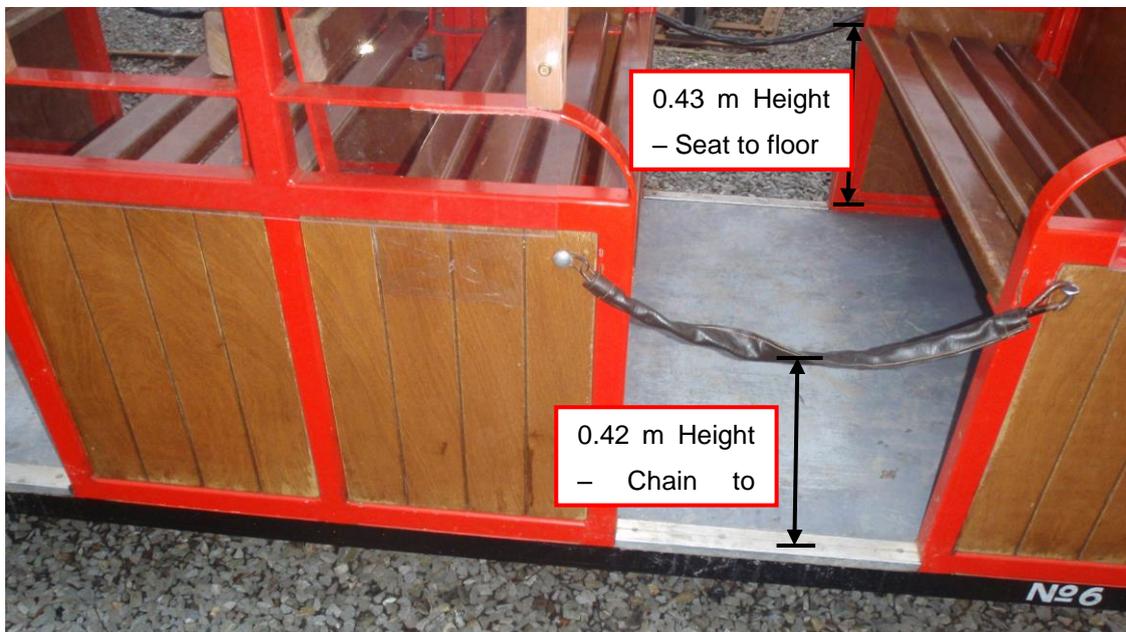
Figure 10 – Heights, from floor, of seat and chain

- 45 On the open carriage the height of the seat from the floor level was 0.43 m, see Figure 10, and the height of the chain from the floor level is 0.42 m, meaning the middle portion of the chain is below the seat height, see Figure 10.
- 46 It should be noted that a chain was added to the carriage post manufacture, there was no record of this having been done or for what reason, but as previously mentioned the carriage was approved by the CRR.

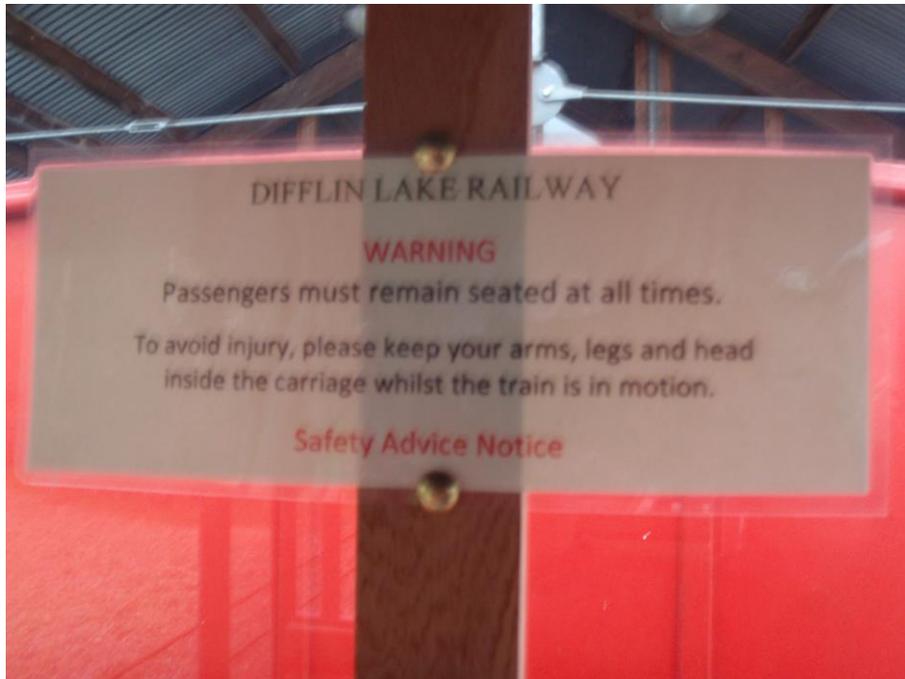
Figure 12 - Notice to passengers displayed on each carriage

85 In addition, DLR have partially addressed the need of passengers to remain seated” through placing notices on the end wall of each carriage, which states “Passengers must remain seated at all times. To avoid injury, please your arms, legs and head inside the carriage whilst the train is in motion”, (Figure 12.)

133 It should be noted, that one of the positives, in relation to the communication of passengers remaining seated is that DLR have erected numerous signs in relation to this (paragraph 85).

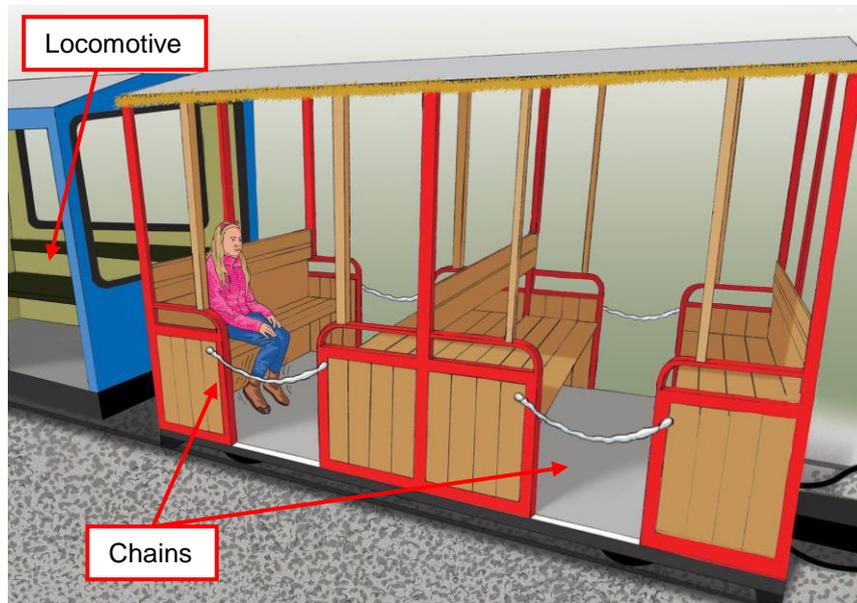
Figure 14 – Girl A positioning in the open carriage

104 Girl A was seated with her back to the locomotive with the legs swinging freely or the tip of her toes touching the floor, as there was an approximate gap of 0.1 m from her feet to the floor level⁶, see Figure 14.

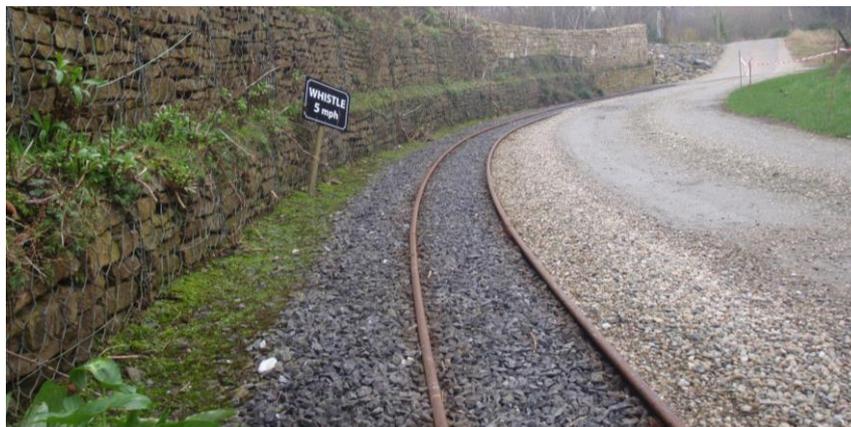
Figure 15 –Trout Lake Curve

106 Just after 17:00 hrs the train departed the designated drop-off/pick-up point and almost immediately began to negotiate right hand curve around Trout Lake curve, (Figure 15).

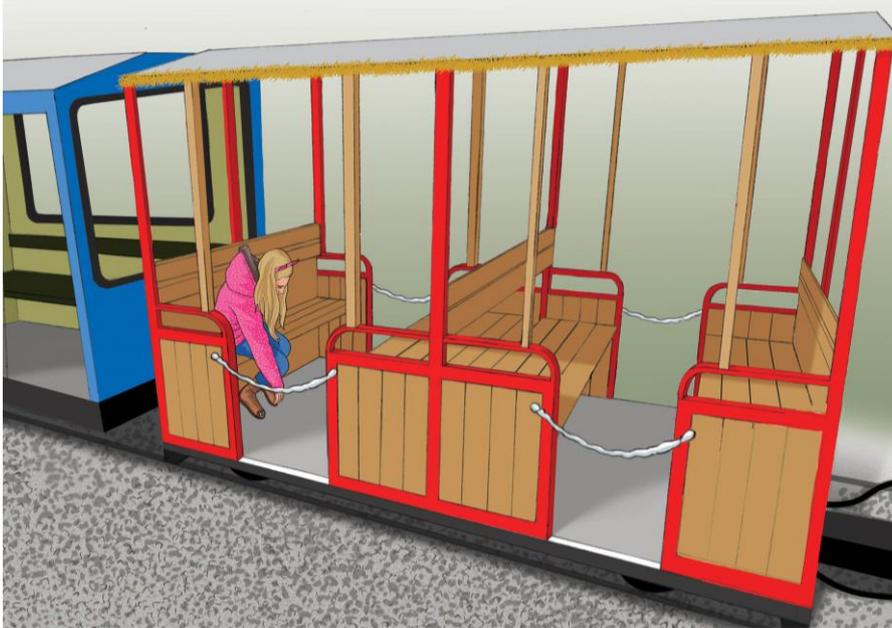
Figure 16 – Girl A leaning forward

107 As the train was travelling, Girl A was seated (as reported by witnesses), and momentarily leaned forward to clean her new boots with her hand, see Figure 16.

152 Girl A's sudden movement attempting to clean her shoe, resulted in an unstable condition, that meant minimal force was required to roll Girl A out of the seat. Girl A being in an unstable position was unable to withstand normal swaying movement of a train in motion (paragraphs 143-148). Better direct supervision of the girl could have mitigated this risk.

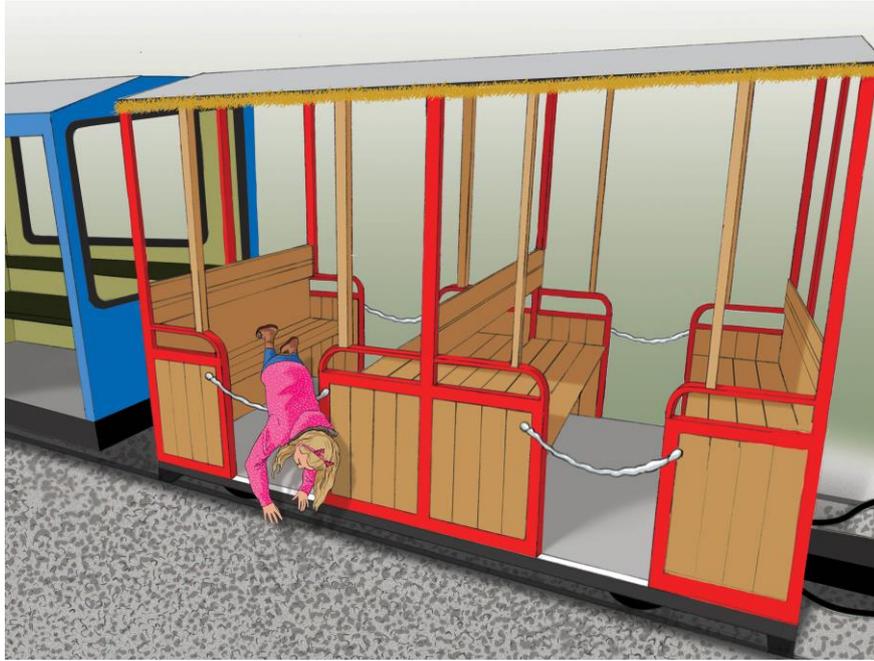
Figure 17 – Girl A falling over the chain

⁷ Girl A (mass of 23kg) experienced an average acceleration of 0.206m/s² which would have resulted in a force of 4.7N (1kg bag of flour exerts 10N of force on a table). Using the maximum calculations, Girl A experienced a maximum acceleration of 1.2 m/s² which would have resulted in a force of 27.6N.

147 This motion would have changed the centre of gravity of Girl A and combined with a cornering force would have caused the unstable Girl A to roll forward, off her seat and towards the outside of the carriage.

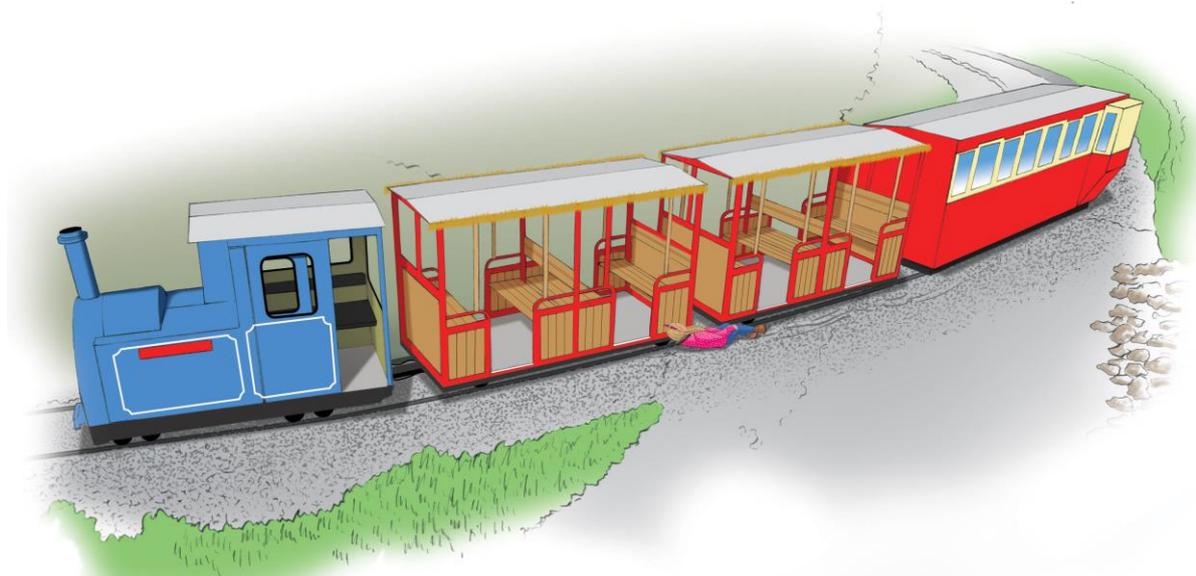
Figure 18 – Girl A being dragged along the gravel

111 Once outside the confines of the train, Girl A's puffy jacket became entangled in the 'C' channel beam on the end of the carriage (paragraph 43) and dragged her along the gravel, see Figure 18.
