**Railway Accident
Investigation Unit**

INVESTIGATION REPORT
Car strikes train at level crossing XM250,
Knockaphunta, Co Mayo
8th June 2014

RAIU Report No: R2015 – 002R1
Published: 04/06/2015

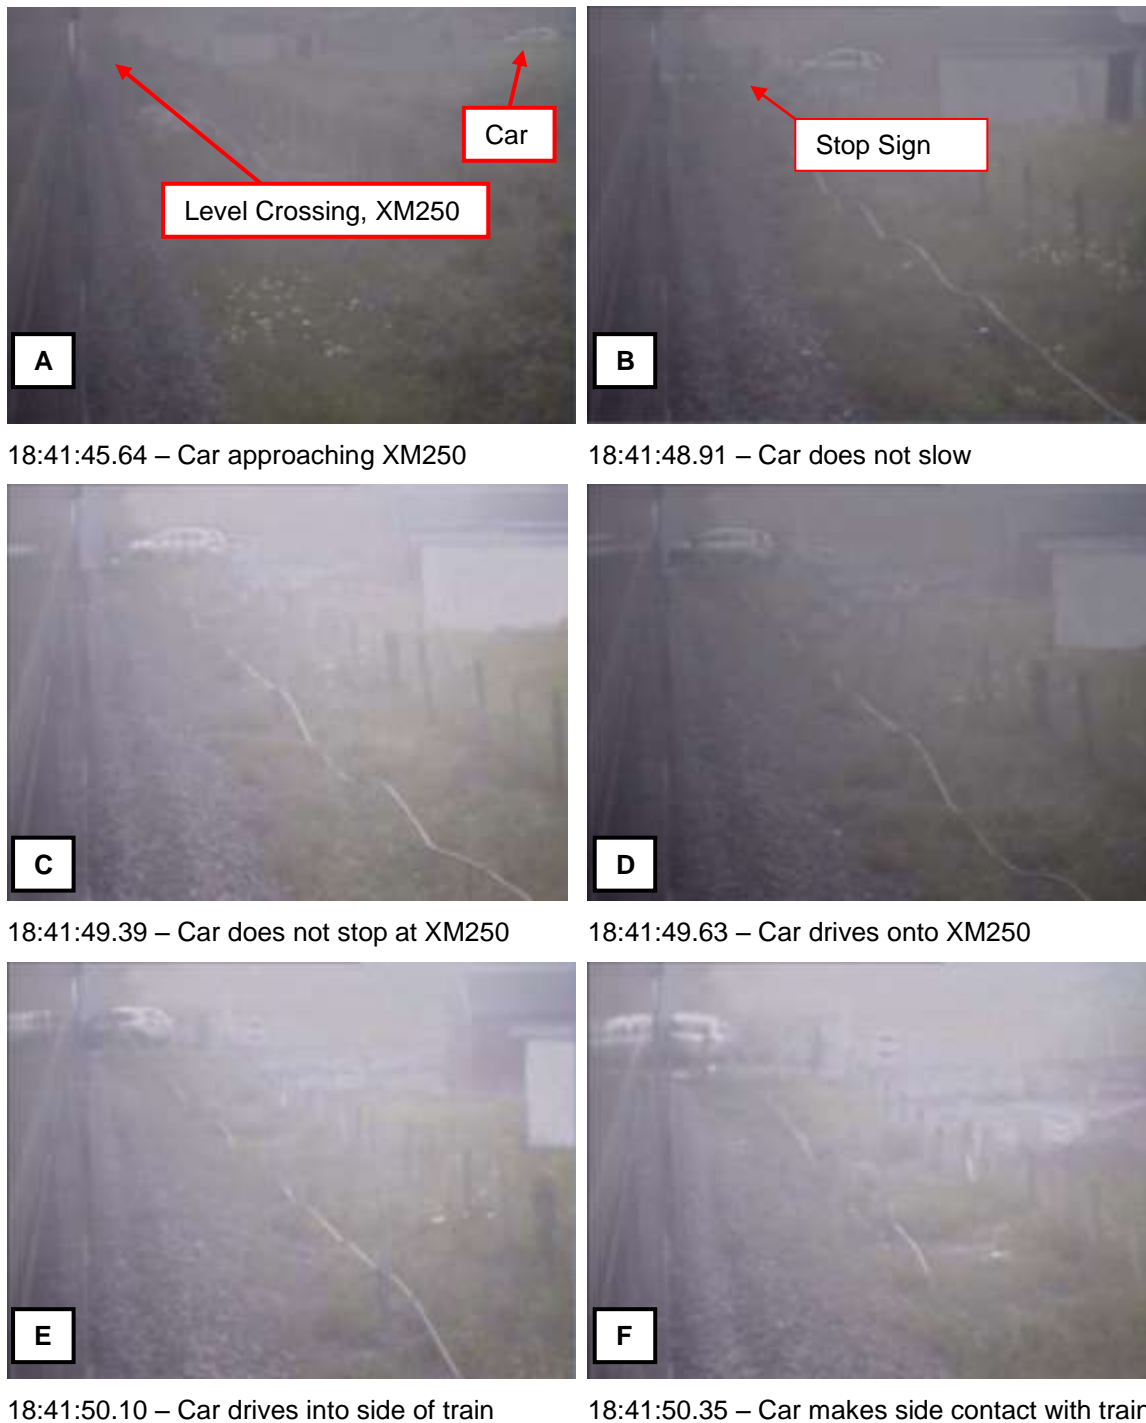
Figure 2 – Car approaching Level Crossing and striking train

- 2 As the train was travelling through the level crossing, a car approached the level crossing from the direction of Castlebar onto the *up side* of the track (see Closed Circuit Television (CCTV) stills A, B, C of Figure 2 (note: the poor resolution of the CCTV is not weather related but due to a build-up of grime on the camera lens housing). The car did not slow or stop as required on the approach to the level crossing and continued to drive onto the level crossing (see CCTV still D of Figure 2) and into the side of the train (see CCTV still E of Figure 2). The period of time from when the car first came into the view of the train and the impact was 4.46 seconds.

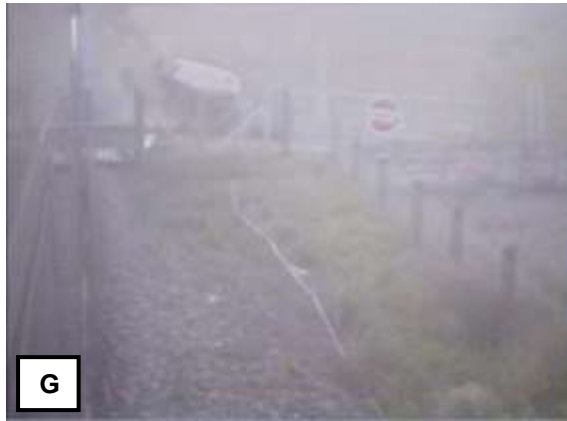
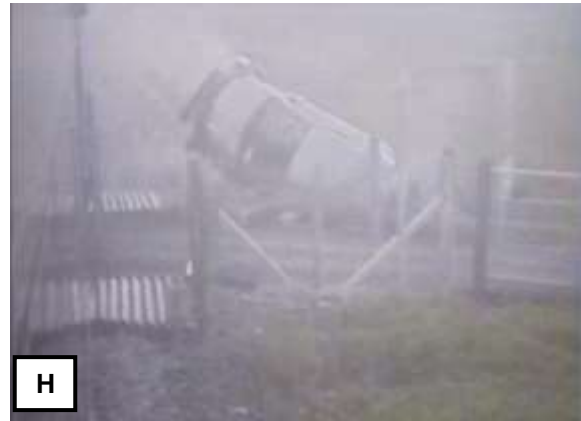
Figure 3 – Car clearing the path of the train

- 3 The train driver immediately applied the emergency brake and the train came to a stop beyond the level crossing.
- 4 The car was dragged sideways by the train, breaking through the concrete post and wire fencing and into the ditch adjacent to the level crossing (see CCTV stills G, H of Figure 3).

18:41:51.31 – Car travels through fencing

18:41:51.79 – Car thrown into ditch

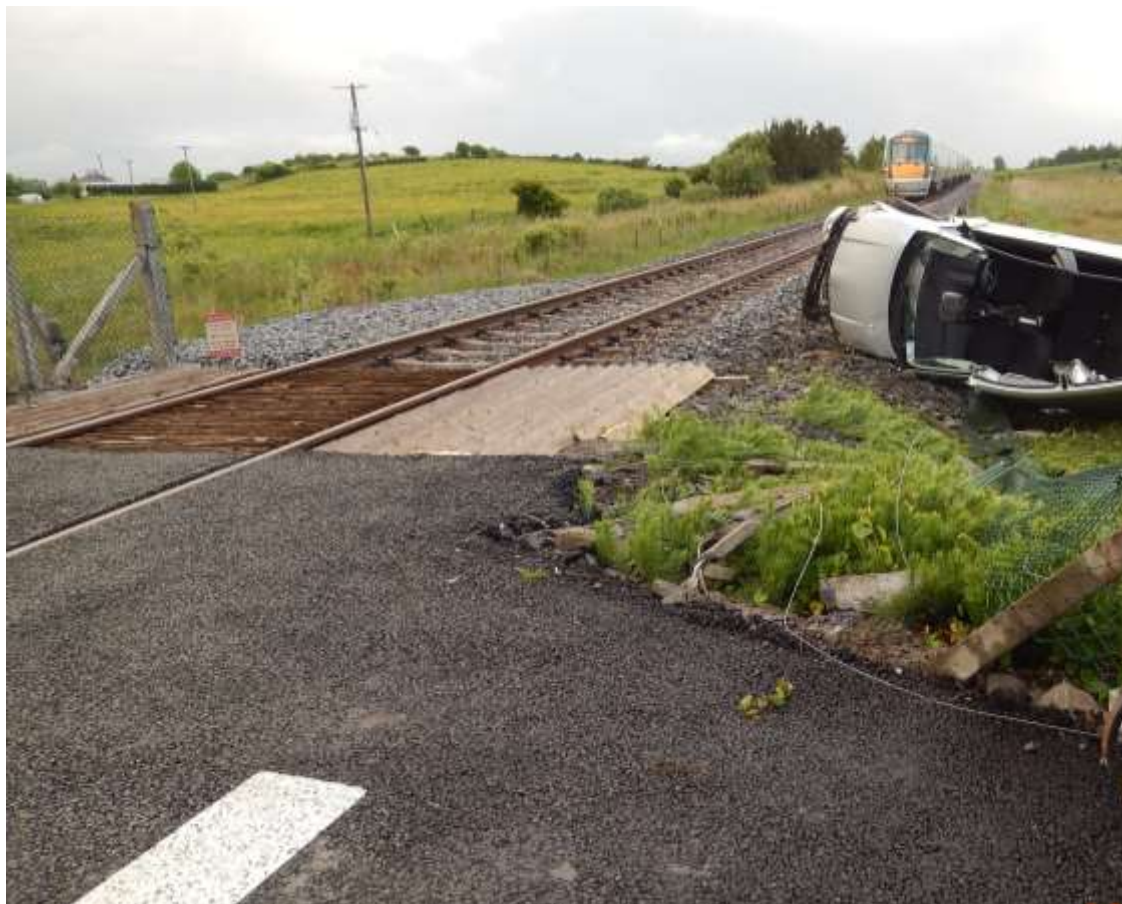
Figure 4 – Car in drainage ditch adjacent to the level crossing & stopped train

- 5 The car came to a stop 10.2 m from the initial point of contact with the train, see Figure 4 (note that the emergency services removed the roof and windscreen of the car to access the car driver).

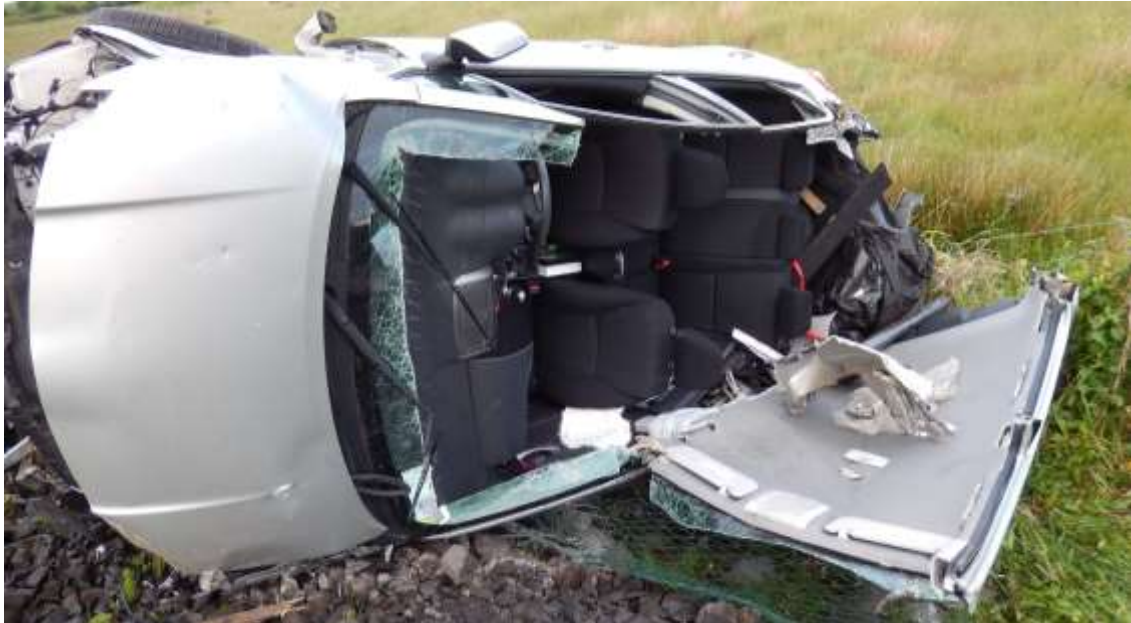
Figure 6 – Damage to car

- 33 The car, a 2009 registered Toyota Auris, was extensively damaged as a result of the accident, Figure 6. Note that the roof and windscreen were removed by the emergency services.

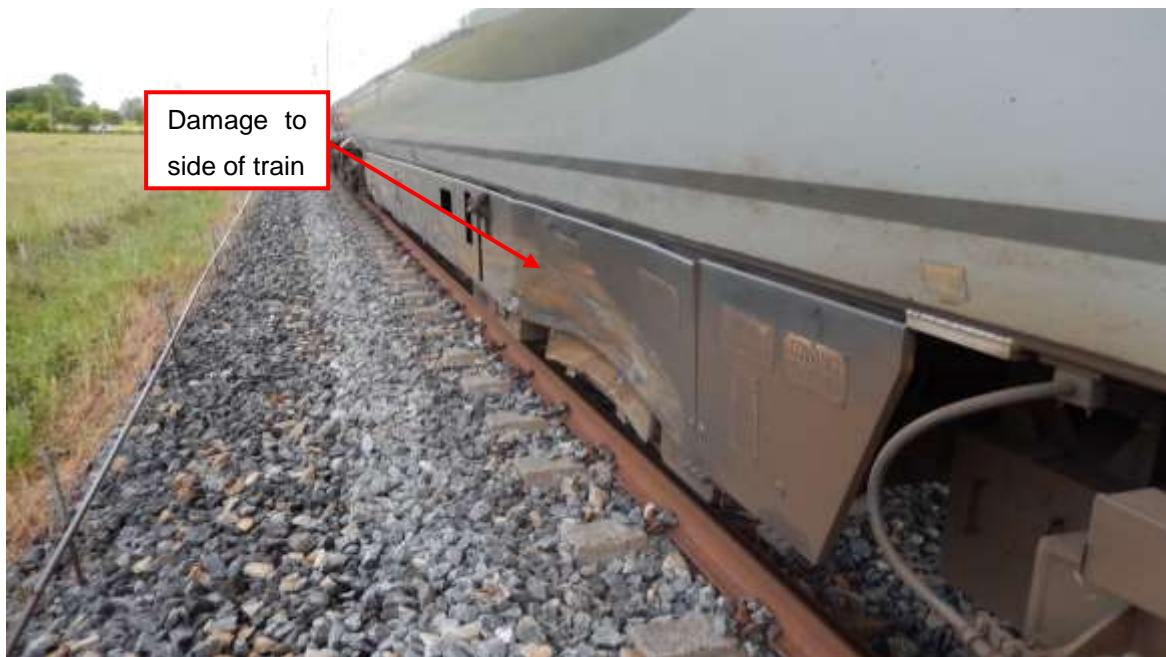
Figure 7 – Damage to the side of the train

- 34 The train was struck on the side damaging the external cabinets and panel, approximately 7 m from the front of the train, see Figure 7.

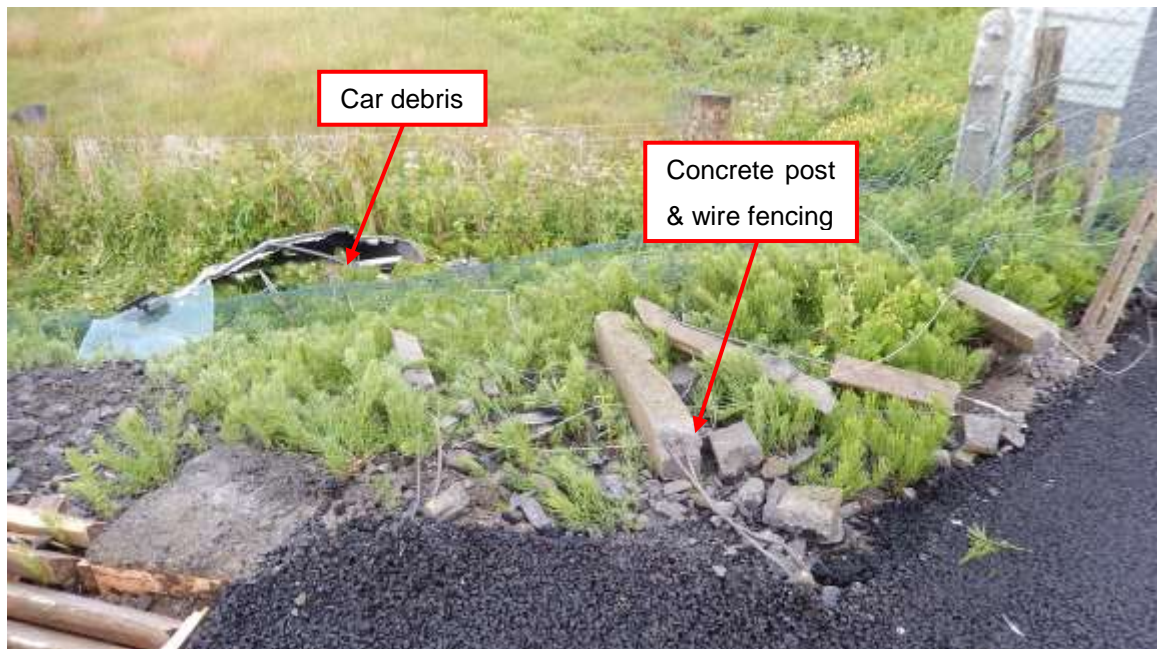
Figure 8 – Damage to level crossing fencing (with debris from car in the background)

- 35 The concrete post and wire fencing at the level crossing was knocked over by the car, on impact, see Figure 8.

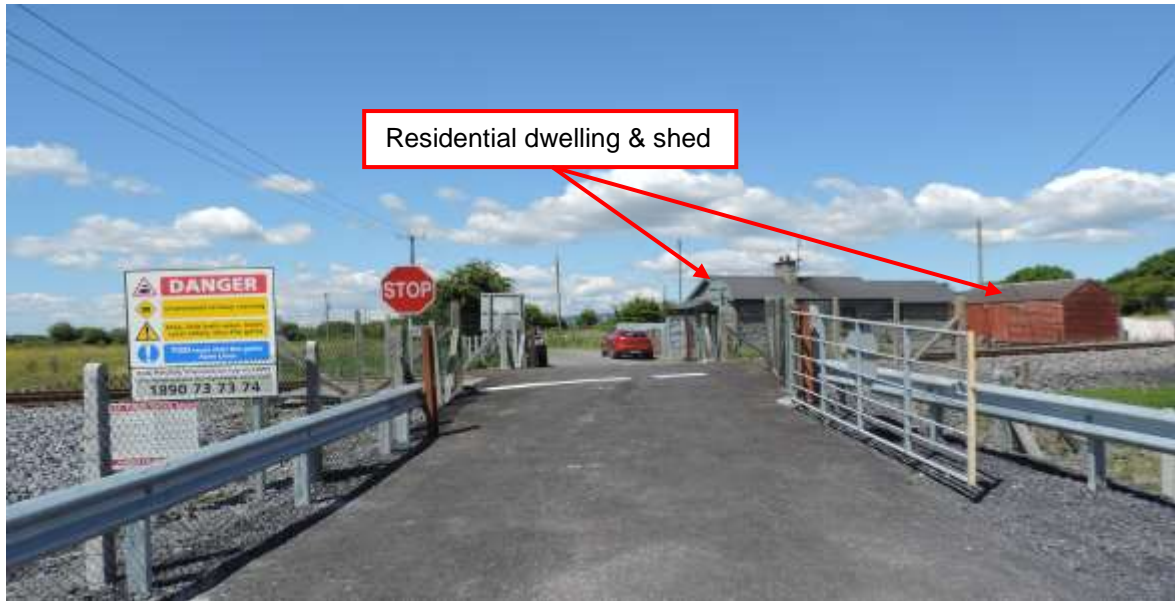
Figure 10 – Residential dwelling and shed

- 43 A residential dwelling (an old railway building) and shed are located 20 m and 15 m, respectively, from the up side of the Level Crossing, see Figure 10.

128 The viewing distances exceed the requirements set out in CCE-TMS-380 from the crossing at the marked white line. However as noted in paragraph 43, there is a dwelling and shed on the near side as a motorist approaches the crossing from the N5 direction which obscures the view to the left on approaching the level crossing.

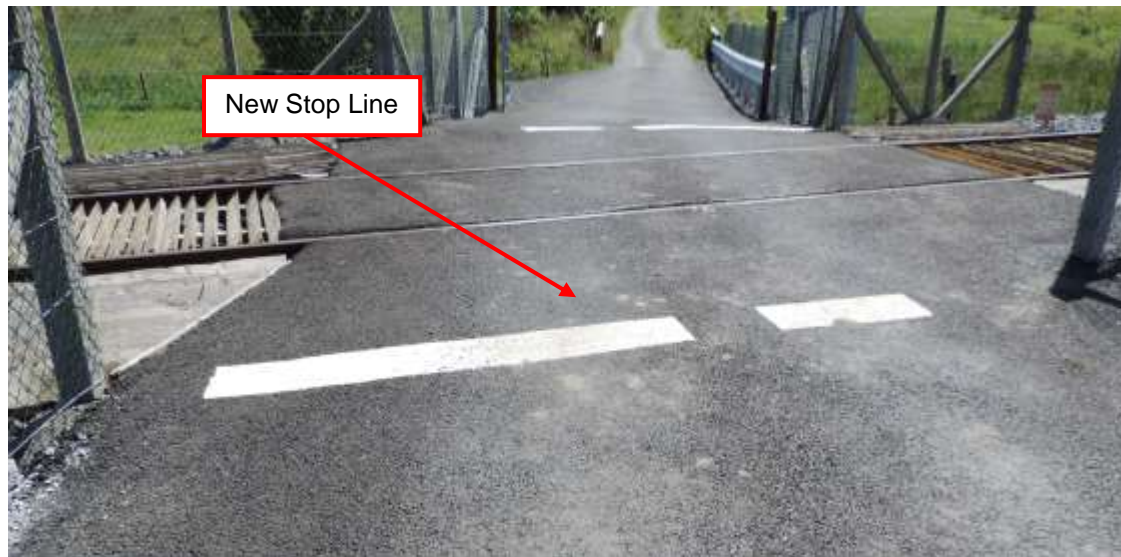
Figure 19 – New Stop Line at the level crossing

- 58 As a result of this consultation, IÉ have commenced painting a 300 mm white line, in the place of any other Stop Line. These white lines are to indicate, to the level crossing user, the safe distance that a vehicle user can stop without the vehicle encroaching onto the path of trains, this is sometimes referred to as the 'decision point' i.e. the point where the motorist decides to cross if safe to do so, and is referred to in this report as the New Stop Line.

126 The Stop Line road marking was introduced by IÉ to show the level crossing users where to stop to safely look for approaching trains (paragraphs 54 - 59). The signage present at the time of the accident does not describe the purpose of this Stop Line; although it is noted that it is clearly given in the new signage currently being trialled.

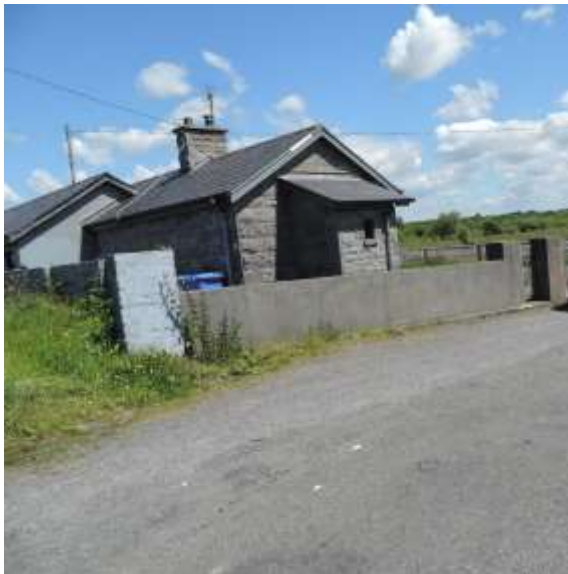
Figure 20 – House on the approach to level crossing

62 On the approach to the level crossing from the direction of the N5, there is a dwelling house with a wooden shed to the rear of the property. Figure 20 show how the drivers view is obscured by the house and shed on approach to the level crossing. However, the view towards Castlebar from behind the New Stop Line is clear and unobstructed, Figure 21.

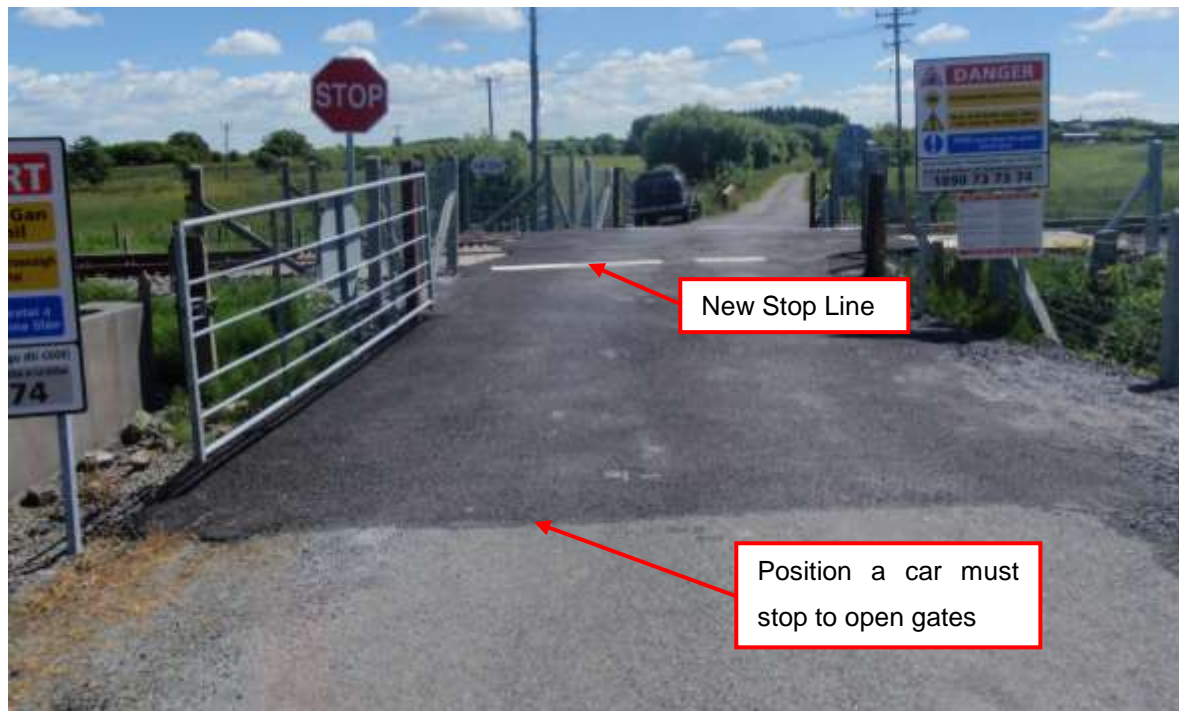
Figure 28 – Car Driver's stopping position and New Stop Line stopping position

77 The Car Driver described to the RAIU, their understanding of the safe operation of the Level Crossing, which entailed stopping at the Level Crossing to open the gates (at the point that the road surface changes), opening the gates, looking for trains as the gates were opened and continuing over the Level Crossing. The Car Driver was unaware that they were supposed to then move forward towards the Stop Line at the crossing and look for approaching trains from this position, see Figure 28.

139 It should also be noted that the Car Driver did not have a clear understanding of how to operate the Level Crossing and was unaware that they were required to drive up to the Stop Line to look for approaching trains; instead they thought that motorists had to stop in the location of the old Stop Sign, open the gates on both sides and continue over the Level Crossing (paragraphs 77 - 78).

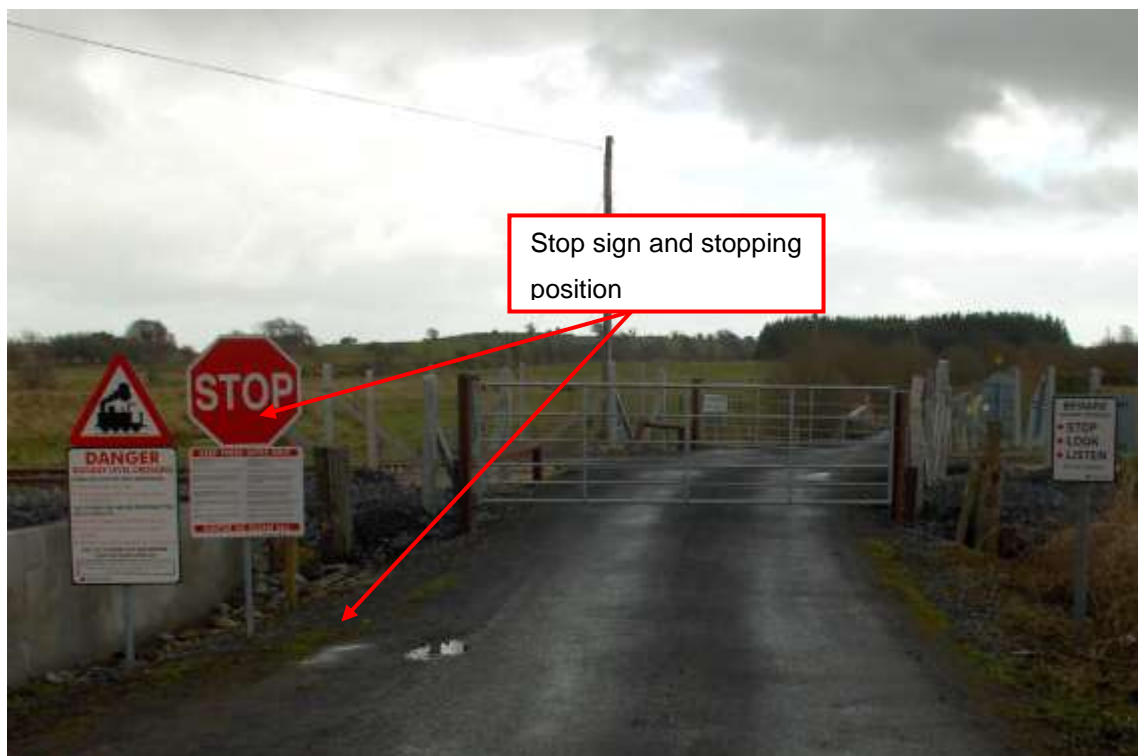
Figure 29 – Old signage at the Level Crossing (pre 2010)

78 In should be noted that the stopping position used by the Car Driver is in the same position as the old position of the Stop Sign, see Figure 29. This signage was changed in June 2010.
