Railway Accident
Investigation Unit
Ireland

Investigation Report

Bearing failure on a train at Connolly Station,

Report number: 2012-R003

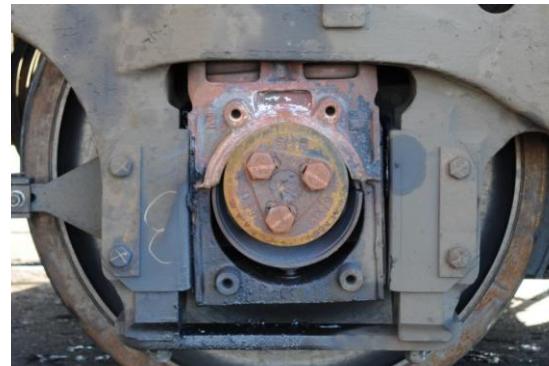
Figure 2 - Failed bearing in axlebox

- 5 The train arrived in Connolly station at 18:33 where it was inspected by a member of CME maintenance staff. The last axlebox on the right side of the train was found to be red hot and smoking. It had suffered a failed bearing. Figure 1 shows the locomotive and Figure 2 shows bearing and its axlebox after they had cooled.

25 The axle journal bearing was destroyed. The *axle journal*, axlebox, pedestal liners and axlebox springs suffered heat damage and were not suitable for further use.

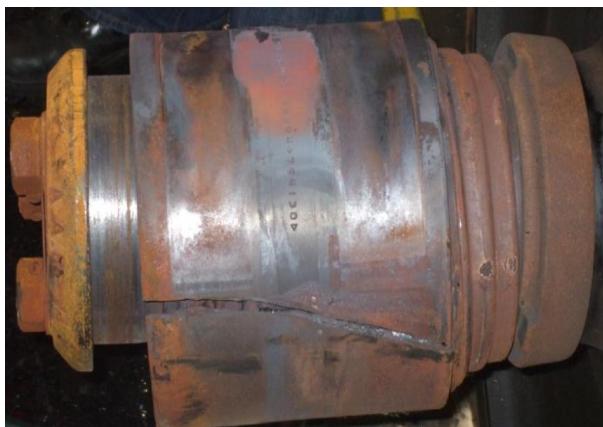
Figure 4 – Bearing on axle journal

- The outboard seal was missing, the seal wear ring in situ. See Figure 4;
- The cup was fractured along its complete width at a position approximately ninety degrees from the centre of the load zone at the top of the bearing where it supports the axlebox, see Figure 4. Metallurgical examination of the cup carried out by ESR Technology on behalf of the RAIU showed no evidence of fatigue and there was no evidence of the cup having been subject to an impact (ESR, 2012). Rollers and sections of the cages of both the outboard and inboard cones were fused to the cup in the area of the load zone, see Figure 7;

- The end cap was in situ with the end cap screws and locking tabs in place, it had suffered flash corrosion as shown in Figure 4.

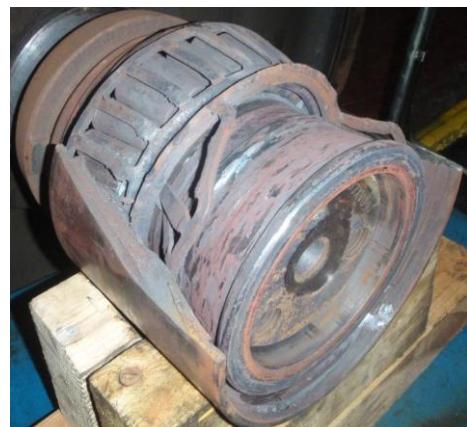
Figure 5 - Inside of bearing

- The grease was lost;
- The backing ring suffered no visible damage;
- The inboard seal was deformed with part of its garter spring protruding, the inboard seal wear ring was in situ;
- The inboard cone had a skewed cage with lipping evident on the sections between the rollers, its rollers were all damaged with several fused to the cup, its raceway surface was covered in smeared metal from the rollers. See Figures 5 and 7;
- The cone spacer was in situ, see Figure 6;

- The outboard cone had a broken cage, the majority of its rollers were missing with several that had fused to cup in load zone, its raceway surface was covered with smeared metal from the rollers. See Figures 5 and 7;

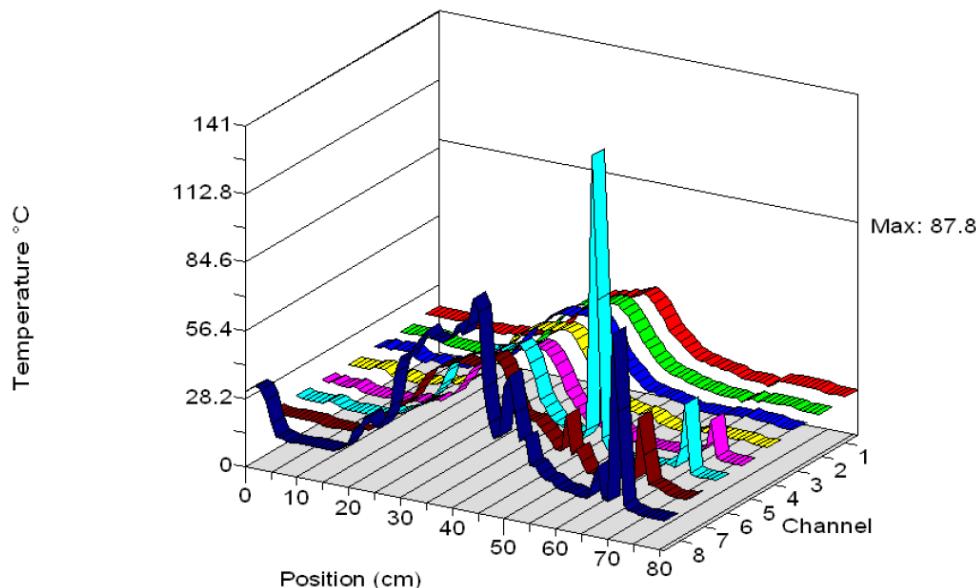
Figure 8 – Drogheda Up HABD temperature readings

- 70 A Differential Alarm was triggered at the Drogheda Up HABD by the last axle on the train. The Drogheda HABD system recorded an axlebox temperature of 87°C for the position of the failed bearing and an axlebox temperature of 22 °C for the other end of the axle, giving a differential temperature of 65°C. A graphical record of the eight point temperature reading for the failed bearing's position is shown in Figure 8, which shows that the alarm was triggered by the sixth sensor registering a temperature spike of 87.8°C. The sensors are referred to as channels 1 to 8 with channel 1 being to the inboard side of the bearing.
