**Railway Accident
Investigation Unit
Ireland**

INVESTIGATION REPORT

**Near miss with an Iarnród Éireann SET Worker at
Rush and Lusk Station, 20th June 2019**

RAIU Report No: 2020 – R003

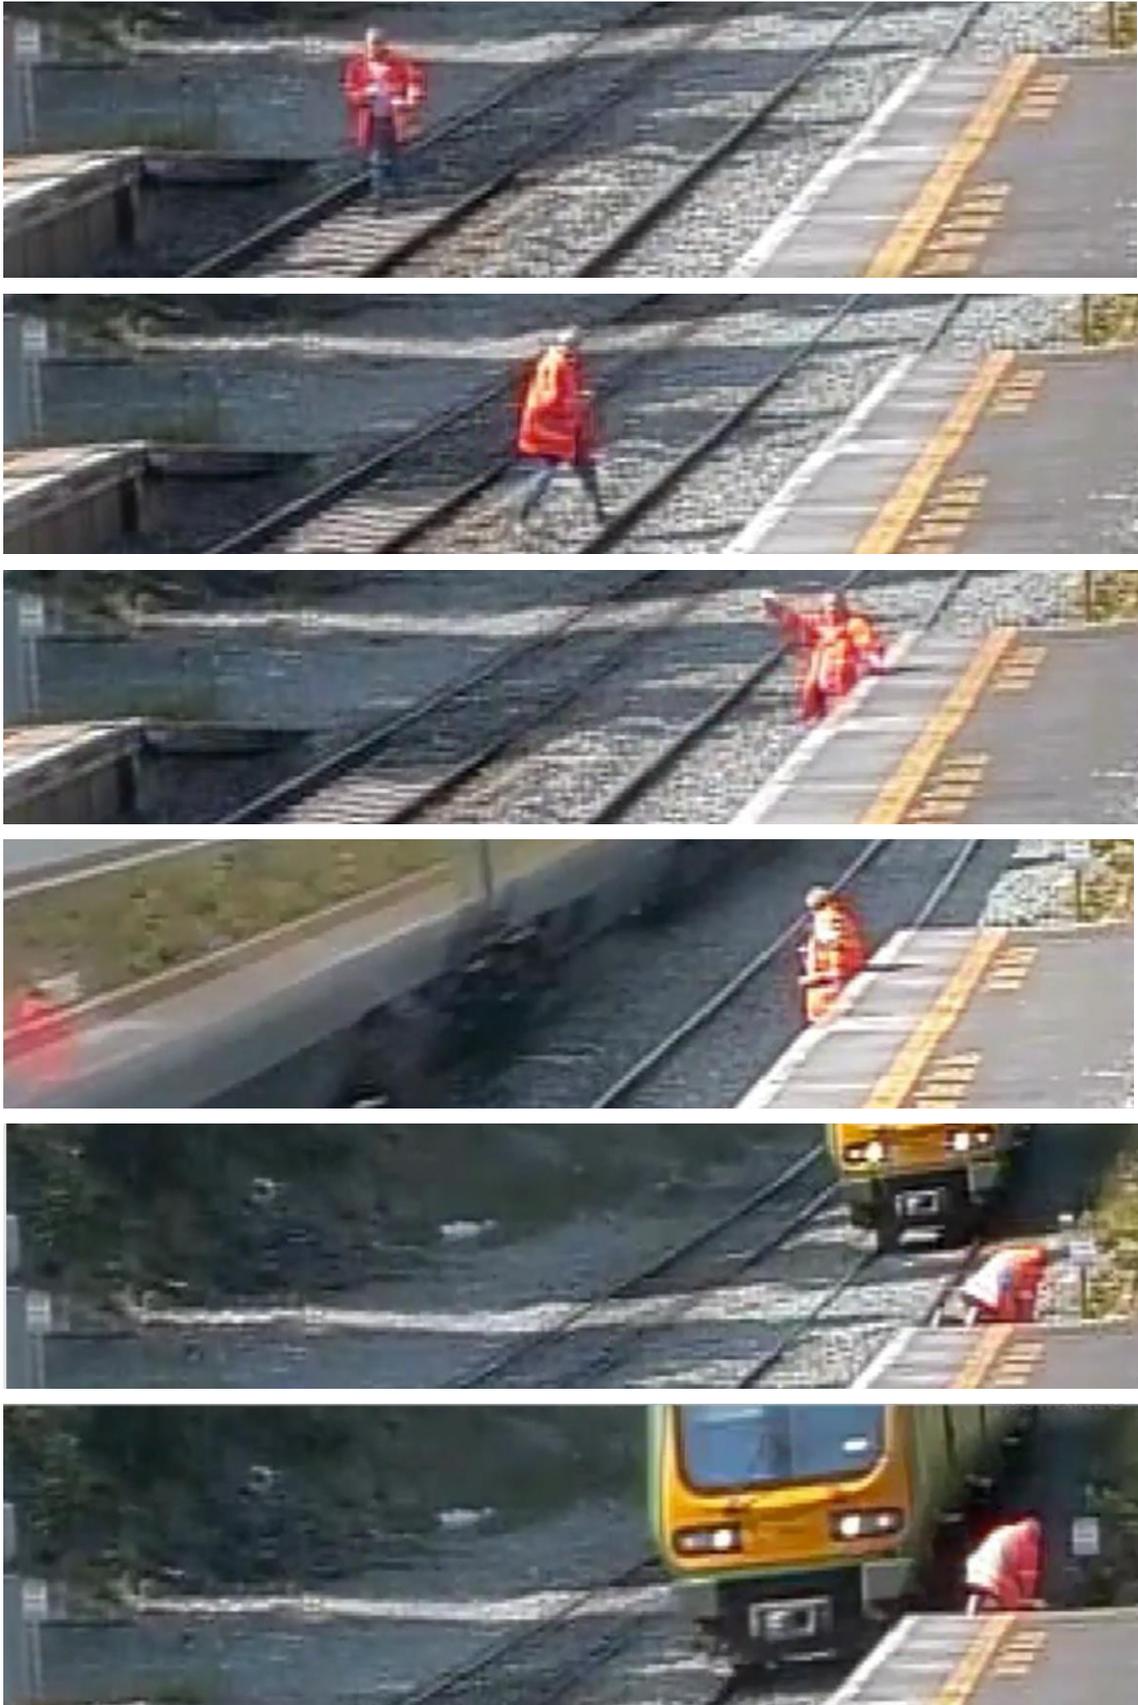
- 15 At 09:50:56, the SET Worker is more than 1.5 m from the track, in a position of safety; he does not suffer any injuries as a result of the incident.

Figure 1 – Train travels passed the SET Worker while not in a position of safety

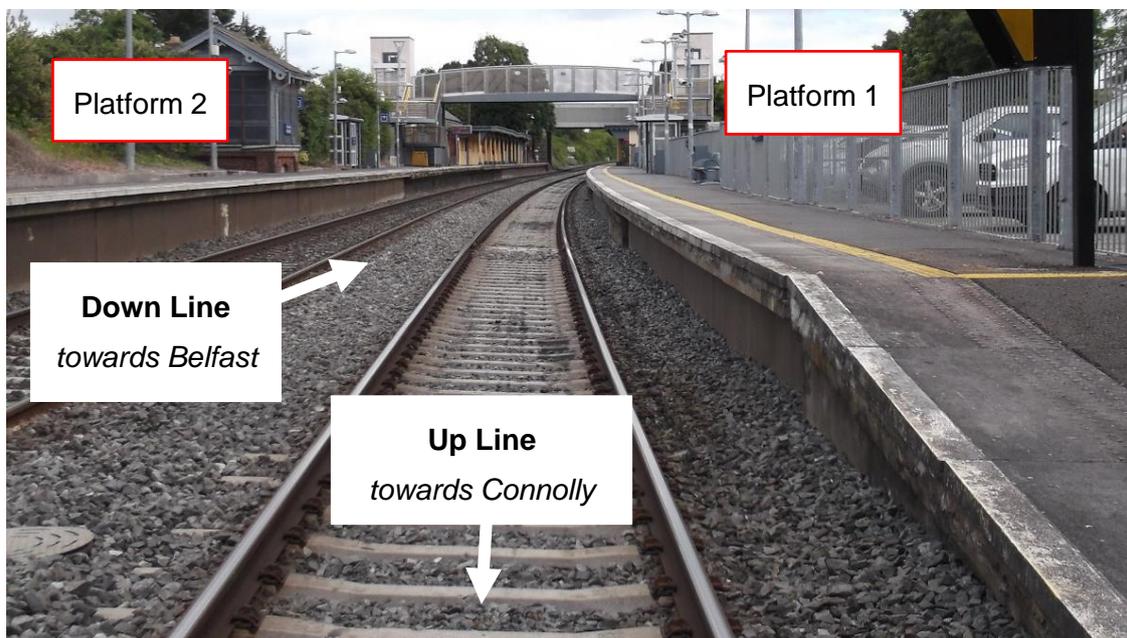
16 Rusk and Lusk Train Station is located between the towns of Rush and Lusk, in north County Dublin at the 14 *milepost* (MP), see Figure 2. The line involved is the Dublin/Belfast mainline. There are continuously welded rails (CWR) mounted on concrete sleeper tracks running through the station (see Figure 3). Rush and Lusk Station has two 175 metre (m) platforms, situated on a curve, Figure 3. As there is not 1.5 m clearance between the platforms; this area is an area of *limited clearance*.

Figure 3 – Curved station platforms (image taken from IÉ Report No. R1007-2019-56)

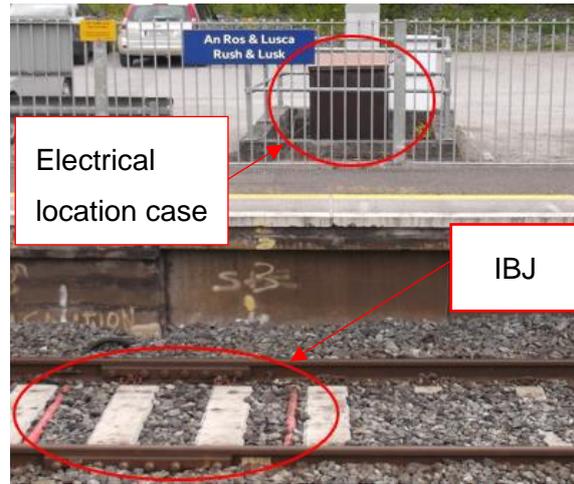
17 An electrical location case is located in the carpark adjacent to Platform 1, see top red circle in Figure 4 (image taken from IÉ Report No. R1007-2019-56); with cabling running from the electrical location case under Platform 1 to an Insulated Block Joint (IBJ) on the Up Line, see bottom red circle in Figure 4. This is the equipment that the SET Worker was examining on the day of the incident. Both these items of equipment can be viewed from Platforms 1 and 2.

Figure 4 – Electrical location case & IBJ

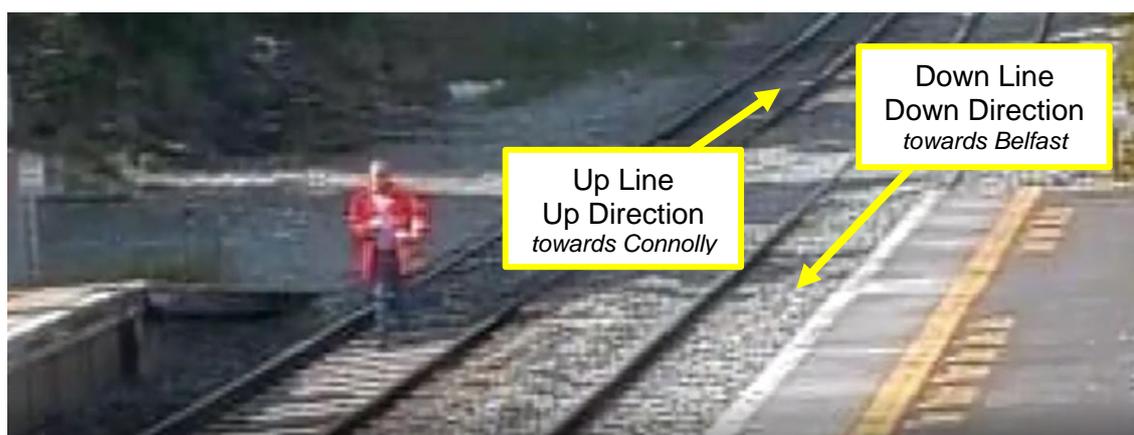
- 64 At 09:50:31 the SET Worker leaves the ramp at Platform 1 and is walking in the down direction on the Up Line, holding a drinking cup in his right hand and paperwork in his left hand, see Figure 7 (images taken from station CCTV). He is now positioned in an area of limited clearance⁵

Figure 7 – SET Worker walking on the Up Line

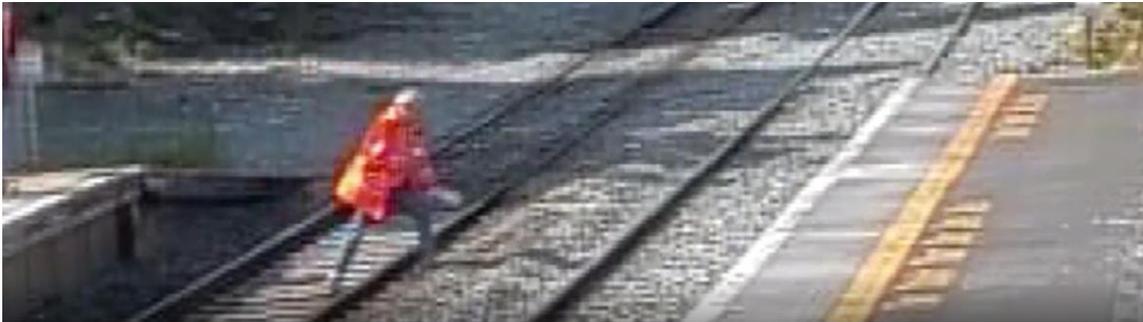
65 At 09:50:38, the SET Worker hears the horn of the 08:00 hrs Belfast to Connolly passenger train and looks up and sees it approaching and starts to walk towards the Down Line, see Figure 8.

Figure 8 – SET Worker walking towards the Down Line

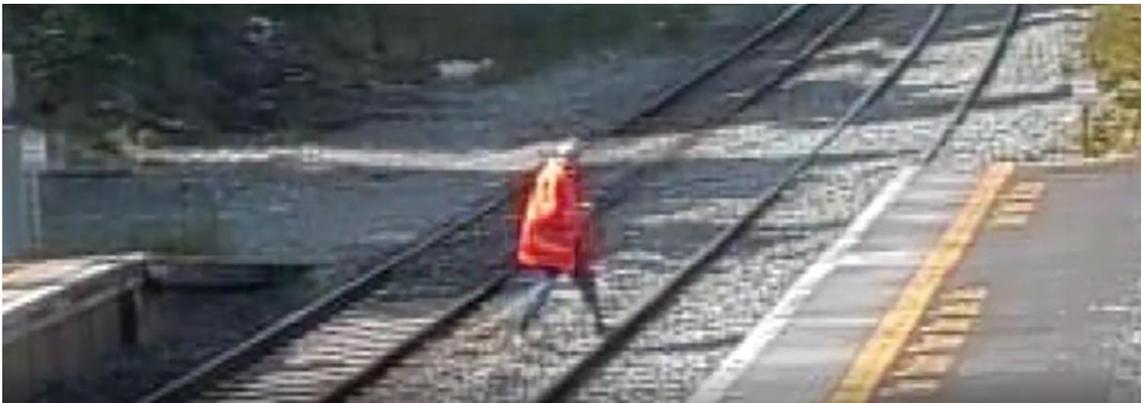
66 While crossing lines, he looks in the Up Direction, at the Down Line, see Figure 9.

Figure 9 – SET Worker looking, in the Up Direction, at the Down Line

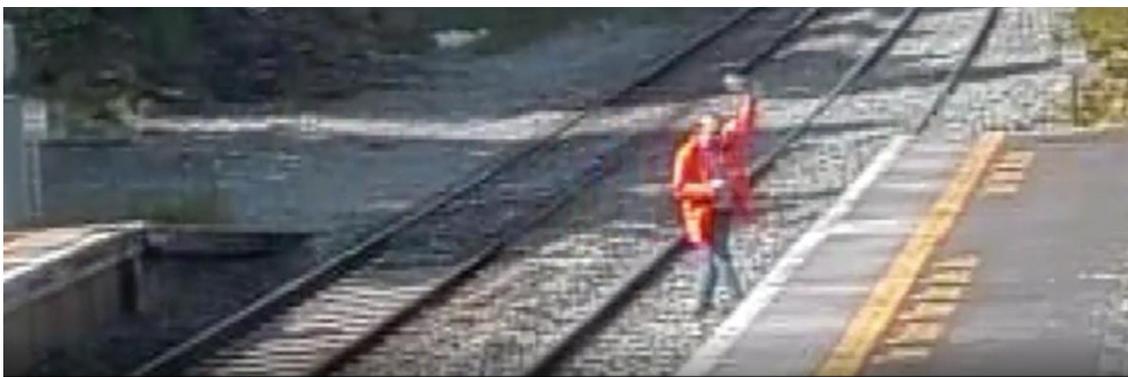
67 At 09:50:42, while standing in the middle of the Down Line, he raises his hand above his head to acknowledge the presence of the train, see Figure 10; he is not in a position of safety, he remains in an area of limited clearance⁶.

Figure 10 – SET Worker raising his hand over head to acknowledge the train

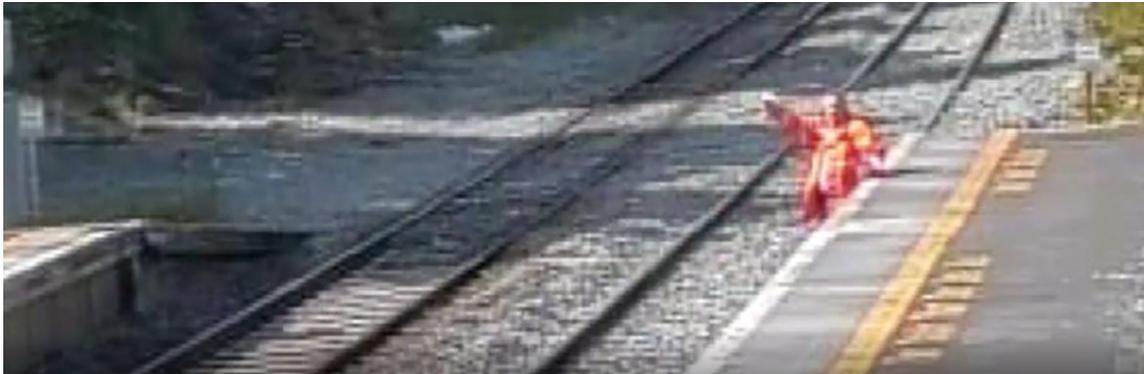
68 At 09:50:44 is walks across to the Down Platform and leans his elbow down on the platform and raises his other hand to acknowledge the train for a second time, see Figure 11; he is not in a position of safety.

Figure 11 – SET Worker acknowledging train for second time

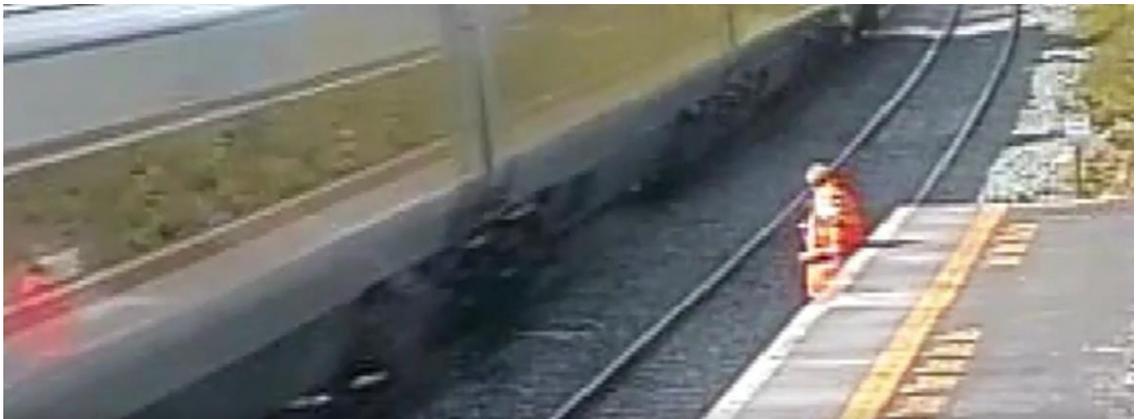
69 At 09:50:46, as the SET Worker watches the Belfast to Connolly train pass, the SET Worker sees the 09:29 hrs Pearse to Drogheda empty train approaching on the Down Line, see Figure 12.

70 The driver of the 09:29 hrs Pearse to Drogheda empty train sounds the horn several times and applied the emergency brake on seeing the SET Worker.

Figure 12 – SET Worker sees a train approaching on the Down Line

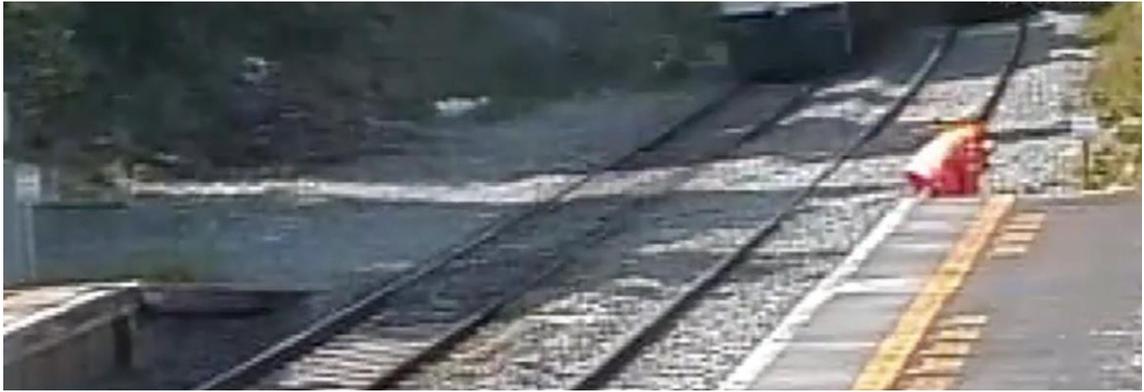
71 The SET Worker walks towards the ramp of the Platform and begins to climb up on the ramp of the Down Line Platform, see Figure 13, he stumbles as he tries to climb up.

Figure 13 – SET Worker climbing the ramp

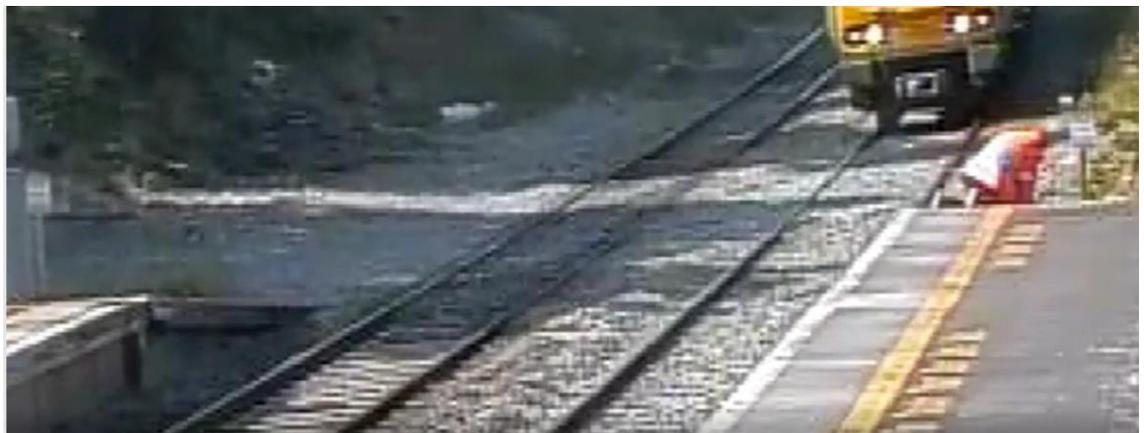
72 At 09:50:53 the SET Worker clears the track, although he is not in a position of safety, see Figure 14.

Figure 14 – SET Worker clears the track

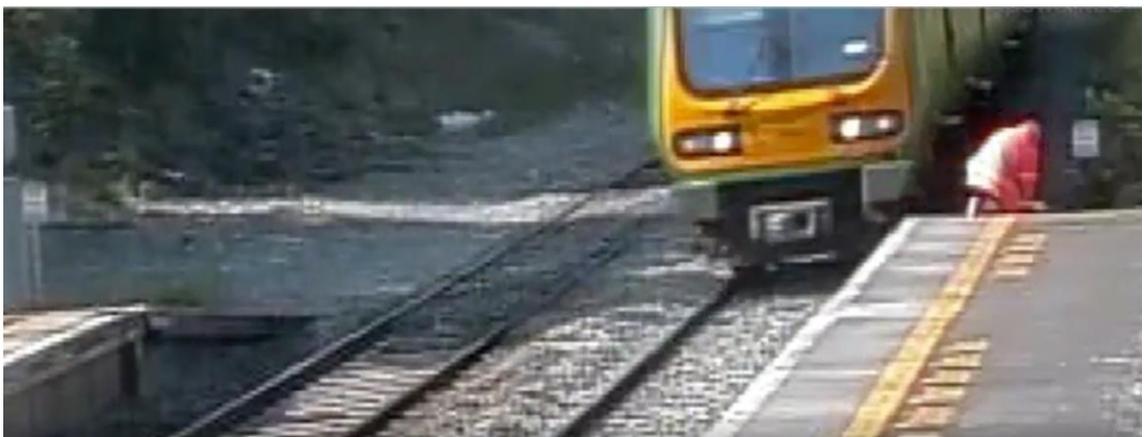
73 One second later, at 09:50:54, the train travels past the SET Worker, see Figure 15.

Figure 15 – Train travels passed the SET Worker

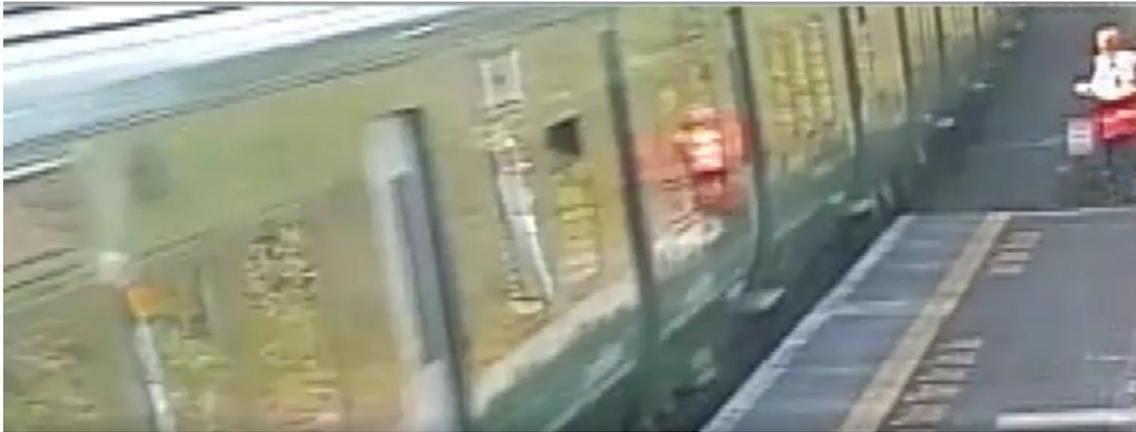
74 At 09:50:56, the SET Worker is more than 1.5 m from the track, in a position of safety, see Figure 16.

Figure 16 – SET Worker in a position of safety

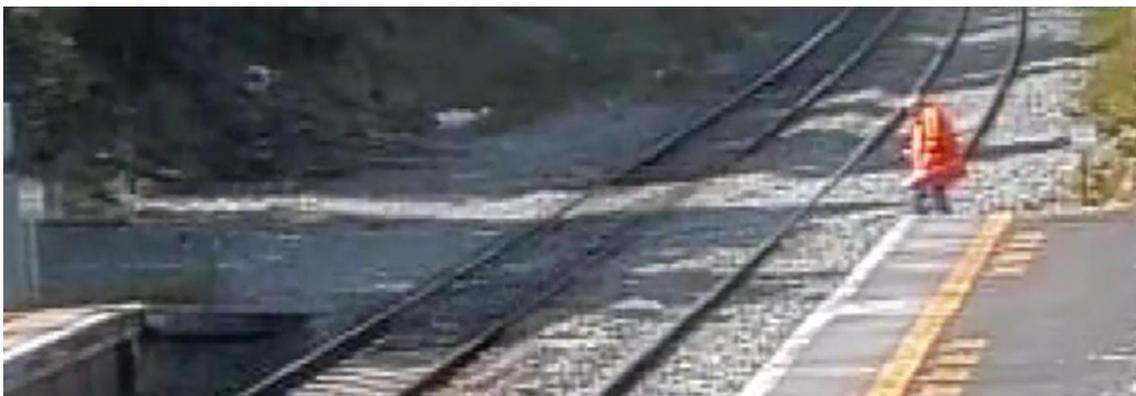
75 At 09:51:11 (seventeen seconds after the incident), the SET Worker travels back down onto the Down Line, see Figure 17.

Figure 17 – SET Worker goes back onto the track

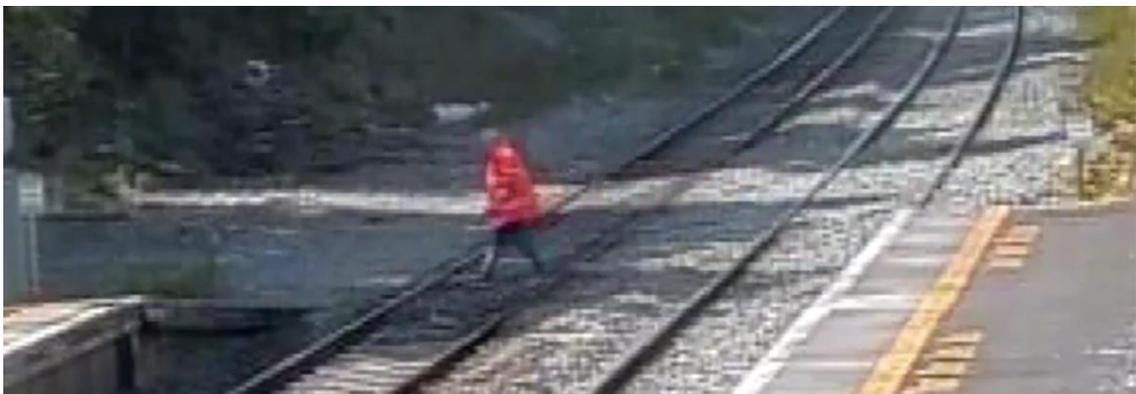
76 The SET Worker crosses the Down Line and the Up Line (09:51:15), see Figure 18; and, onto the Up Platform (09:51:21) into a position of safety.

Figure 18 – SET Worker crosses over the Up Line

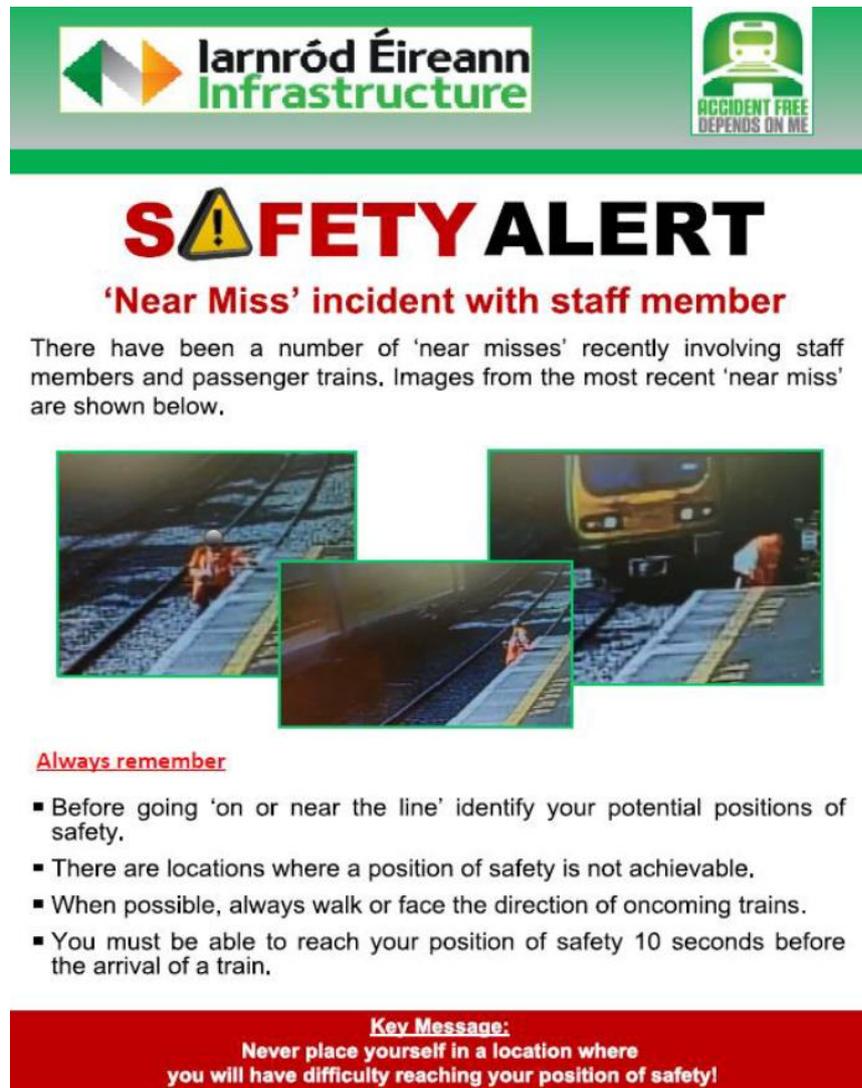
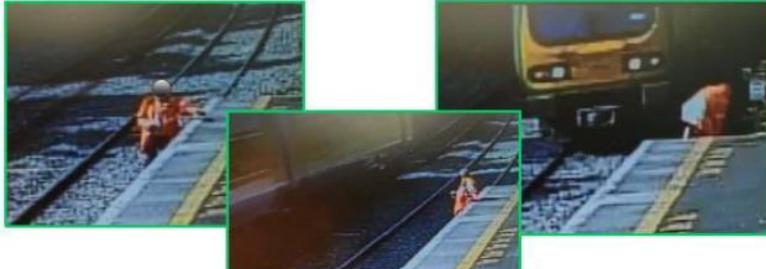
'Near Miss' incident with staff member

There have been a number of 'near misses' recently involving staff members and passenger trains. Images from the most recent 'near miss' are shown below.

- Before going 'on or near the line' identify your potential positions of safety.
- There are locations where a position of safety is not achievable.
- When possible, always walk or face the direction of oncoming trains.
- You must be able to reach your position of safety 10 seconds before the arrival of a train.
