DEPARTMENT OF INDUSTRY AND COMMERCE,  
IRISH FREE STATE.

REPORT ON ACCIDENT TO  
DRUMM BATTERY TRAIN.

24th July 1935.

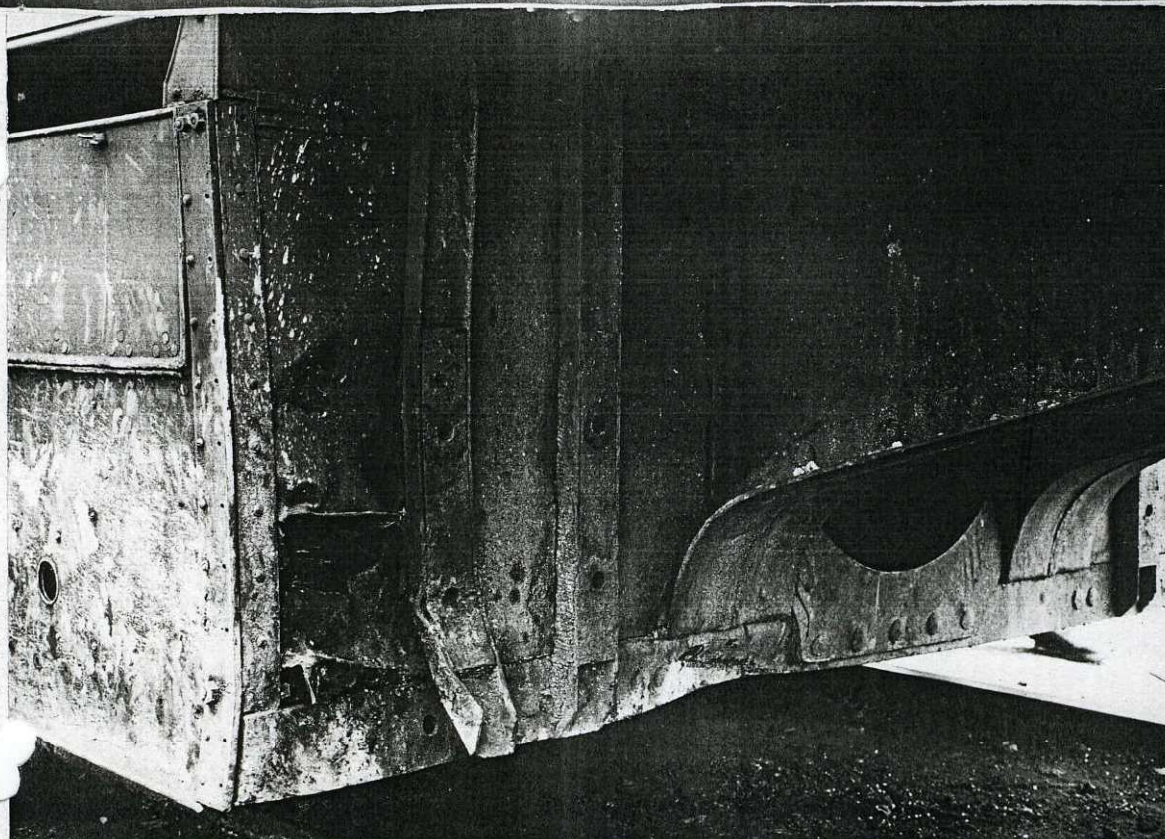
(1) Offside leading corner of leading coach.

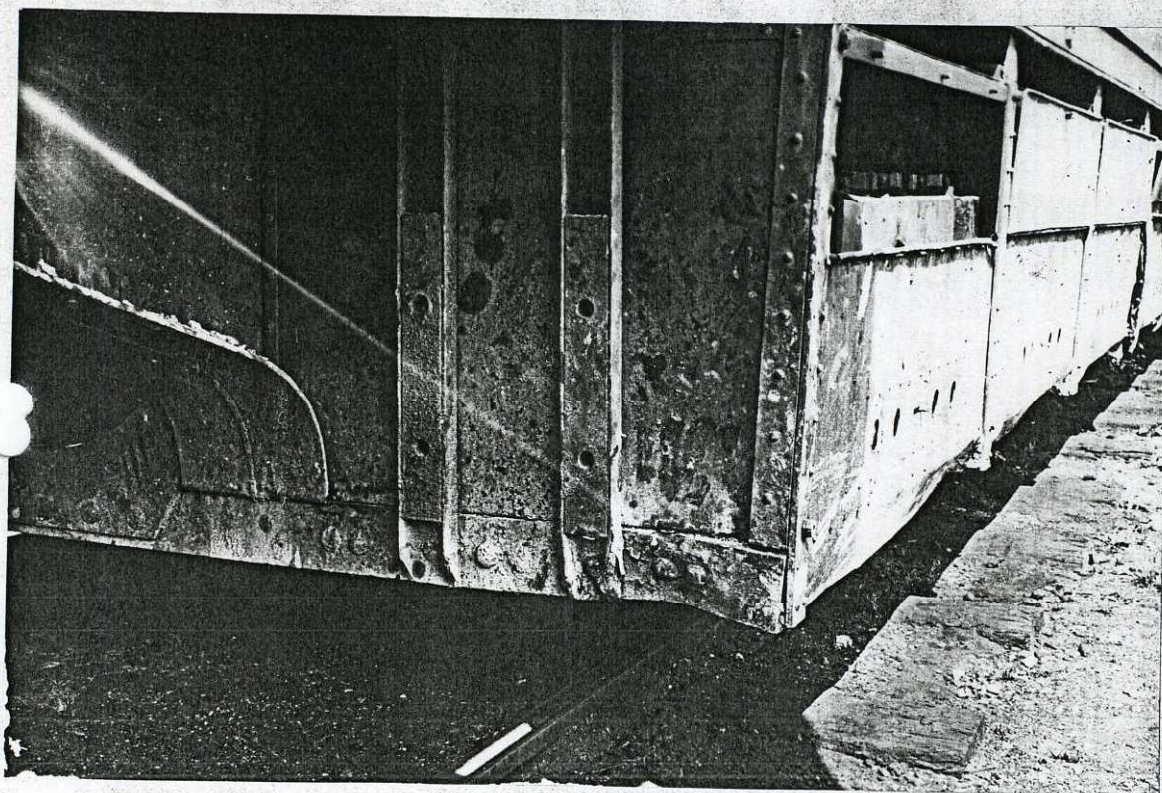
(2) Near side leading corner of leading coach.

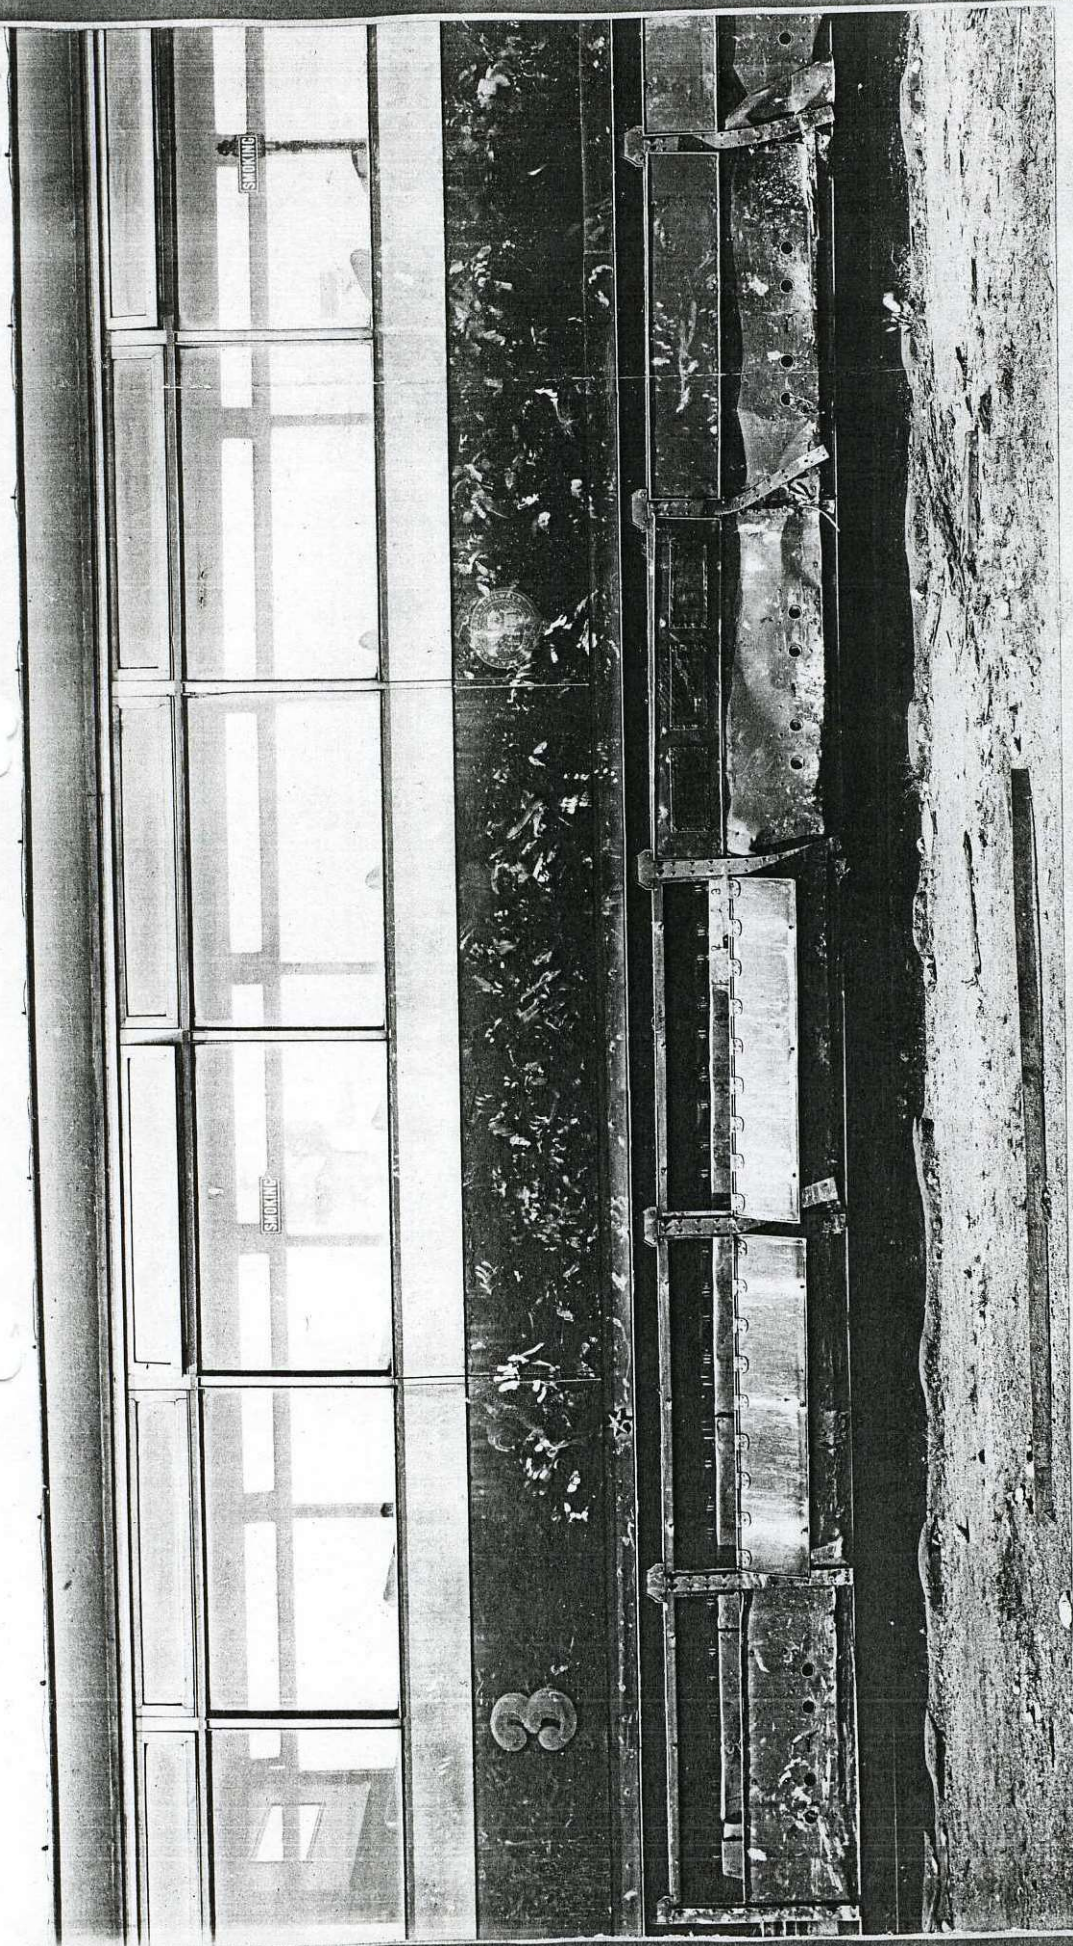
(3). Cells 1 to 24. Bay 4.

The front bogie truck mounted the debris and was brought to rest before the remainder of the train, and forced about 3 feet 6 inches back under the leading coach, raising the front end 3 feet before the train came to a standstill. The train travelled through the debris for some 20 feet, and the impact with the debris bent and distorted the channel iron members at the lower outside edge of both battery chambers in the leading coach (Photo.3).

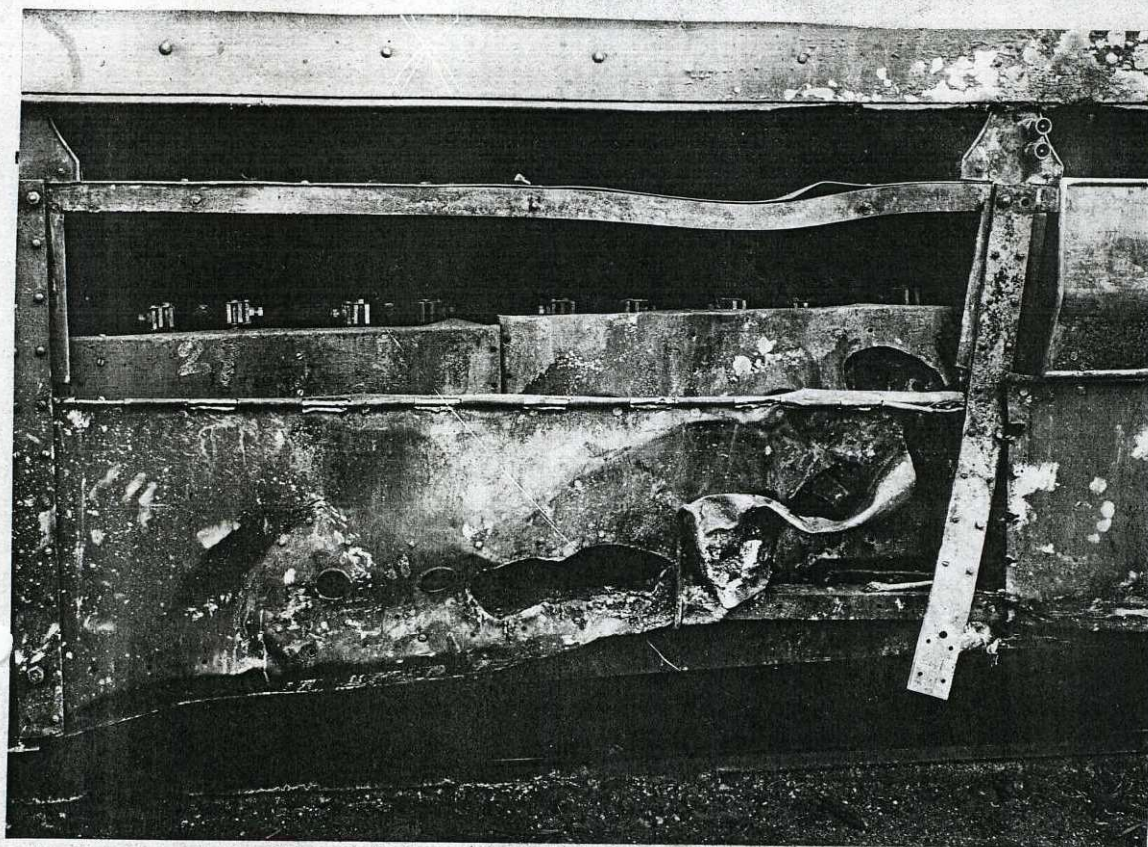
(4). Cells 28 to 25. (Left to Right) Bay.3.

As the result of the derailment the channel iron sections at the bottom edges of the battery chambers were bent, and in the case of the offside chamber of the leading coach were pressed against the steel sides of the crate and forced the steel sides into contact with the containers of the adjacent cells. This point, which is marked "X" on the diagram, is about 24 feet from the leading end of the offside chamber. (Photo. 4).

At point "X" severe arcing and burning had taken place and a very heavy current had evidently passed to the coach underframe.

very heavy current from the battery through the short circuit, estimated at 3000 to 4000 amperes, continuing for 3 or 4 minutes, which generated sufficient heat to burn the insulation on the cables, and char the adjacent woodwork of the floor and sides of the coaches and the wood barriers in the crates.

(1) In our opinion the first essential precaution is to eliminate the possibility of accidental connection between the cell containers and the coach underframe by constructing the sides of the crates of hard wood or other suitable insulating material. (This has already been done in train "B", and is provided for in the specification for new trains.)

(2) The general design of the battery chambers and their suspension from the underframe should

be carefully considered with a view to ensuring that in the event of a collision or derailment the possibility of an electrical connection being set up between the cell containers and the under-frame is reduced to a minimum.

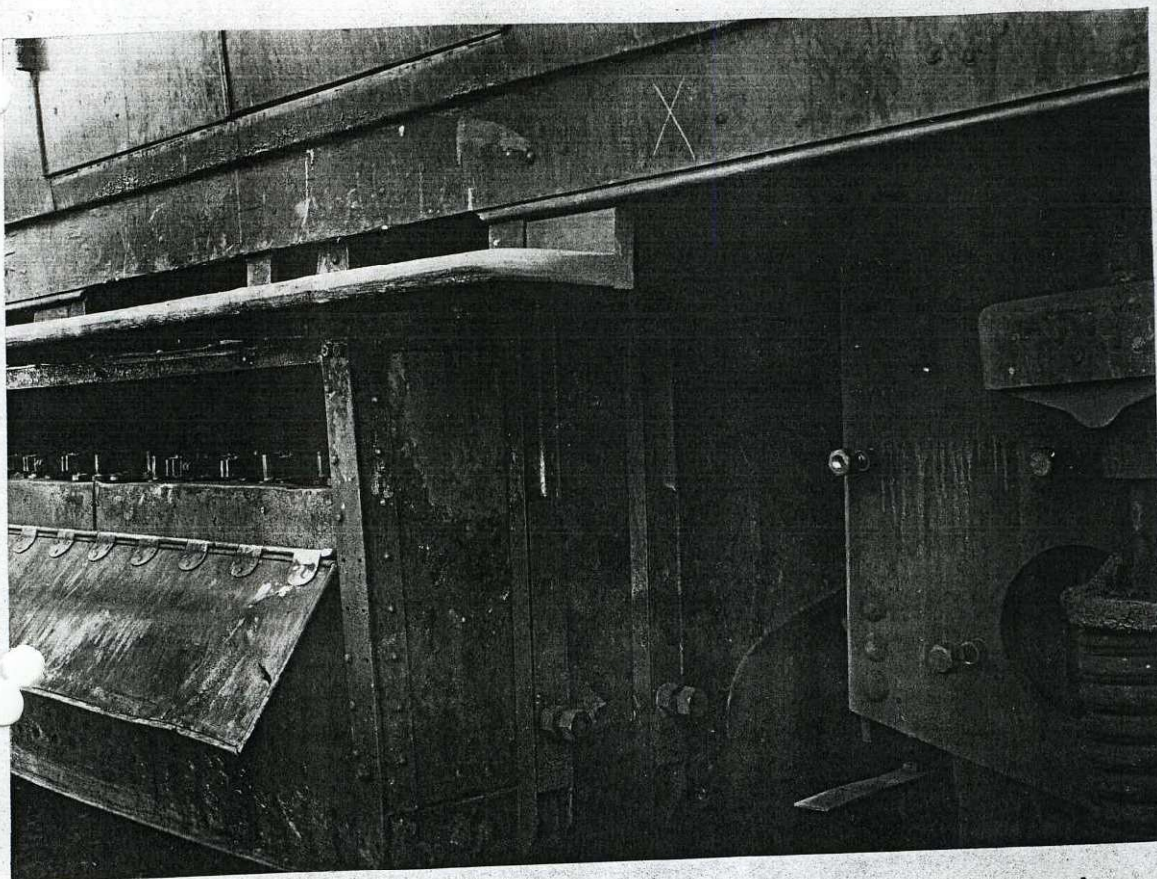
(6). Leading offside corner of trailing coach.

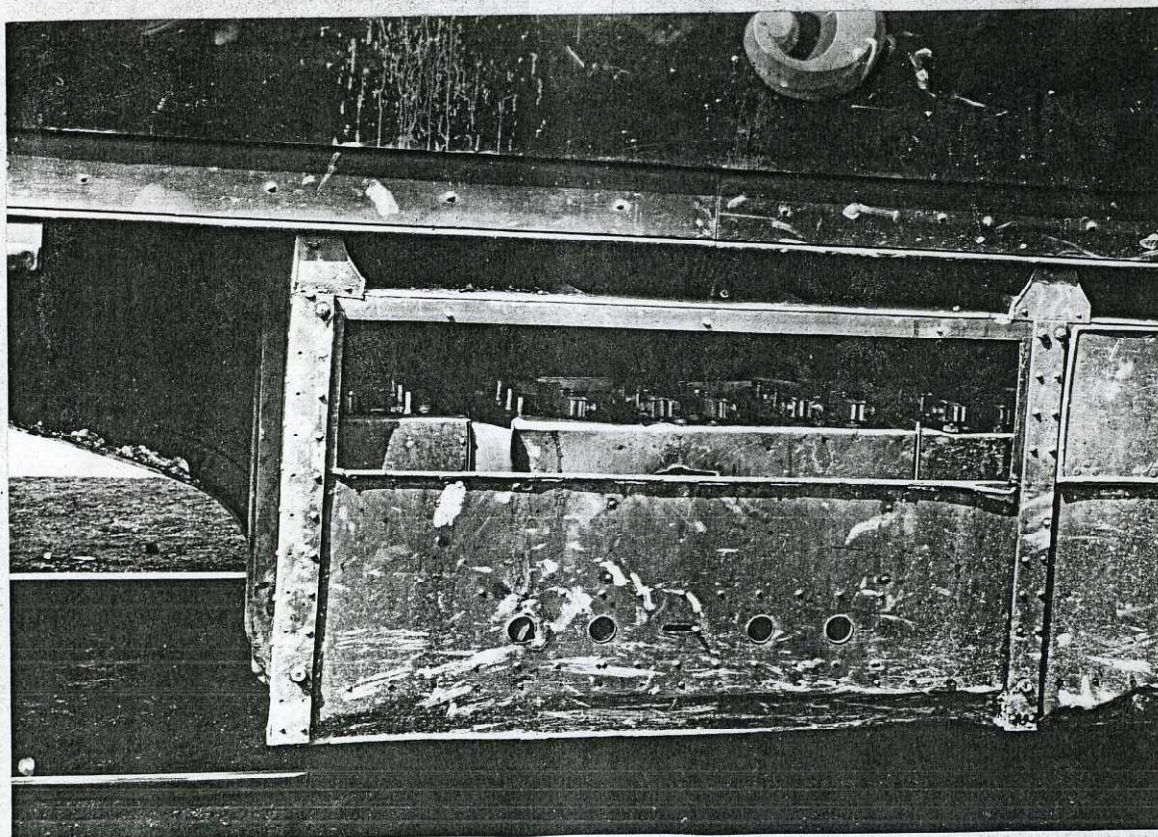
(9). Cells 1 to 5. Bay 4.

The general distortion of the battery chamber similarly forced parts of the metal structure into contact with steel containers at other points in the leading coach, causing local short circuits between these containers via the coach frame, but these local short circuits may be regarded as of secondary importance in the present

considerations. (Photo.9).
