RAILWAY ACCIDENT

THE COLLISION THAT OCCURRED

AT ROSSLARE STRAND STATION

ON 13th AUGUST, 1974.

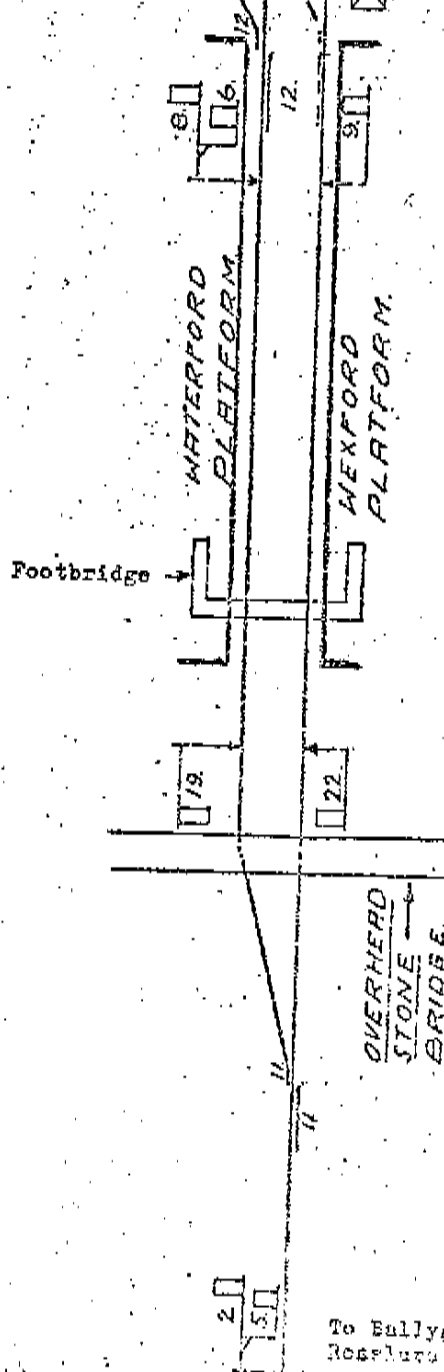
LAYOUT OF
ROSSLARE STRAND
STATION
(Not to Scale)

ON 13th AUGUST, 1974

Site and Signalling (see Attachment A)

Section of track removed
May, 1973.
