**Railway Accident
Investigation Unit
Ireland**

INVESTIGATION REPORT

**Collision between an Iarnród Éireann passenger
train and rail-mounted maintenance equipment,
Rosslare, Wexford, 11th January 2020**

RAIU Investigation Report No: 2020 – R004

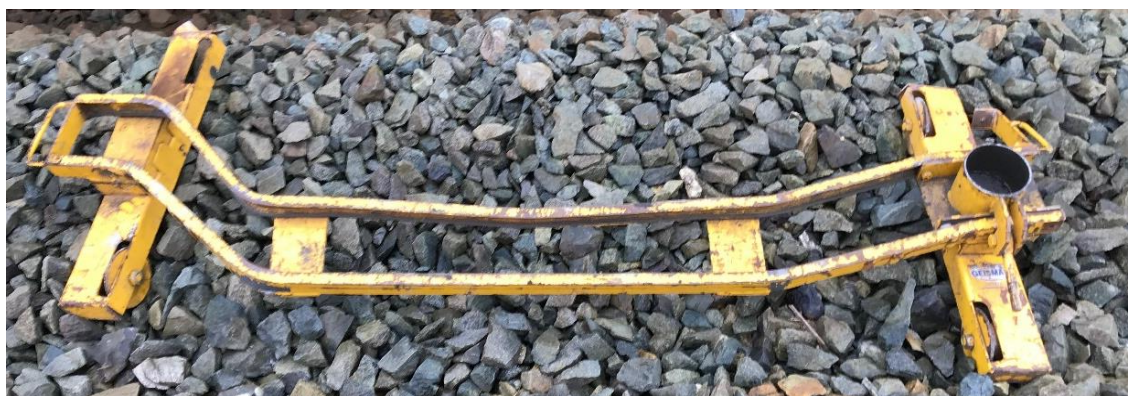
Figure 2 – Damaged RMME

13 At approximately 10:52 hrs, Train A602 collided with the RMME on the approach to Rosslare Europort, see Figure 2 for a photograph of the RMME after the collision.

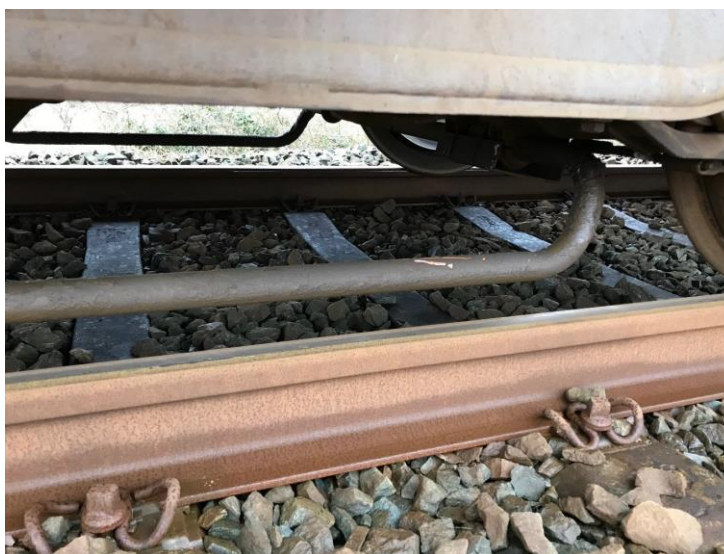
Figure 3 – Damage to TCA on ICR 22343

19 There was also minor damage to the Track Circuit Assistor (TCA) fitted to the lead bogie on InterCity Railcar (ICR) 22343, see Figure 3.

- 97 Driver A602 then carried out checks on Train A602 and the only damage found was some marks apparent on the TCA underneath the front bogie (as shown in Figure 3). Following subsequent telephone calls made by Driver A602 to: the Rosslare Line Signaller; the Mainline Regulator; and, CME staff located at Laois Train Care Depot Portlaoise; Driver A602 was given permission for the train to proceed to Rosslare Europort.
