**Railway Accident
Investigation Unit
Ireland**

INVESTIGATION REPORT

**Collision between a car and a train at Kilnageer
Level Crossing (XM240), Mayo, 29th April 2020**

RAIU Investigation Report No: 2021 – R001

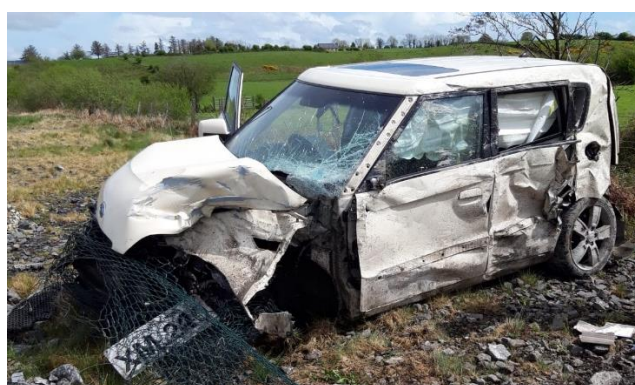
Figure 2 – Car after the collision with Train A809

13 At the same time a car approached LC XM240 with the gates open (left open by a previous user) and began travelling through LC XM240. When Driver A809 saw the car, he made a full-service brake application; however, the train could not stop in time and struck the car, see Figure 2.

- 28 IÉ-RU's Chief Mechanical Engineer's (CME) Department reported that there was €25,000 worth of damage to the following areas of Train A809: valance and framework; steelwork; levelling arm and associated bracket; front end hose; horn pipe; electrical-head cover; paintwork; manual pull cord release box; and, side exterior.
- 29 IÉ-IM estimate the cost of repairs to LC XM240 totalled €3,220 plus VAT.
- 30 The car was undrivable after the accident.

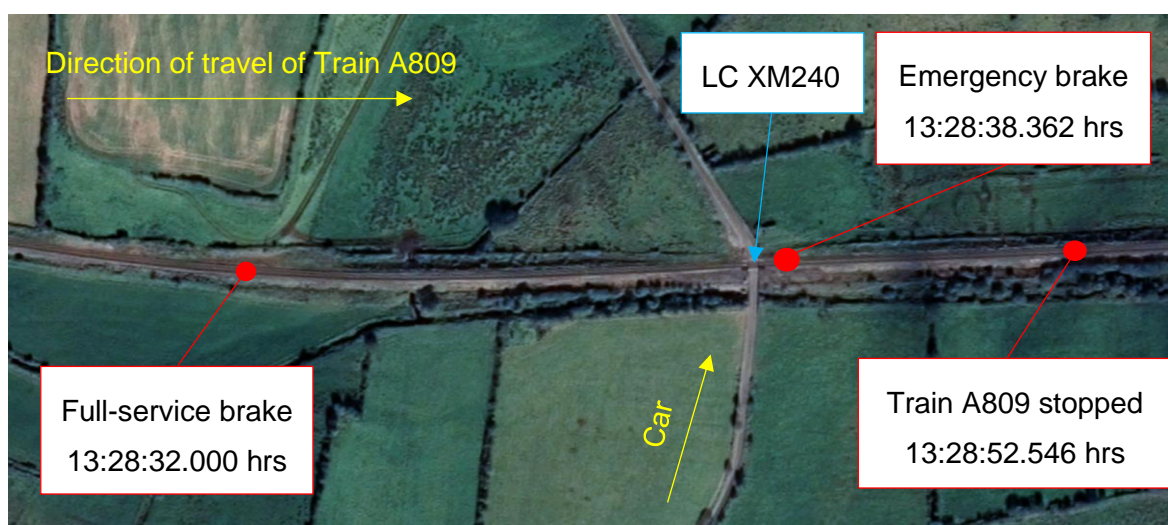
Figure 5 – Braking and stopping position of Train A809

- Lights were illuminated at full beam;
- *Horn* was sounded four times on the approach to LC XM240, the horn is further discussed in paragraphs 40 to 45;
- Train was travelling at 57 mph (92 km/h) on approach to LC XM240;
- At 13:28:31.641 hrs, at a distance of 266 m before LC XM240, there was a full-service brake application (see Figure 5);
- At 13:28:36.081 hrs (4.44 seconds after the full-service brake application), Train A809 travelled through the centre of LC XM240, striking the car;
- At 13:28:38.362 hrs (2.281 seconds after travelling through the centre of LC XM240 and striking the car; and, 43 m past the centre of LC XM240) Driver A809 made an *emergency brake application*¹;
- At 13:28:52.546 hrs the train comes to a stop, 125 m after the emergency brake was applied and 168 m past LC XM240.

- 98 Six seconds later, as the car continued to travel onto LC XM240, Driver A809 made an emergency brake application (after striking the car); Train A809 was travelling at 41 mph (66 km/h).

- 99 Train A809 continued through LC XM240, collided with the car at 13:28:45 hrs; before coming to a stop at 13:28:52 hrs at a distance of 168 m past LC XM240. The car was pushed clear of the line and came to a stop approximately thirty metres from LC XM240, see Figure 19.

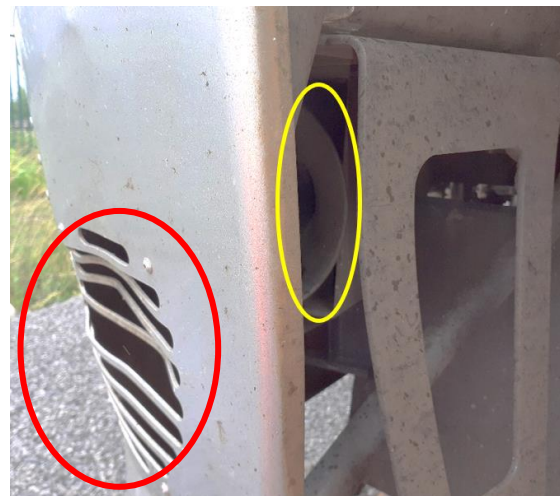
Figure 6 – Train horn ICR 22347

- 40 The horn audible warning device on the ICR fleet consists of two individual horns, high and low tone horns, fitted on either side of the front underframe of the cab.
- 41 The horns were damaged as a result of the collision, it was noted during a post-accident inspection that the non-drivers side horn (circled yellow) does not align with the louvre cuts in the quarter panel fairing (circled red), see Figure 6.

- 42 IÉ-RU have confirmed that the horn fitted to the ICRs were required to be supplied, by Rotem, in accordance with Railway Group Standard GM/RT 2180 Issue 3, Visibility and Audibility Requirements for Trains, published in February 2000 (to be referred to as GM/RT 2180 for the remainder of this report).
- 43 GM/RT 2180 required that the “horn of an approaching train shall be audible for a distance of at least 400 m along the track and up to 5 m to each side of the track, in conditions which are predominantly still and with non-excessive background noise levels”. As an ICR has a maximum speed of 160 km/h, the *C-weighted sound pressure level* produced by the horn should have been in accordance with the numbers set out in Figure 7.

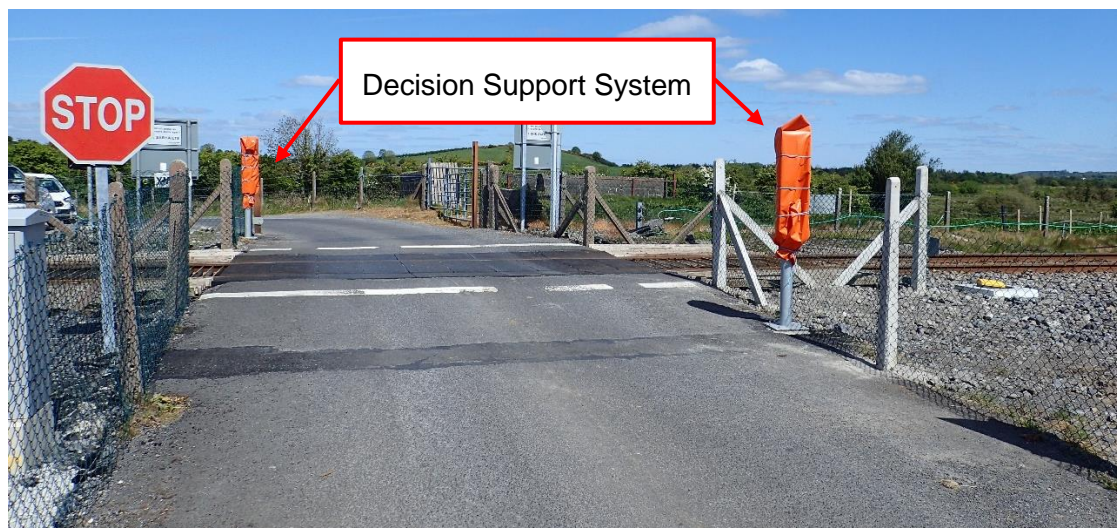
Figure 10 – LC XM240 (photograph taken on the 11th May 2020)

59 IÉ-IM have designated LC XM240 (Figure 10) as an OP Level Crossing.

84 There is a known history of misuse/ abuse³ at LC XM240, and at one time was the highest risk OP Type Level Crossing on the IÉ Network.

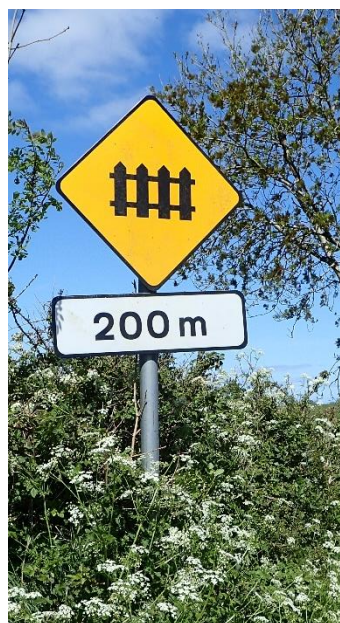
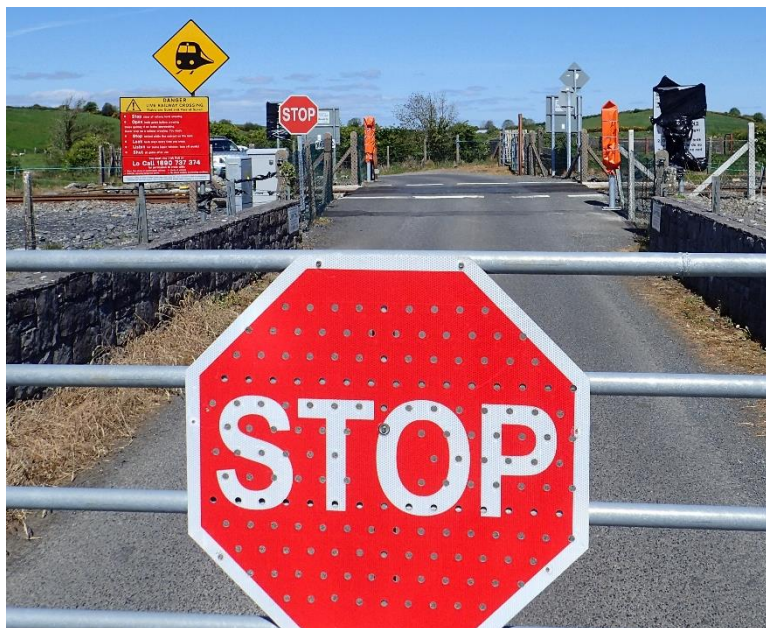
Figure 12 – Examples of Warning Signs at the approach to and at LC XM240

65 These signs were present at LC XM240, see Figure 12 for examples of the warning signage at the approach to and at LC XM240.

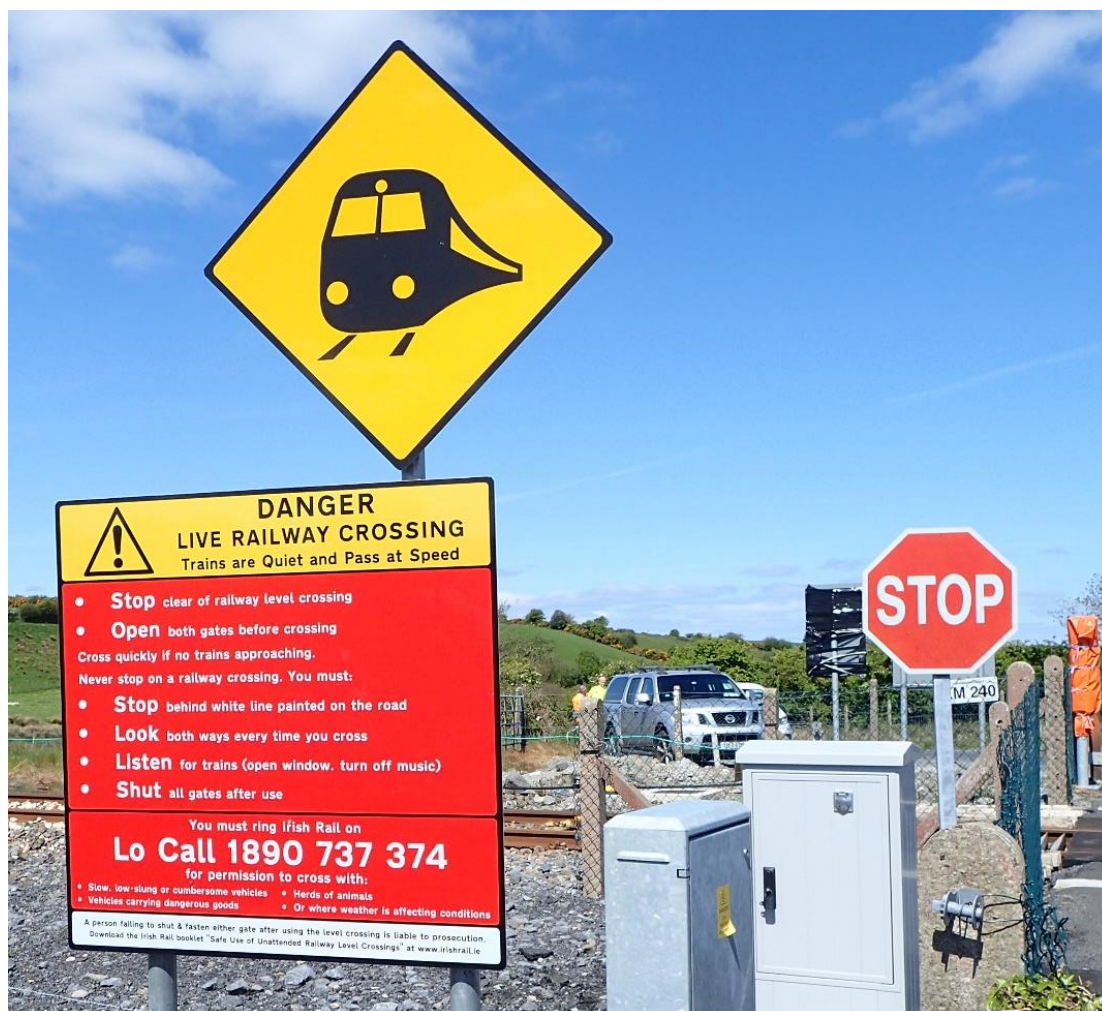
Figure 13 – Signage at LC XM240 related to CCE-TMS-380

- 67 The signage was upgraded in April 2019 at LC XM240 to meet the requirements of CCE-TMS-380, and included (for each side of the level crossing): one “Puffing Billy” (Diamond Type) signs (opposed to the triangle steam train version which are now redundant); two “Danger Railway Level Crossing” signs (one English language, one Irish language) and two “Stop” signs, one “Keep These Gates Shut”, see Figure 13 for signage at LC XM240.

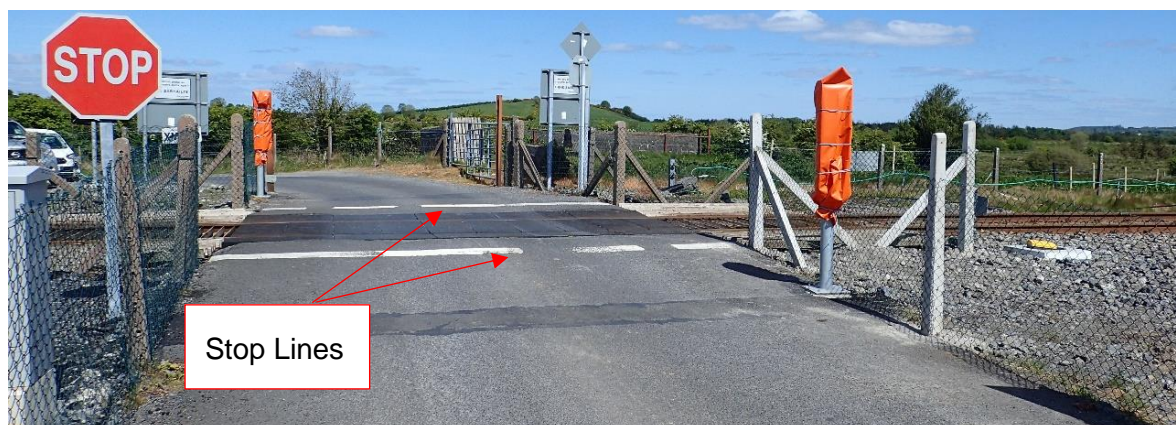
Figure 14 – LC XM240 Stop Lines on either side of the railway

- 68 IÉ-IM have painted Stop Lines on the road to indicate, to the level crossing user, the safe distance that a vehicle user can stop without the vehicle encroaching onto the path of trains, this is sometimes referred to as the “decision point” i.e. the point where the motorist decides to cross if it is safe to do so. The Stop Line is a 300 millimetres (mm) continuous white line which is painted from the left edge to a point, two-thirds across the roadway and continues as a broken white line to the edge of the roadway (this has been designed in agreement with the Department of Transport). The line is located approximately 2 m from the running edge on each side of the level crossing road approaches, see Figure 14.

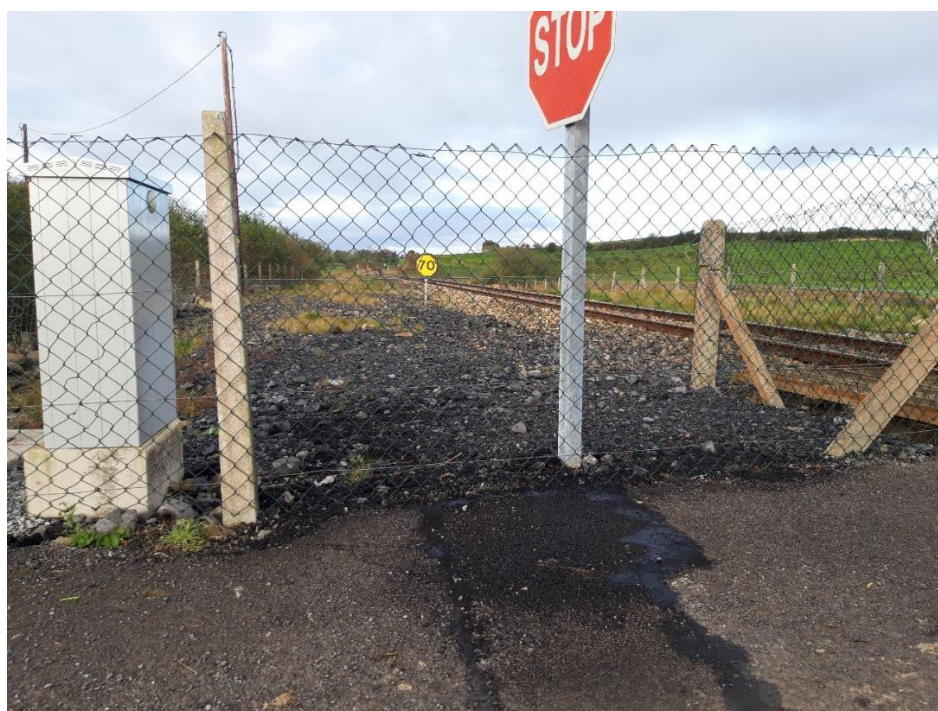
Figure 15 – From the Down side of the line, looking in the Down direction

- 69 The maximum permitted line speed for the section of railway line through LC XM240 is 60 mph (96.6 km/h) in the both the Up and Down directions; meaning that the required *viewing distances*, as set by CCE-TMS-380, is a minimum of 300 m.
- 70 The viewing distance at LC XM240 measured on the Down side (the position of the Car Driver on the day of the accident), looking in the Down direction (the direction from which Train A809 was approaching) was measured at 346 m. Figure 15 is a photograph taken in front of the Stop sign and behind the Stop Line.
