**Railway Accident  
Investigation Unit  
Ireland**

# **INVESTIGATION REPORT**

**Collision between a Bord na Móna Flat Wagon and  
Kilcolgan Level Crossing Gates, Offaly,  
8<sup>th</sup> June 2020**

RAIU Investigation Report No: 2021 – R002

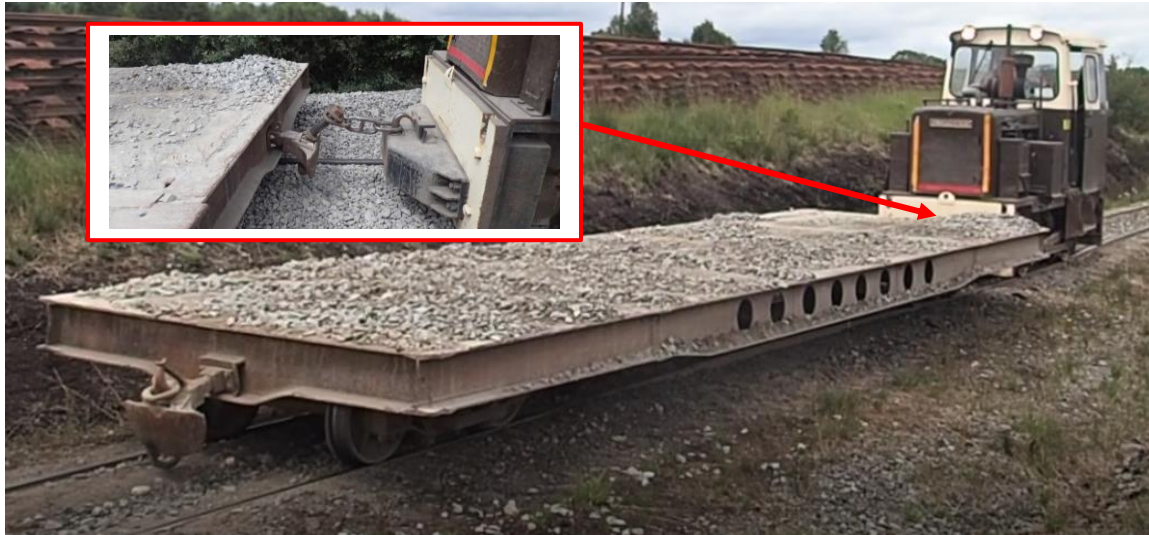
Figure 2 – Locomotive coupled to Flat Wagon (coupling arrangement inset)

- 13 The Locomotive was uncoupled from the Flat Wagon to facilitate the rerailing (see inset of Figure 2 for the coupling arrangement). A lifting chain was placed around the excavator bucket and the Flat Wagon coupling. The Flat Wagon was then lifted, aligned with the track and lowered onto the rail. The chain was removed from the Flat Wagon coupling and the Flat Wagon rolled away towards Kilcolgan Level Crossing (located two kilometres away).

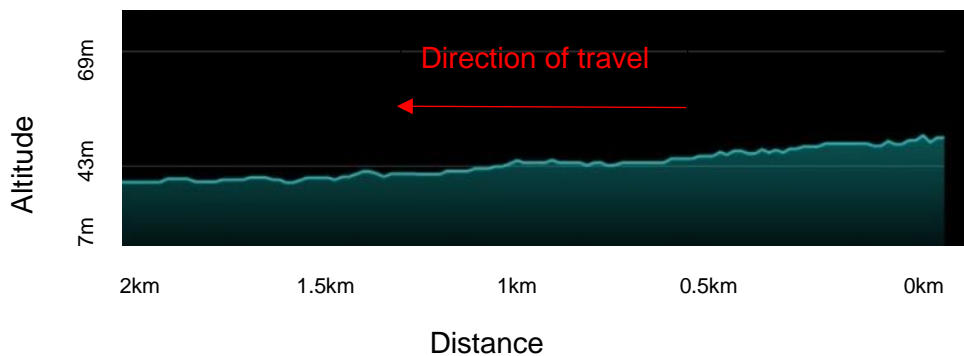
Figure 3 – Altitude over distance

- 28 The rail network consists of 850 kilometres (km) of permanent British Standard Rail narrow gauge (914 millimetres (mm)) incorporating ninety-seven level crossings and forty-six underpasses<sup>2</sup>.
- 29 The section of single line track on which the Flat Wagon rolled away is the Boora – Lemonaghan Rail Line; with the altitude changing from 50.5 metres (m) at the point of the runaway (0 km) to an altitude of 39.3 m at Kilcolgan Level Crossing Gates (two kilometres away), see Figure 3.

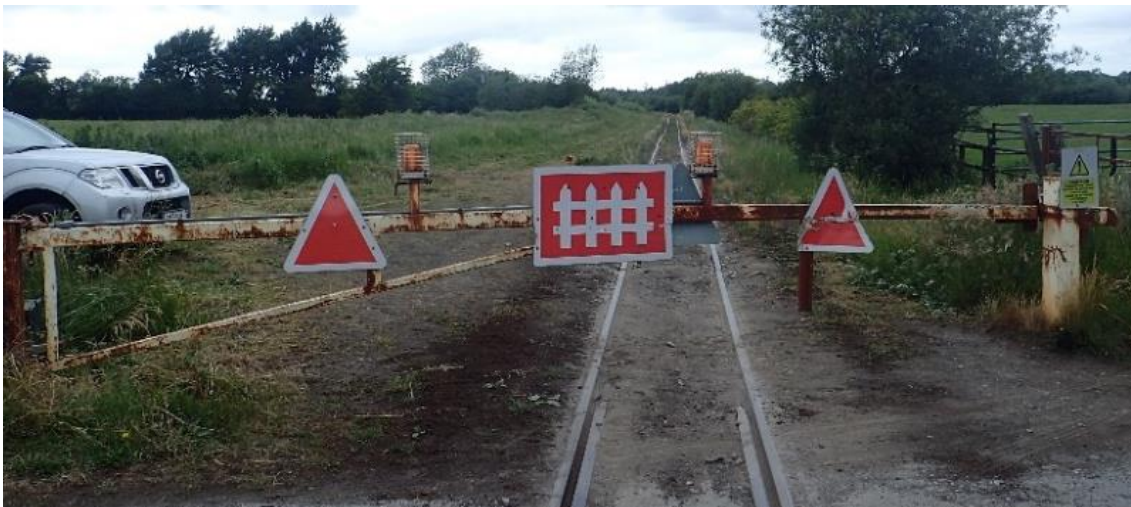
Figure 5 – Kilcolgan Level Crossing gates

19 The Kilcolgan Level Crossing gates suffered minor damage to the locks and lights.

31 The gates are manually opened and closed by the BnM locomotive drivers. Gates have warning beacons and reflective signs attached (see Figure 5). Swing posts and latching posts are set in concrete.

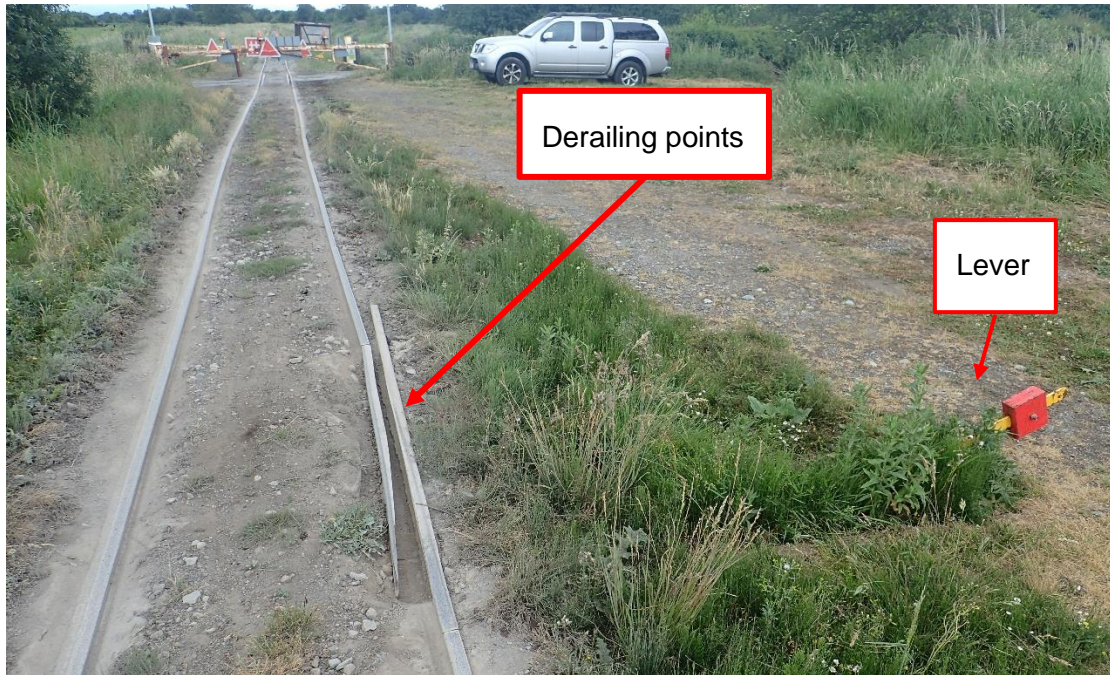
Figure 6 – Derailing points (in the open position – locomotive would derail)

- 33 The classification of the level crossing in terms of operation, is a BnM *Type 2 Level Crossing* as the derailing points have to be manually operated to open or close the derailing points by means of a lever as the derailing points are not connected to the level crossing gates<sup>3</sup>; see Figure 6 for the derailing points associated with Kilcolgan Level Crossing.

58 It should be noted, that at the time of the accident, there was no means of securing the derailing points in the open position; and, BnM management have stated that a number of incidents of interference of derailing points by members of the public have taken place; and An Garda Síochána have been notified.

107 It is noted that there is no means of securing the derailing points in the open position (paragraph 58) and youths had been seen in the area before the accident (paragraph 80). Incidents of interference with the derailing points has been previously reported to An Garda Síochána (paragraph 58). It cannot be fully determined by the RAIU how the points were in the closed position prior to the accident.

127 Although it is noted that the derailing points at Kilcolgan LC have now been fitted with automatic derailing points mechanisms; given the risk to road users at other BnM level crossings, this should be expanded to locations vulnerable to misuse; as a result, the RAIU make the following safety recommendation (CaF-01):

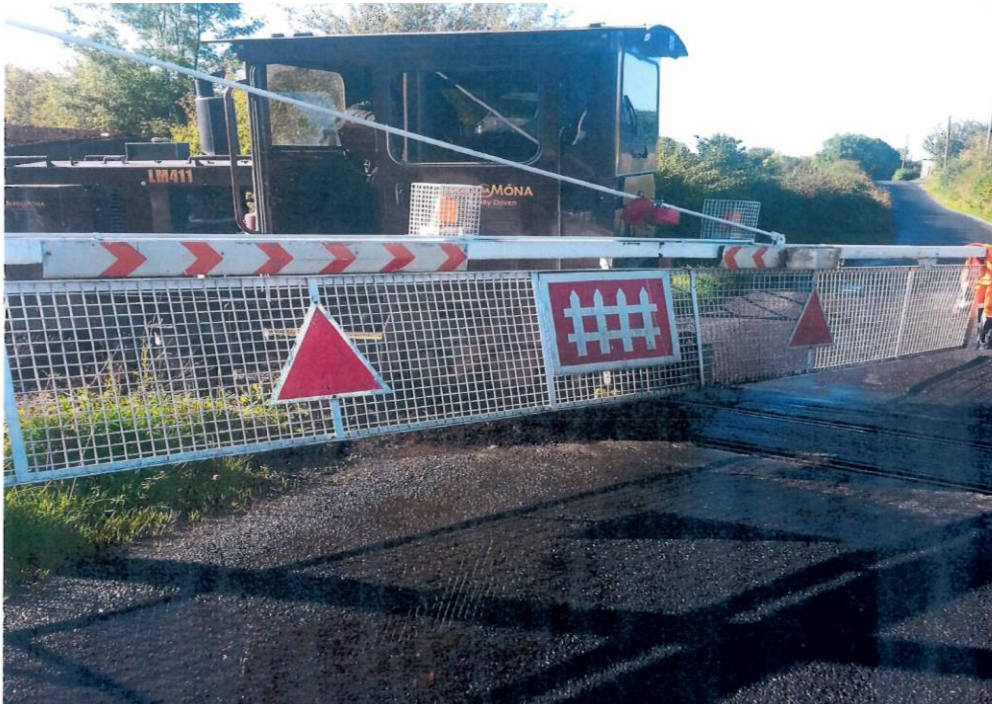
Figure 14 – Collision of BnM Locomotive with Endrim Level Crossing gates

- 96 The BnM investigation found that on the approach to the Endrim LC gates the locomotive driver slowed down prior to the derailing points (which were in the open position) but felt a “thump” from behind (from the attached flat wagons) pushing the locomotive through the derailing points. The derailing points derailed the locomotive and the first wagons directly behind the locomotive; but the locomotive continued forward striking and opening the crossing gate, against the road. The second and third wagons behind the locomotive passed the derailing points without derailing (possibly due to the level crossing being a BnM *Type 1 level crossing*, where the derail points are attached to the operation of the gate by means of wire rope, and the derailing points moved to the open position. The derailing points did not prevent the Locomotive colliding with Endrim LC gates and did not protect the roadway as the gate opened across the road.

- At a speed of 6.8 km/h, 51 m from the derailment points the locomotive failed to stop at the derailment points and subsequently derailed and struck the gates of Endrim LC;
- The approach to Endrim LC, from the Boora side, is through a cutting which has resulted in high embankments either side of the track. These high embankments restrict the view of the locomotive drivers and the gates of Endrim LC are not visible until the driver is within 300 m of the level crossing. There is currently no warning signage in place on the approach to Endrim LC to indicate to the locomotive drivers the distance they are from the level crossing gates.
