INVESTIGATION REPORT

Chassis Plate Fracture on General Motors Class 201, Locomotive 224, 7th July 2020

RAIU Investigation Report No: 2021 – R004

Published: 1st July 2021

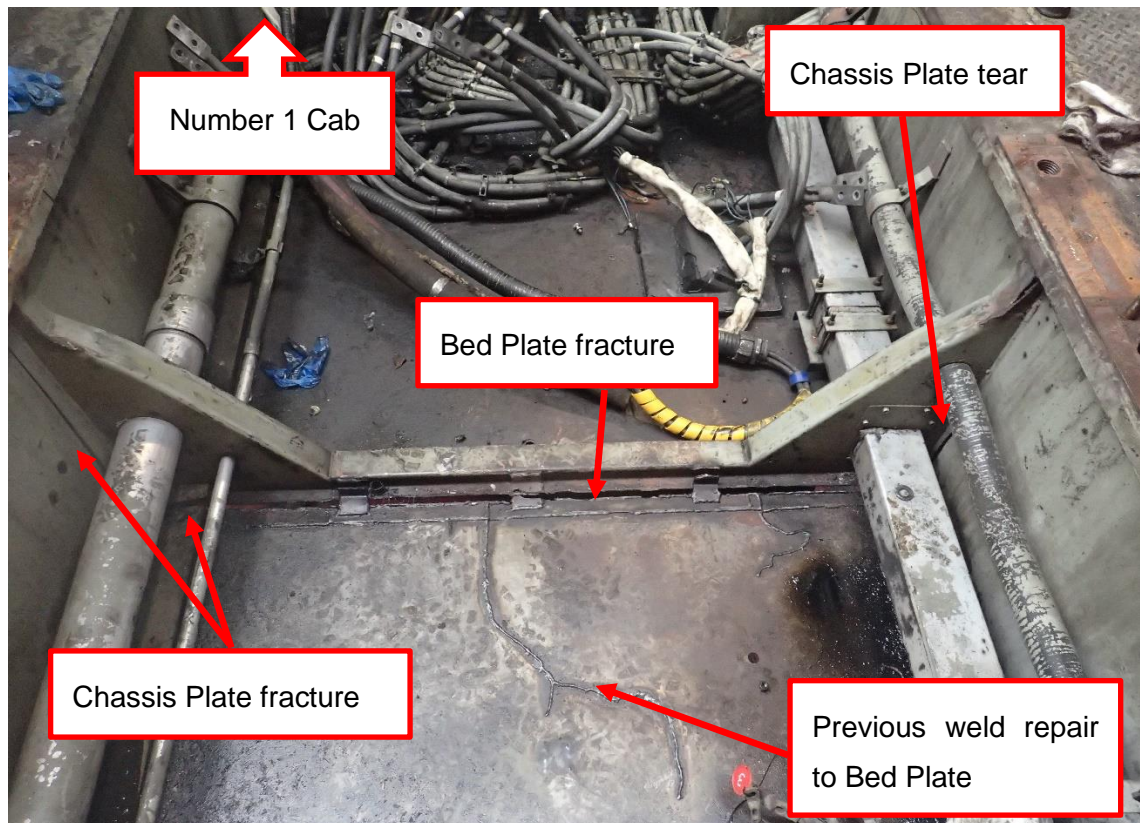
Figure 2 – Locomotive 224 with engine and generator removed

- 13 At Inchicore Works a preliminary examination identified a Chassis Plate fracture on Locomotive 224. The engine and generator were removed from Locomotive 224 to allow for further investigation and a clear view of the fracture area. The removal of the engine and generator exposed a Bed Plate fracture that propagated into the left hand side of the Chassis Plate (facing Number 1 Cab, Figure 2) and the subsequent tear of the Chassis Plate on the opposite side.

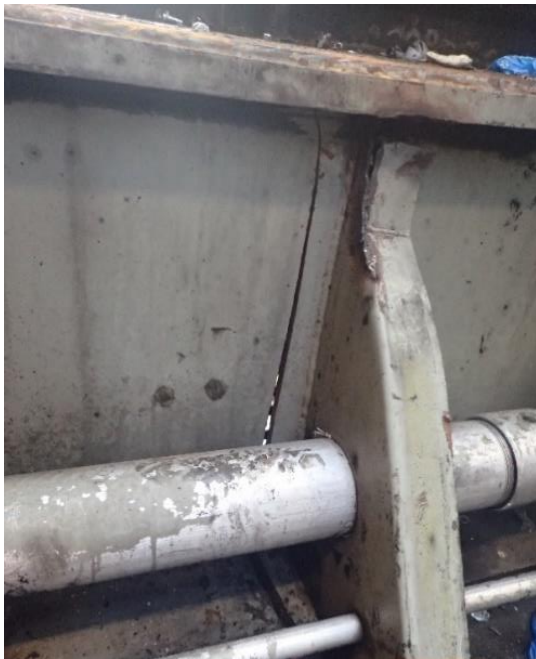
Figure 4 – Fracture to Chassis Plate

- 20 The Chassis Plate fracture on the left hand side facing the Number 1 Cab and a tear of the Chassis Plate on the opposite sides of Locomotive 224, see Figure 4.
- 21 The engine coolant pipe suffered a leak.
- 22 The main generator suffered severe damage as a result of misalignment due to the Chassis Plate fracture, see Figure 5.

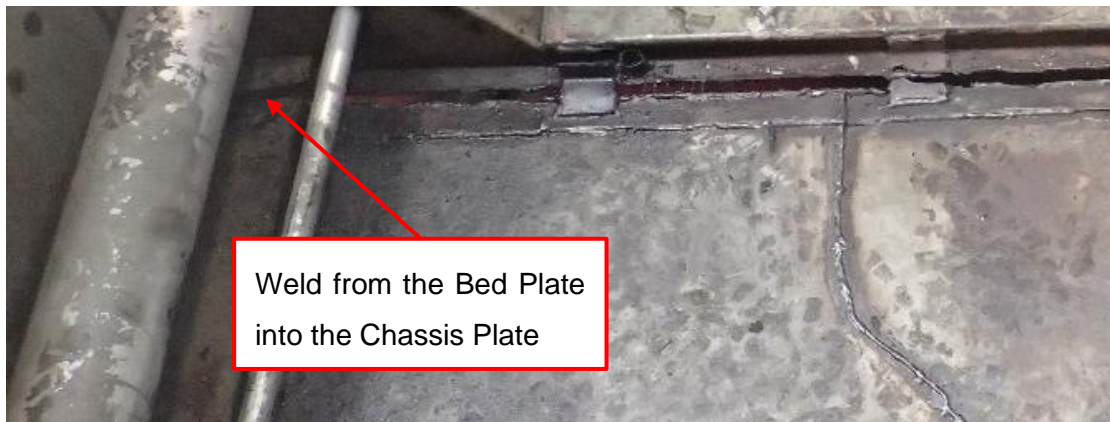
Figure 11 – Weld from the Bed Plate into the Chassis Plate

- 78 The weld repair resulting in the 2020 failure (the weld repair from the Bed Plate into the Chassis Plate) on Locomotive 224 could only have been carried out when the engine was removed (i.e. in 2010 or 2019) as evident from the profile of the weld and the access required to carry out the weld repair.

- 79 On one of these occasions, when the Bed Plate on Locomotive 224 was being repair welded, the welder unnecessarily continued the weld from the Bed Plate into the Chassis Plate⁴, see Figure 11.

- 80 This weld repair was not carried out in accordance with the EN 15085 standard series (although it is noted that these were not mandatory) or any IÉ weld repair specification (paragraph 69 and 70).

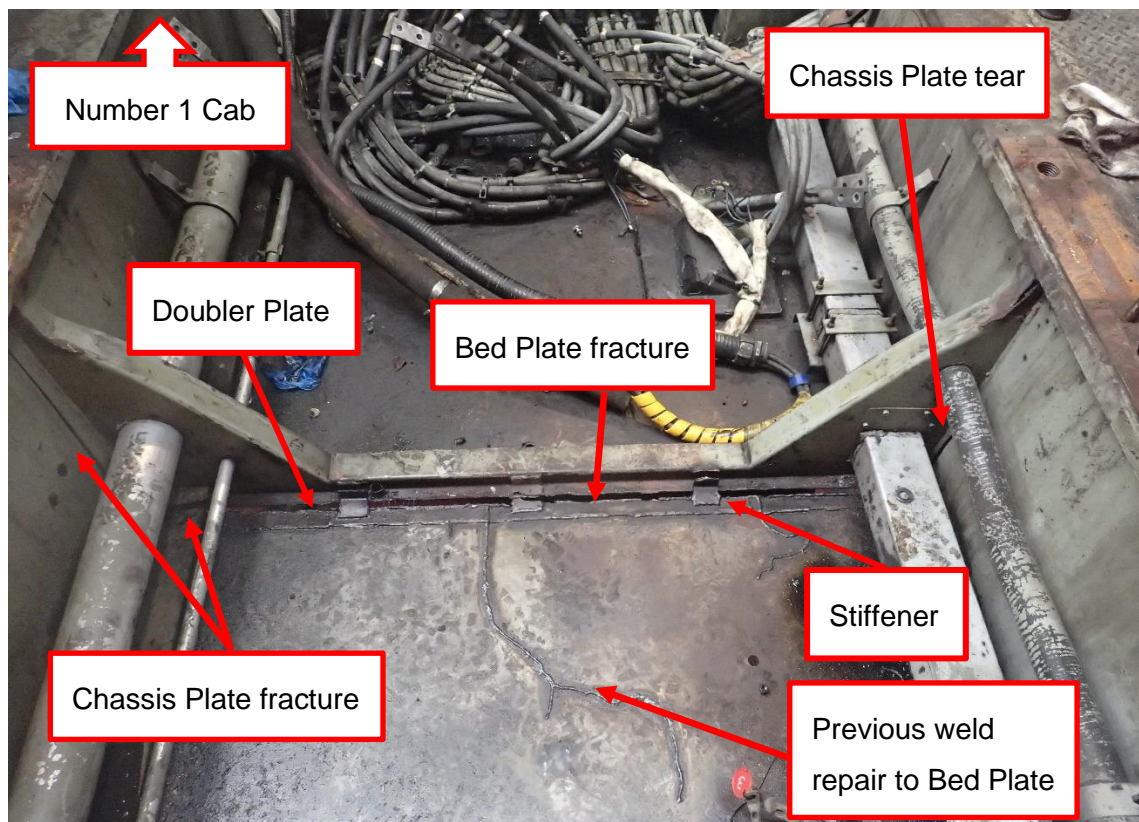
Figure 12 – Locomotive 224 with engine and generator removed

83 A visual examination showed that a doubler plate had been welded on top of the cracked Bed Plate during a previous repair; this doubler plate was reinforced with small stiffeners that had been welded intermittently across the surface of the doubler plate, see Figure 12.

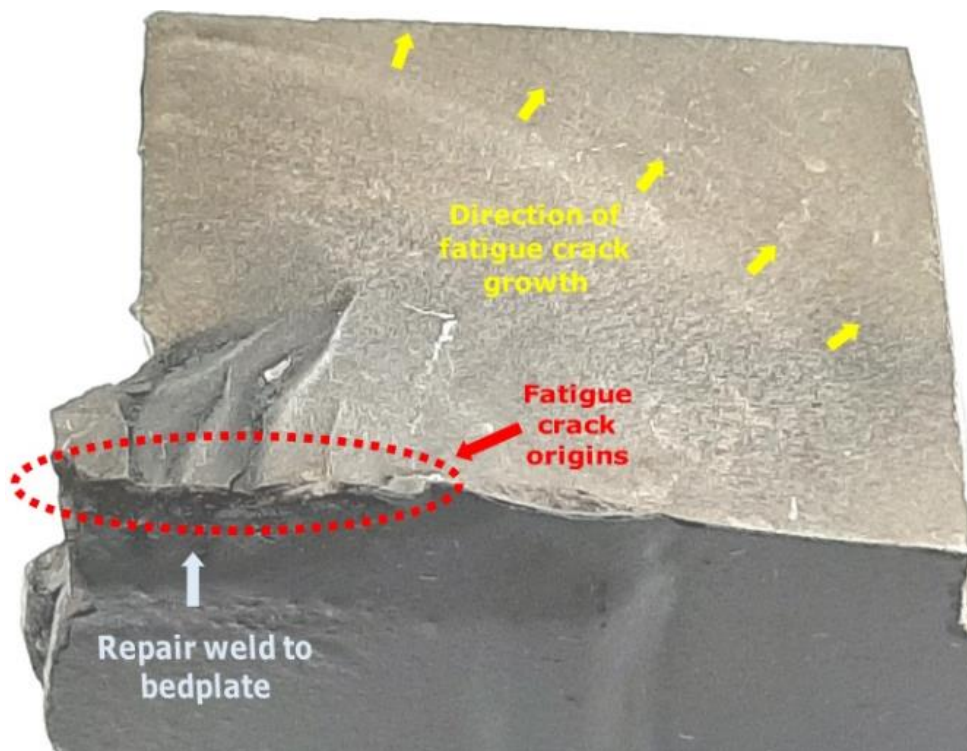
Figure 13 – Chassis plate fracture surface

85 No defects were found in the *weldments* within the failure zone, but the repair weld area would have resulted in a high residual tensile stresses as the mass of the Chassis Plate would act as a *heat sink* from the heat of the weld. The rapid cooling of the weld would create an area of high residual tensile stress in the zone.

86 Examination showed multiple fatigue cracks which originated at the base of the repair weld. These cracks had propagated upwards into the Chassis Plate material at an approximate angle of 70°. After a short distance, the cracks coalesced to form a combined crack front which then developed outwards at right angles along the Chassis Plate. The *beach marks* were very finely divided and formed an almost flat fracture surface which would indicate slow fatigue crack progression, see Figure 13.

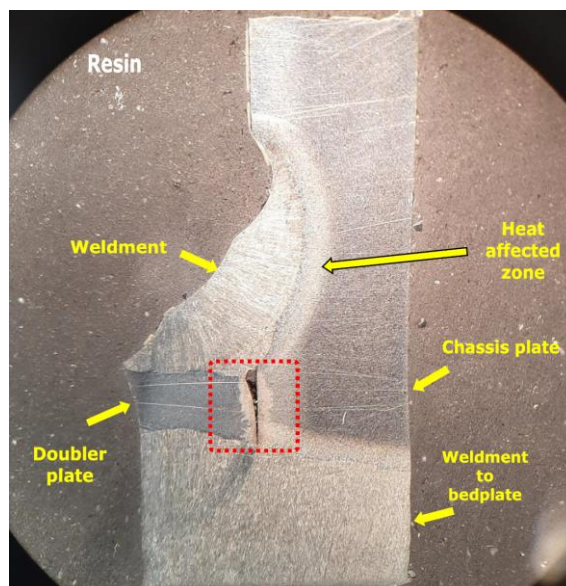
Figure 14 – Microsection A

- 89 Microsection A (Figure 14) shows that the welding of the doubler plate created a large *undercut* in the Chassis Plate at the top of the weld. A fit-up gap between the doubler plate and the Chassis Plate was also evident (red square in Figure 14). Examination of the microstructure showed good fusion and depth of penetration of the weld to the chassis plate. No inclusions, *slag*, *porosity* or other defects were detected. The *heat affected zone* (HAZ) was uniform between the weld material and the chassis plate.

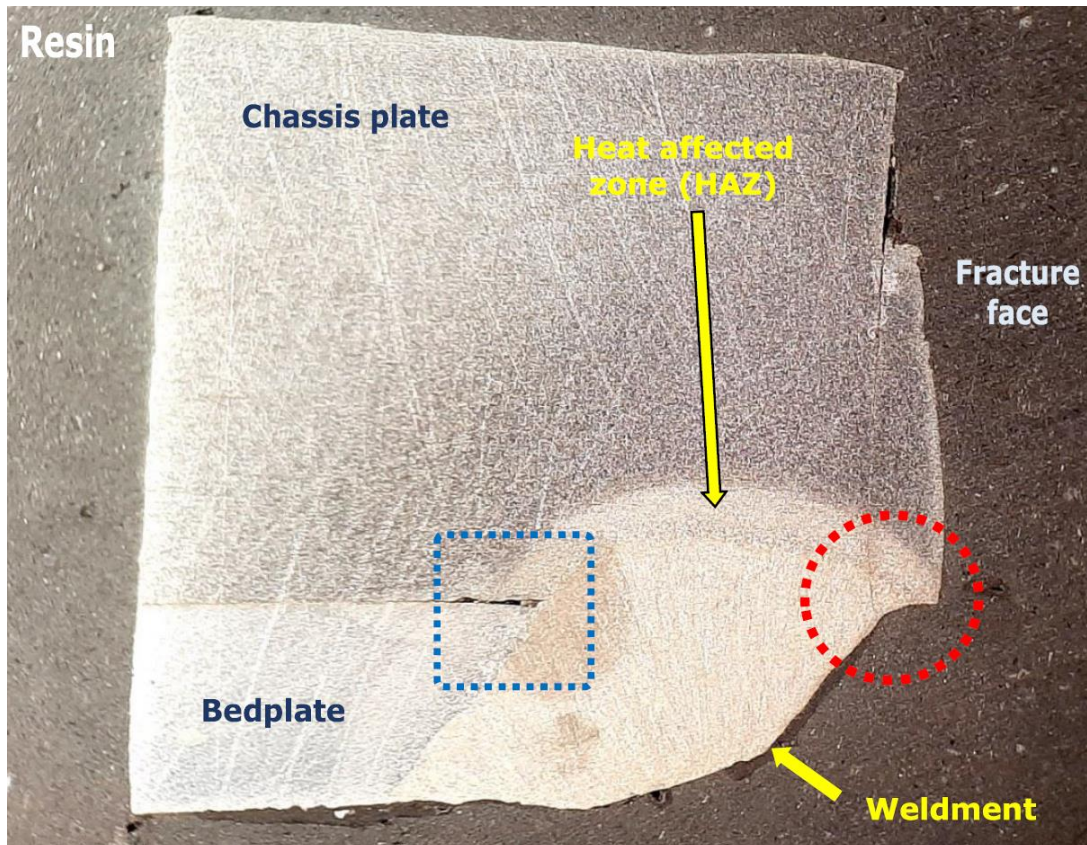
Figure 15 – Microsection B

- 90 Microsection B (Figure 15) shows the welding repair of the Bed Plate to the Chassis Plate, HAZ and a small fit-up gap between the Bed Plate and the Chassis Plate. A section of the chassis plate fracture surface is about to fall away from the right hand side due to cracks initiating near the *toe* of the weld. No material defects were detected in the Chassis Plate, Bed Plate or weld material. This particular weld runs at right angles to the length of the Chassis Plate and parallel to the Bed Plate/doubler plate.

- 91 A large fatigue crack had initiated close to the toe of the weld and had propagated vertically upwards through the chassis plate material. Also faintly visible in the circled region are crack indications within the weld material.
