**Railway Accident
Investigation Unit
Ireland**

INVESTIGATION REPORT

**Near miss with an Iarnród Éireann CCE Worker
near Gormanston Station, 21st July 2021**

RAIU Report No: 2022 – R002

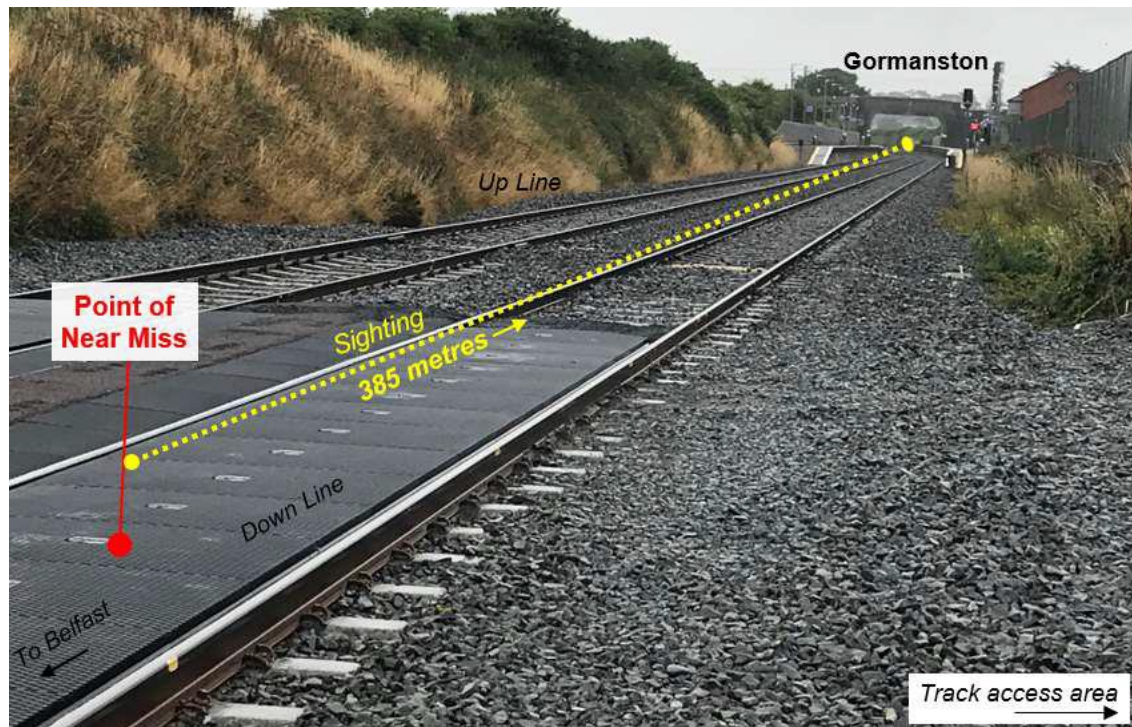
Figure 7 – Sighting distance

50 The maximum speed through Gormanston Station is 90 mph (145 km/h); with the minimum distance provided for this speed being 700 m.

51 IÉ-IM calculated that the sighting distances at the point of the near miss to be 1900 metres (m) for trains approaching on the Up Line and 385 m for trains approaching on the Down Line (see Figure 7). In this incident, the CCE Worker was on the Down Line, as a result the sighting distances were almost half the required length and as such, the CCE Worker should not have been on the line without alternative protection arrangements.

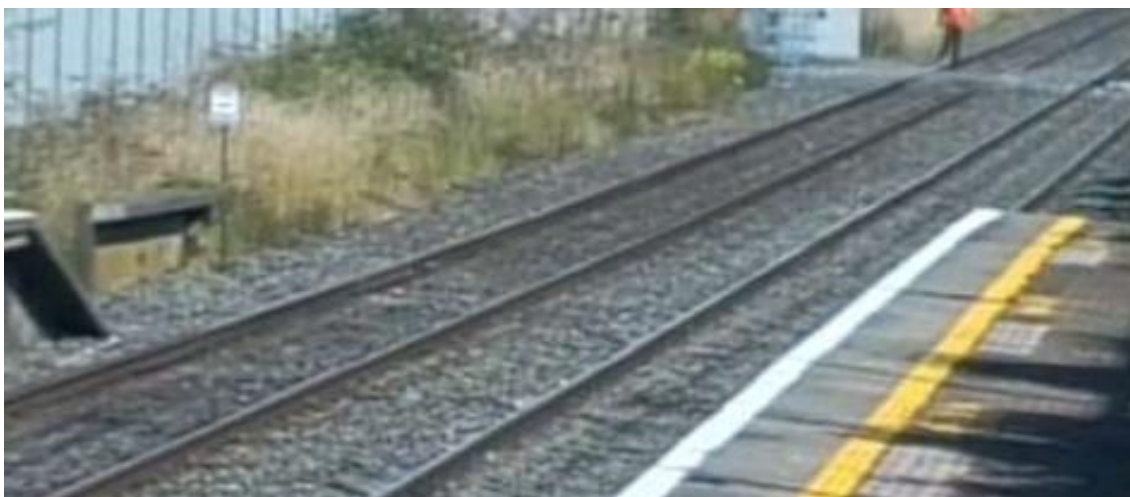
Figure 8 – CCE stepping onto the Down Line

59 At 10:04:48 hrs, the CCE Worker again returns to the line to carry out another visual inspection, and steps onto the Down Line, see Figure 8, without looking in the Up and Down directions. It should be noted, that at this time there was a lot of noise from the works being undertaken.

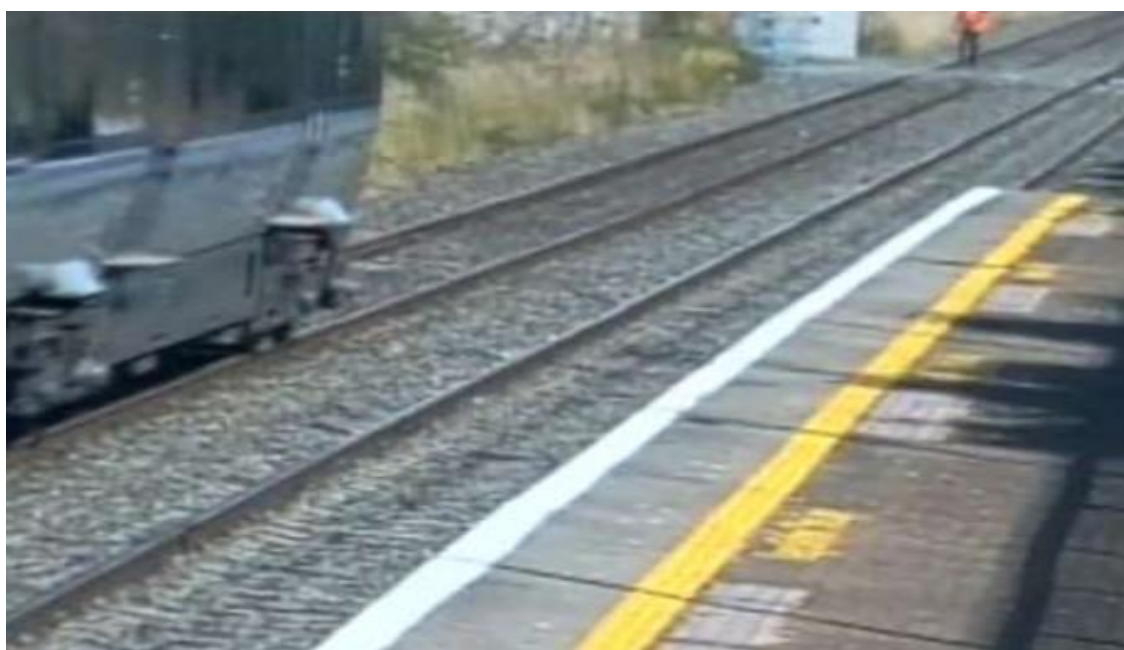
Figure 9 – CCE Worker walking towards Gormanston Station and approaching train

60 The CCE Worker then takes a number of steps towards Gormanston Station, and towards the approaching Train A124, see Figure 9.

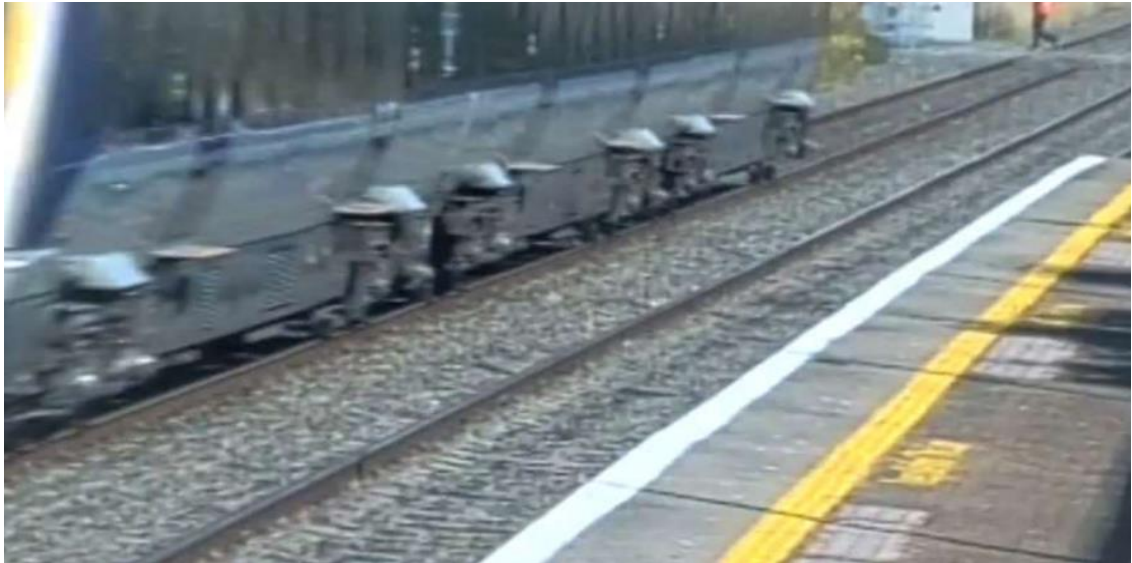
Figure 10 – CCE Worker walking off the railway line

61 The CCE Worker sees Train A124 and clears the line at 10:04:55 hrs (see Figure 10); with Train A124 passing four seconds later at 10:04:59 hrs.

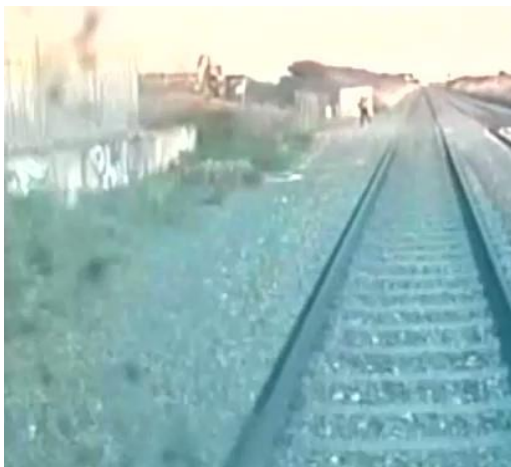
Figure 11 – CCE Worker exiting line

62 Train A124 was travelling at 88 mph (142 km/h) when Driver A124 saw the CCE Worker, sounded the horn and applied the emergency brake; the CCE Worker can be seen leaving the railway, see Figure 11. As Train A124 passes the CCE Worker, the CCE Worker acknowledges the train, see Figure 12.
