**Railway Accident
Investigation Unit
Ireland**

INVESTIGATION REPORT

Luas Overhead Line Failure, Stillorgan,

RAIU Investigation Report No: 2021 – R006

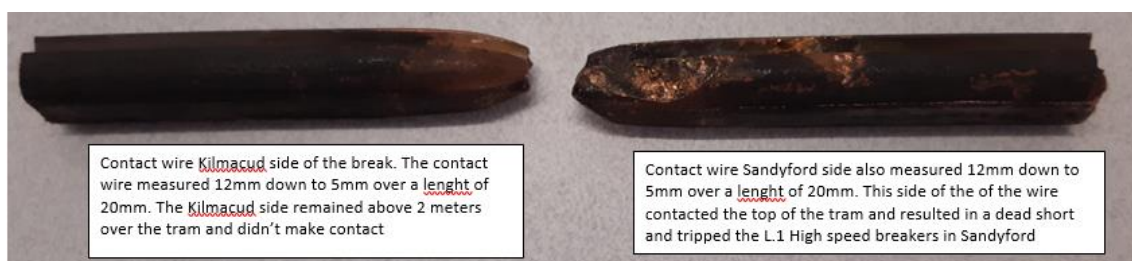
Figure 8 – Image taken from S2M Report

71 Post-incident, S2M produced a fourteen page report into the incident, entitled “S2M Overhead line failure at Stillorgan tram stop 02/11/20”, published in December 2020, to be referred to as the S2M Report for the remainder of this report. The S2M Report identifies the immediate cause of the OCS parting was “because of local overheating caused by the high electric current flowing from the wire to the tram’s pantograph”. The OCS parting was concluded to be as a result of necking (Figure 8), which was “caused by Joule heat due to the current flowing between the contact wire and the pantograph carbon band, through an arc due to poor contact condition. Once the contact wire is softened, its mechanical strength decreases resulting in breakage due to tension force”.

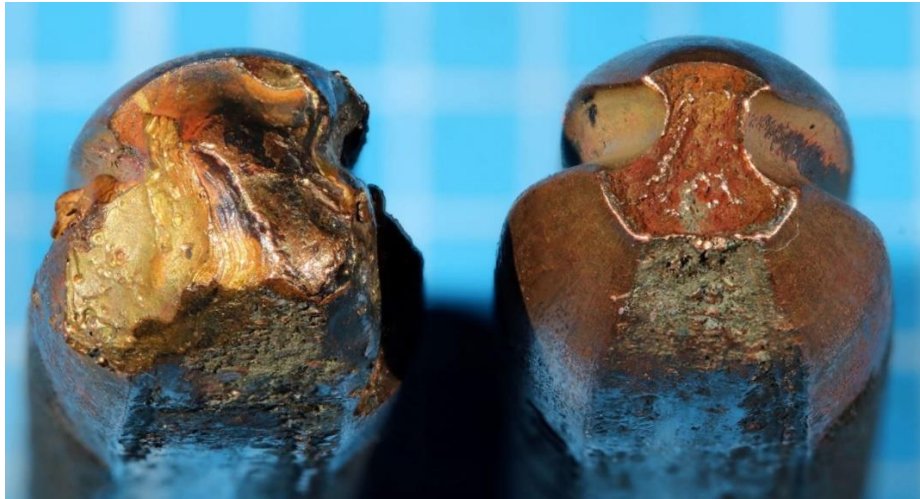
Figure 9 – Images of failed OCS wire from Stillorgan

75 A visual examination of the section of the wire that struck the roof of the tram (left hand wire in Figure 9) and short circuited revealed a molten surface whereas the wire that remained hanging from the OCS (right hand wire in Figure 9) exhibited a surface consistent with overloading. It was identified that the OCS wire necked and fractured, in a manner consistent with ductile overload with the fracture surface visually consistent with overloading, with no evidence of stable crack growth mechanism, such as fatigue.

- The contact wire failed by ductile overloading. It was considered highly likely that repeated occurrences of trams stopping and re-starting at Stillorgan Stop had resulted in sufficient cumulative resistive heating to cause the wire to be locally annealed. This had negated the effects of cold drawing, which had been performed when the wire was manufactured, and reduced its tensile strength. Consequently, the wire failed due to overloading, despite the fact that the tensile load applied to it may have been within normal operating parameters;
- The resistive heating caused the progressive growth of a scale of black Cupric Oxide on the surface of the wire. This increased the effective resistance of the wire and would have exacerbated the resistive heating.

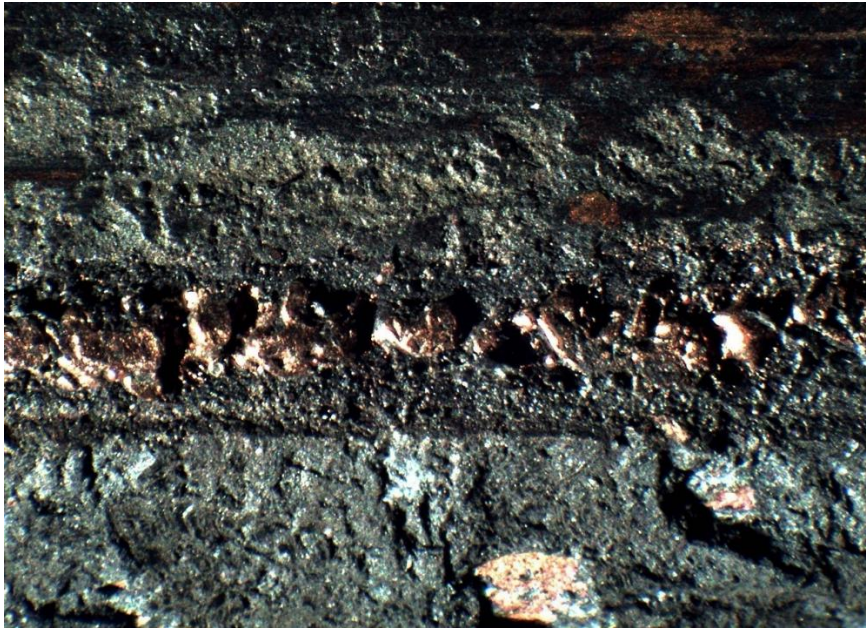
Figure 10 – Close-up of black coating on the OCS wire

76 The failed wire was covered with a black coating (see Figure 10) unlike the more accustomed pale green colour patina normally associated with copper oxidation. A sample of the black coating was scraped off the wire and inserted into a scanning electron microscope, fitted with an energy dispersive X-ray microanalyser and identified as Cupric Oxide which forms on copper when it is exposed to a temperature of between 300°C and 400°C and cooled⁹. Repeated occurrences of heating and cooling would result in the copper being annealed. The annealing of the wire would negate the effects of *cold drawing* of the wire during manufacture and reduce its tensile strength.

⁹ The RAIU have identified that the reasons for the presence of Cupric Oxide should be determined and have identified this as an Additional Observation, AO-03 (paragraph 154), and made a Safety Recommendation, Safety Recommendation 202102-05 (paragraph 167).

77 The Cupric Oxide was tested for electrical conductivity; the test showed that the black coating was insulative at both the contact and non-contact surfaces of the wire.

- Safety Recommendation 202106-05 – Transdev should investigate the reason for the build-up of Cupric Oxide on the OCS wire. The investigation should include but not limited to:

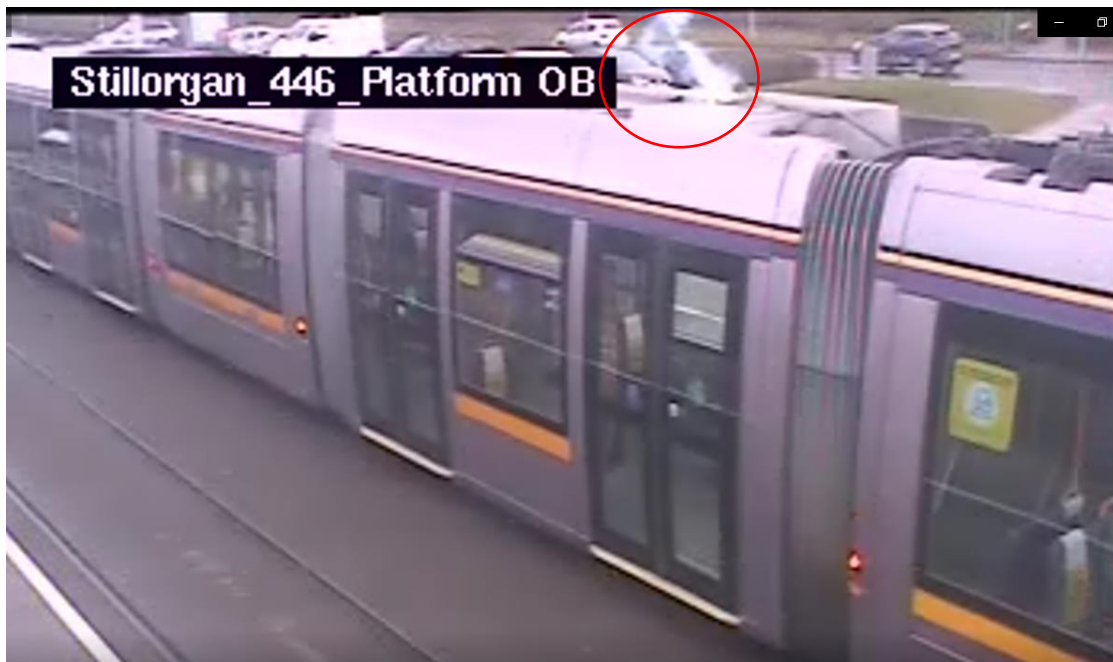
Figure 14 – Short-circuit between the OCS and roof of Tram 5010

- 89 At 14:34:59 hrs the OCS broke while Tram 5010 was stopped at Signal B11 and the MCB on Tram 5010 opened.
- 90 The broken OCS wire fell on the roof of Tram 5010 resulted in OCS ESS HSCB Sandyford L1 (into City Centre / Inbound) short circuiting, opening and de-energising the section (see Figure 14).

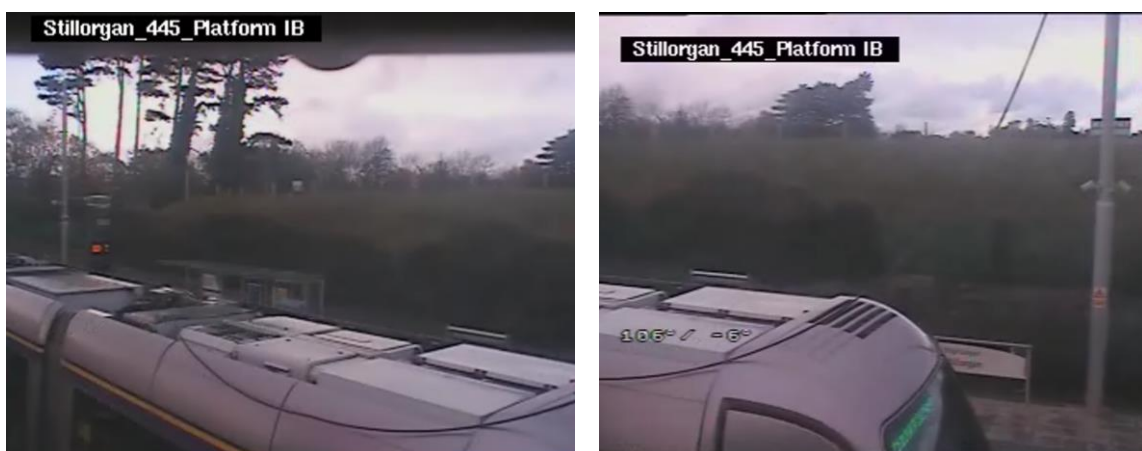
Figure 15 – Stillorgan CCTV images viewed by Traffic Supervisor

- 91 At 14:35:15 hrs, Driver 5010 reports to the Traffic Supervisor that the OCS was sagging. The Traffic Supervisor views the CCTV monitors for Stillorgan Stop (Figure 15) and sees that the OCS wire has detached.

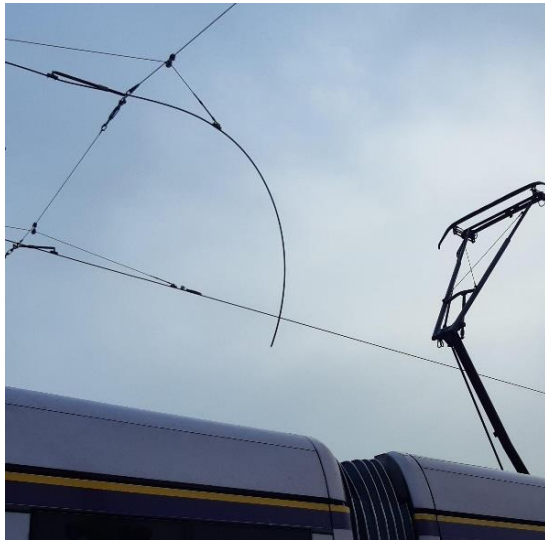
- 92 The detached OCS wire has one end approximately two meters above the roof of Tram 5010 (Figure 16) and the other end resting on the roof of Tram 5010, the outbound track and the platform at the Stillorgan Stop (Figure 17).

Figure 16 – OCS hanging over Tram 5010 Figure 17 – OCS wire on outbound track

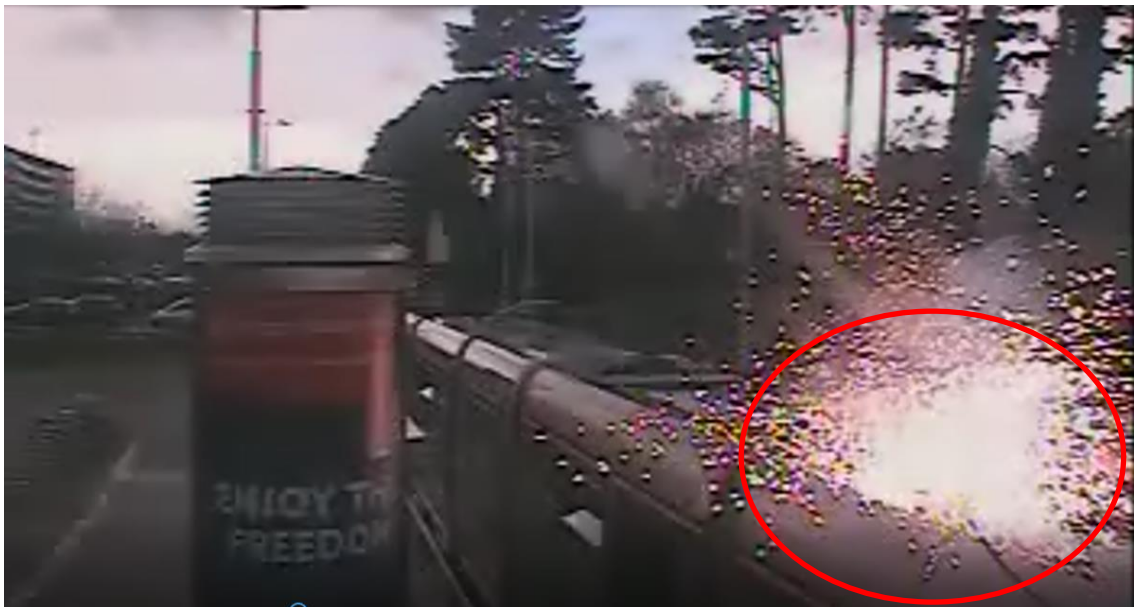
Figure 20 – Second short-circuit between the OCS and roof of Tram 5010

- 99 At 14:37:31 hrs, two minutes and thirty-two seconds after the first short circuit, Tram 5003 entered the Insulated Overlap between Sandyford ESS and Central Park (the Insulated Overlap is prior to Sandyford Stop); when the pantograph bridged both sections of wire, the de-energised section at Stillorgan Stop re-energising.
- 100 With the broken wire still resting against the roof of Tram 5010 at Stillorgan, the re-energising of the section resulted in a second short circuit (Figure 20).

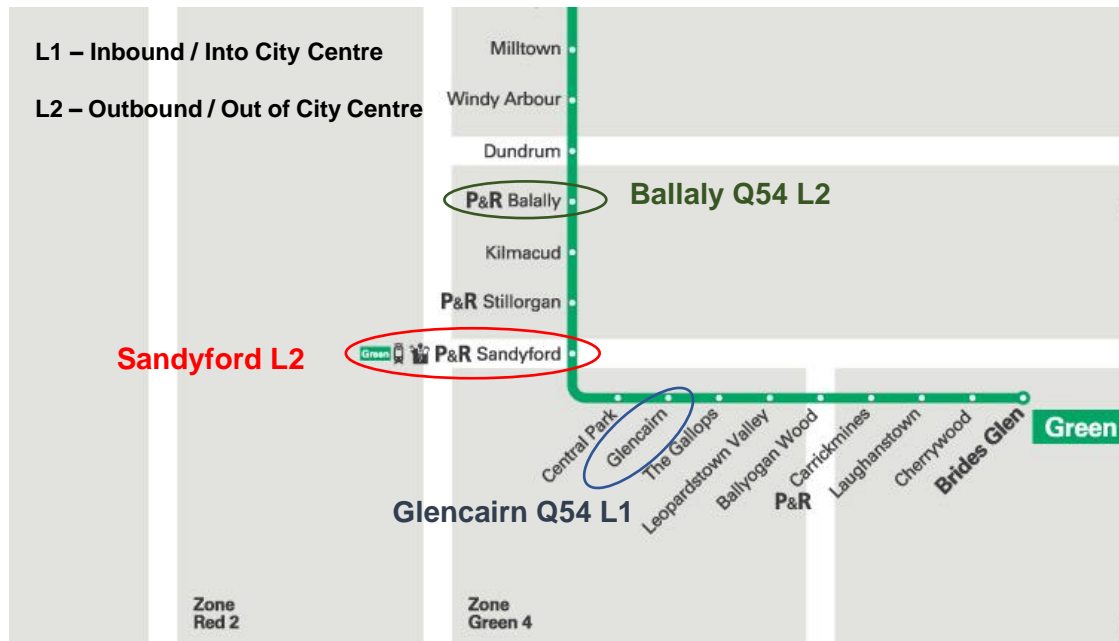
Figure 21 – OCS ESS HSCB Locations

101 Additionally, Sandyford HSCB L2 and Glencairn HSCB L1 tripped out due to overcurrent (Figure 21); this is visible to the Traffic Supervisor, through using SCADA.
