Investigation Report 2012–R001

Car Strike at Morrough Level Crossing, XG173,

County Galway,

14th February 2011

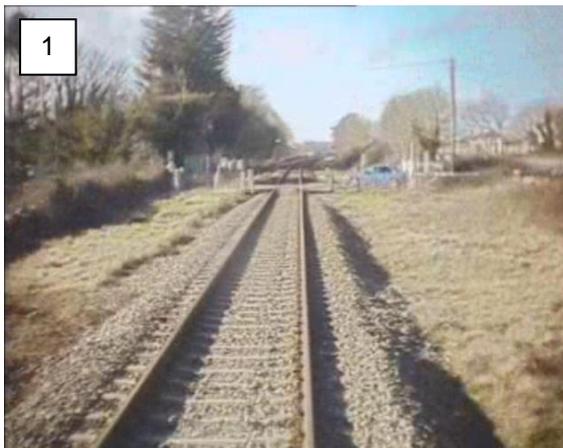
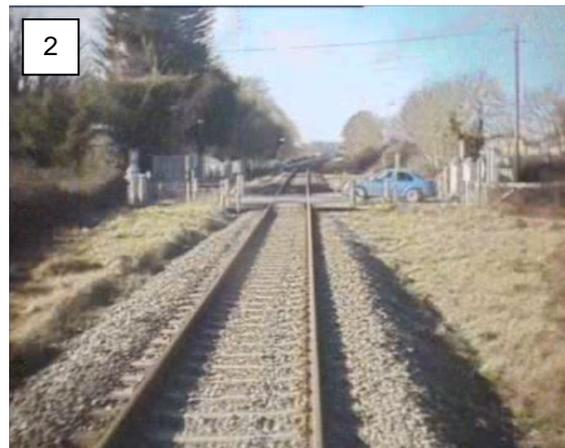
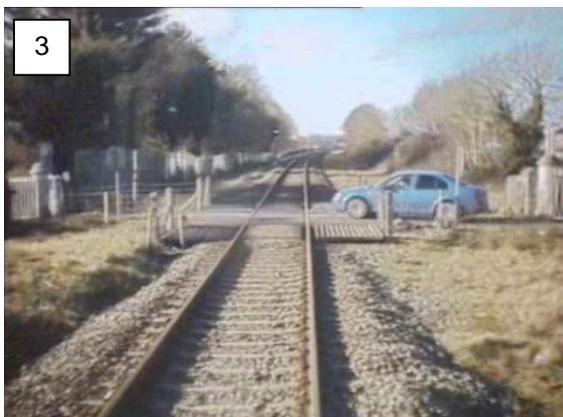
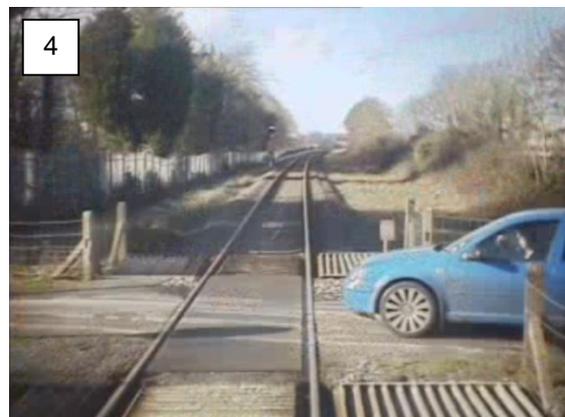
Figure 2 – CCTV snapshots of the Train's approach to the Level Crossing

1: Car approaching Level Crossing

2: Car arriving onto Level Crossing

3: Car driving onto the Level Crossing

4: Car position immediately before strike

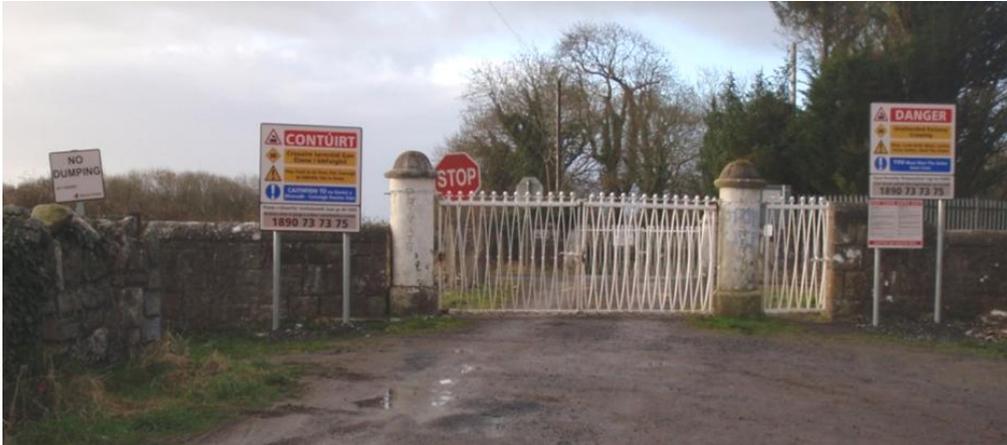
Photograph 1 – Morrough Level Crossing, approaching the Up side with the gates closed

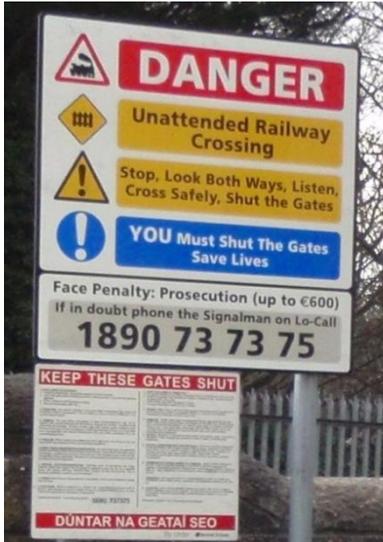
Photograph 3 – English language instructional sign

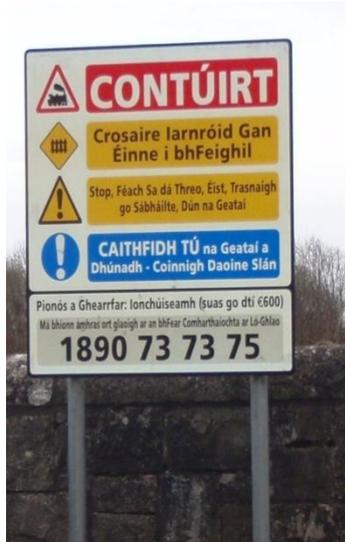
Photograph 4 – Irish language instructional sign

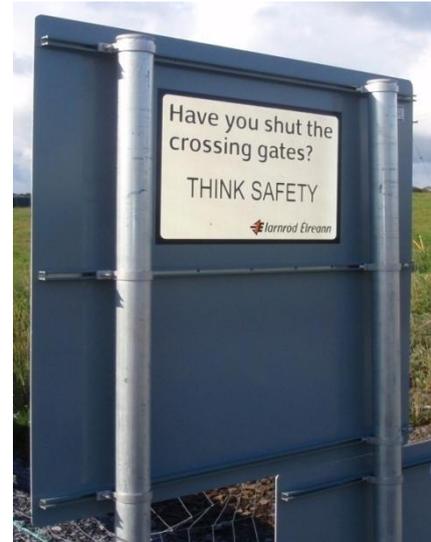
Photograph 5 – ‘Have you shut the crossing gates?’ sign

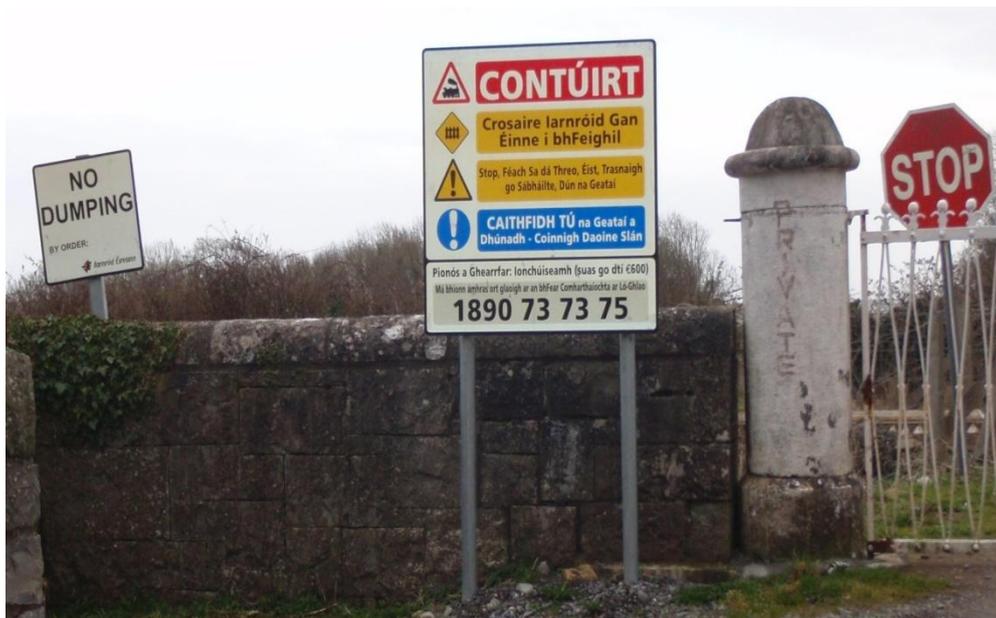
A ‘Stop’ sign was erected by IÉ on the left approach of the level crossing, positioned inside the gates, twelve feet (3.65 m) from the nearest rail on the crossing, as one of the suite of signage to be erected at level crossings as is normal practice for IÉ. The ‘Stop’ sign at the Level Crossing is as prescribed by the Department of Transport’s ‘Traffic Signs Manual’ 2010, (Section 6.15.9). However there was no continuous white line, sometimes associated with the Stop sign, present at the Level Crossing. There were no other road markings accompanying the ‘Stop’ sign or indicating the *decision point*. There is a ‘No Dumping’ sign to the left of the Irish Language sign, see Photograph 6. “Private” is painted vertically down the left hand pillar in dark paint which is faded due to weathering, see Photograph 6; and “Property” is painted vertically down the right hand pillar.

Photograph 6 – Instructional signage, ‘no dumping’ signage and Stop sign

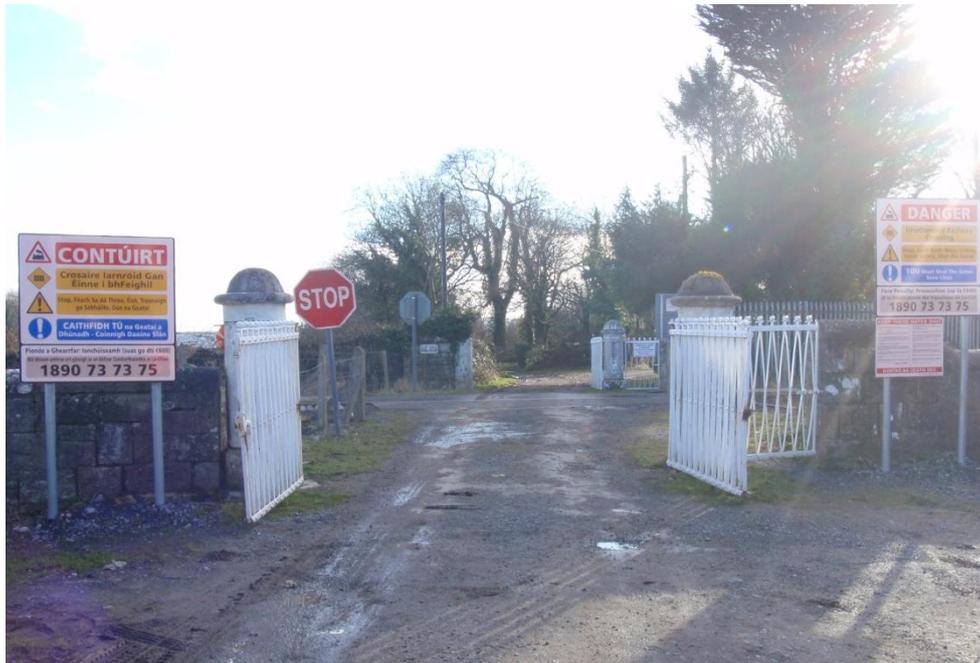
However, the “Private” and “Property” text on the pillars would have been obscured as the Car Driver approached the Level Crossing as the gates were open, see Photograph 7.

Photograph 7 – Level Crossing approach with the gates opened outwards

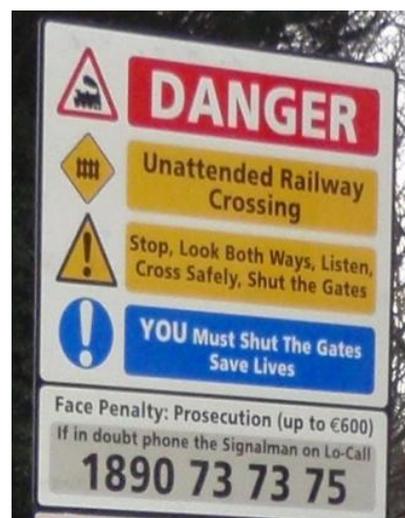
Photograph 9 –Level Crossing sign
