# Railway Accident Investigation Unit

## INVESTIGATION REPORT Runaway locomotive at Portlaoise Loop 29<sup>th</sup> September 2011

RAIU Report No: R2012 – 002  
Published: 19<sup>th</sup> September 2012

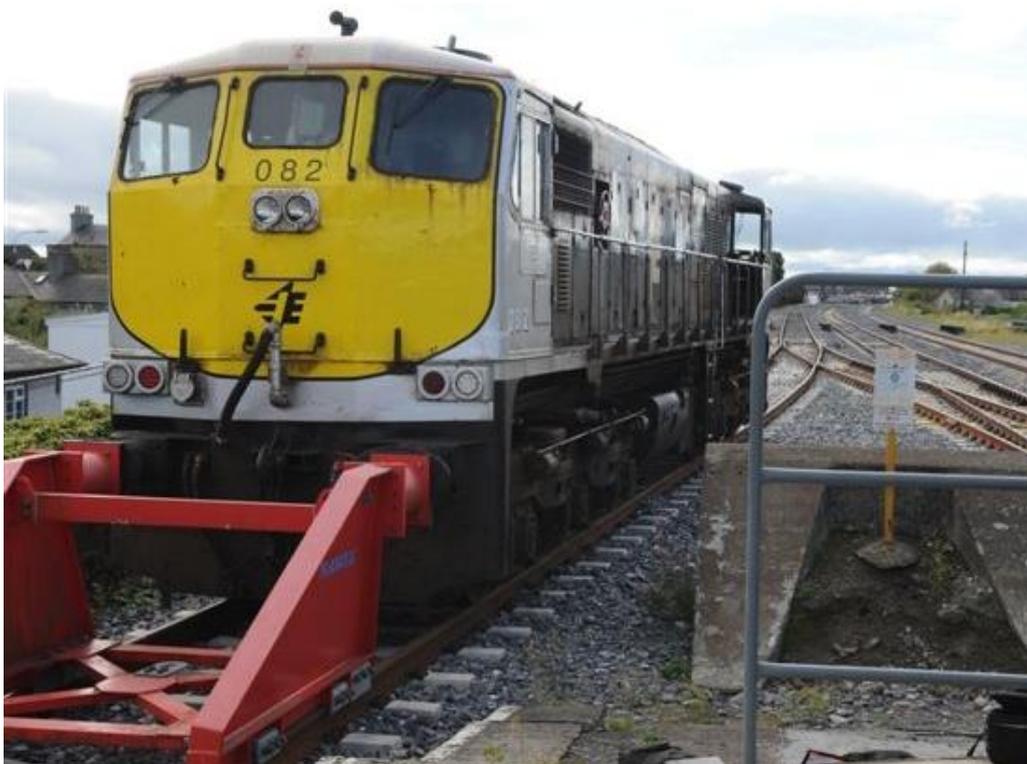
**Figure 3 – Locomotive at stopping position at buffer stop**

- 3 While stopped on Portlaoise Loop (which has a gradient of 1 in 230, sloping down towards Dublin), the Train Driver disembarked the locomotive to set the *ground frame* (see Figure 2) for Portlaoise Rail Depot. While standing at the ground frame the Train Driver saw the locomotive travelling away from him, in the direction of Portlaoise Station.
- 4 The locomotive travelled approximately 306 metres (m) from its stationary position, passing a signal at danger and striking the *buffer stop* in the former Bay Platform road at Portlaoise Station. The locomotive then moved the buffer stop 9 m before finally coming to a stop (315 m from its original stationary position). See Figure 3 for photograph of accident.

- 5 The locomotive crossing over the points triggered the *Track Circuit Interrupter*, placing all signals protecting the entrance and exit from the Loop to danger.
- 6 The Train Driver then contacted the mainline signalman, through his supervisor, to inform him of the situation and stop all trains in the area.
- 7 There were no passengers or other crew members on the locomotive and nobody was injured as a result of the occurrence.
- 8 There was minor damage to the buffer stop. There was no damage to the locomotive.

- 15 There were no fatalities or injuries to the Train Driver or any other person as a result of this accident.
- 16 There was no damage to the locomotive as a result of the impact with the buffer stop. The buffer stop moved, as would be expected, but did not receive any damage as a result of being struck.

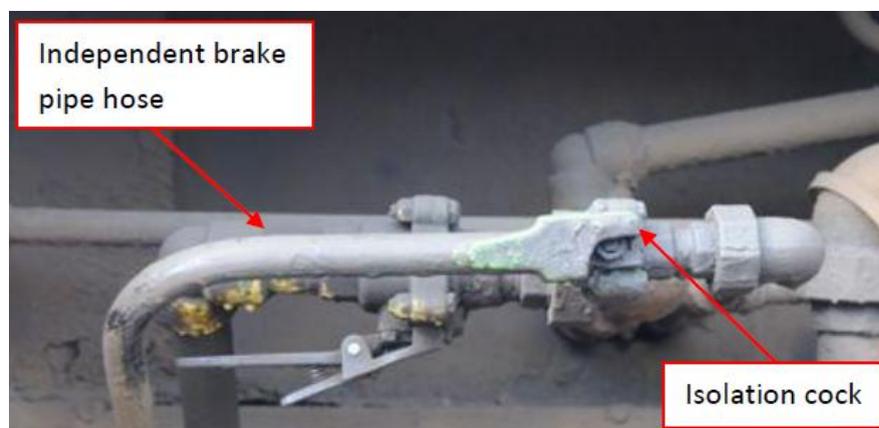
**Figure 6 – Isolation cock for the independent brake pipe**

34 The locomotive was examined after the accident and a leak was discovered at the isolation cock for the independent brake pipe hose, see Figure 6. Three other leaks were detected on the locomotive brake system. However, IÉ under the supervision of the RAIU conducted a number of simulations and verified that the leak discovered at the isolation cock for the independent brake pipe hose was the only one which contributed to the accident.

- 55 The locomotive did not undergo its last major overhaul (paragraph 29), due five months before the accident, which would have included the replacement of the isolation cock, irrespective of condition at the time of overhaul. Therefore had the leak in the isolation cock for the independent brake pipe hose existed at this time of the scheduled overhaul, it would have been replaced as part of this maintenance.

- 66 As a result of the locomotive not undergoing its last major overhaul, due five months before the accident, the braking system for the locomotive did not undergo routine maintenance prior to the accident occurring which would have included the replacement of the isolation cock. Had the isolation cock been leaking at the time of the scheduled overhaul it would have been replaced at this time (paragraph 55).

- 78 The CME, within a week of the accident, reviewed and changed the VMI to include the brake leakage tests.
- 79 As a result of the accident, braking examinations were carried out all Class 071 locomotives in the fleet. These examinations resulted in five other locomotives having faults detected in relation to their braking system, however, none of these faults were of a safety critical nature and none were similar to the fault detected in this occurrence. These faults were rectified before being re-entered into service.

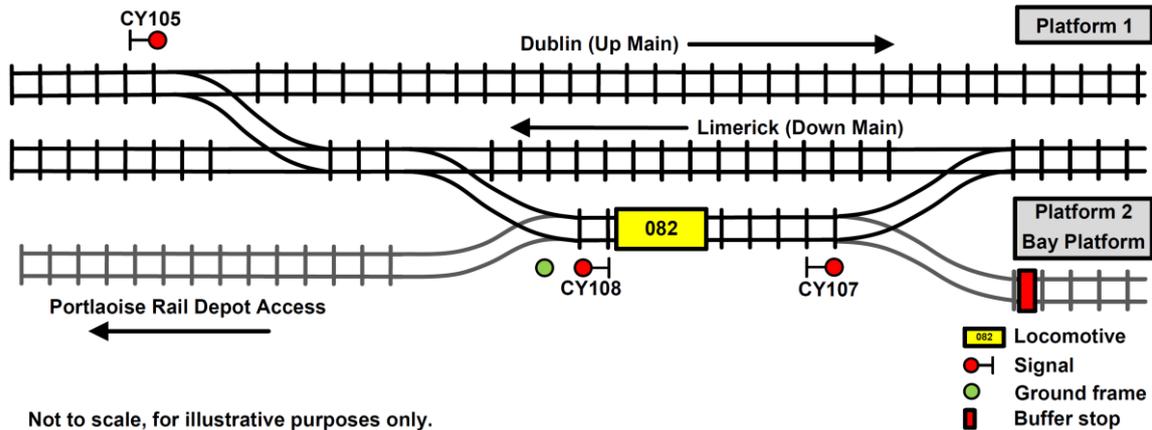
Figure 8 – Locomotive stopped on Portlaoise Loop

- 47 The Train Driver crossed from the Up Main onto the Down Main and then onto the Portlaoise Loop where he stopped at signal CY108, see Figure 8.

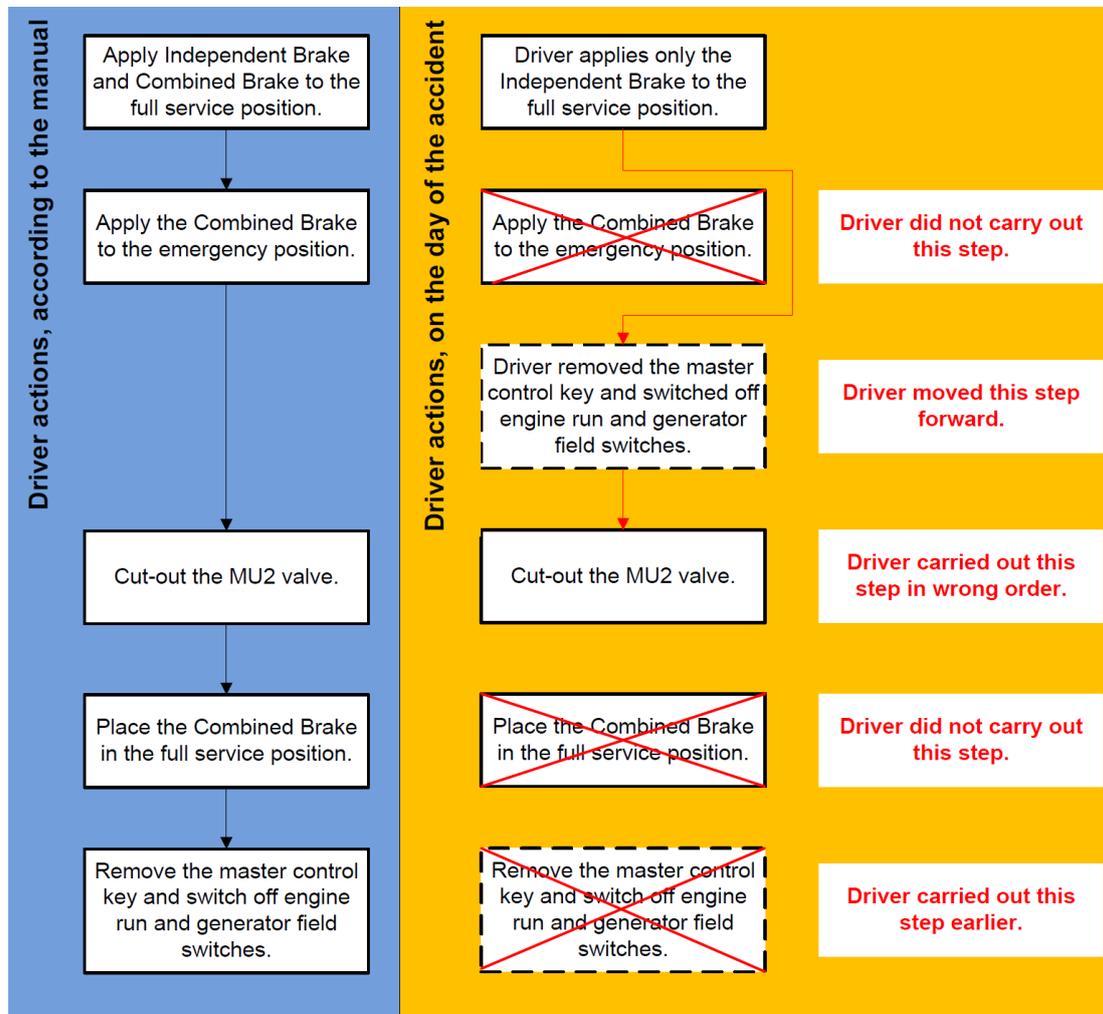
**Figure 10 – Actions to be taken by train drivers in relation to vacating a cab according to the manual compared with actual actions taken by Train Driver on the day of the accident.**

49 The Train Driver did not follow these procedures in full. Figure 10 compares the actions that should have been taken by the Train Driver, to those actions that the Train Driver actually carried out on the day of the accident in relation to the 'cab being vacated'. In summary, in relation to the 'cab being vacated' the Train Driver did not apply the Combined Brake to the full braking position or the emergency braking position at any stage.

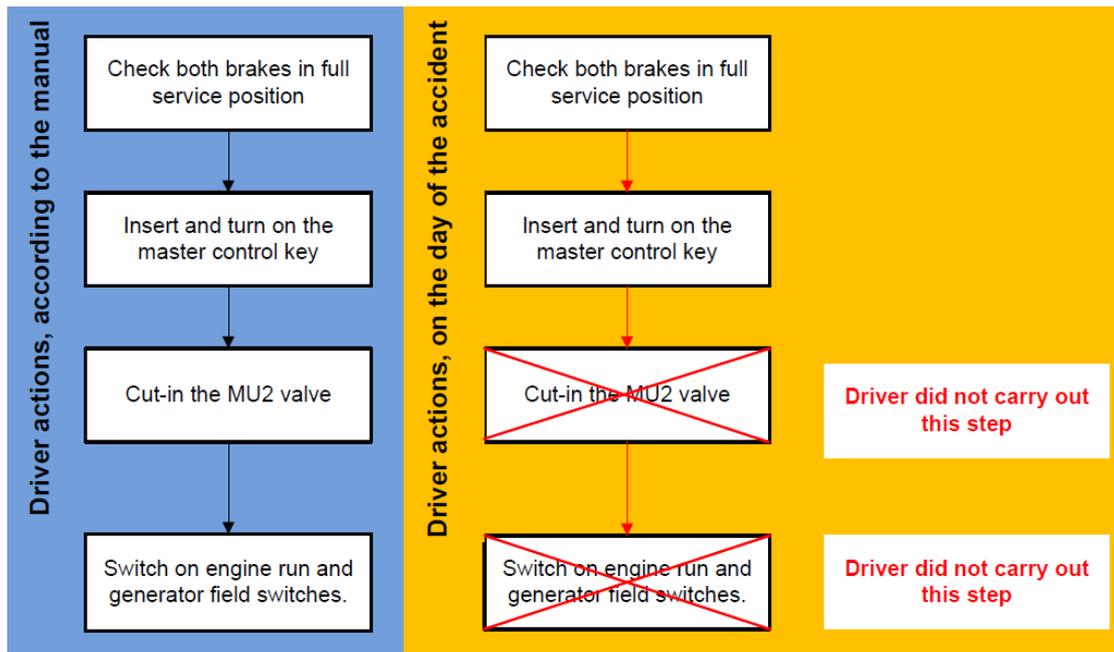
**Figure 11 – Actions to be taken by train drivers in relation to occupying a cab according to the manual compared with actual actions taken by Train Driver on the day of the accident.**

50 In relation to 'cab being occupied', the Train Driver did not cut-in the MU2 valve, and only placed his equipment in Cab 1, see Figure 11. However, cutting-in the MU2 valve in Cab 1 would still have resulted in the brakes applying, see Figure 9.

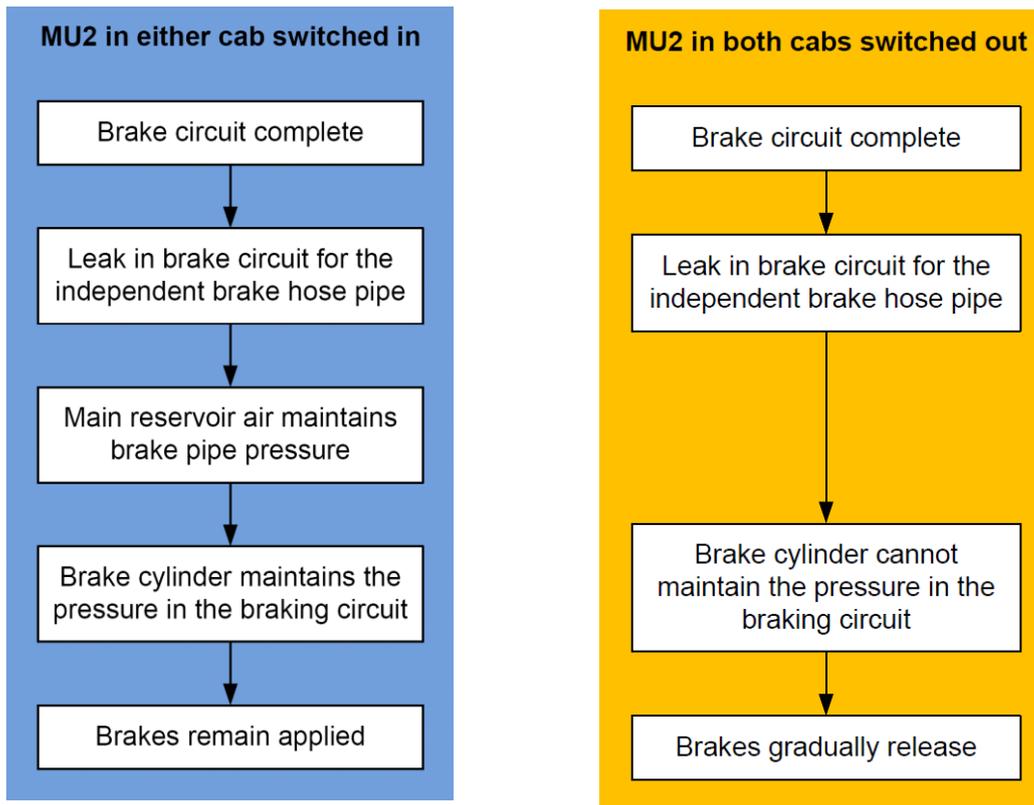
Figure 12 – Illustrating what would occur with either or no MU2 valve cut-in (and the leak present).

51 The Train Driver, who believed that the locomotive was secured and was safe to leave unattended; then disembarked, and made his way to the ground frame in order to set the route into Portlaoise Rail Depot. While the Train Driver was operating the ground frame, air leakage caused the locomotive brakes to release 2 minutes and 42 seconds after he had cut out the MU2 valve in Cab No.2, and the locomotive started rolling down the gradient towards Portlaoise Station. Had the full service brakes been applied as per the train drivers' instructions the brakes would have remained applied, despite the leak at the isolation cock for the independent brake pipe hose, see Figure 12. The fact that the combined brake handle was left in release allowed the brake cylinder pressure to drop as a result of the air leak at the isolation cock for the independent brake pipe hose, therefore causing the brakes to release, and the locomotive started to roll down the gradient, see Figure 12.

- 58 Examining the actions that the Train Driver took on the day of the accident, had the braking system been fully operational (i.e. without any leaks), the braking system would have been expected to perform despite the Train Driver not following the correct procedures. In addition, given the circumstances on the day of the accident (i.e. the leak being present), the brakes would still have remained applied if the Train Driver took the same actions in relation to vacating Cab 2, but had cut-in the MU2 valve in Cab 1 (Figure 12). However, with the leak present, and both MU2 valves cut out, brake cylinder pressure could not be maintained and therefore gradually released (Figure 12).

- 62 The Train Driver not carrying out these actions, combined with the air leak at the isolation cock for the independent brake pipe hose, resulted in the locomotive brakes gradually being released (Figure 12) and the locomotive running away as it was on a gradient, passing a signal at danger and striking the buffer stop.

- 69 Although, under certain conditions the brakes on the locomotive would have remained applied despite the Train Driver not following the correct procedures for vacating and occupying cabs (paragraph 58, Figure 10 and Figure 11); the locomotive's brakes did release when the Train Driver did not cut-in either MU2 valves (Figure 12) as there was a leak in the isolation cock.

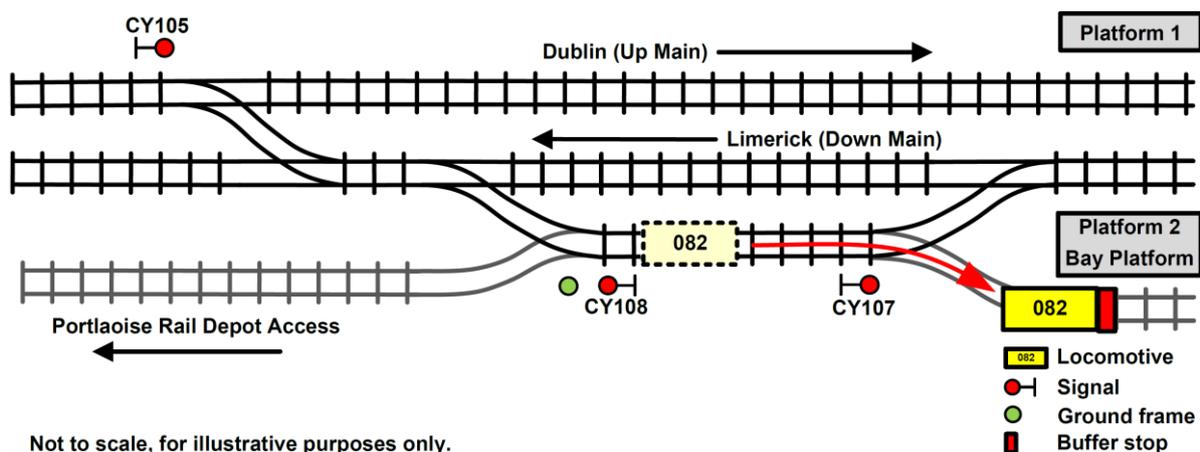
Figure 13 – Locomotive at buffer

52 With the brakes gradually releasing, and the locomotive being on a gradient, the locomotive began to roll towards Portlaoise Station, reaching an approximate speed of 23 km/h, passing signal CY107 at danger and colliding with the buffer stop at the Bay Platform before coming to a stop, see Figure 13.
