# Railway Accident Investigation Unit

## INVESTIGATION REPORT Tram collision with a bus on O'Connell St 16<sup>th</sup> September 2009

RAIU Report No: R2013 – 001  
Published: 28<sup>th</sup> February 2013

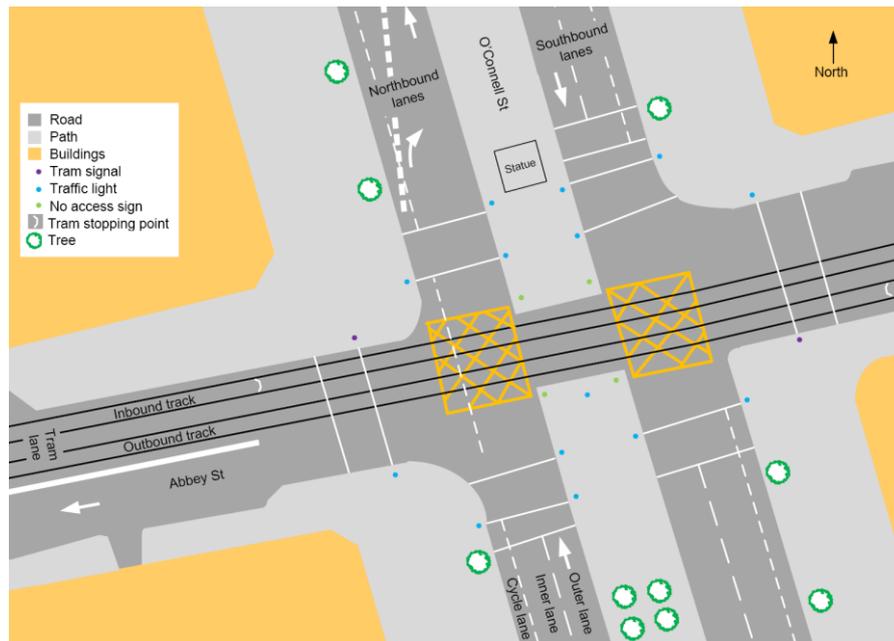
**Figure 2 – Junction Layout (not to scale, for illustration only)**

- 3 The bus was travelling along O'Connell St, in a northerly direction and entered the yellow box at the junction with Abbey St at the same time as the tram, see Figure 2. The bus had a green traffic signal displayed before it entered the junction. Another bus was travelling at a slower speed in the inside lane having picked up passengers.

- 4 The leading driver's cab of the tram impacted the side of the bus just behind the front wheels. The bus was then moved laterally to its right as the tram continued forward and derailed. The driver's cab of the tram penetrated the side of the bus. The front section of the tram bent to its left as the rear of the tram and the bus both continued forwards in their respective directions of travel. The bus mounted the central reservation. The front of the bus collided with a traffic light pole and the right side of the bus collided with a traffic sign pole. Both poles were knocked over. The front of the bus then made contact with a second traffic light pole.

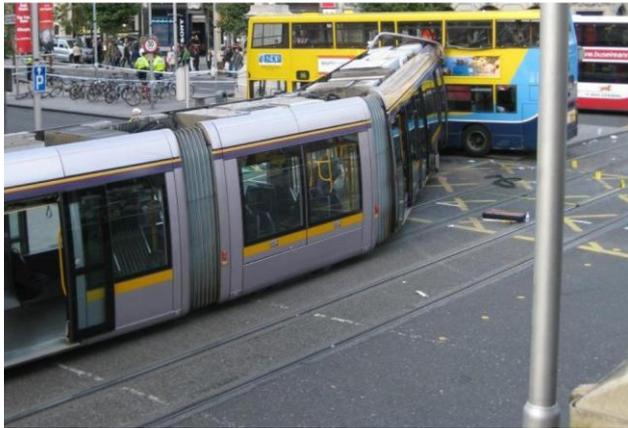
**Figure 3 – Photograph of final position of vehicles**

- 5 The bus came to a stop with its leading right wheel and both rear wheels on the central reservation on the north side of the junction of O'Connell St and Abbey St. The tram came to a stop with the leading driver's cab of the tram protruding into the saloon of the bus. The first section of the tram was bent to the left relative to the rest of the tram at approximately a 15 degree angle to the direction of the tram tracks. The leading bogie was raised off the rails and the bogie under the second section of the tram was also derailed with its wheels resting on the road, see Figure 3 and Figure 4.

- 29 The tram sustained severe frontal damage, with the cab and sub frame having to be replaced. Although the tram derailed, there was no significant damage to the infrastructure.
- 30 Substantial damage was caused to the middle nearside directly behind the wheel arch of the bus as a result of the front of the tram first making contact with the wheel arch, and as the bus moved forward, the tram penetrated the aluminium skin of the bus. The tram also slid up and over the side outrigger of the bus impacting into the passenger compartment of the bus.
- 31 Two traffic light poles and a road traffic directional sign pole were damaged as a result of the collision.

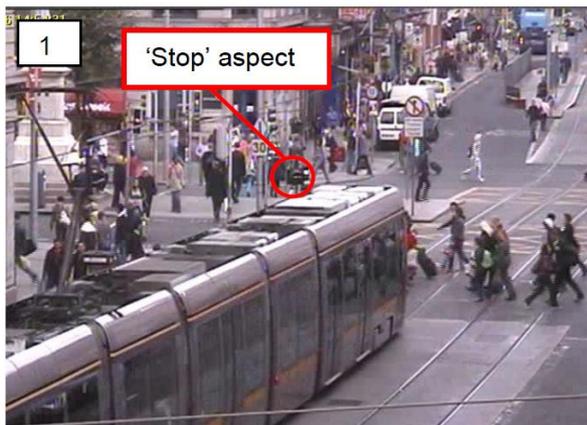
Tram stops at the stop line and remains at this point for 44 s. Tram aspect showing 'Stop'.

68 From the tachometer data it can be seen that the tram stopped before the junction for 44 s, then moved forwards 0.8 m before stopping for a further 21 s. The tram then moved forwards, entering the junction, sounded the horn for 1 s and applied the emergency brake at a speed of 19 km/h. It should be noted, that as the tram was reacting to the tram driver's brake application the speed briefly increased to a maximum of 20 km/h. The tram decelerated to a speed of 17 km/h prior to the collision. The distance travelled, after the brake application, was approximately 22m. The outputs from the tachometer are illustrated in Figure 13 (distances are approximate values).

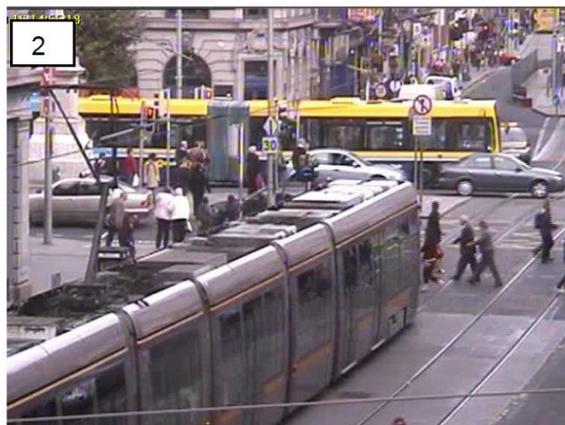
The tram moves forward a distance of 0.8m and remains here for a further 21 s. Tram aspect remains at 'Stop'.

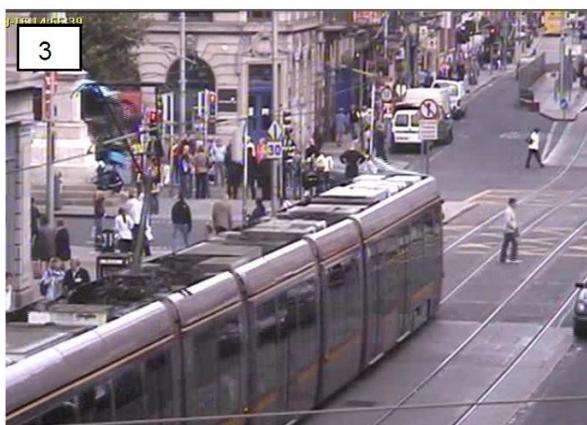
The tram then moves across the junction. Tram aspect remains at 'Stop'.

83 Tram 3002 proceeded through a stop signal at the junction of Abbey Street and O'Connell Street as a bus crossed through the junction on a green traffic signal which resulted in a collision. The immediate cause of this collision was as a result of a lapse in concentration by the tram driver.

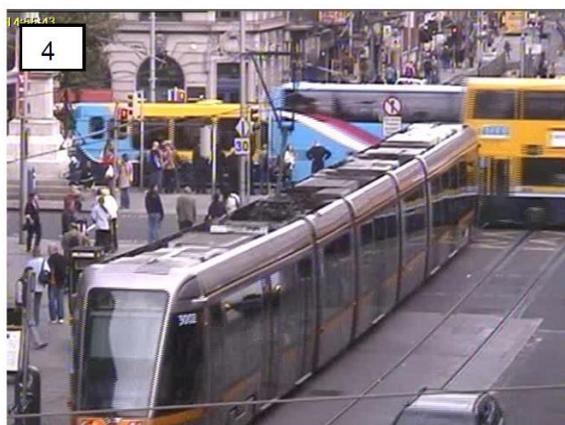
Bus enters the junction as the tram moves through the signal. Tram aspect remains at 'Stop'.

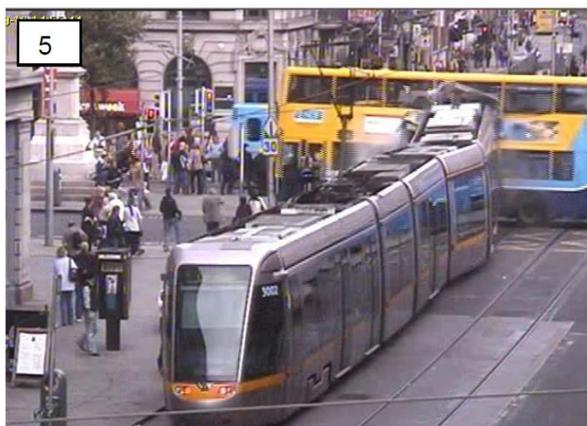
Tram impacts with the bus as it travels through the junction. Tram aspect remains at 'Stop'.

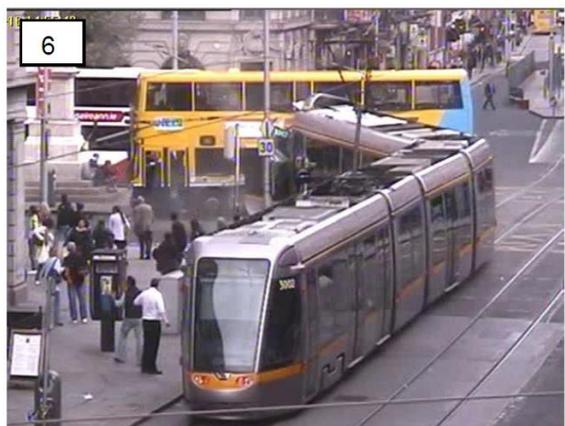
Tram derails and bus is pushed across the junction. Tram aspect remains at 'Stop'.
