# Railway Accident Investigation Unit

## INVESTIGATION REPORT Tractor struck train at level crossing XE020, County Clare 20<sup>th</sup> June 2012

RAIU Report No: R2013 – 002  
Published: 17/06/2013

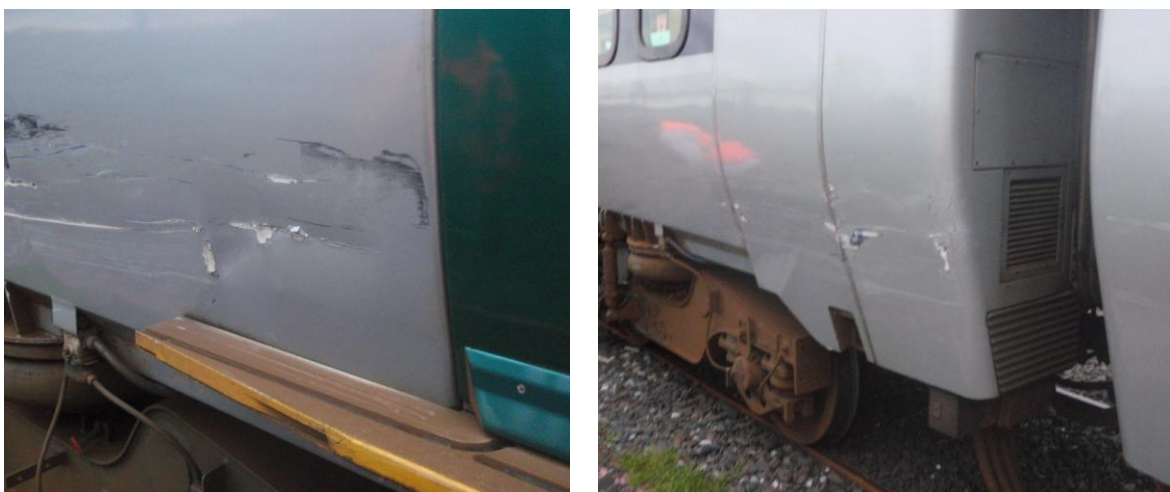
**Figure 2 – Damage to train**

- 15 There was superficial damage to the right side of the train, see Figure 2 for photographs of the damage.

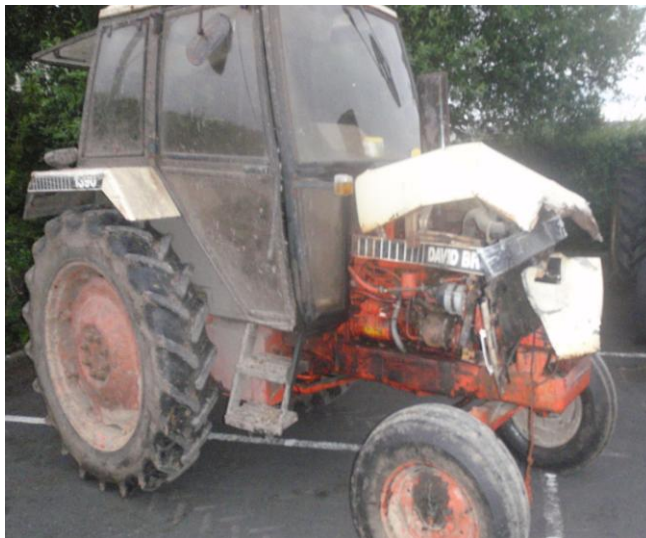
**Figure 3 – Damage to the tractor**

- 16 The tractor sustained damage to the lights and bodywork directly in front of the front axle; with the battery box and associated electrical equipment removed in the collision. See Figure 3 for photograph of the damage sustained by the tractor. The tractor was repaired and is back in daily use.

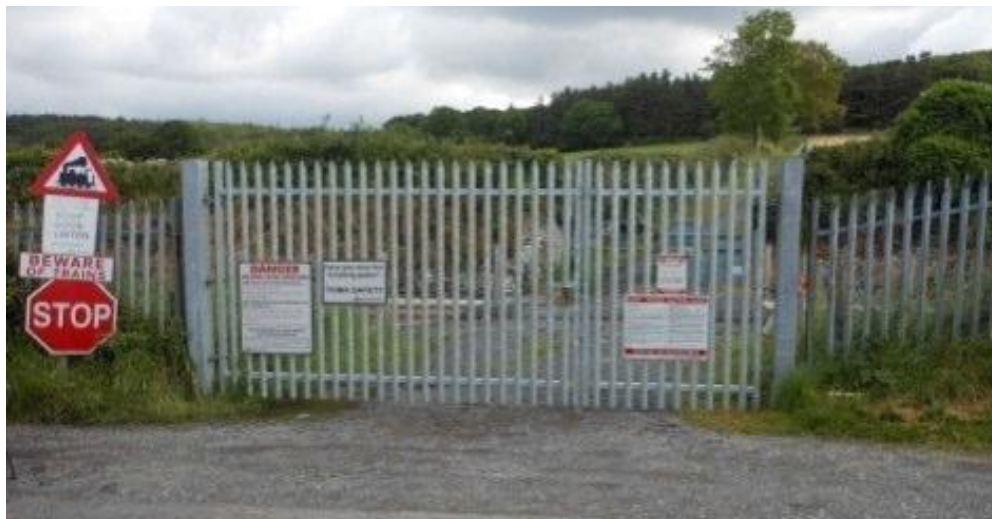
**Figure 4 – Down side level crossing approach**

23 Level crossing XE020 is located 9 miles 389 yards on the Limerick to Athenry railway line (within the Limerick to Ennis section), in a rural area. It is an 'F' type level crossing, which means it is a user worked unattended field crossing. The level crossing is fitted with a palisade gate which is padlocked and is part of a perimeter fence on the Down side which is adjacent to the R462 national road, see Figure 4.

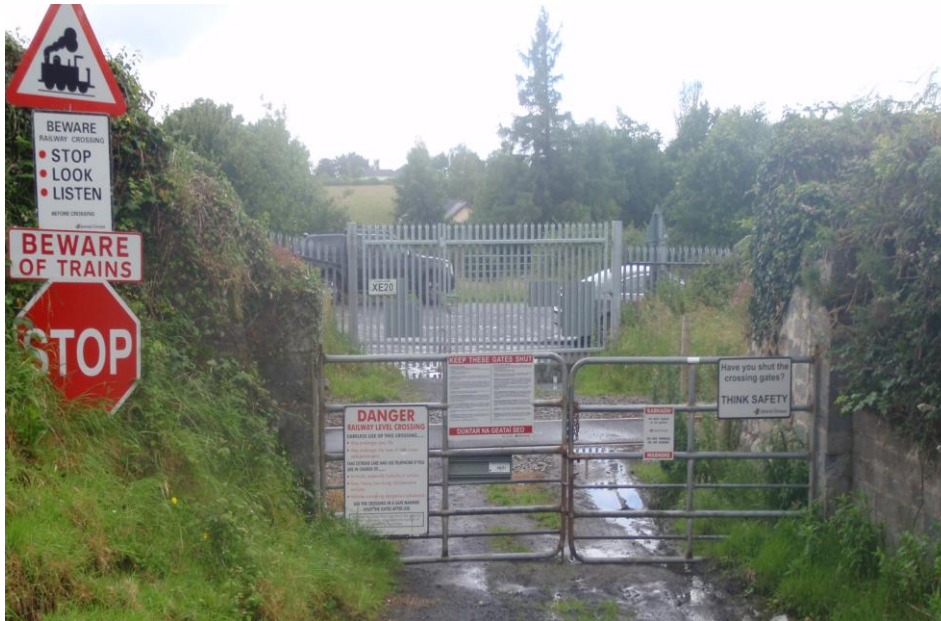
Figure 5 – Up side level crossing approach

24 Field gates are fitted and padlocked on the Up side of the level crossing, see Figure 5. The signage in place complies with IÉ's Technical Management Standard CCE-TMS-380, 'Technical Standard for the Management of User Worked Unattended Level Crossings' (which will be referred to as CCE-TMS-380 for the remainder of the report), which was issued on the 9<sup>th</sup> May 2012 and replaced the previous level crossing standard, MW50.

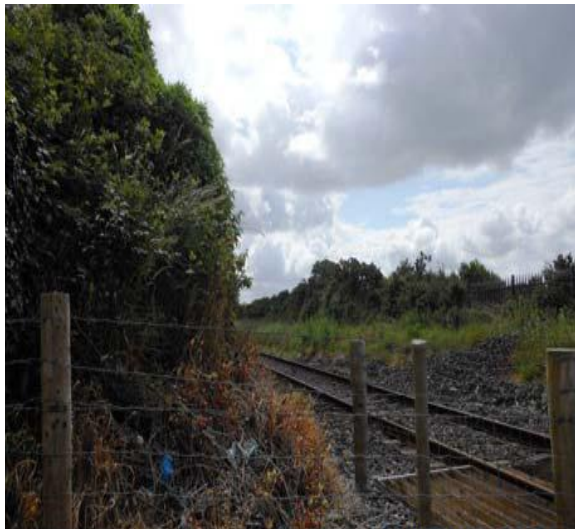
**Figure 7 – View on Up Side looking Up**

28 The level crossing failed to achieve all but one of the viewing distance requirements. In particular, it was not achieved on the Up Side – looking Up (towards Limerick), Figure 7, which is the side from which the train approached the level crossing in relation to the tractor. The viewing distance was recorded at 34 m.

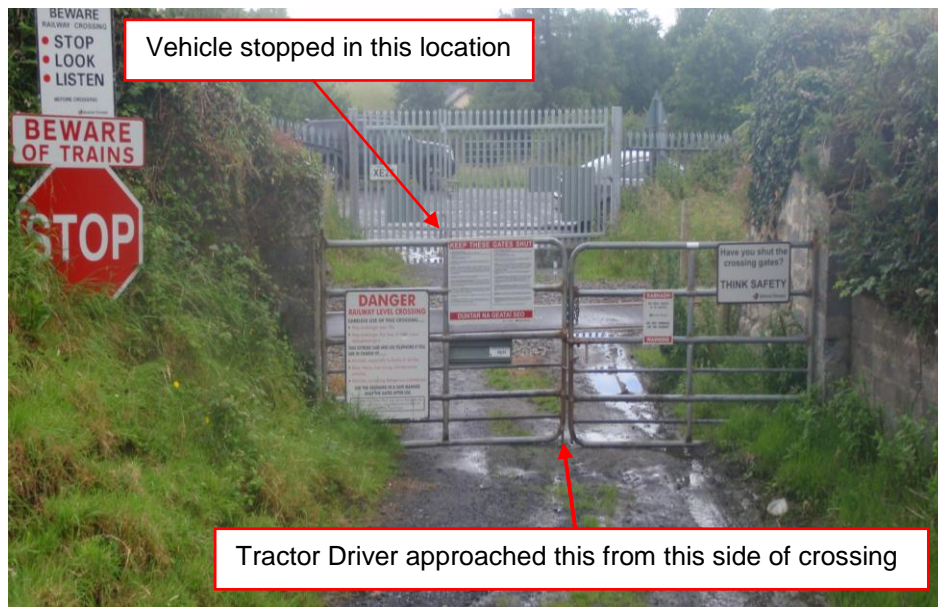
**Figure 10 – Events at level crossing leading up the accident**

- 38 He returned to the tractor and edged forward slightly. At this point, a motor vehicle on the R462 pulled into the gateway blocking his exit, see Figure 10. The driver of the vehicle saw the tractor and then continued on his journey.

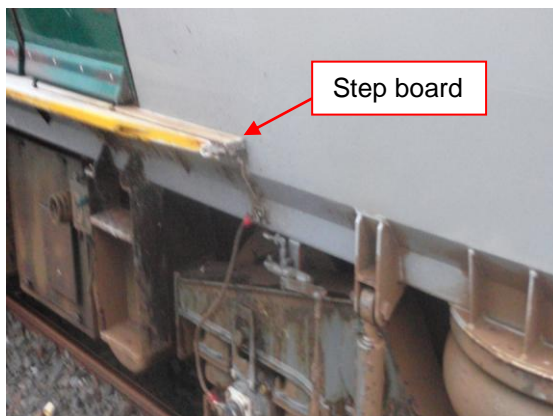
Figure 11 – Step board

- 42 The Tractor Driver after opening the gates and checking the signals then edged forward and collided with the train as it passed through the level crossing. The first point of contact with the train was at the step board on the second set of doors rear of the first carriage, see Figure 11, at a point 13 m from the front of the train, see Figure 12. The train continued through the level crossing with the tractor scraping along the train for a distance of 3 m before being pushed sideways off the train. The Tractor Driver did not hear the train horn at any point.

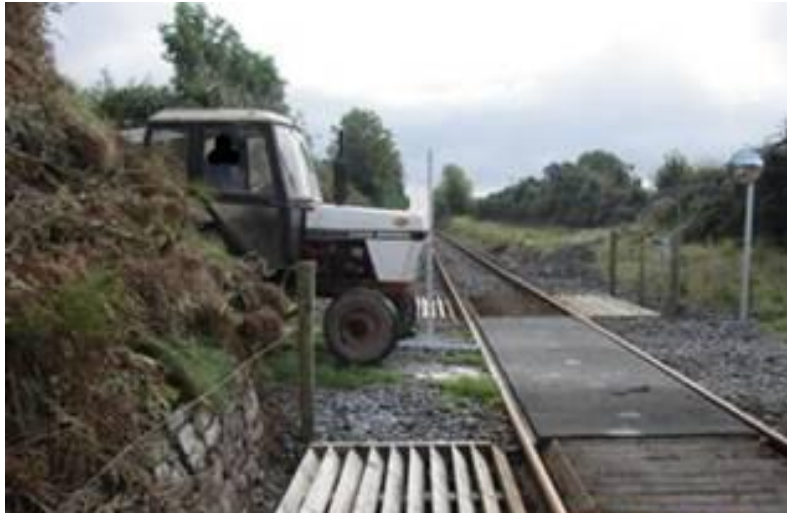
Figure 15 – Position the tractor requires to look for approaching trains

53 A reconstruction was carried out at the level crossing with the tractor once it was repaired. It was found that in order for the Tractor Driver to obtain a view of an oncoming train exiting the field gate on the up side the tractor had to move forward to a point where the edge of its front body work was 0.6 m from the outside edge of the nearest rail, see Figure 15. On the day of the reconstruction, the train horn could be heard from a position of 250 m from the level crossing.
