**Railway Accident
Investigation Unit**

INVESTIGATION REPORT

**Tractor struck train at level crossing XE020,
County Clare
20th June 2012**

RAIU Report No: R2013 – 002

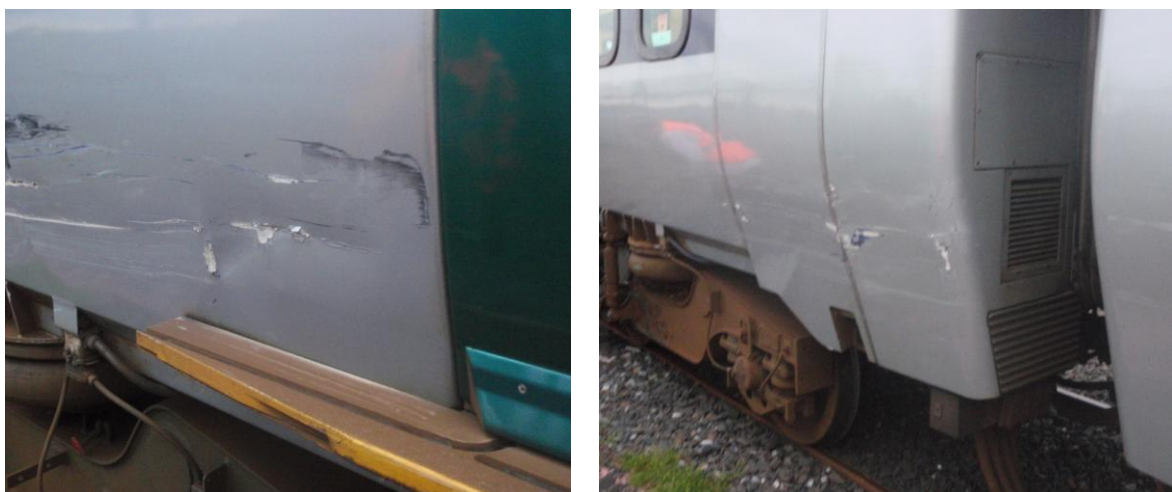
Figure 2 – Damage to train

- 15 There was superficial damage to the right side of the train, see Figure 2 for photographs of the damage.

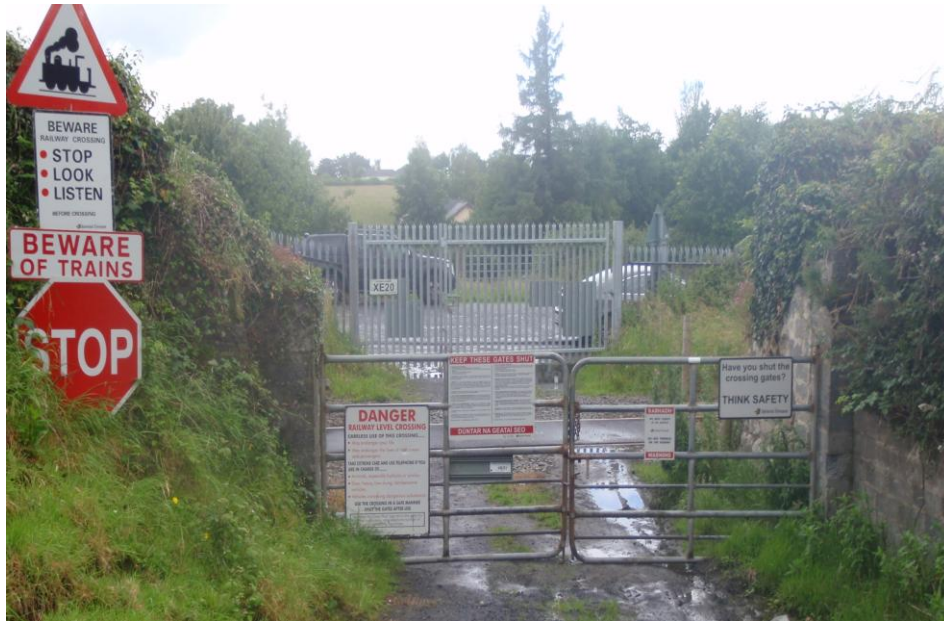
Figure 5 – Up side level crossing approach

- 24 Field gates are fitted and padlocked on the Up side of the level crossing, see Figure 5. The signage in place complies with IE's Technical Management Standard CCE-TMS-380, 'Technical Standard for the Management of User Worked Unattended Level Crossings' (which will be referred to as CCE-TMS-380 for the remainder of the report), which was issued on the 9th May 2012 and replaced the previous level crossing standard, MW50.

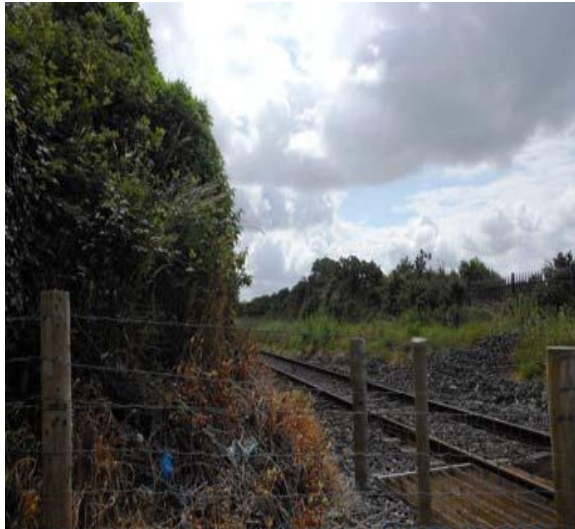
Figure 7 – View on Up Side looking Up

- 28 The level crossing failed to achieve all but one of the viewing distance requirements. In particular, it was not achieved on the Up Side – looking Up (towards Limerick), Figure 7, which is the side from which the train approached the level crossing in relation to the tractor. The viewing distance was recorded at 34 m.

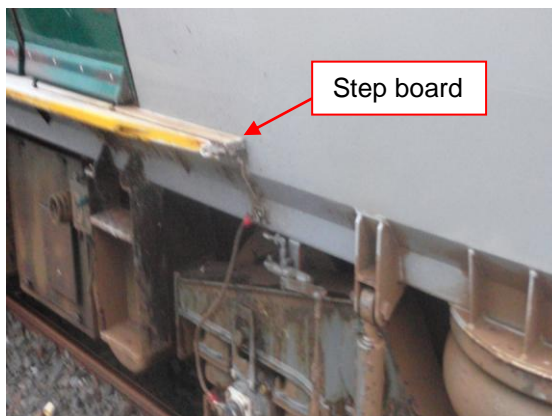
Figure 11 – Step board

- 42 The Tractor Driver after opening the gates and checking the signals then edged forward and collided with the train as it passed through the level crossing. The first point of contact with the train was at the step board on the second set of doors rear of the first carriage, see Figure 11, at a point 13 m from the front of the train, see Figure 12. The train continued through the level crossing with the tractor scraping along the train for a distance of 3 m before being pushed sideways off the train. The Tractor Driver did not hear the train horn at any point.

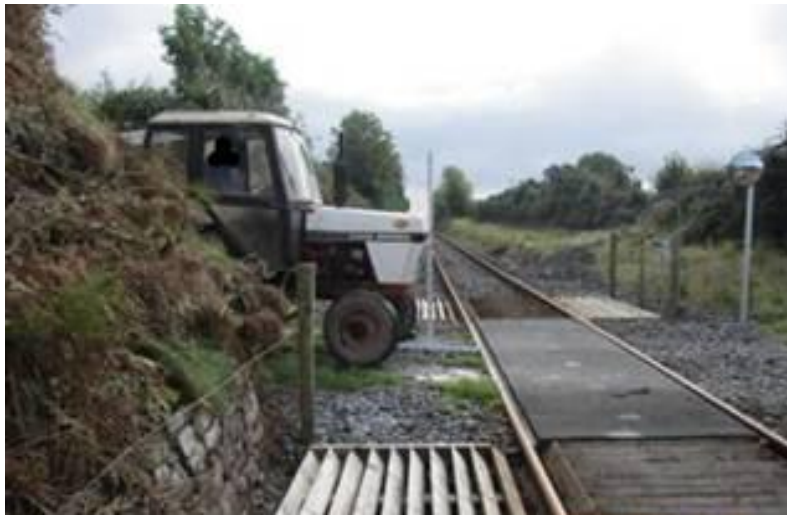
Figure 15 – Position the tractor requires to look for approaching trains

- 53 A reconstruction was carried out at the level crossing with the tractor once it was repaired. It was found that in order for the Tractor Driver to obtain a view of an oncoming train exiting the field gate on the up side the tractor had to move forward to a point where the edge of its front body work was 0.6 m from the outside edge of the nearest rail, see Figure 15. On the day of the reconstruction, the train horn could be heard from a position of 250 m from the level crossing.
