Railway Accident Investigation Unit

INVESTIGATION REPORT **Rock fall at Plunkett Station, Waterford,** **31st December 2013** RAIU Report No: R2014 – 006 Published: 18/12/2014

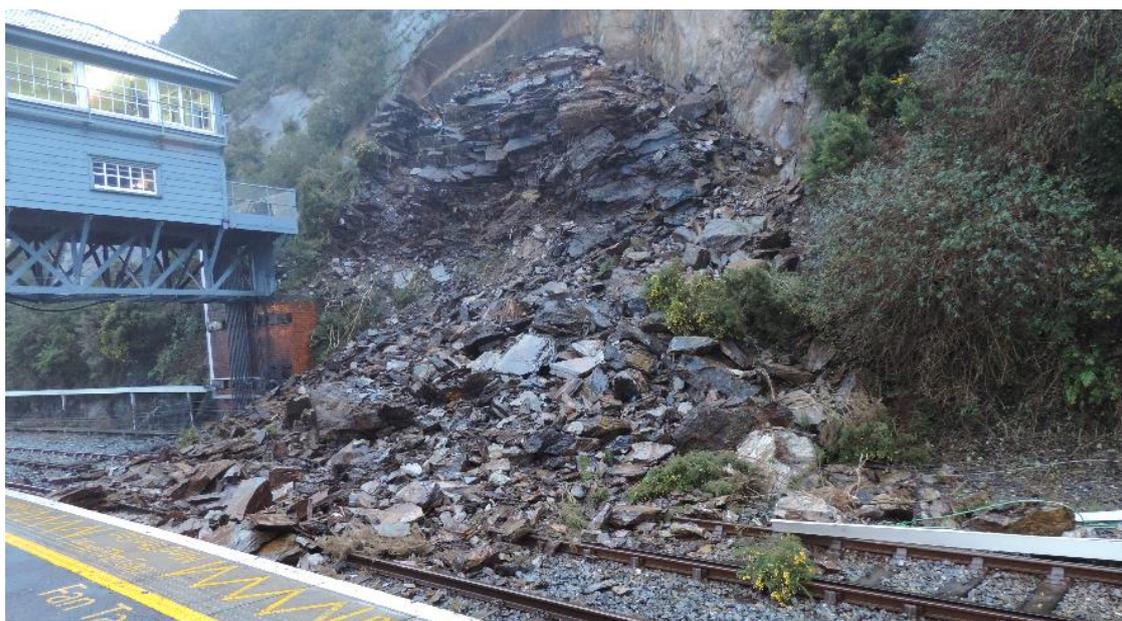
Figure 2 – Rock fall adjacent to the Signal Cabin at Plunkett Station

- 2 When the Signaller went out onto the steps of the Signal Cabin to investigate, he saw that a large portion of the *rock face* running adjacent to the station had collapsed onto the two tracks which run under the Signal Cabin and through Plunkett Station, see Figure 2.

- 21 The rock fall resulted in minor damage to the track and the footings for Signal Cabin. However, there was considerable damage to the signalling system, in particular, the disabling of the signalling connected to the Signal Cabin which resulted in a number of points and signals being rendered inoperable.

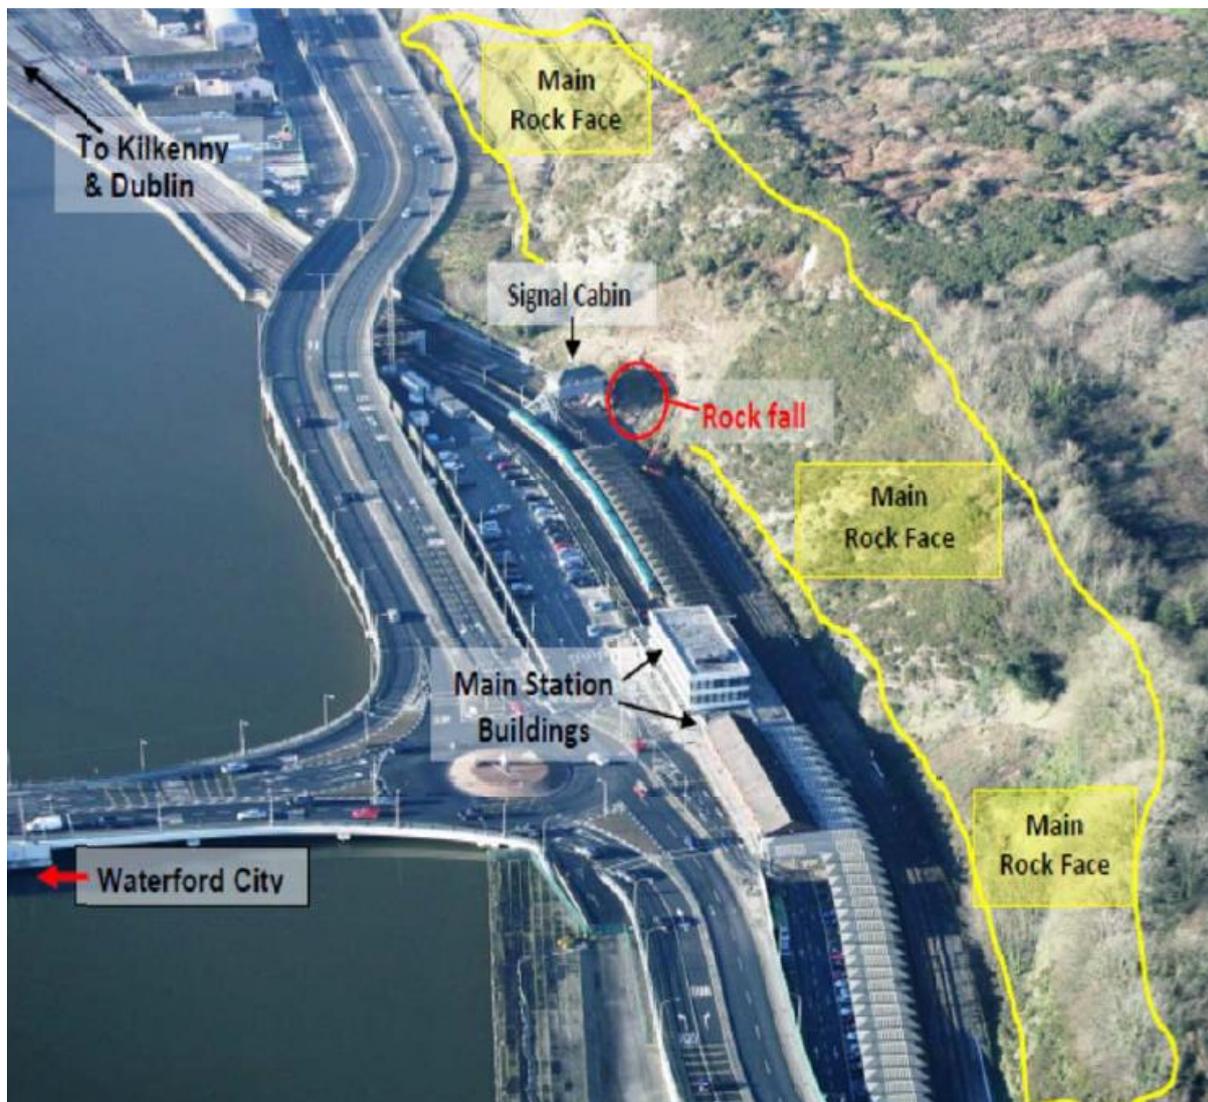
Figure 4 – Aerial view of the rock face and location of the rock fall

- 32 The length of the rock face is approximately 375 m and runs the entire length of Plunkett Station. The rock fall occurred within the proximity of Plunkett Station, adjacent to the Signal Cabin, see Figure 4.

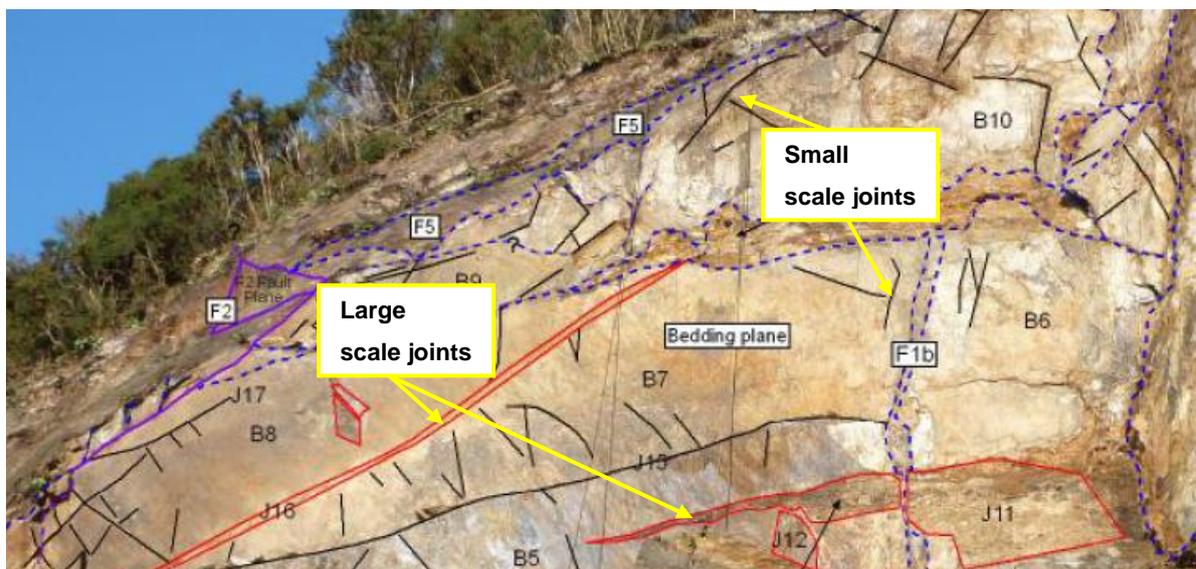
Figure 5 – Joints at incident site

- Small scale joints which are closely to medium spaced² (60 – 600 millimetres (mm)) which are limited in lateral extent, inclined to either the east or the west, and are abundant at the site, see black lines in Figure 5;

- Larger scale mega joints which are medium to widely spaced (200 – 2000 mm) which are more laterally extensive, see red lines in Figure 5.

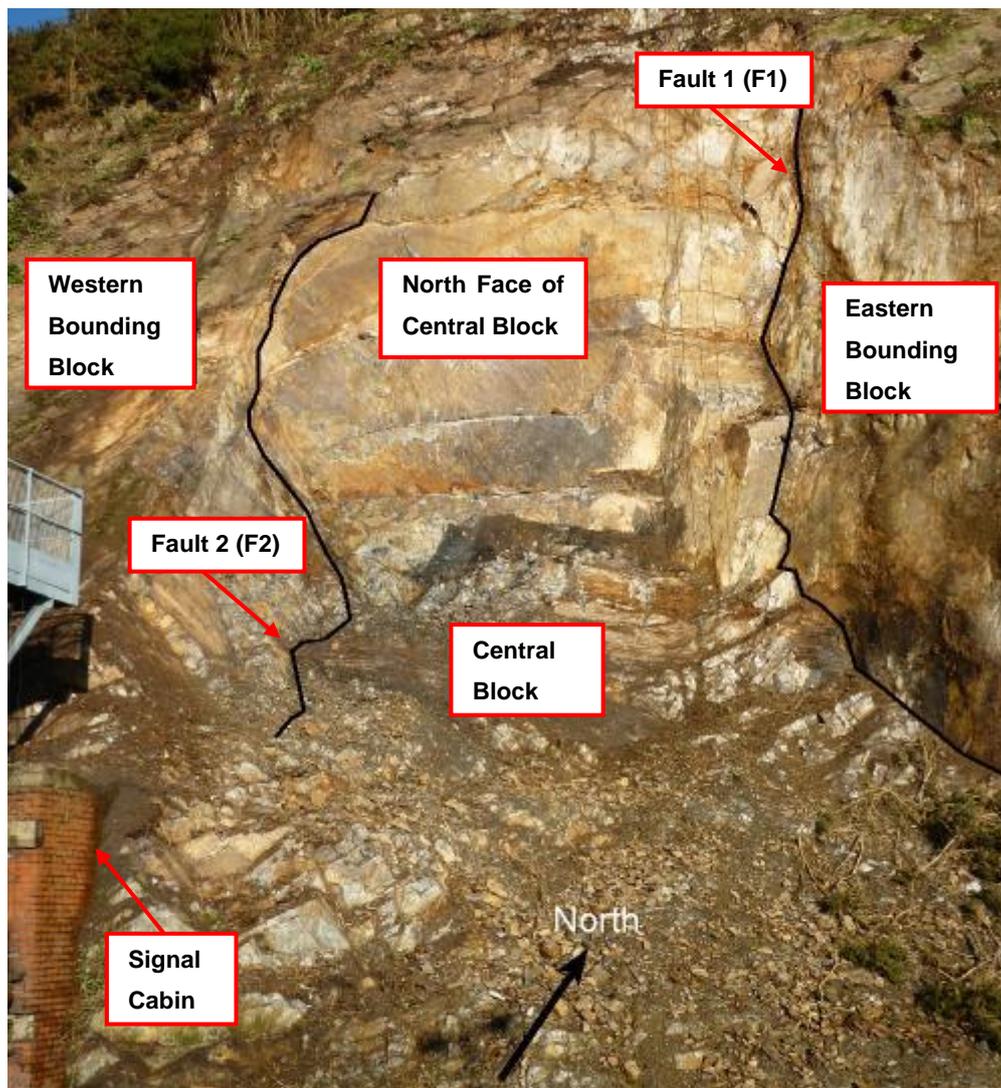
Figure 6 – Rock face after the debris was removed

- F1 – Located on the eastern side of the Central Block (area of rock fall), see Figure 6. F1 is inclined at approximately 82° to the west-southwest with the *fault zone* showing relatively intense weathering probably due to groundwater migration;
- Fault 2 – Located on the western side of the Central Block, see Figure 6. F2 consists of a 1 metre (m) wide fault zone containing a number of internal fault elements, suggesting a history of multi-event *tectonic movements*.

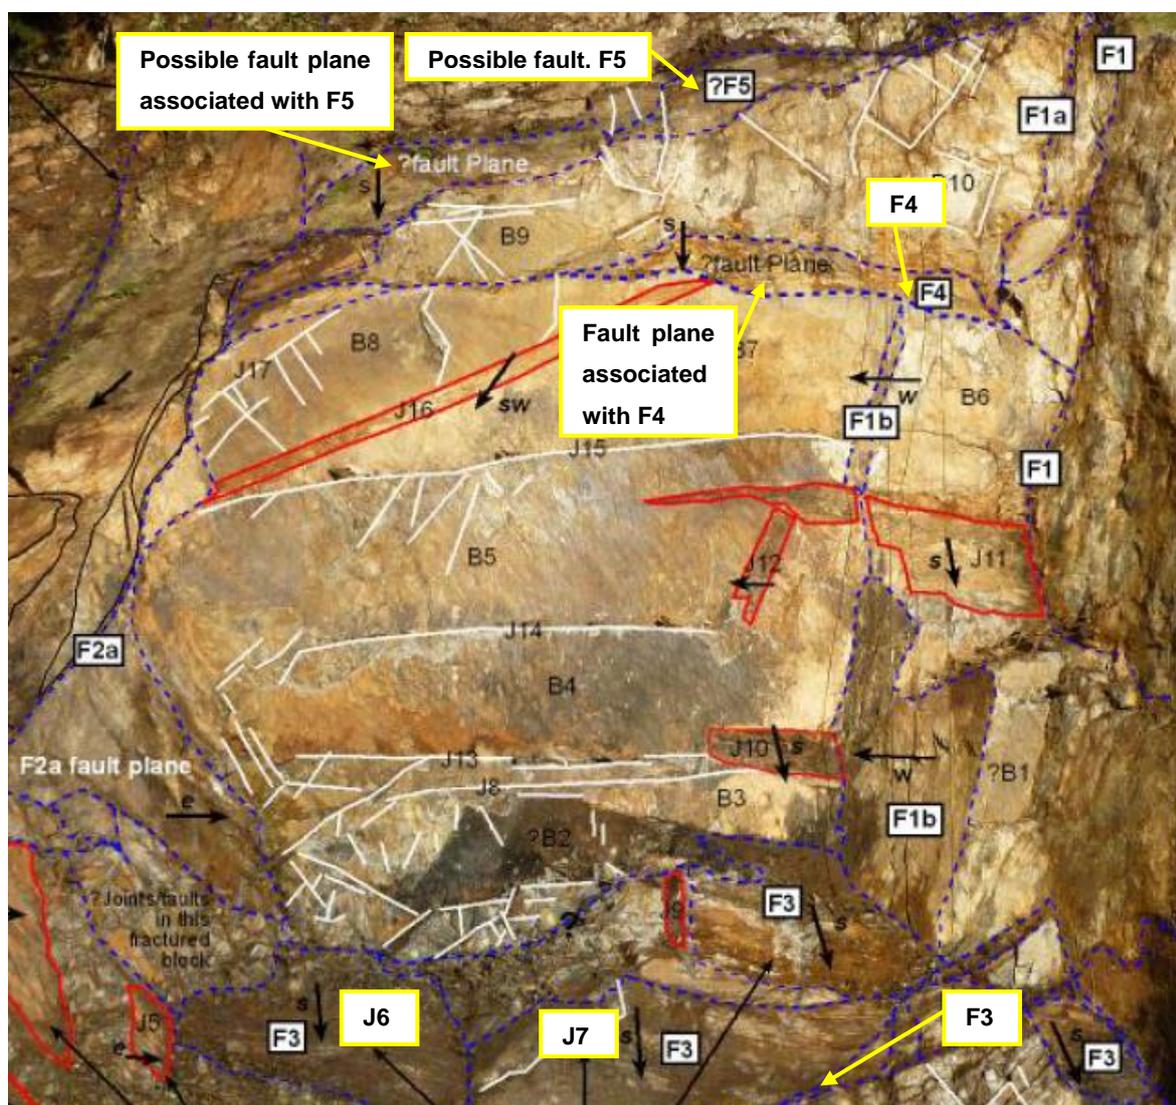
Figure 7 – Joints and faults around the Central Block

- F3 – Spans the Central Block, consisting of a number of interconnected *fractures*, linking F1 and F2. Joint 6 (J6) and Joint 7 (J7) may be joints or maybe part of F3. Irrespective of whether they are joints or faults, they are major planes of weakness which facilitated the collapse by providing a surface on which the rock mass was able to slide southwards;
- F4 – Southward inclined fault zone in the northern part of the Central Block, see Figure 7, which is also an important surface of weakness due to its direction of inclination;
- F5 – Southward inclined fault zone, which may be a fault, located at the top of the Central Block north face, see Figure 7.

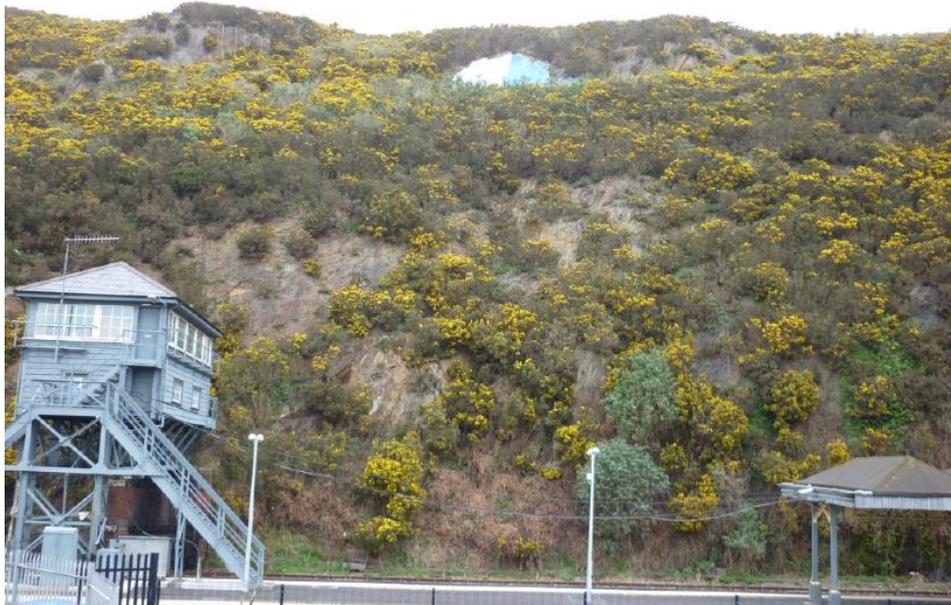
Figure 11 – Photograph taken in 2012, in the location of the 2013 rock fall

56 The most recent GEI carried out on the rock face at Plunkett Station was on the 2nd March 2012, the rock face was broken up into three different GEIs to accommodate for the long nature of the rock face and the inspections were carried out from the track. The GEI included a photograph of the rock face, taken on the day of the GEI, see Figure 11.

57 The Inspection Card noted “loose rocks” in three locations, and allocated a Design Rating of 2, a Condition Rating of 3 (Poor) and a Deterioration Rating of 3 (Discernible deterioration).

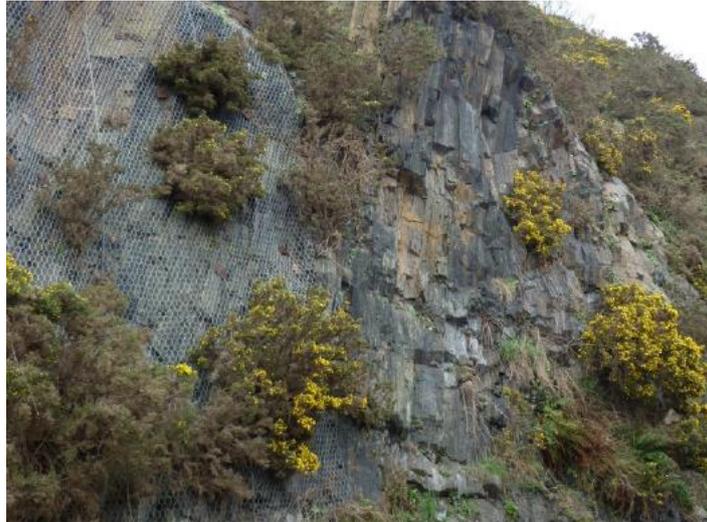
Figure 12 – Rock netting present in 2012 GEI

62 The Inspection Card also noted that the continuation of the rock netting was required, but not urgent; and suggested the possible consideration of a catch fence when the “siding” was removed. The rock netting was present at other locations on the rock face, see Figure 12 for an example of the rock netting. It should be noted that the Consultant’s Report confirmed that the continuation of rock netting was not urgent.

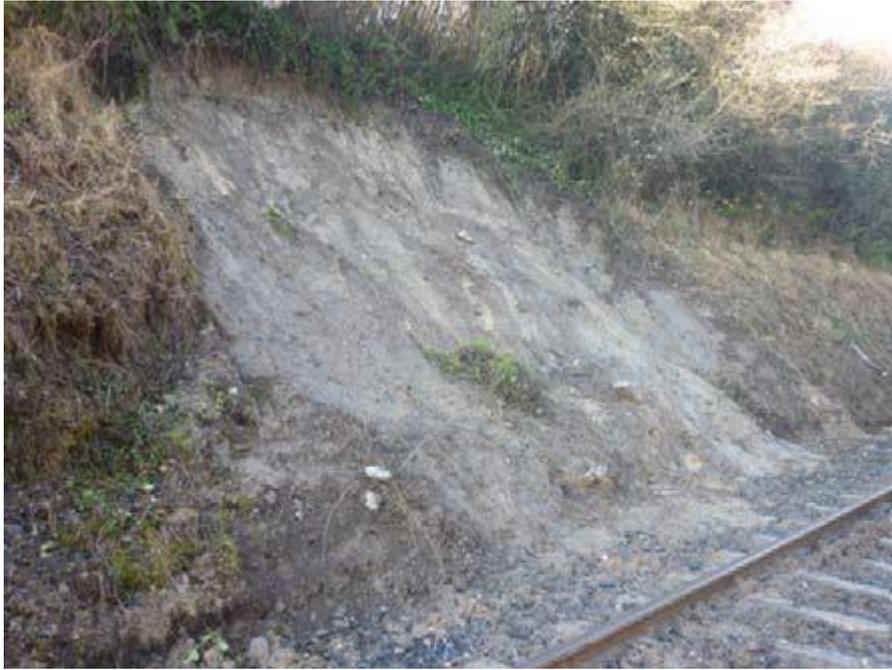
Figure 15 – Landslide between Ballyhale and Lavison

108 At approximately 06:40 hrs on the 31st December 2013, the 06:05 hrs passenger service from Waterford to Heuston struck a landslip just north of Legan Level Crossing (XW113) at the 38 ¼ MP, between Ballyhale and Lavison. The first three coaches of the train sustained damage to the undercarriage and the train came to a stop with the rear coach over the bulk of the debris, see Figure 15. There were eight passengers onboard and there were no injuries reported.

109 An internal IÉ investigation report into the incident found that the immediate cause of the landslide was due to the saturation of the cutting material following heavy rainfall over the days preceding the 31st December 2013; the rainfall for the month of December was above average. Causal to the incident was the saturation of the embankment due to higher levels of water within the field and insufficient drainage at the crest of the slope, which allowed water to infiltrate the steep cutting slope, causing the top layer of the cutting material to slip down the bank, see Figure 16. Underlying to the incident was the difficulty in observing changes in water levels and drainage in adjacent land during routine track patrolling and GEIs.

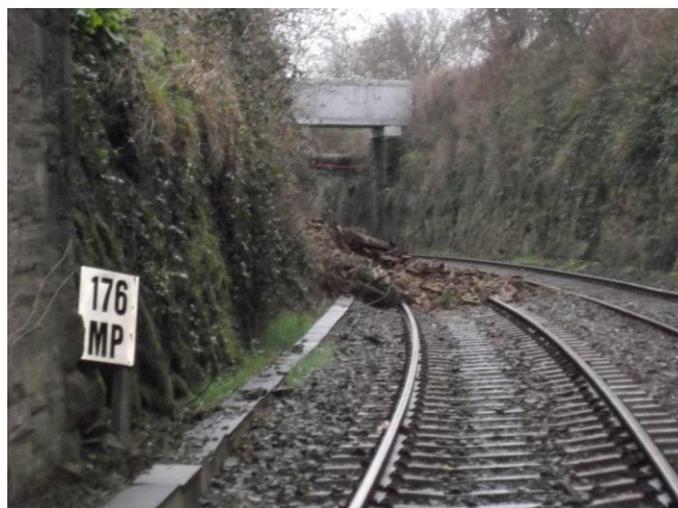
Figure 17 – Landslide at 176 MP

112 At approximately 22:40 hrs on the 7th March 2014, a rock fall, consisting of approximately thirty tonnes of debris, occurred on the cutting near the 176 MP between Rushbrooke and Cobh Stations. The rock fall occurred on the side of the down line (towards Cobh). The line was under *possession* (with no passenger services) at the time of the incident, to facilitate the renewal of an *overbridge*. Staff who were working at the overbridge heard the rock fall and went to investigate and found that the down line was blocked as a result of rock fall debris, see Figure 17.

113 An internal Technical Investigation Remit was commissioned by IÉ and published on the 14th March 2014; it found that the ingress of water passing through the mudstone/shale rock, and the general weathering of the rock reduced the integrity of the rock to a state where the rock became unstable; resulting in the rock collapsing due to its reduced ability to support itself, causing the failure of the bond between two layers of rock along a 60 degree plain. The remit found that the constant flow of water through the cutting was contributory to the incident occurring.
