**Railway Accident
Investigation Unit**

INVESTIGATION REPORT
Vehicle struck by train at Corraun level
crossing, XX024, Co. Mayo,
12th February 2014
RAIU Report No: R2015-001
Published: 30/04/2015

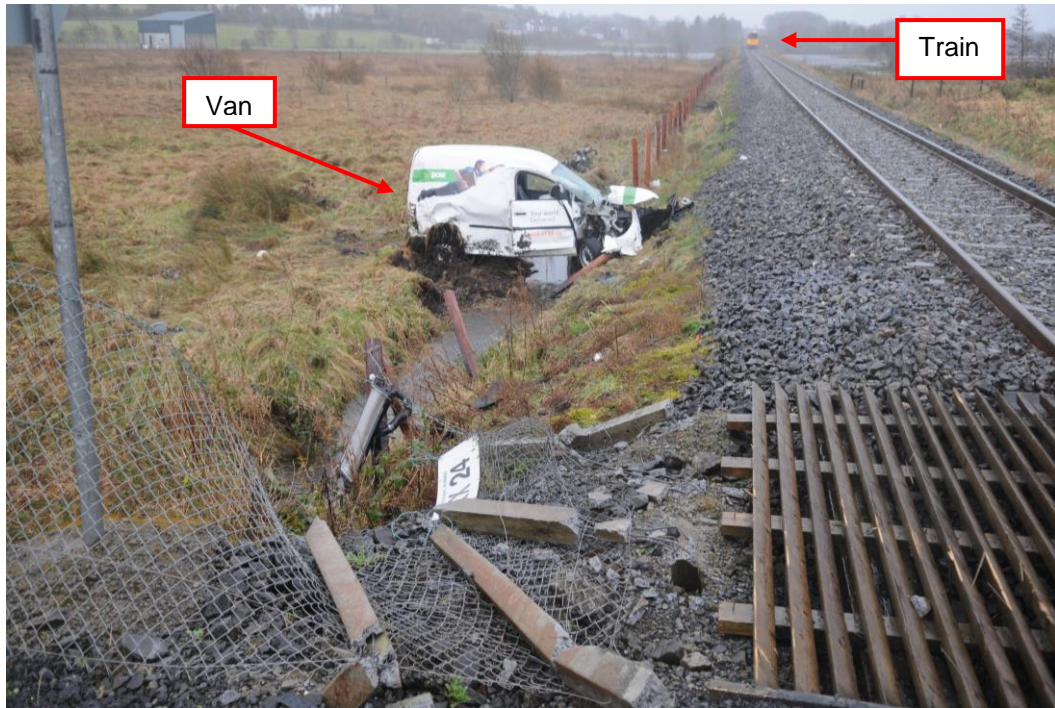
- 2 At the same time, the 09:35 hrs passenger service from Ballina to Manulla Junction (train identification number A863) was travelling through the Level Crossing and struck the van. On impact, the van was thrown clear of the train and into the adjacent drainage ditch before coming to a stop. The train came to a full stop 311 metres (m) past the Level Crossing, see Figure 2.

Figure 2 – Scene of the accident

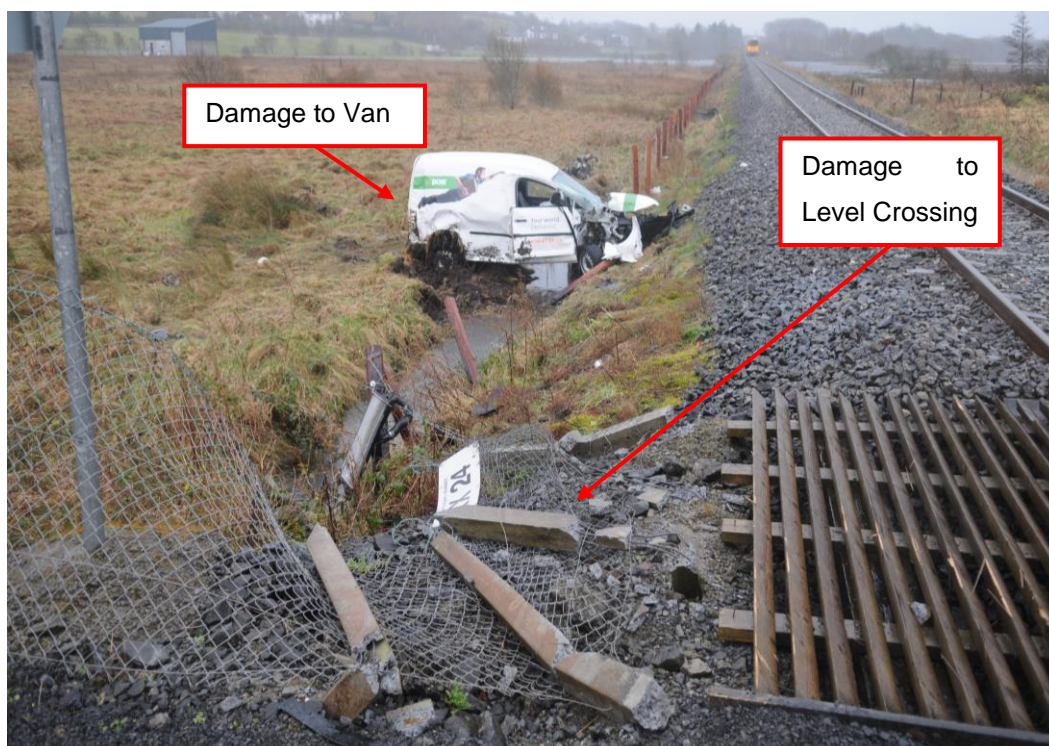
- 23 The An Post van was a Volkswagen Caddy, first registered in 2012. It had received a full service in the week prior to the accident. As a result of the accident, the van suffered severe frontal damage forward of the bulkhead and the force of the impact dislodged the engine and gearbox from the front chassis legs, see Figure 4. The Van Driver had not reported any defects to the van before the accident.

Figure 4 – Van and Level Crossing damage

- 24 There was damage to the Level Crossing infrastructure as a result of this accident, see Figure 4.

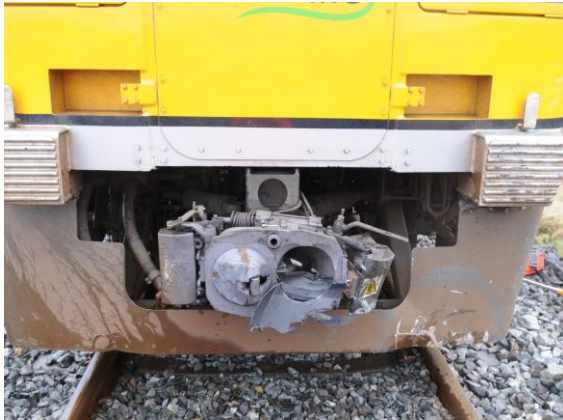
- 25 The front of the train was slightly damaged (Figure 5) and there was light damage to the front side panel of the leading carriage, 2817 (Figure 6).

Figure 5 – Damage to front of train

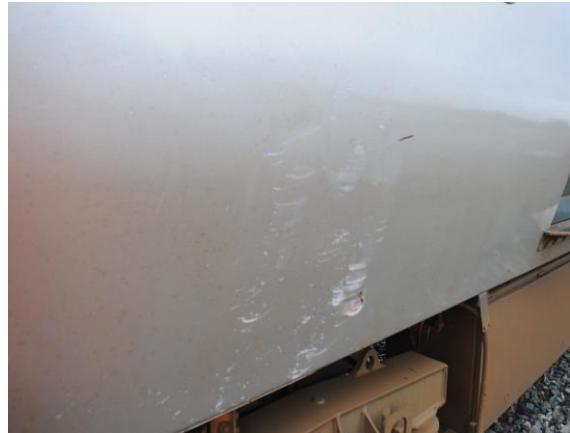
Figure 6 – Damage to side of train

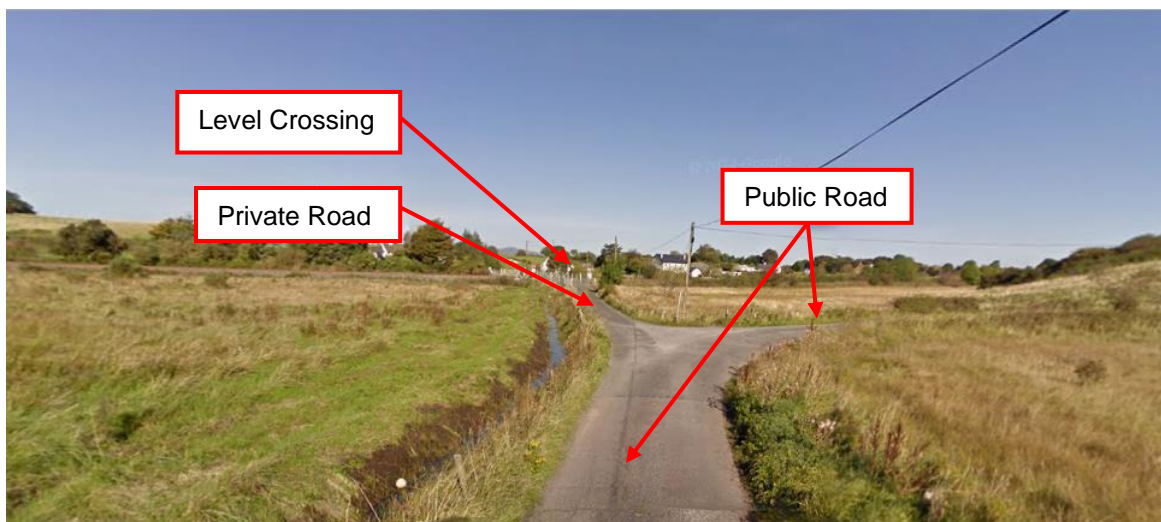
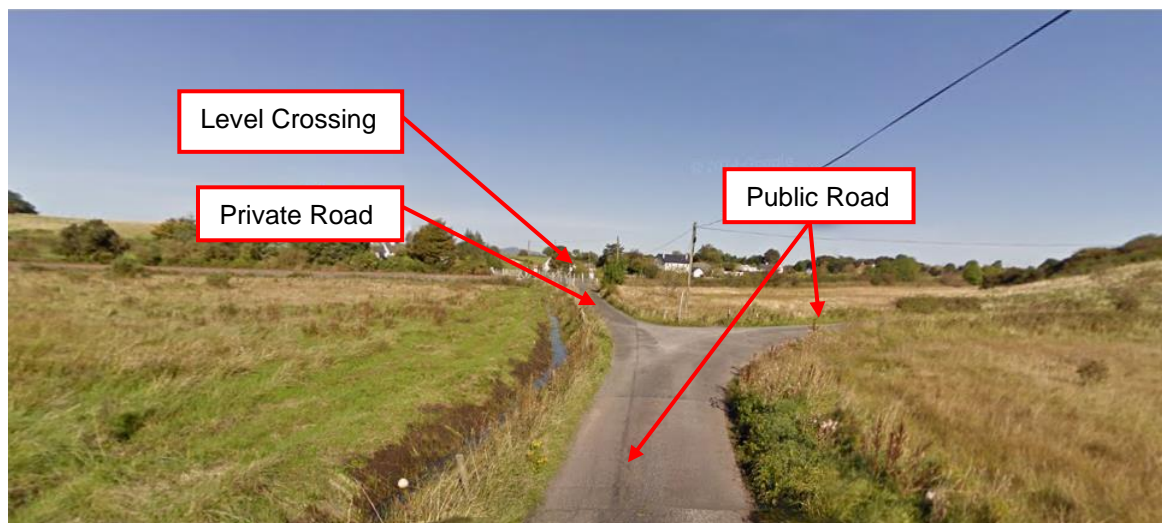
- 45 From the access point of the private road, which is unrestricted to members of the public, the road runs a distance of 75 m until it reaches the Level Crossing, see Figure 9.

Figure 9 – View from public road onto private road (with the Level Crossing)

128 The Level Crossing is located 450 m from the N5, the national road from Castlebar to Swinford. It is located on a private road, which has unrestricted access from a third class public road L57721, see Figure 23. As a result, it is easily accessible to members of the public (paragraph 44).

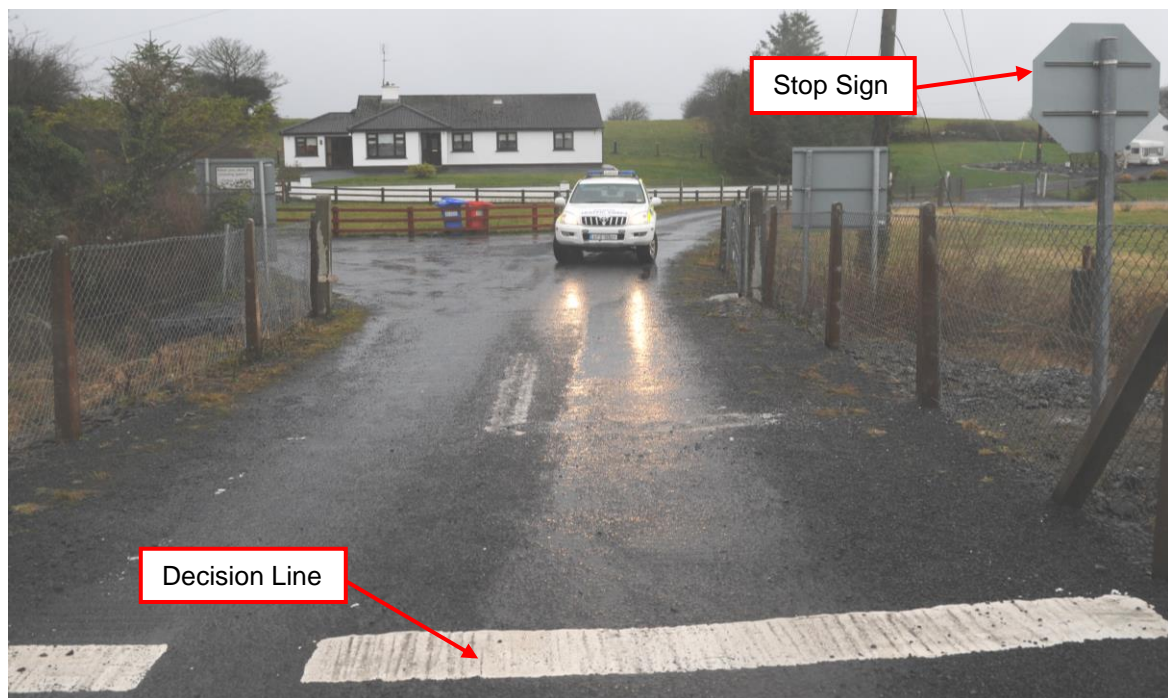
- 67 This Decision Line is a 300 millimetres (mm) continuous white line which is painted from the left edge to the centre onto the roadway; it continues as a broken white line from the centre to the right edge of the roadway. The line is located approximately 3 m from the nearest rail on each side of the level crossing road approaches, see Figure 14.

Figure 14 – Decision Line & Stop Sign

- 68 At the Level Crossing, the Decision Line is marked with a broad white line broken at one end, consistent with the IÉ programme outlined above. It is located beyond the regulation Stop Sign. The location where the Stop Line should be located can be seen in Figure 14; in this instance, the Stop Line was burnt off by the IÉ Contractor after they initially painted it, in error, instead of the Decision Line.

- 70 There is no other signage or road markings associated with this Decision Line to convey its meaning, i.e. that is the Decision Lines are to indicate, to the level crossing user, the safe distance that a vehicle user can stop without the vehicle encroaching onto the path of trains. However, it should be noted, that the new type signage states “Stop behind white line painted on road”, see Figure 15. To date, it has not been established how effective this new signage is in conveying a message to the road user, as the trial period is still ongoing.

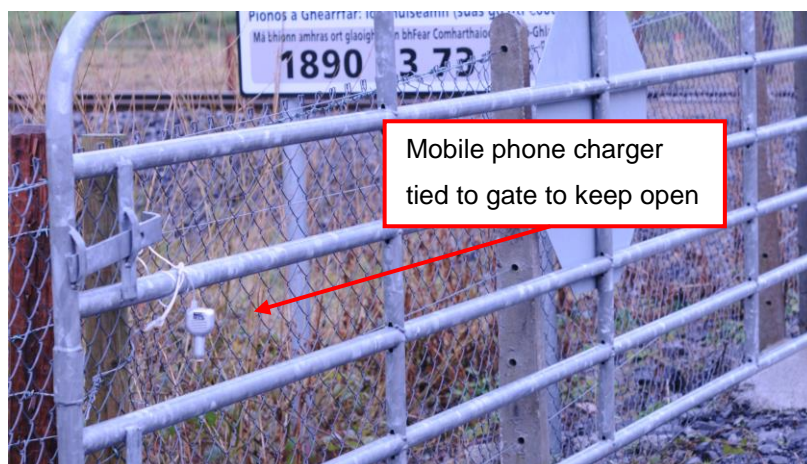
Figure 12 – New signage

- 95 On the day of the accident, post-accident examination of the gates found that both gates had been tied open. The up side gate was tied open with a nylon cord and the down side gate was tied open by the wire of a mobile phone charger, see Figure 22.

Figure 22 – Gates tied open with mobile phone charger

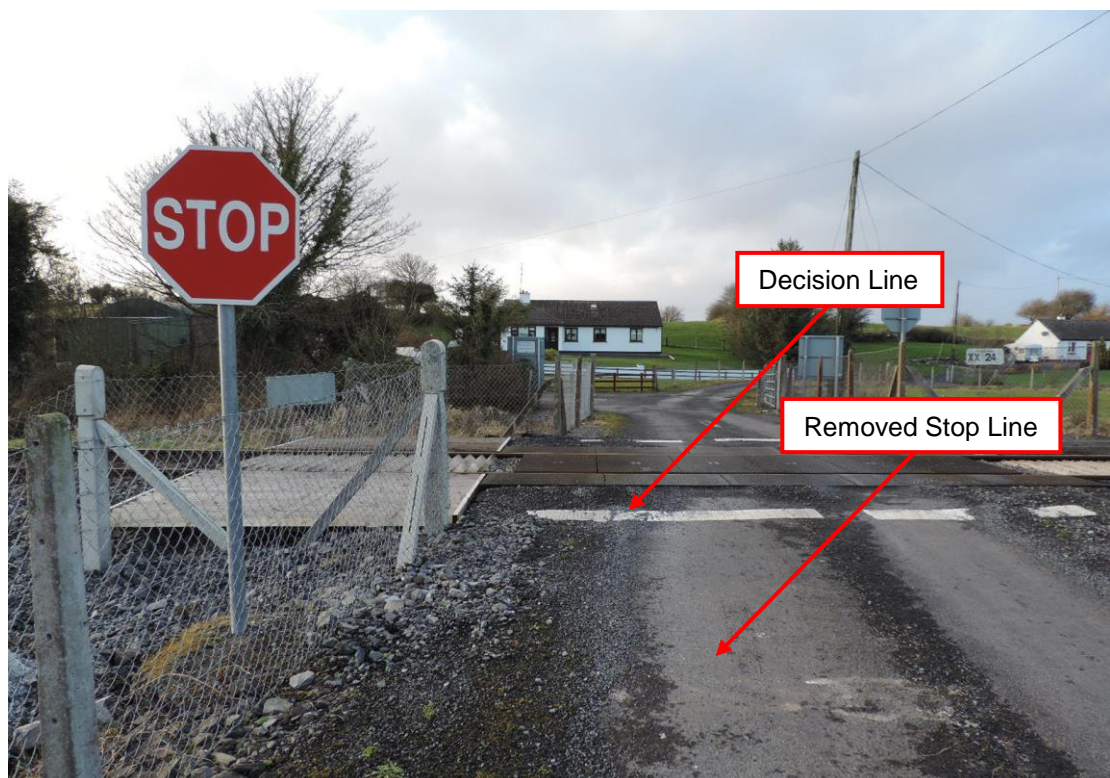
135 As a result of a previous RAIU safety recommendation (paragraph 65), IÉ have commenced a programme of placing Decision Lines at user worked level crossings (paragraph 66). These Decision Lines are broad white lines broken at one end (paragraph 67). As a result, IÉ have removed the Stop Lines normally associated with the Stop Signs (paragraph 62), see Figure 24.

Figure 24 – Decision Line & Stop Line

136 Despite removing the normal Stop Line and replacing with the Decision Line, IÉ have provided no information or indication as to what the level crossing user should do on the approach to the Decision Line (paragraph 70). This information is provided in the new signage being trialled by IÉ. As a result, this may lead to an unfamiliar user incorrectly using the Level Crossing (paragraph 70).

137 The stop lines at XX024 was applied by a contractor in error and not in compliance with the tender as given by IÉ, these were burnt off before the decision lines were applied by the contractor.
