**Railway Accident
Investigation Unit
Ireland**

INVESTIGATION REPORT

**Road Rail Vehicle occurrences on Iarnród Éireann Network
from 2015 to 2018**

RAIU Report No: 2019 – R004

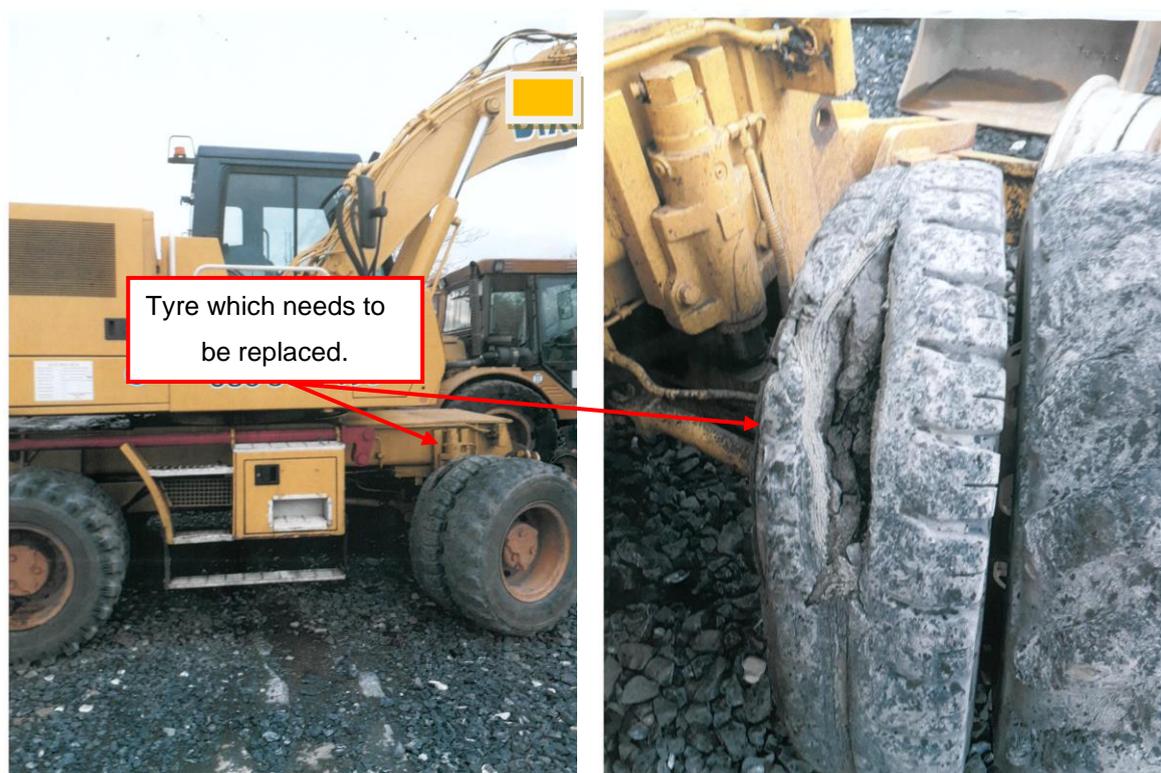
Figure 7 – Tyre identified by IÉ-IM which needs replacement

- Another inspection carried out by IÉ-IM on the 24th November 2018 found that there was “two bad tyres” on an RRV dumper owned by a contractor which the inspector requested to be changed and the contractor informed IÉ-IM they were changed, however, the inspector followed up on site on the 27th November 2018 and only one tyre had been changed.

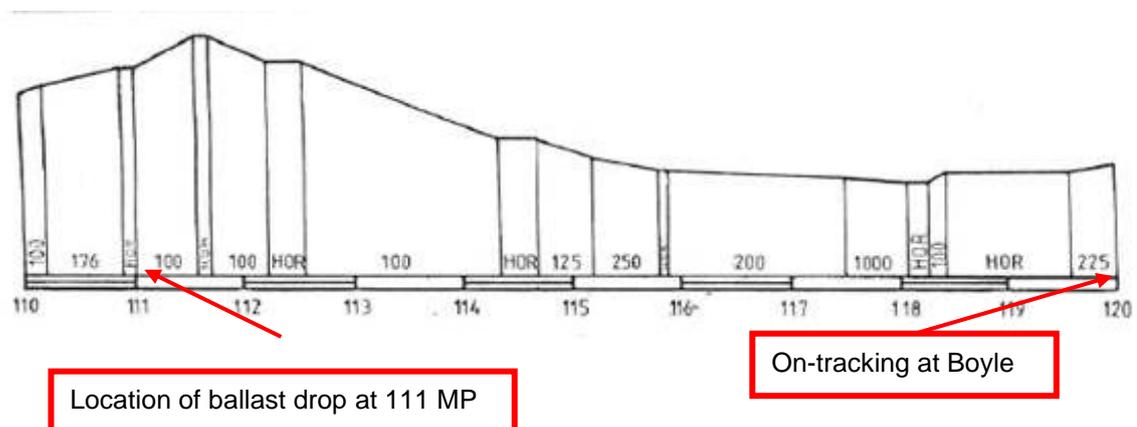
Figure 13 – Illustration of gradients at location of the accident

185 The two RRVs Dumpers had ballast placed upon them and then all four RRVs were on-tracked and accompanied by their respective ES/PICs as they travelled in the direction of Boyle with the two RRV Dumpers leading. All four RRVs carried out two controlled stops at a signal and level crossing without incident (RRV3 and its operator were removed here due to a slip and fall accident, the TSC left with the injured party, and PICOP was assigned as the new TSC). The RRVs continued and stopped again at another level crossing where there was an apparent dispute in relation to passing the level crossing signal at danger, and arrangements were made for the level crossing barriers to be closed for the RRVs crossing. The RRVs continued up an incline towards Boyle Station, before travelling around a curve and continuing downhill to the location of the ballast drop (at approximately the 111 Mile Post (MP)), see Figure 13.

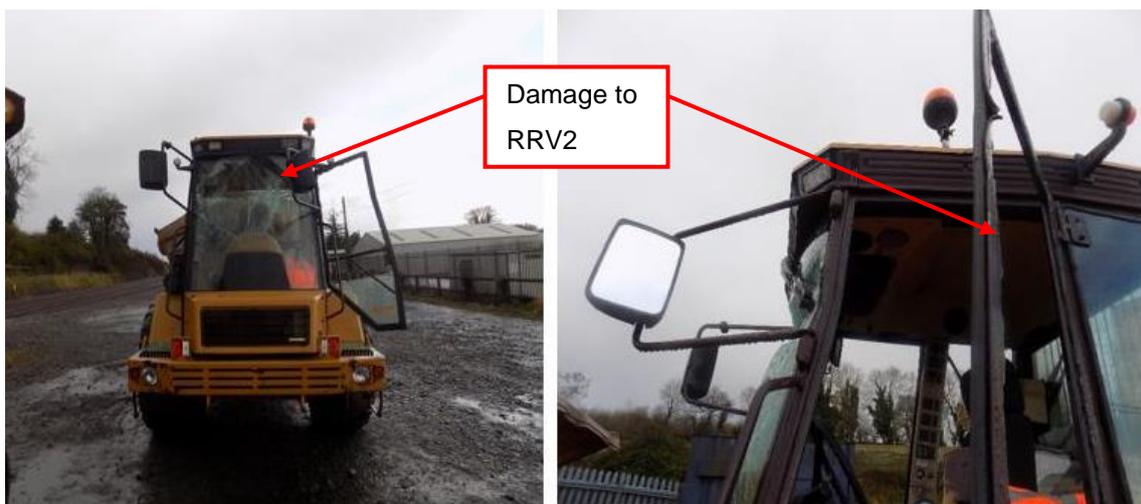
Figure 14 – Damage to RRV

187 The ES/PIC travelling with RRV1 instructed the operator of RRV1 to stop, which he did. The operator of RRV2 saw RRV1 had stopped and notched down through the gears and applied the brakes, however, RRV2 went into a slide, and the bin of RRV2 collided with the cab of RRV1 at a low speed (no more than walking pace), breaking the windscreen of RRV2 (see Figure 14). The ES/PIC accompanying RRV did not see that RRV1 had stopped as his focus was on keeping the door of RRV2 closed, and as such did not issue any instructions to stop.

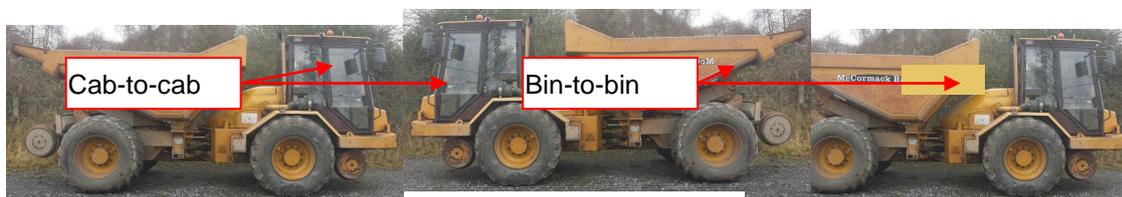
Figure 15 – Cab-to-cab / bin-to-bin orientation

194 The RAIU also noted that had the convoy been travelling in a bin-to-bin / cab-to-cab orientation (see Figure 15), the damage to the RRV would probably be less. It is noted by the RAIU that some RRV suppliers, require that RRVs travel in this orientation, but also understand, that this is not always possible due to the type of work to be carried out.

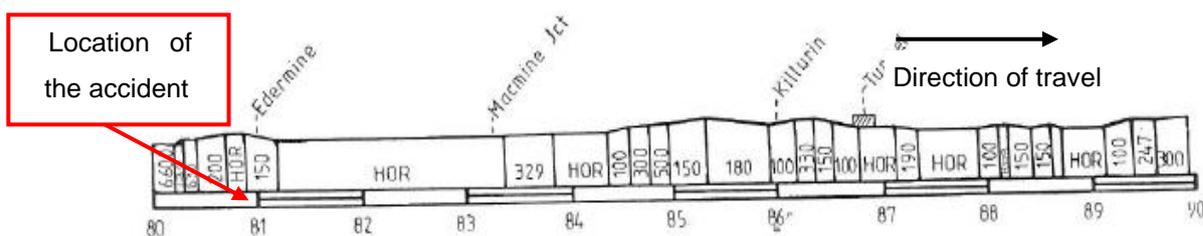
Figure 17 – Illustration of the gradient at the location of the accident

204 The PICOP/ES/PIC travelled on the first RRV Dumper (RRV1) in the convoy (consisting of RRV1, RRV2, RRV3, RRV4) toward Macmine Old Station, adopting the same procedure as before to cross Edermine LC. On arrival at the ballast stockpile, the RRV Dumpers were loaded with ballast. The convoy then began travelling back downhill towards Edermine LC (see Figure 17 illustrating a 1:150 gradient), with the PICOP/ES/PIC travelling on the lead RRV Dumper.

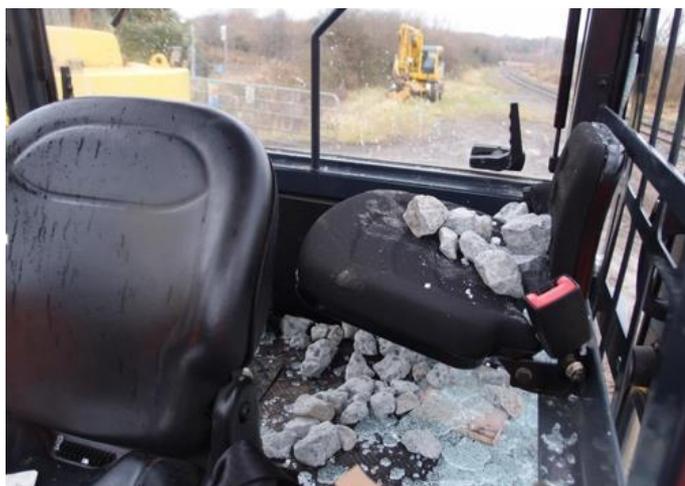
Figure 18 – Damage to RRV

207 The Operator of RRV2 had applied the brakes (similar to the first approach to the Up Stop Signal for Edermine LC). However, the Operator of RRV2 stated that RRV2 seemed to slide and accelerate towards RRV1.

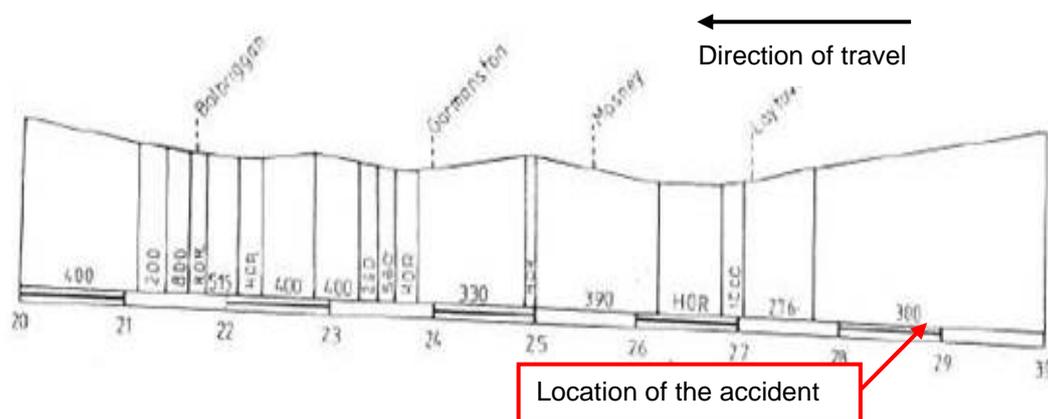
Figure 24 – Illustration of the gradients at the location of the accident

278 At this stage of the night, it was raining very heavily as RRVO1 slewed the excavator around and started to travel back (downhill) to RRV2 at a slow speed, see Figure 24. On approach to RRV2, RRVO1 applied the brakes but the rail wheels “locked-up” resulting in RRV1 going into a slide and colliding with the brushbox attached to RRV2. Both RRVs sustained minor damage and there were no injuries to staff.

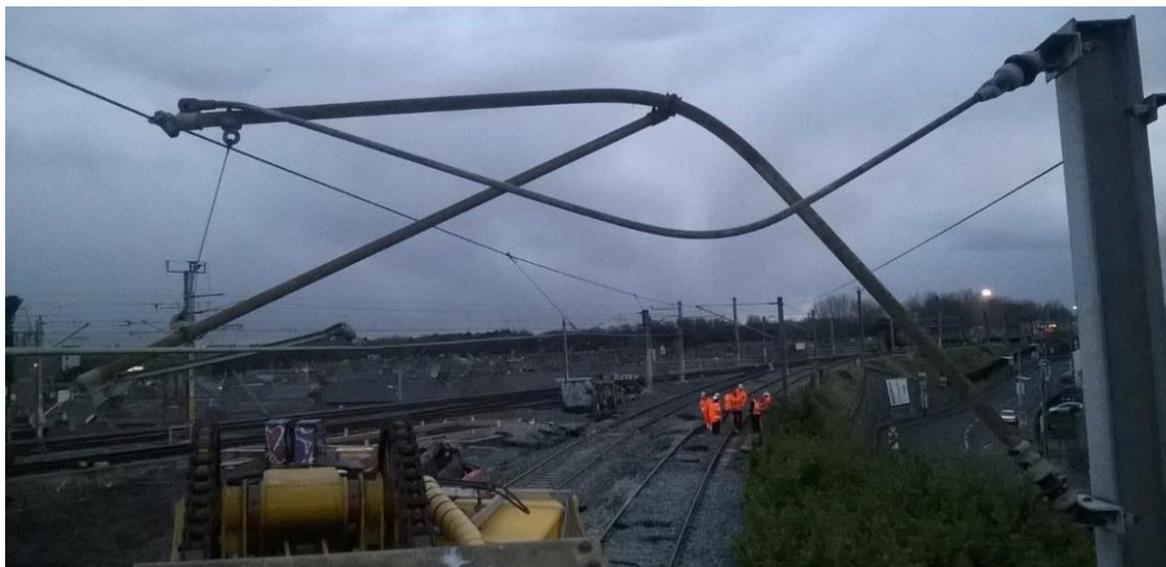
Figure 26 – Damage to the cantilever

292 On arriving back at the worksite, the operator of RRV1, RRV Operator 1, informed the ES/PIC that RRV2 (operated by RRV Operator 2) had struck the OHLE wires. The ES/PIC then went to the scene and saw that there was damage to the OHLE cantilever and not the wires (see Figure 26). When the ES/PIC returned to talk to the Operators of the RRVs, they informed him that RRV2 had not struck the OHLE cantilever, only the wires.

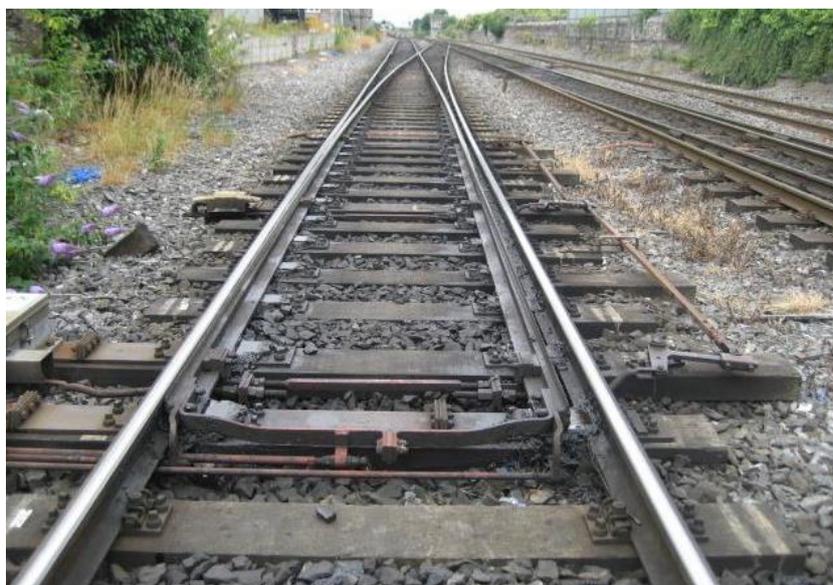
Figure 31 – Points 704

340 At the time of the conversation, the PICOP/ES/PIC and the Signaller did not discuss Points 704a (see Figure 31); with the PICOP/ES/PIC assuming they were in the normal position, when in fact, they were lying in the reverse position. It should be noted that Section T Part 3 Clause 11.3.1 of the IÉ Rule Book states that Signallers must “keep any points in the possession in the proper position except when a movement is to enter, leave or cross the possession there”. In this instance, the Signaller did not place/keep Points 704a in the proper (normal) position.

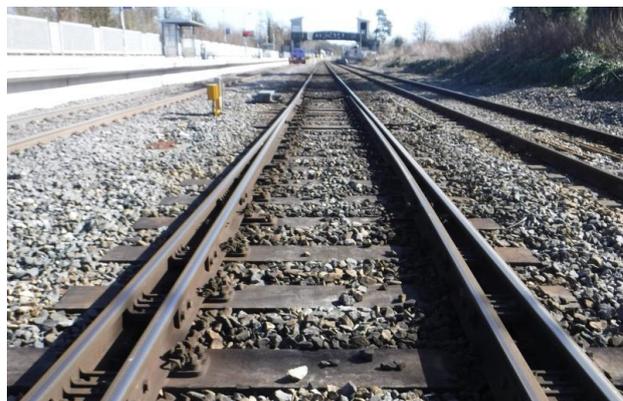
Figure 41 – Points CLC252

394 As the RRV Dumper approached trailing points CL252 (A end), see Figure 41, the PIC was pre-occupied trying to make contact with the Gatekeeper for Clonsilla Level Crossing to arrange for the passage of the RRVs through the crossing; as a result, he did not check the position of Points CL252. The RRV travelled over the points at no more than walking pace and the points were trailed through by the leading bogie of the RRV, causing the leading bogie to derail.
