# Railway Accident Investigation Unit Ireland

**Annual Report**  
**2021**

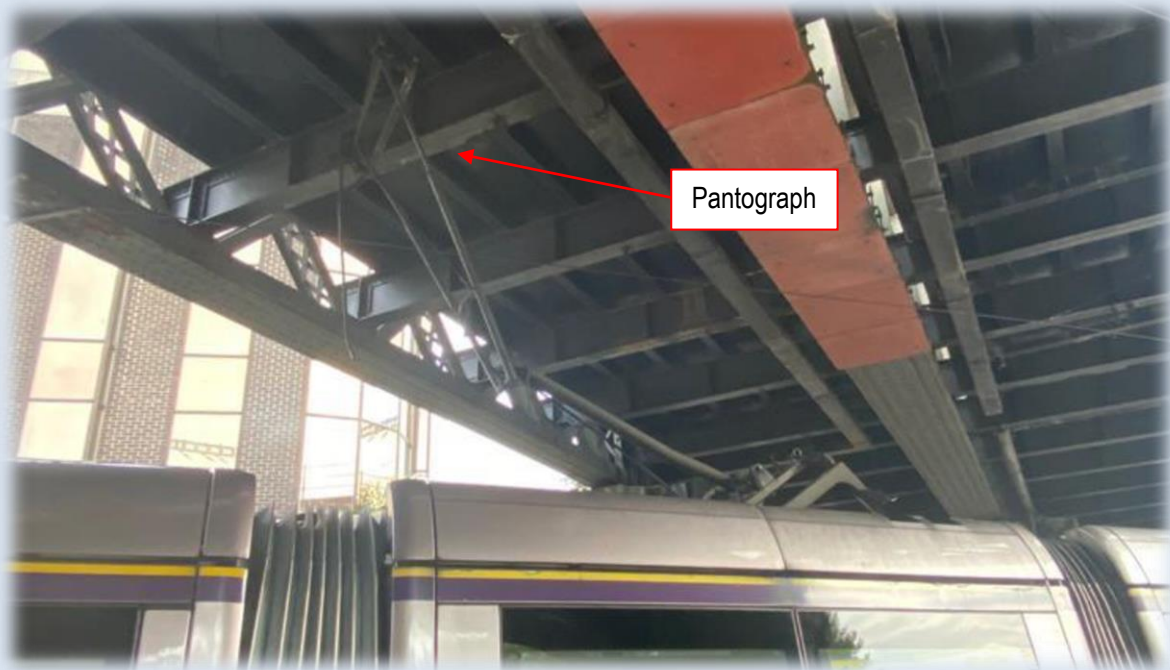
#### Luas pantograph collision with railway bridge, Beresford Place, 11<sup>th</sup> June 2021

At approximately 01:16 hrs on the 11th June 2021 the Parafil termination failed on the cross-span between a pole and the Strong Registration Arm attached to the Luas network Overhead Contact System (OCS) on the Outbound line, cess side, close to Beresford Place Iarnród Éireann (IÉ) railway bridge; causing the Strong Registration Arm to hang down over the tram line. This results in the contact wire losing stagger and striking the negative copper strip on the insulated plates located under the railway bridge resulting in a dead-short and tripping (stopping the electrical flow) the electrical power in the O'Connell to Spencer Dock section. There were no trams in the section, the last outbound tram to pass the section was Tram 3026 at approximately 01:00 hrs.

At 05:12 hrs, on Sweep Tram 3016's approach to Beresford Place railway bridge, and the location of the partially detached Strong Registration Arm, the pantograph of Tram 3016 loses contact with the contact wire and strikes with the cross-span assembly. The force of impact on the cross-span assembly causes the Strong Registration Arm to become detached from the contact wire and becomes entangled on the pantograph, contacting both the foot of the pantograph and roof of the tram; causing a dead-short and trips the power in the O'Connell to Spencer Dock electrical section. Sweep Tram 3016 continues forward, pulling down the feeder cable; with the pantograph colliding with and damaging the insulated plates under the railway bridge.

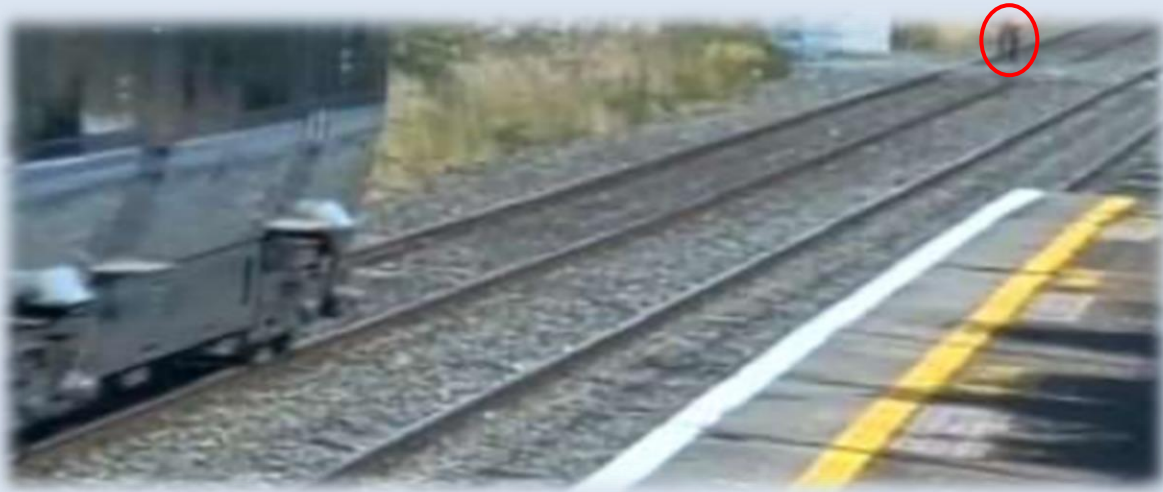
## Near miss with an Iarnród Éireann CCE Worker near Gormanston Station, 21<sup>st</sup> July 2021

On the morning of Wednesday 21st July an IÉ Chief Civil Engineer's (CCE) Department employee (to be referred to as CCE Worker for the remainder of this report) was performing the role of Track Safety Co-ordinator (TSC) for a group of construction staff upgrading a retaining wall adjacent to a track access point at the northern end of Gormanston Station, County Meath; the worksite was away from the railway line in a position of safety.

At approximately 10:04 hrs the CCE Worker (circled red in photograph above) went back onto the railway line, into the five foot, to collect the temperature gauges, when he looked towards Gormanston Station and saw Train A124 approaching, he cleared line four seconds before Train A124 travelled past him.

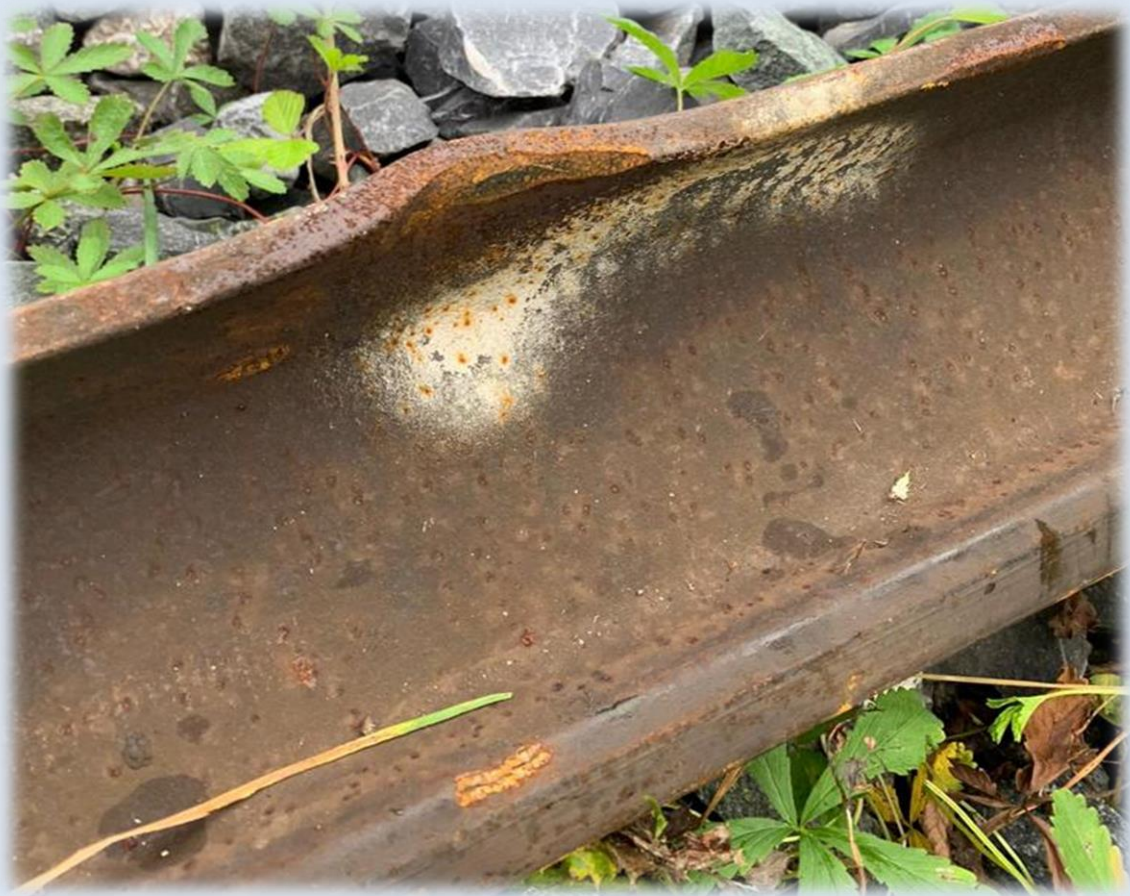
At approximately 00:18hrs on Friday 27<sup>th</sup> August 2021, the driver (Driver J283) of an empty unscheduled empty train travelling from Limerick Junction to Heuston Station (Train J283) reported to the Controlling Signaller that the train had struck something on the line, the item was a holding gear (a piece of equipment that is clamped to the rail during rail replacement works). The collision resulted in damage to the front wheel of the control car and rail (which was replaced on the night of the accident).

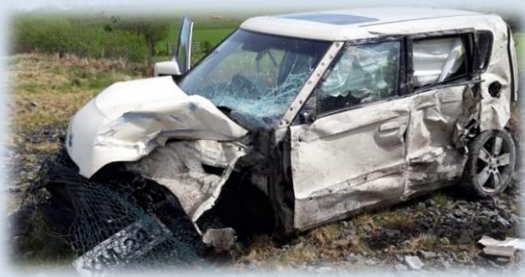
## Collision between a car and a train at Kilnageer, Level Crossing (XM240), Mayo, 29<sup>th</sup> April 2020

At approximately 13:40 hour (hrs) on the 29<sup>th</sup> April 2020, the 13:10 hrs passenger service from Westport to Dublin (Train A809) was approaching Kilnageer Level Crossing (LC) XM240, located approximately six kilometres (km) from Castlebar, County Mayo. At the same time a car approached LC XM240 with the gates open (left open by a

previous user) and began travelling through LC XM240. When the driver of Train A809 saw the car, he made a full-service brake application; however, the train could not stop in time and struck the car. Causal factors associated with this accident are:

- The Car Driver failed to stop to look for trains on approach to LC XM240 as required by the Road Safety Authority's (RSA) Rules of the Road, in part, as a result of the level crossing gates being open;
- The sounding of the train horn was not effective at warning the Car Driver of the approaching train.

- The RSA should update the "Rules of the Road" to include guidance on the DSS;
- IÉ-IM should update the 'The SAFE use of Unattended Railway Level Crossings' booklet to include guidance on the DSS;
- IÉ-RU should put systems in place to ensure ICR train horns meet the current standards for sound pressure levels;
- The CRR should review and update Section 5, Level Crossings, of their Guidelines for the Design of Railway Infrastructure and Rolling Stock, to ensure that guidance/reference on the DSS is included.

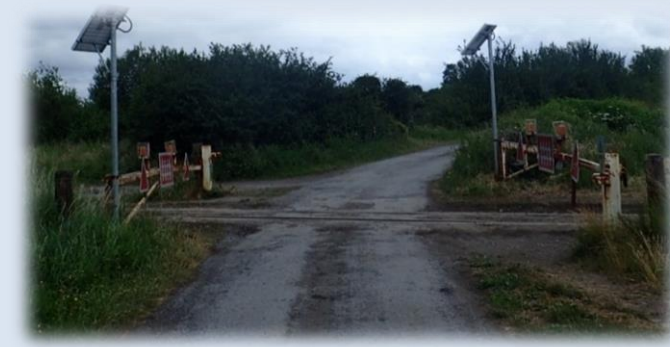
## Collision between a Bord na Móna Flat Wagon and Kilcolgan Level Crossing Gates, Offaly, 8<sup>th</sup> June 2020

At approximately 13:15 hrs on the 8<sup>th</sup> June 2020 a Bord na Móna (BnM) double rake system travelled through Kilcolgan Level Crossing, closing and opening the derailing points to allow passage through the crossing. At some stage after the passage of the double rake through Kilcolgan Level Crossing, the

derailing points were placed in the closed position (possibly by trespassers).

- The Engineering Department of BnM should carry out the technical evaluation into the efficacy of the derailing points, etc. identified in BnM internal investigation report into the collision between a BnM locomotive and the gates of Endrim Gates on the 21st September 2017;
- BnM should update their Specification for Crossings to include the requirements of the Department of Transport's Traffic Signs Manual; based on this BnM should update the signage on the approaches to all BnM level crossings.

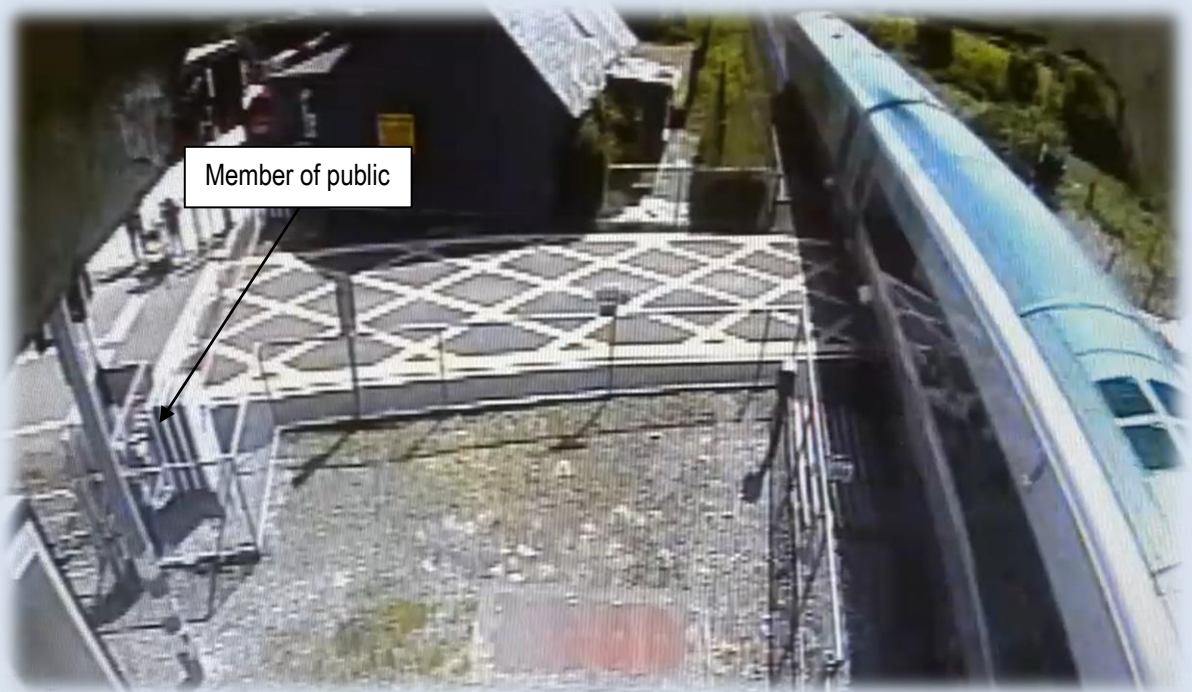
At approximately 12:13 hrs on the 24<sup>th</sup> May 2020, a Level Crossing Control Operative (LCCO), located at Athlone Local Control Centre (ALCC) cleared Closed-Circuit Television (CCTV) LC XA068, located in Ashfield, Offaly, for the passage of the 11:00 hrs passenger service from Galway to Heuston (Train A703) while a member of the public (MOP) was inside the barriers of the level crossing. The MOP had requested assistance from LCCO using the telephone provided at the level crossing. LCCO advised the MOP that they would raise the barriers and instructed the MOP to stand beside some level crossing equipment (clear of the tracks, but within the confines of the level crossing). LCCO did not raise the barriers and allowed Train A703 to pass through LC XA068. The MOP was uninjured as a result of this incident. The RAIU identified the following causal factors:

- The MOP did not clear the confines of the level crossing when the warning lights and bell activated to indicated that the barriers were about to lower for an approaching train;
- LCCO did not see the MOP prior to pressing the "Crossing Clear" buttons;
- LCCO did not, when they became aware of the MOP trapped inside the barriers, immediately press the "Emergency Alert" button to the "On" position as set out in the Athlone & Mallow Level Crossing Control Centre Instructions.

- IÉ-IM should introduce measures to deter pedestrians from using unauthorised routes onto CCTV Level Crossings.
- IÉ-IM should conduct a focussed review on the instances of MOP entrapment at Sydney Parade (LC XR004) and Serpentine Avenue (LC XR002) with a view of identifying any actions that can be taken to prevent the re-occurrence of MOP entrapments.

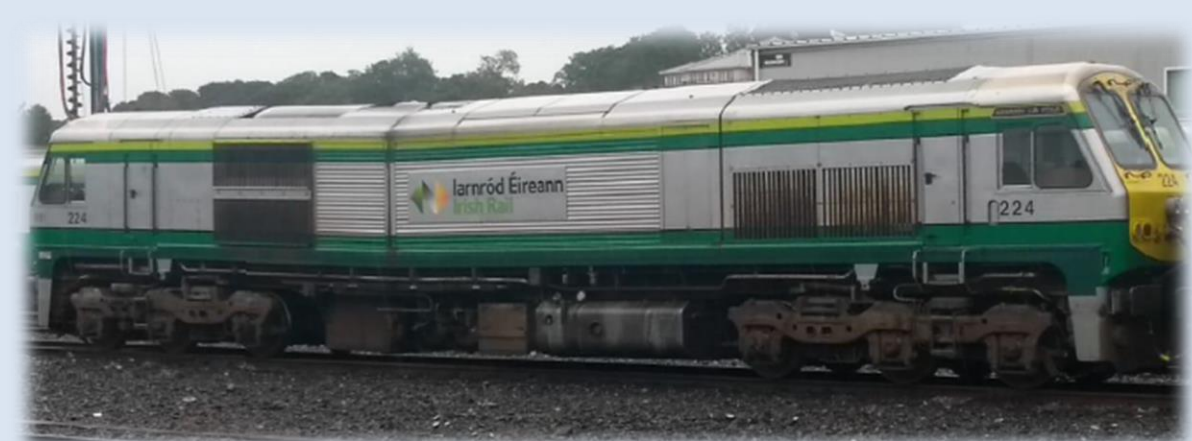
## Chassis Plate Fracture on General Motors Class 201, Locomotive 224, 7<sup>th</sup> July 2020

On the 7<sup>th</sup> July 2020, while Locomotive 224 was at Heuston Station awaiting transfer to Inchicore Works, a driver observed the body of Locomotive 224 was sagging near the centre point and reported it to his supervisor who in turn alerted the relevant parties. On inspection, by the Chief Mechanical Engineer's (CME) Department's maintenance staff a main frame crack was identified. Locomotive 224 was then shunted to Inchicore Works for a more thorough examination. The Locomotive's engine and generator were removed to give a clear view of the damage. The crack was examined by IE's Chief Chemist and Metallurgist, who was independently supervised by a metallurgist specialist, contracted by the RAIU. The metallurgical investigation identified that the failure occurred in the weld repair of the Bed Plate that was continued into the Chassis Plate.

In service, cyclic loading, particularly bending stress on the underside of the Chassis Plate (that had high residual tensile stresses generated from within the repair weld), resulted in multiple fatigue initiation sites developing and merging into a common crack that propagated through the Chassis Plate during the journey causing the Chassis Plate to fracture. The loss of integrity to the structure of Locomotive 224 resulted in a coolant pipe been disturbed and subsequent leak and the misalignment of the generator resulting in and electrical shut down fault.

- The flat Bed Plates were not replaced with cupped Bed Plates when Bed Plate cracks were identified as set out in the Original Equipment Manufacturer (OEM) Service Advisory SA 08-007;
- During a weld repair of the Bed Plate, the Bed Plate was unnecessarily welded to the Chassis Plate.

- IÉ-RU CME should review all weld repairs carried out to structures of all rolling stock to assess the risk posed by such weld repairs and mitigate against the failure mode;
- IÉ-RU CME should develop a procedure for evaluating maintenance advice received from OEMs or other railway organisations to determine applicability to IÉ fleets and assess any associated risks.

- IÉ-RU CME and IÉ-IM CCE should carry out a risk assessment on the implications of the increased axle load of a 201 Locomotive.

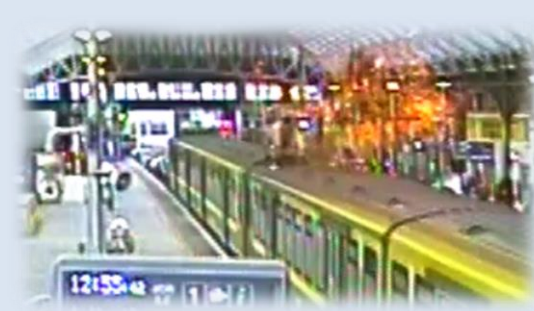
## Overhead Line detachment, Pearse Station, 1<sup>st</sup> October 2020

At approximately 12:55 hrs on the 1<sup>st</sup> October 2020, the 12:04 hrs IÉ DART service from Greystones to Howth (Train E920) was coming to a stop in Pearse Station when the second pantograph (Pantograph 396) of the train set (Unit 8128) lost contact with the Contact Wire of the Overhead Line Equipment (OHLE). The Pantograph Head and Upper Arm lowered rapidly resulting in the Pantograph

Lower Arm extending to its maximum reach and contacting the OHLE. This action caused the Pantograph Lower Arm to flip, driving the Upper Arm and Pantograph Head on to the roof of the train resulting a short circuit and a large flashover. The short circuit caused a loss of power to the OHLE in the section. Train E920 coasted before being brought to a stop, on Platform 1, by the driver (Driver E920).

- The short circuit between the Pantograph Head and the roof of the train caused the Catenary Wire to overheat, reducing its strength, detaching and falling onto Platform 1;
- The OHLE in Pearse Station is positioned at 4.46 m above the rail allowing the Pantograph Lower Arm to strike the OHLE in the event of a Pantograph elbow chain failure;
- The elbow chains on Pantograph 396, on EMU 8128, failed due to excessive wear of the chain pins and chain link holes over a period of time due to the lack of lubrication;
- The failure of Pantograph 396's elbow chains resulted in the Lower Arm rising and the Upper Arm and Head lowering; providing an electrical path for a direct connection between the OHLE and the train body;
- The High Speed Circuit Breaker Auto-Reclose restored power to the failed section.

- The pantograph planned preventative maintenance regime did not identify the deterioration in the chains of Pantograph 396 or the poor condition of the grease that had previously been applied;
- The information contained in the IÉ CME-TMS-316 Department Engineering Change files for the extension of the pantograph overhaul from three to five years does not substantiate the conclusion reached, highlighting a lack of governance in the outsourcing of the overhaul of EMU pantographs;
- The compliance checks on the EMU fleet did not include the checking of pantographs.

- IÉ-RU CME should in conjunction with the OEM develop a maintenance regime for the pantographs, taking into consideration the operational conditions and traceability of safety critical components;

- IÉ-RU CME should carry out, in conjunction with the OEM, a condition assessment to determine the correct period for the overhaul of the IÉ-RU pantographs;

- IÉ-RU CME to include requirements to check pantograph maintenance activities in the Compliance Coordinators documentation records / check sheets;
- IÉ-IM SET should evaluate the auto-reclose function of the OHLE control system on the DART network to ensure the safe operation in the event of failures which could expose staff and passengers to live OHLE.

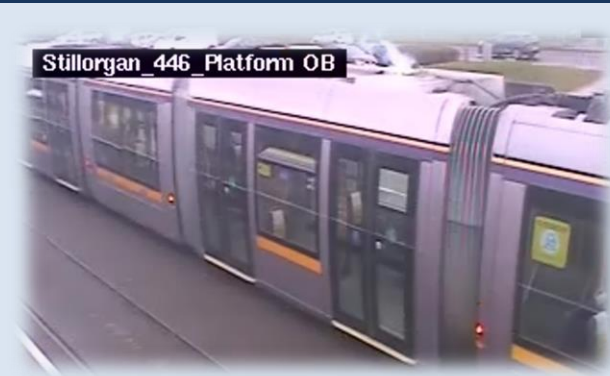
## Luas Overhead Line Failure, Stillorgan, 2<sup>nd</sup> November 2020

The Traffic Supervisor viewed the images from the CCTV cameras located at the Stillorgan Stop and saw the OCS had broken and was lying across the top of Tram 5010, the outbound track and platform. The Traffic Supervisor instructed Driver 5010 not to open the passenger doors and to keep all passengers inside the tram until otherwise advised. The Supervisory Control And Data Acquisition (SCADA) system indicated that the section in the area of Stillorgan was de-energised.

A systemic factor identified that the OCS inspection regime was not robust and failed to identify OCS wire necking, as evidenced at numerous locations on the Green Line.
