Railway Accident Investigation Unit Ireland

Annual Report
2022

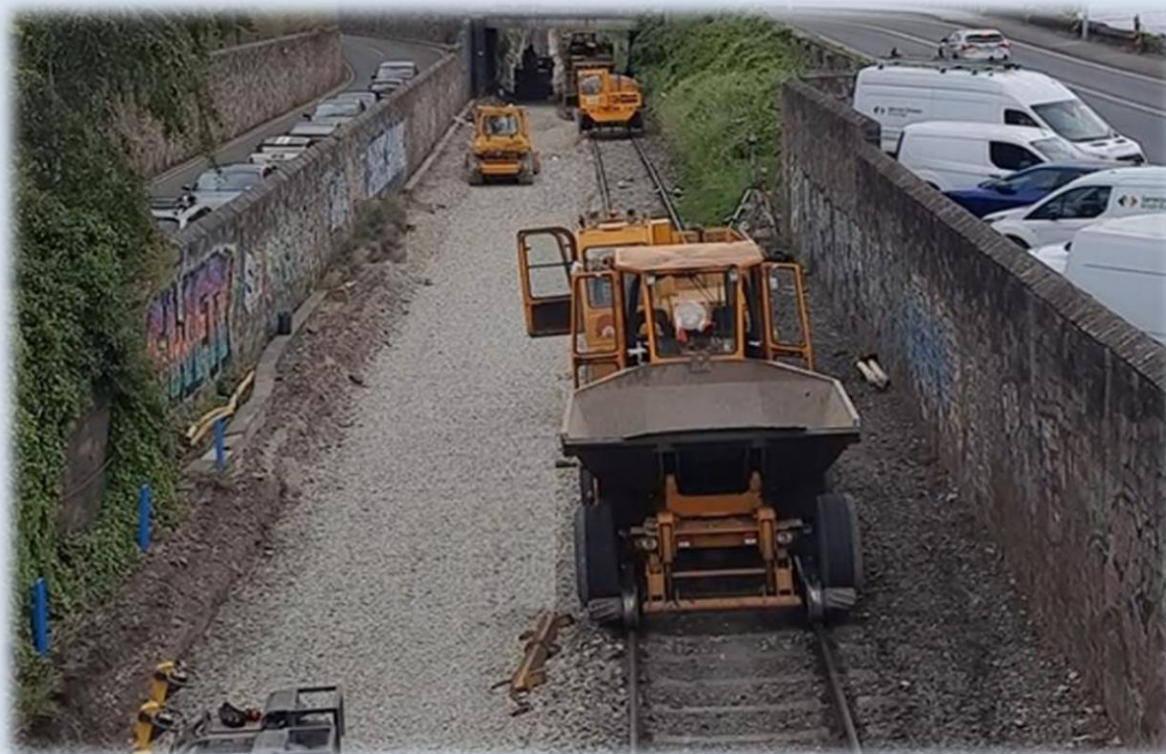
Collision of an RRV Dumper with a member of IÉ infrastructure maintenance staff, Tivoli, Cork, 6th July 2022

On the 6th July 2022, engineering works was being undertaken in a T3 Possession on the Cork-Cobh-Midleton lines, including track panel relaying and steel bridge repairs between Woodhill and Tivoli. There were thirteen items of hired plant and machinery in the worksite, including six RRV Dumpers, which were used for drawing stone from a lineside stockpile at Tivoli access point on the Cobh side of the Up Line. On completion of the loading movement the RRV Operators (RRVOs) awaited directions from the Person In Charge(PIC)-RRV to tip the stone over the course of the track relaying works.

Two RRV Dumpers, located on the Up Line, were laden with stone ballast with the buckets facing Cobh. The RRVOs configured the driving positions and directional lights of the RRV Dumpers for the reversing movement.

Engineer 1, who was on site supervising the works, was coming to the end of his shift and was giving an update briefing to Engineer 2 who had arrived on site for the late shift. After discussing an unforeseen issue in relation to soft ground conditions, Engineer 1 agreed to remain on site in order to discuss the matter further with their Regional Manager, who had arranged to visit the site. Engineer 1 decided to make a number of work-related phone calls on his company issued mobile phone and moved to a position of safety, walking from the Down Side to the Up Side cess, close to the leading RRV Dumper.

All work on site was stopped and medical attention was given by staff on site before an ambulance crew attended the scene and advised Engineer 1 that he did not have to attend the hospital.

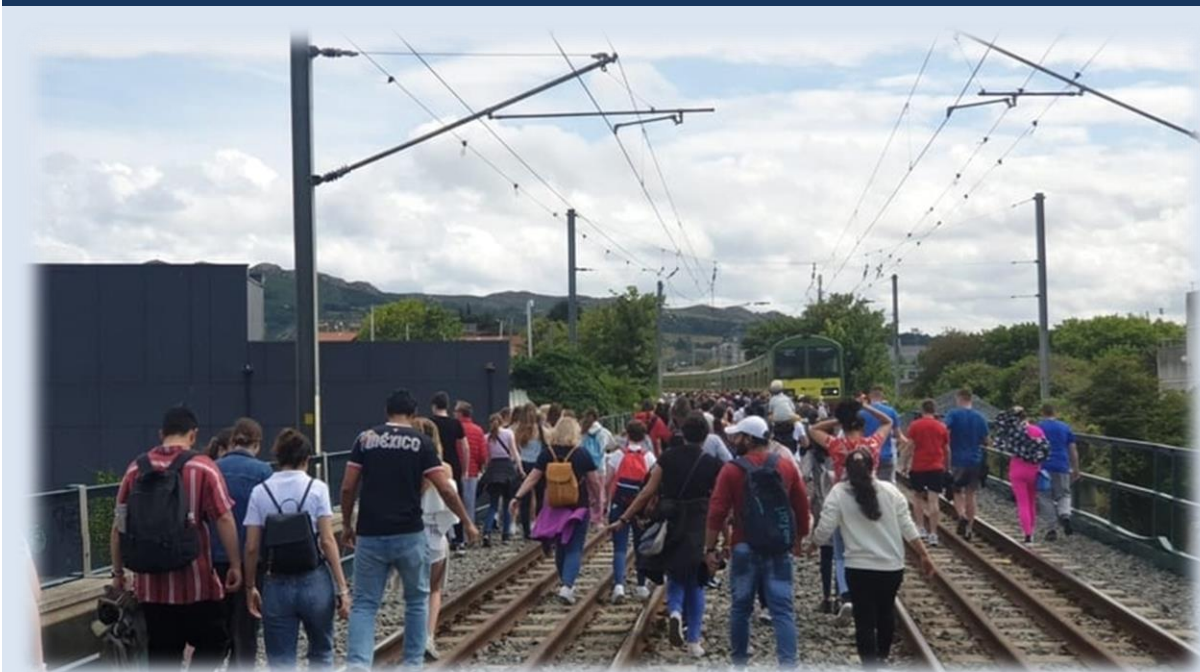
ÍÉ self-detrainment of passengers from DART trains, between Shankill and Bray, 24th July 2022

On Sunday 24th July, the weather conditions were sunny and hot. It was the day of the 2022 Bray Air Display and the 2022 All-Ireland Senior Football Championship Final in Croke Park, with both events drawing thousands of people.

A door fault on a DART train during the morning resulted in delays to services and increased dwell times. This resulted in large numbers of passengers accumulating on the platforms, many with small children and buggies. When boarding, passengers were reluctant to move down the carriage away from the entrance doors due to the heat.

The air conditioning was off on Train E268 (unknown to Driver E268), and as the windows were sealed (by design) there was no forced or passive ventilation on the train, leading to increasingly uncomfortable conditions for passengers, with reports of some passengers suffering from heat exhaustion.

As Train E268 was stopped, this resulted in Trains E103 and E208 also being stopped at Signals BR26 and BR26 (between Shankill and Bray), respectively. These trains did not have air conditioning; and, as they were stationary there was no forced ventilation; there was also insufficient passive ventilation through the opened windows due to crowding, resulting in increasingly uncomfortable conditions for these passengers.

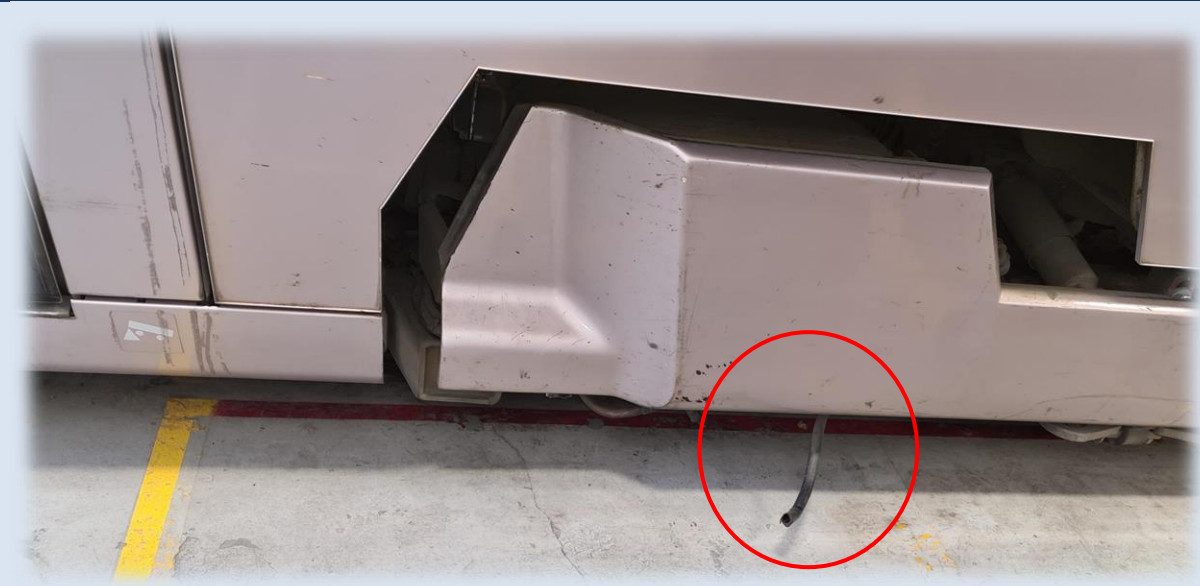
TDLR Luas tram current return circuit failure at Connolly Stop, 25th October 2022

At approximately 08:08 hrs on the 25th October 2022, a tram driver leaving Connolly Stop observed what he thought was a hose sticking out from a side skirt on Tram 3012 and reported the incident to LNMC.

LNMC contacted the driver of Tram 3012 and allowed the tram to remain in passenger service to the Red Cow Stop where it was removed from service.

On examination at the Red Cow Depot the hose was identified as a live electrical Current Return Cable that had severed. Further examination revealed a failed Earth Shunt Cable and overheating of the Axle End Assembly on the adjacent axle.

The RAIU decided to conduct a full investigation due to the risk of elecotion of passengers due to a live cable protruding from underneath a tram in service.

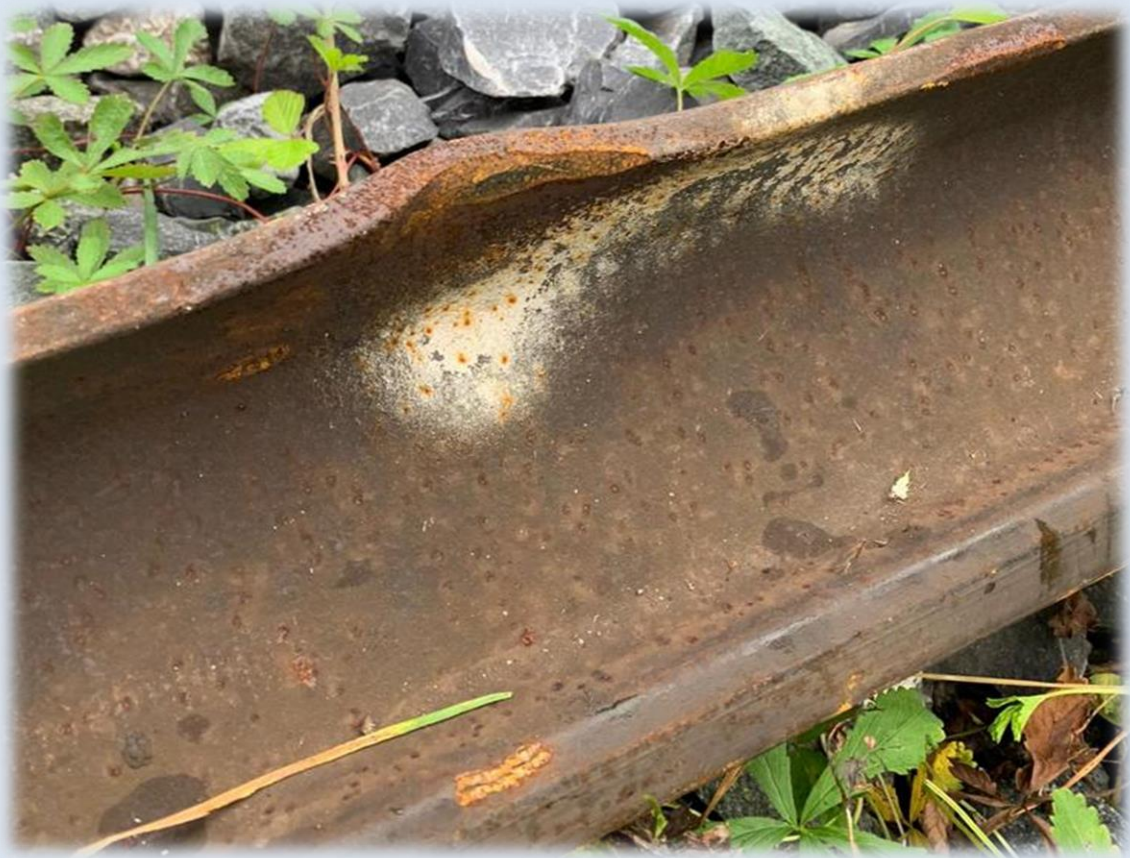
At 23:00 hrs on the 26th August 2021 a work detail incorporating: three IÉ-IM CCE members of staff (Engineering Supervisor (ES), PIC and General Operative (GO)) and eight contracted staff, met for a safety briefing at a works compound adjacent to the old Curragh Station, County Kildare.

The work scheduled by the CCE Infrastructure Department was to replace a defective 9 m section of rail. The work crew were briefed by the ES on their duties for the night and given site safety information including that the work would be under an Absolute Possession (T3 Possession).

When the work detail arrived at the site of the defective rail, the GO started to loosen the bolts which fix the rail to the concrete sleeper, while one of the contracted welders started digging the ballast out from around where the clamp was to be placed (the clamp is part of holding gear equipment that is clamped to the rail during the works).

The two other contracted welders started to attach the clamp to the Down Leg of the Up Line. The contractor that was digging the ballast, turned to put down his shovel, when he saw the lights of an approaching train and shouted “train on” and all staff quickly moved to a position of safety.

The train (Train J283), an unscheduled empty train was travelling from Limerick Junction to Heuston Station, approached the worksite and struck the clamp which was clamped onto the rail. The driver of Train J283, Driver J283, brought the train to a stop and contacted the Mainline Signaller to report the collision and near-miss with staff.

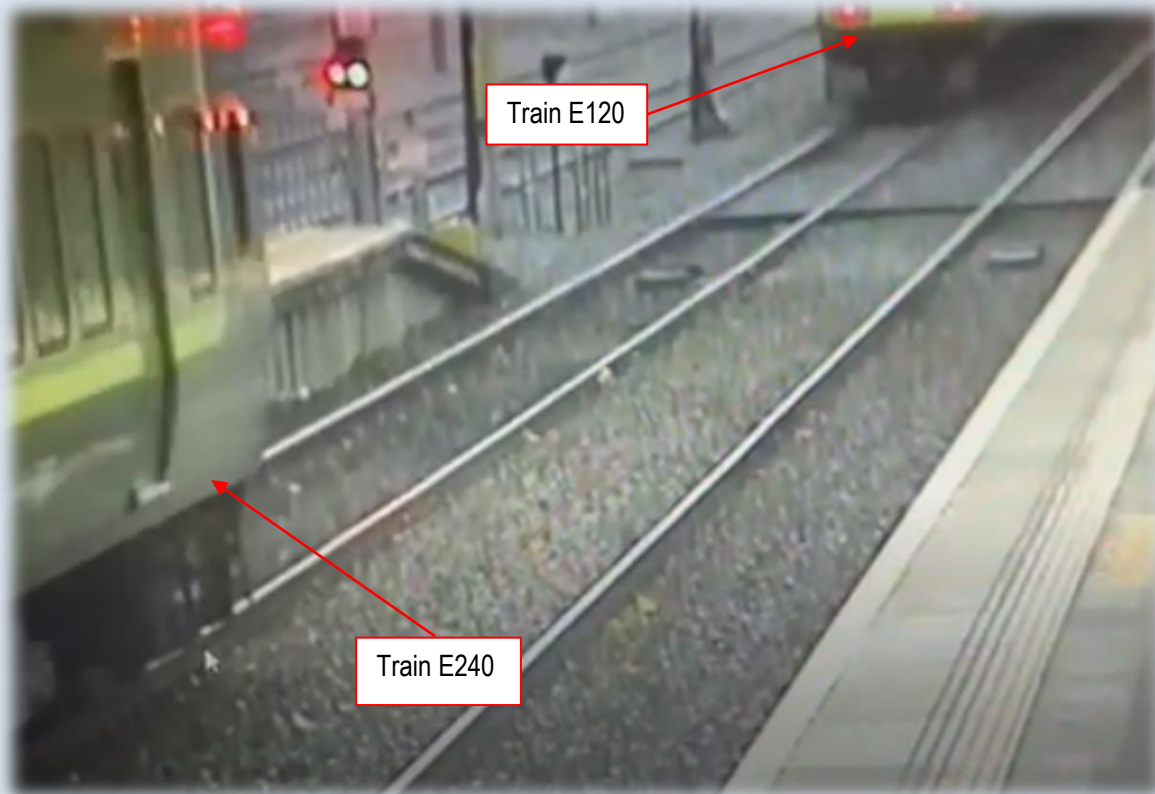
At approximately 15:59 hrs on 7th December 2021 the 15:31 hrs IÉ DART passenger service from Malahide to Bray (Train E120) was stopped at Clontarf Road Station Up Platform. The signal to the rear, Signal DN295 was displaying a Red Aspect to protect Train E120.

Around the same time, the 15:40 hrs DART passenger service from Howth to Bray (Train E240) was approaching Signal DN287 at Clontarf Road Station.

At 16:01 hrs Train E120 departed Clontarf Road Station with a planned stop at the Crew Ramp at Fairview Depot for a change of driver (the driver of E120 who brought the train to the Crew Ramp will be known as Driver E120a for the remainder of this report and the replacement driver will be known as Driver E120b). When Train E120 departed Clontarf Road Station the aspect of Signal DN295 situated at the south end of Clontarf Road Station Up Platform changed from green to red to protect Train E120 as it stopped at the Crew Ramp, Fairview.

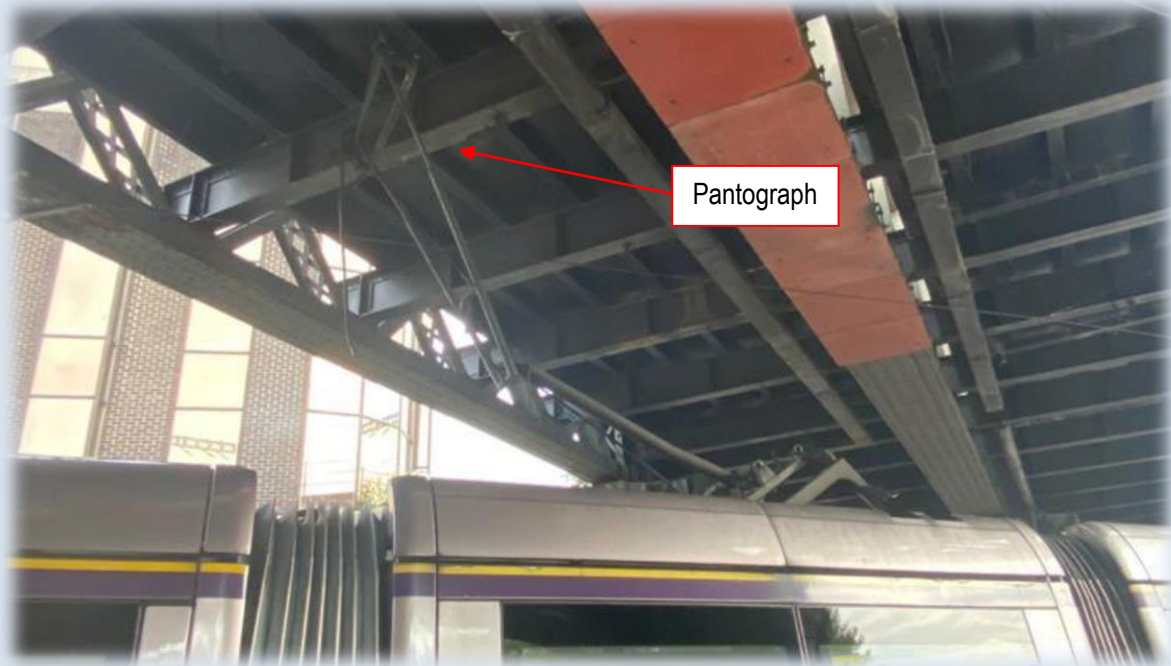
At approximately 01:16 hrs on the 11th June 2021 the Parafil termination failed on the cross-span between a pole and the Strong Registration Arm attached to the Luas network Overhead Contact System (OCS) on the Outbound line, cess side, close to Beresford Place IÉ railway bridge; causing the Strong Registration Arm to hang down over the tram line. This results in the contact wire losing stagger and striking the negative copper strip on the insulated plates located under the railway bridge resulting in a dead-short and tripping (stopping the electrical flow) the electrical power in the O'Connell to Spencer Dock section. There were no trams in the section, the last outbound tram to pass the section was Tram 3026 at approximately 01:00 hrs.

LNMC were alerted to the ESS trip-out and contacted Infrastructure Maintenance who arrived at O'Connell ESS at 01:25 hrs and reset both Traction and HSCBs with no issues; the Infrastructure Maintenance staff did not inspect the OCS as it was not required under any TDLR internal documents.

At 05:12 hrs, on Sweep Tram 3016's approach to Beresford Place railway bridge, and the location of the partially detached Strong Registration Arm, the pantograph of Tram 3016 loses contact with the contact wire and strikes with the cross-span assembly. The force of impact on the cross-span assembly causes the Strong Registration Arm to become detached from the contact wire and becomes entangled on the pantograph, contacting both the foot of the pantograph and roof of the tram; causing a dead-short and trips the power in the O'Connell to Spencer Dock electrical section.

In this accident, there are two distinct events, namely the failure of the Kevlar parafil and the Infrastructure Maintenance response to the trip-out at 01:16 hrs, and as such the causal, contributing and systemic factors (where identified) are separated.

In terms of the failure of the Kevlar Parafil terminations, the mechanism of failure is likely the result of the failure of the core fibres (which cannot be visually inspected) deteriorating over period of time as a result of in-service stresses (paragraph 119). At the time of the accident, there was a programme in place for the replacement of the Kevlar parafil for 6 mm diameter stainless steel wire rope with inline discreet insulators, however, the replacement had not yet been undertaken at the location of the accident. Causal factors are:

- CaF-01 – The planned inspections of the OCS cannot identify the deterioration of the Kevlar parafil fibres at the terminations.
- CaF-02 – The Kevlar parafil rope had not been replaced with 6 mm diameter stainless steel wire rope with inline discreet insulators, an ongoing Luas network maintenance project, at the time of the accident.
- CaF-03 – No ground level survey of the electrical section was carried out after the notification of the first trip-out; this inspection would have identified the partially detached Strong Registration Arm.

No contributing or systemic factors were identified in terms of the failure of the Parafil rope.

Due to a number of actions already taken by TDLR no safety recommendations are warranted as a result of the accident. The actions taken include the Parafil replacement project, which is ongoing, whereby the existing Kevlar Parafils are being replaced with 6 mm diameter stainless steel wire rope with inline discreet insulators. In addition, TDLR now require a full ground level survey of the electrical section to be taken in the event of a trip-out.

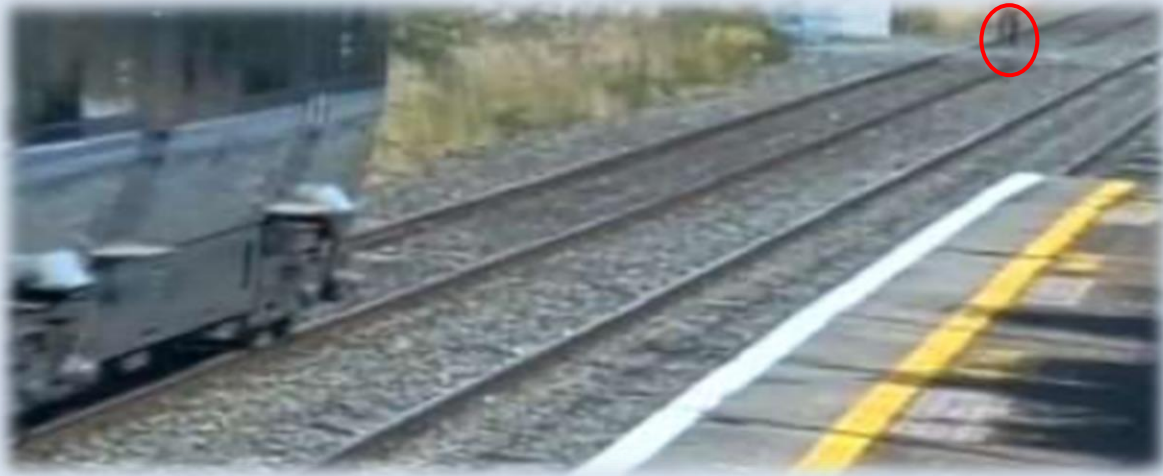
Near miss with an Iarnród Éireann CCE Worker near Gormanston Station, 21st July 2021

On the morning of Wednesday 21st July an IÉ CCE Department employee (CCE Worker) was performing the role of Track Safety Co-ordinator (TSC) for a group of construction staff upgrading a retaining wall adjacent to a track access point at the northern end of Gormanston Station, County Meath; the worksite was away from the railway line in a position of safety.

The weather that morning was hot and sunny and the CCE Worker decided to go onto the railway line to place two temperature gauges on the track to check the track temperature; a task that was not requested to be carried out by any member of management.

- CaF-01 – The CCE Worker made a decision to carry out track inspection, by his own volition, without the request from his manager; possibly because it had been habituated in the previous days due to the hot weather conditions;
- CaF-02 – The CCE Worker did not ensure that he could adhere to the requirements of CCE-RA-15050 and the IÉ Rule Book prior to accessing the track; possibly due to a lack of concentration;
- CaF-03 – The CCE Worker did not look or listen for trains prior to accessing the track the final time; as he was likely distracted by the noise from the improvement works.

- SF-01 – CCE did not have a risk assessment for rail temperature monitoring, indicating how, when and where, monitoring should occur;
- SF-02 – CCE documentation does not require any pre-planning documentation for CCE Departmental staff, to be completed prior to going on or near the line, with checklists to manage risks that might be encountered; or, which would highlight to CCE Department staff that it is unsafe to go on or near the track without a proper Safety System of Work (SSOW).
- SF-03 – Despite the IÉ Rule Book being robust in its protection of staff going on or near the line, the current CCE-RA-15050 of document does not reflect this robustness in ensuring that the risks associated with CCE staff members working on their own are captured and managed.

- Safety Recommendation 2022002-01 – The IÉ-IM CCE Department should develop a formalised process, through their Safety Management System (SMS) suite of documents, for IÉ-IM CCE staff walking/ working alone, which should be completed prior to any member of CCE staff going on or near the line; at a minimum consideration should be given to:
 - Whether it is necessary to go on or near the line to conduct the walk / work;
 - What local knowledge is required to walk /work safely;
 - Whether all the requirements of the IÉ Rule Book / SSOW can be met;
 - What special protection arrangements are required either at night or during the day.

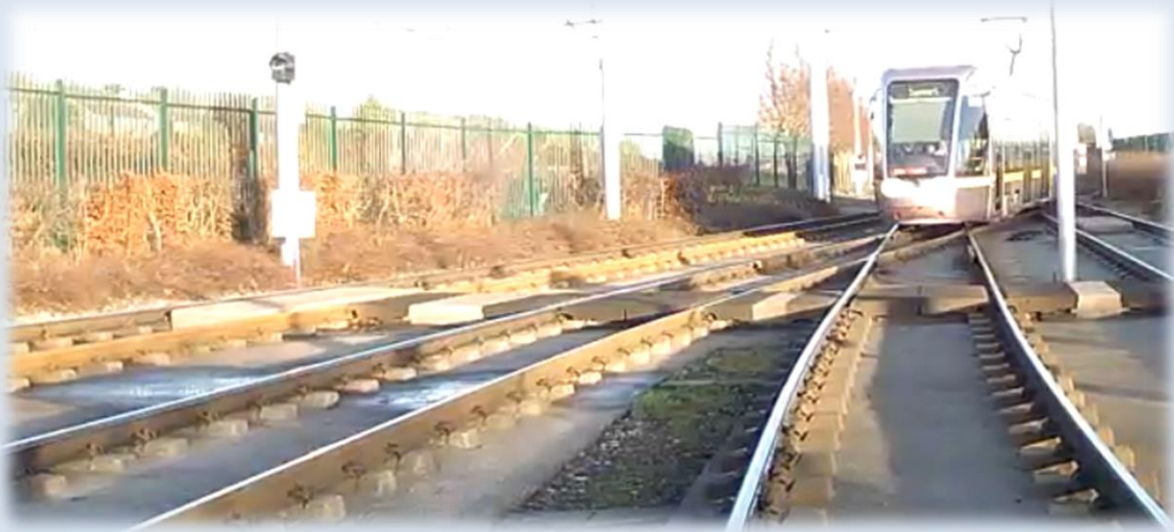
Trend investigation into Signals Passed At Stop on the LUAS network

In February 2020, the RAIU received the monthly occurrence notifications from TDLR in relation to incidents and accidents on the Luas network in January 2020; here it was notified that there had been a signal passed at Stop (SPAS) at Cookstown Interchange, County Dublin, with a conflicting movement (see Closed Circuit Television (CCTV) still above), taken from the tram that passed the signal at Stop). The RAIU expanded the investigation, to a trend investigation into all SPAS events in the 2019, 2020 and the first six months of 2021; a total of thirty-six SPAS incidents.

- CoF-05 – Drivers had an incorrect expectation of signals upgrading to proceed on approach as a result of:
 - Normally having a proceed at certain locations;
 - Inputting an RTS request and assuming the signal has upgraded (but hasn't);
 - Reading road traffic signals in error;
 - Looking at the movements of other trams.
- CoF-06 – Drivers operating in degraded mode.
- CoF-07 – Drivers being distracted, preoccupied or losing situational awareness as a result of personal issues, pedestrians, in-cab distractions (AVLS, sun glare), and forgetting signals.

- SF-01 – Driver training is deficient in terms of the:
 - Minimum activity criteria related to the LSS Locations;
 - Training criterion for depot movements;
 - Understanding of the importance of RTS requests, emergency brake applications and
 - the correct input of the AVLS.
- SF-02 – The Tramway Safety Instruction (TSI) Manual is not robust enough in terms of some of the movements to be carried out around depots and LSS locations; and the application of emergency brake.
- SF-03 – There were number of instances of driving rule breaks in terms of non-application of the emergency brake and inputting of the AVLS.

- AO-02 – TDLR do not have a formalised Signal Sighting Committee (SSC); where the positioning of the signal can be examined to see if it was contributory to a SPAS event and where this is the case changes to the asset or its operational context would reduce the likelihood of a further accident or incident occurring, the SSC should recommend what retrospective action is appropriate.

- AO-08 – The current internal investigation process produces generic reports which do not capture the trends around SPAS incidents, in particular, at multi-SPAS signals; or other specific conditions which may prevent the re-occurrence of a similar SPAS incident.

- Safety Recommendation 2022003-01 – Transport Infrastructure Ireland (TII) should determine if in-cab technological and/or mechanised systems could be introduced to assist drivers with the prevention of SAS SPAS incidents, taking into account requirements for ensuring safety risk is as low as reasonably practicable (ALARP). Analysis should include an appraisal of available systems and the effect they may have on mitigating sub-standard driver performance.

- Safety Recommendation 2022003-02 – TDLR should enhance the TSI Manual operating instructions for all depot and LSS locations based off site-specific risk assessments for the different locations. These enhancements should include step-by-step guidance on how trams are moved at these locations; this should include how verbal permissions are granted by LNMC.

- Safety Recommendation 2022003-03 – TII should review the technical specification of the onboard AVLS console to see if it is possible to limit the inputting of the AVLS service files to when the tram is stationary; and if so, implement this change.

- Safety Recommendation 2022003-04 – TDLR should, with the assistance of a qualified human factors expert, review the timings and locations of SPAS incidents to establish reasons as to why drivers are involved in SPAS incidents at certain times and locations.

- Safety Recommendation 2022003-05 – TDLR should, with the assistance of a qualified human factors expert, introduce training in relation to error prevention techniques as a tool for drivers to manage distraction, pre-occupation and incorrect expectation.

- Safety Recommendation 2022003-06 – TDLR should review its current training regime with a view to increasing training and competency assessment of drivers, in particular in terms of driving in depots and LSS locations and in degraded mode.

- Safety Recommendation 2022003-07 – TII should, as part of the increased driver training and competency assessment, consider the introduction of a driver training simulator which would assist in driving training in depots, LSS locations and in degraded mode.

- Safety Recommendation 2022003-08 – TDLR should ensure that tram signals are referenced correctly in the TDLR suite of documents, this in turn should reinforce, to the drivers, which signals are Stop signals.
