# Railway Accident Investigation Unit Ireland

## Annual Report 2025

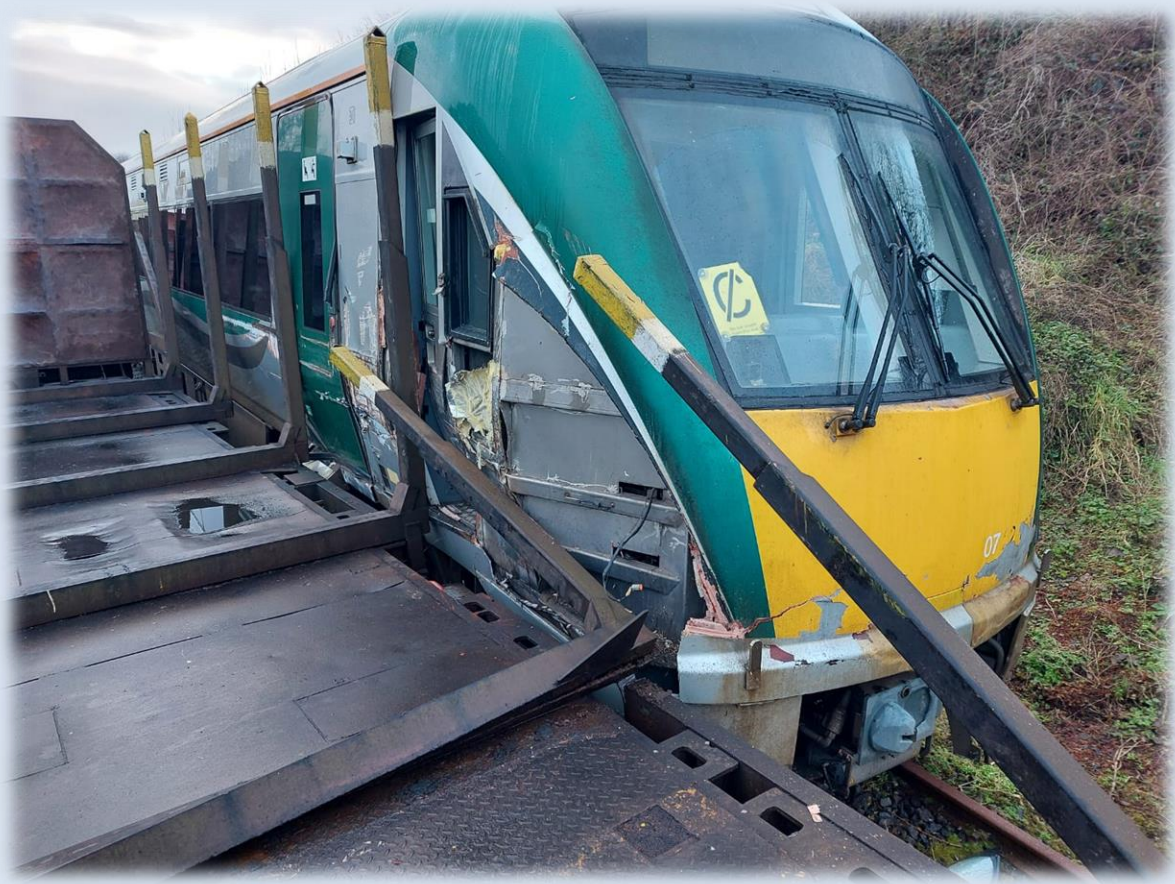
On the 10<sup>th</sup> February 2025, an ICR was driven onto the Shed Road in Westport Yard in expectation of the arrival of the Timber Train into the Cabin Siding. The ICR was fouling into the loop.

The driver for Locomotive 076 undertook a number of shunting movements before propelling the timber wagons down the loop siding, colliding with the ICR which was fouling the loop, causing damage to the leading cab (22139) and a timber wagon.

The physical damage is estimated to be €100,000.

- USAN Safety Recommendation 1: IÉ-IM, in conjunction with IÉ-RU Operations, should risk assess all siding locations with a view to identifying whether fouling points markers should be installed at other siding locations.

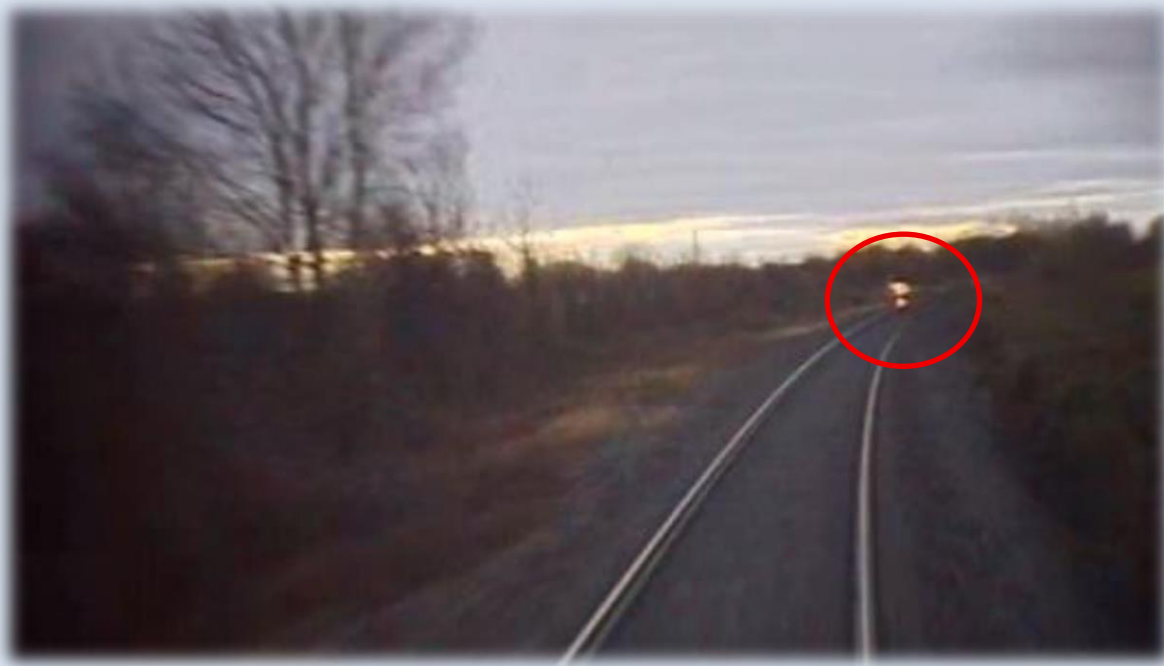
On 24 November 2025 a patrol ganger was conducting a patrol; the patrol ganger was walking in the Up direction in the five foot when they heard a train approaching in the Up direction i.e. the patrol ganger had their back to the approaching train. The train was travelling at 79 mph (127 km/h) as it approached the location. The patrol ganger, on hearing the train, moved clear, but only reached a position of safety less than three seconds before the train arrived (see image below from the train's FFCCTV, patrol ganger circled).

On notification of this incident, this was the eighth near miss between staff and trains, between the 27<sup>th</sup> February 2023 and 24<sup>th</sup> November 2025, three involved patrol gangers, two were related to the Bray Tunnels, one involved OHLE workers, one involved a PWI and one involved SET workers. The RAIU then made the decision to commence the drafting of a USAN<sup>2</sup>.

<sup>2</sup> USAN 006 was published on 9 January 2026, making five safety recommendations. Significantly, the RAIU made a number of recommendation to seek to reduce the risk of track workers being struck by trains by requiring IE-IM to publish and maintain Track Access Index instructions, stop lone track patrolling where adequate sighting distances cannot be achieved, review the use of alternative or technological methods for track inspection, identify opportunities to undertake inspection and maintenance during planned safe access rather than while trains are running, and strengthen management and supervisory controls to ensure that the hierarchy of risk controls is applied before staff are exposed to the railway.
