**Railway Accident
Investigation Unit
Ireland**

INVESTIGATION REPORT

Luas isolation irregularity, Kylemore to Suir Road,

RAIU Investigation Report No: 2021 – R007

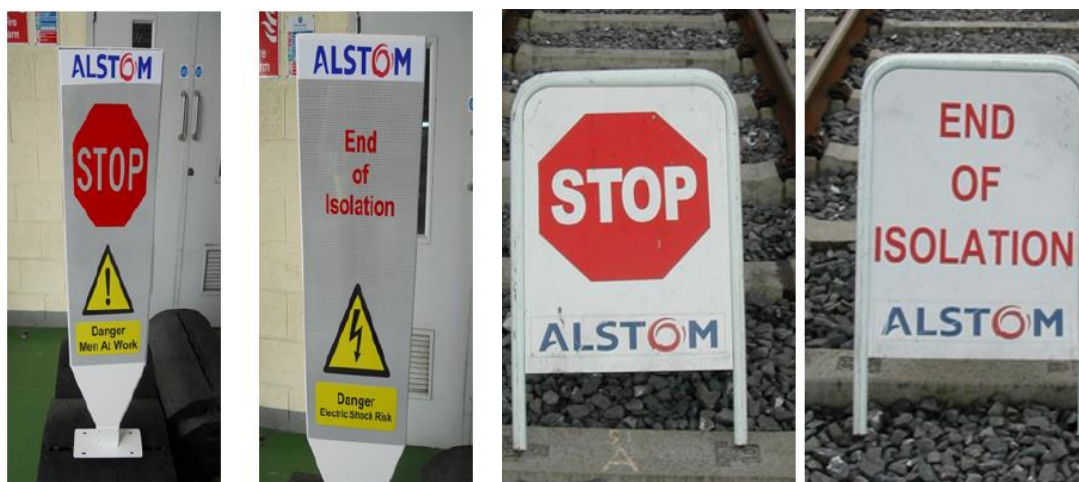
Figure 6 – Examples of Isolation Signage

⁶ The Isolation Signage is not illuminated or secured at its location and can be removed by unauthorised people; these factors have been identified as an Additional Observation, AO-03 (paragraph 123), and a safety recommendation has been issued (paragraph 138).

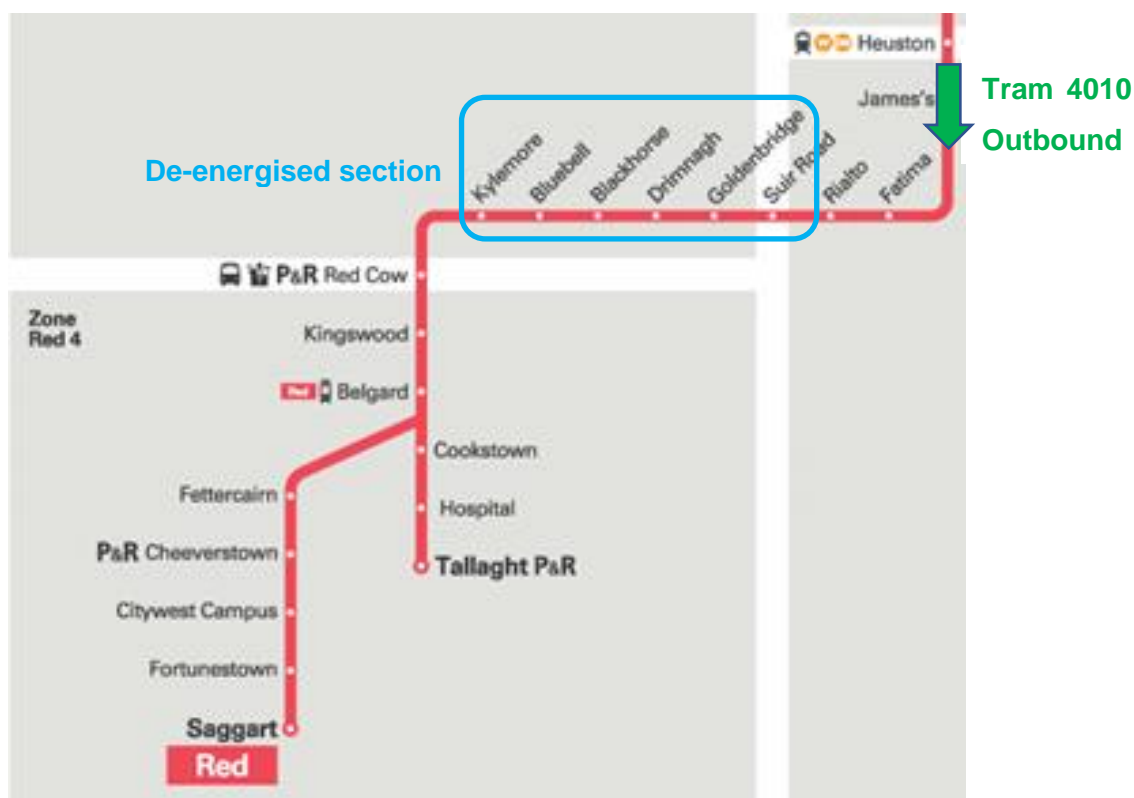
Figure 9 – Location of Tram 2010 in relation to de-energised section

- 86 At 01:09 hrs Tram 4010 was passing James’s outbound (Figure 9); the location of Tram 4010 was available to the Traffic Supervisor on the AVLS, but the Traffic Supervisor did not check the screen.

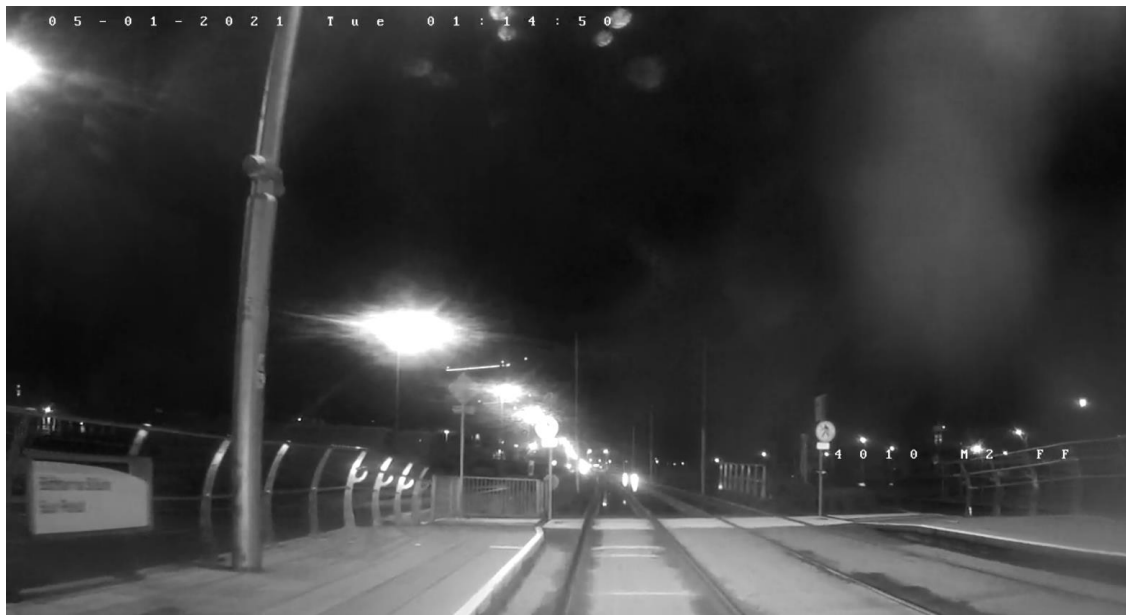
Figure 11 – FFCCTV image from Tram 4010 at Suir Road Stop

- 88 At 01:14:50 hrs, Tram 4010 passed through Suir Road Stop, see Figure 11, for a FFCCTV image from Tram 4010 at Suir Road, note that there is no Isolation Signage, although it is noted that the Switching Programme Form does not require that the Isolation Signage be erected at Suir Road until the isolation has been completed at Suir Road.

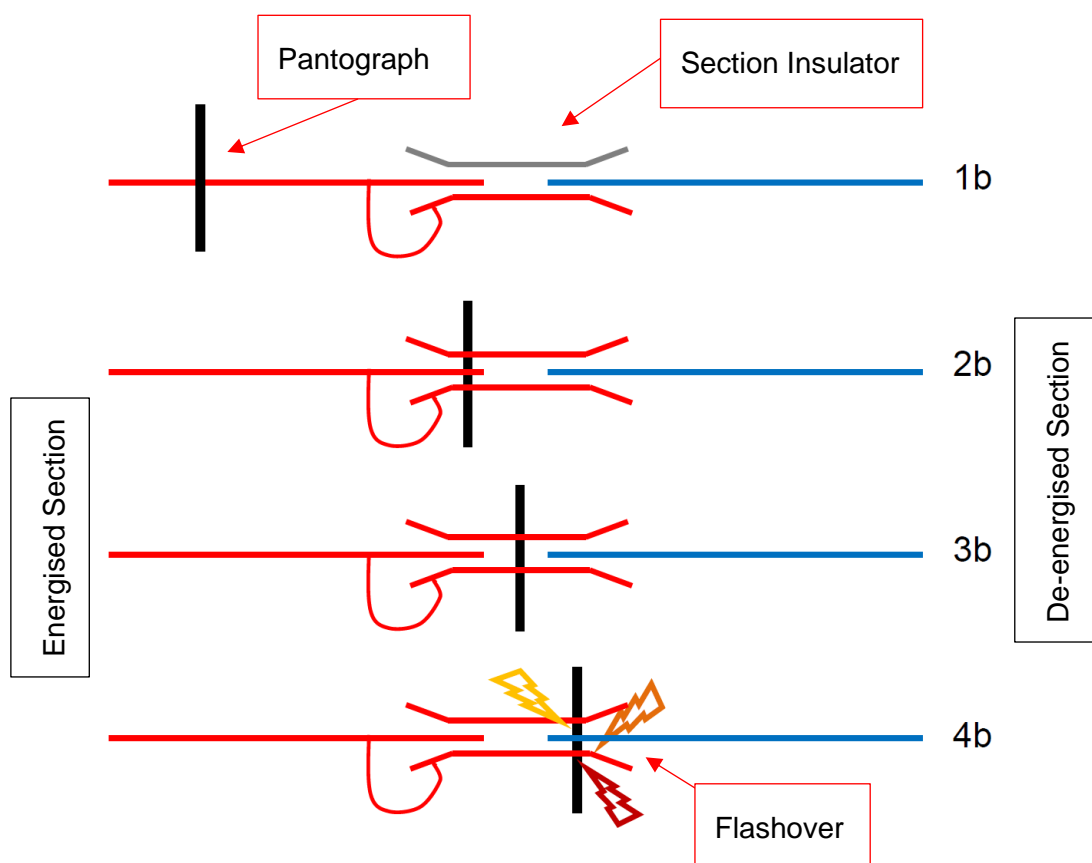
Figure 13 – Pantograph of Tram 4010 during bridging of Section Insulator

90 At 01:15:02 hrs, the pantograph of Tram 4010 bridged the energised section of the OCS (the section on which Tram 4010 was travelling i.e. Heuston to Suir Road, see red in Figure 13) with the de-energised Kylemore to Suir Road Section (Section 151-152-153, see blue in Figure 13) through the Section Insulator. This caused a large flashover due to the current travelling from the energised section to the de-energised section, see 4b in Figure 13.

99 The pantograph of Tram 4010 bridged the energised section of the OCS (the section on which Tram 4010 was travelling i.e. Heuston to Suir Road) with the de-energised Kylemore to Suir Road Section through the Section Insulators (paragraph 90). Section Insulators provide a continuous supply of power to the tram when the tram passes from one section to the next and also allows for de-energising of one section at a time (paragraph 46). The movement of the pantograph over the Section Insulator caused a large flashover due to the current travelling from the energised section to the de-energised section.

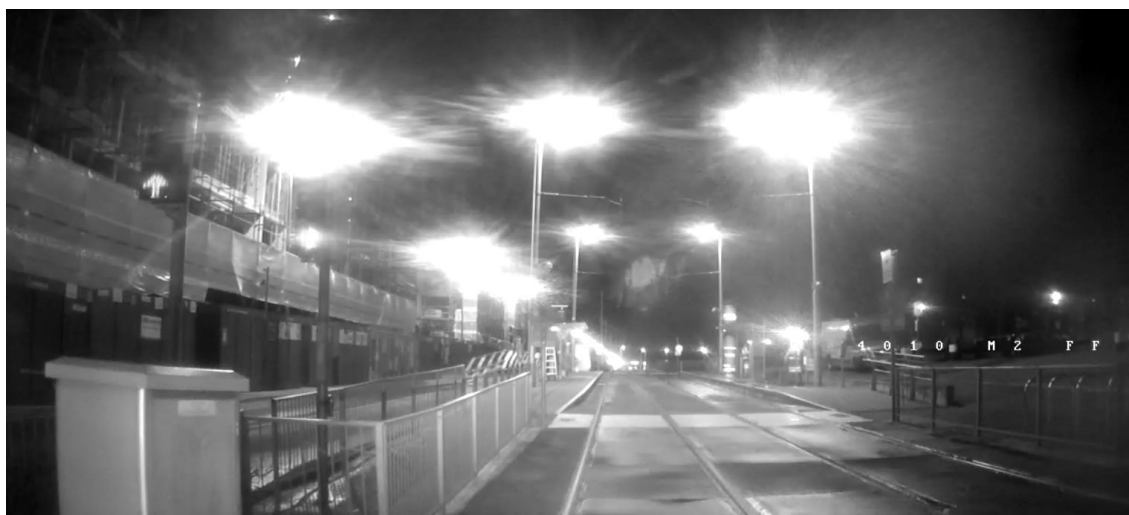
Figure 14 – FFCCTV image from stopped position of Tram 4010

91 At the same time, the MCB on Tram 4010 opened as a result of losing the 750 V DC supply (as Tram 4010 was now positioned in the de-energised section). Tram 4010 coasted for approximately forty-eight seconds before coming to a stop prior to Golden Bridge Stop at 01:15:50 hrs, see Figure 14.

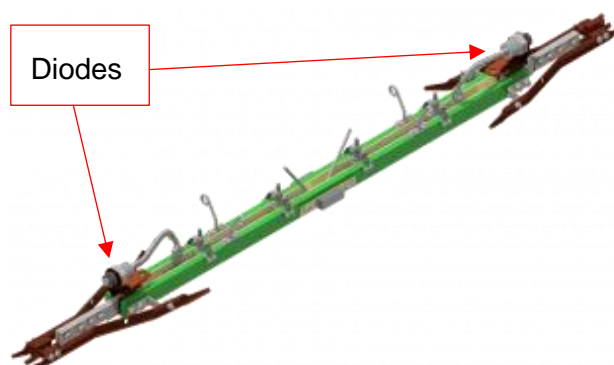
Figure 15 – Section Insulator with diodes

100 Section Insulators fitted with diodes are now available and prevent the transfer of current from a live section into a de-energised section when bridged by a pantograph but still allow for isolation of individual sections. Section Insulators fitted with diodes are not fitted on the Luas network as they were not included in the original design.

101 Had the Section Insulators been fitted with diodes this may have prevented the transfer of current from the live section into the de-energised section, when bridged by the pantograph of Tram 4010 (but still allows for isolation of an individual section).
