**Railway Accident  
Investigation Unit  
Ireland**

# **INVESTIGATION REPORT**

**Luas pantograph collision with railway bridge,  
Beresford Place,**

RAIU Investigation Report No: 2022 – R001

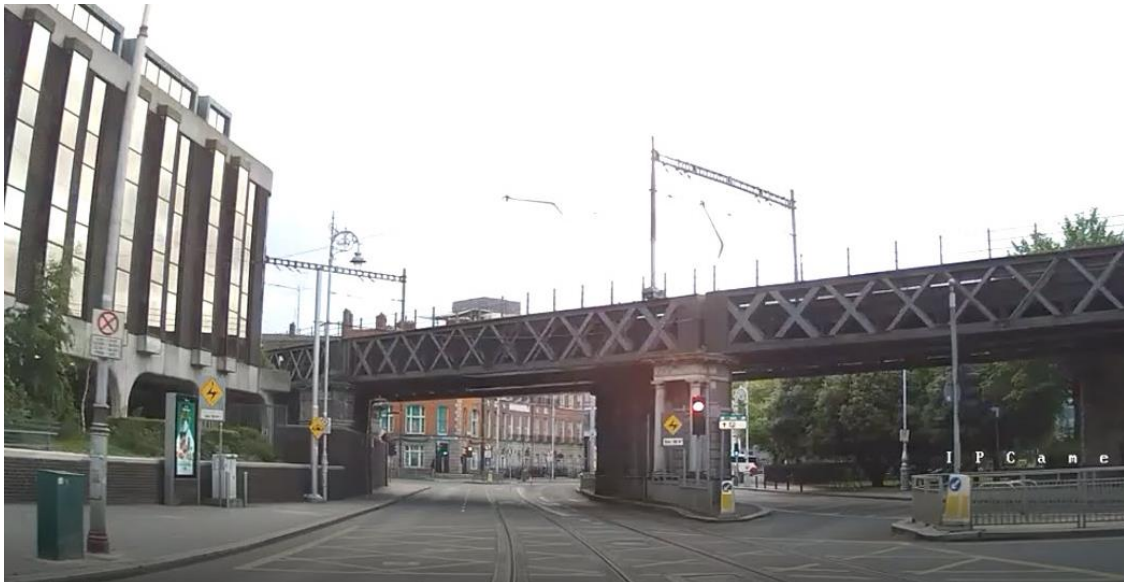
Figure 1 – Daylight on approach to the detached Strong Registration Arm

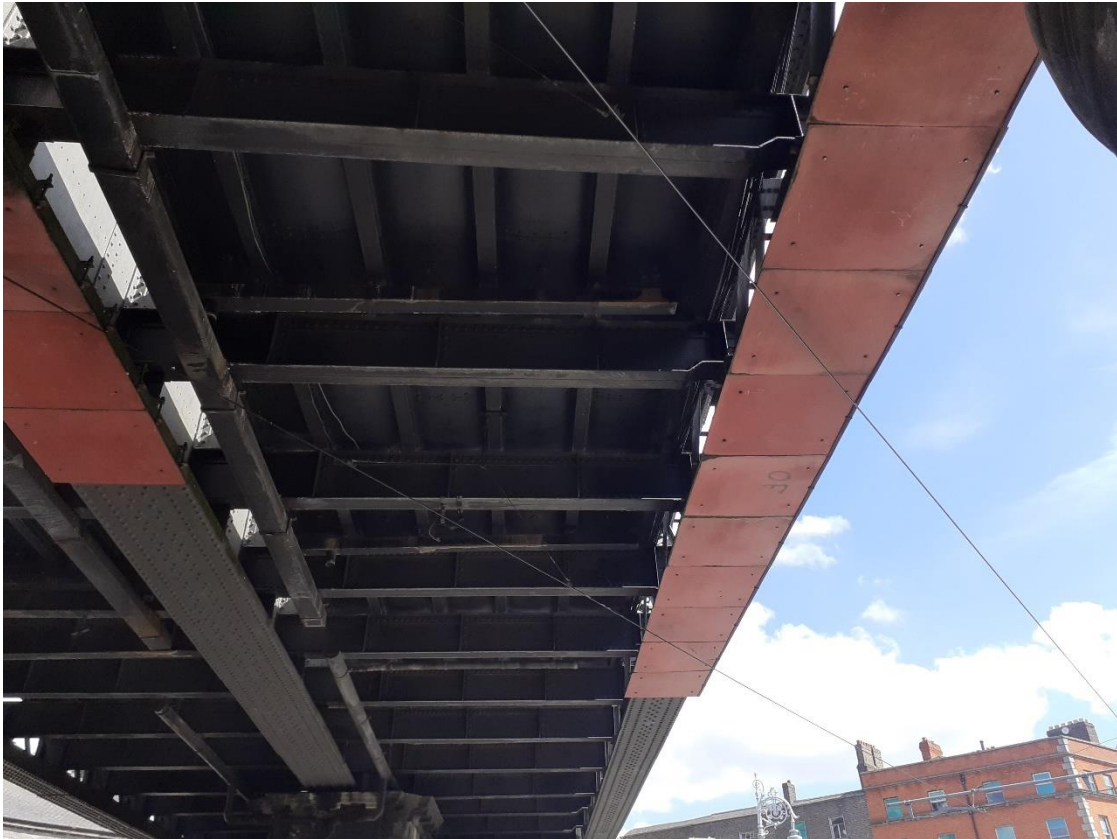
71 Three insulated plates were damaged as a result of the accident (paragraph 23).

Figure 11 – Insulated plates under Beresford Place railway bridge

23 Replacement of three insulated plates to IÉ Beresford Place railway bridge.

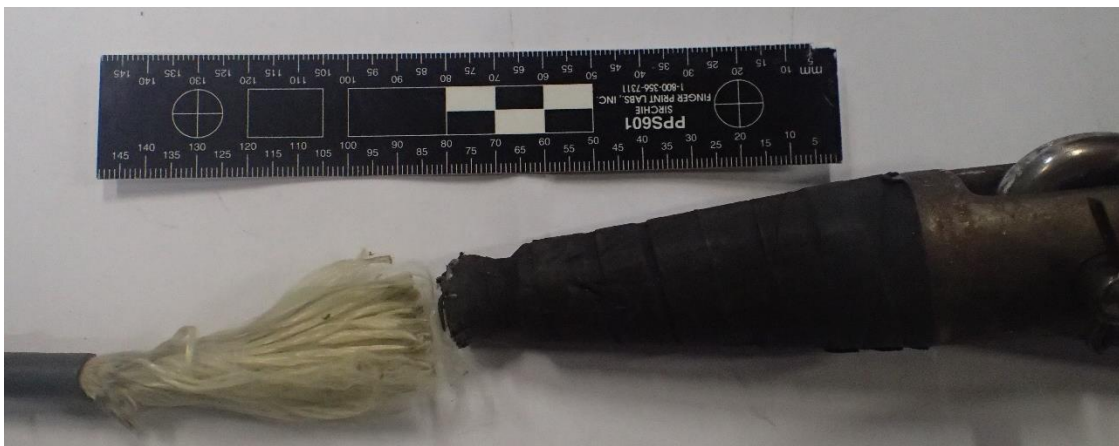
76 Examination of the failed termination revealed that the parafil core fibres had pulled out of the termination barrel (see Figure 13).

Figure 13 – Core fibres pulled from termination barrel

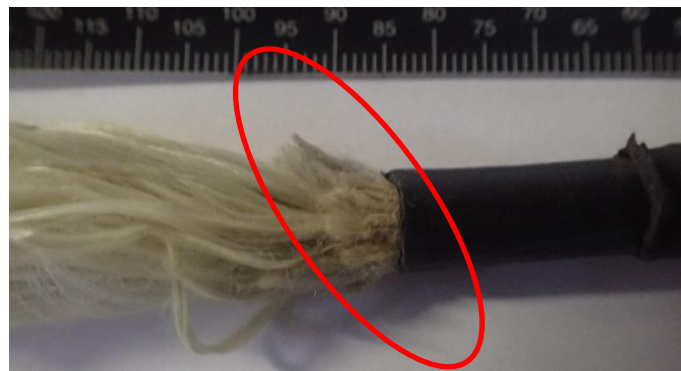
77 On closer examination approximately 15% of the core fibres were shorter when measured from the sheath. The shortened fibres were located evenly around the external diameter of the sheath. When the termination spike was removed the severed remains of the failed fibres were located (Figure 15).

Figure 14 – Close up of core fibres

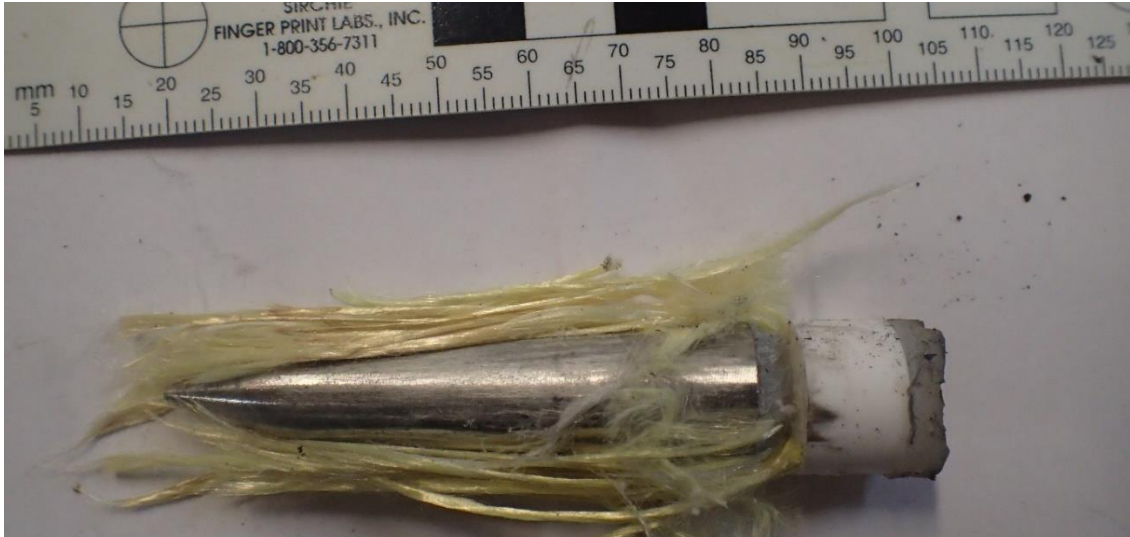
Figure 15 – Severed core fibres removed from the termination

- 78 The failed ends of the parafil core fibres were not a clean cut, suggesting they failed as a result of being pulled apart over a period of time where subjected to in-service stresses.
- 79 There was no evidence of fibre discolouration as a result of water ingress.
- 80 To determine if poor workmanship resulted in the failure, the terminations were re-assembled, using new fibres, excessive force was used in inserting the spike at the centre position and over-centre position. No damage was identified to the core fibres for either assembly; coupled with the fact that there was no evidence of water ingress (paragraph 79) indicates that poor workmanship was not a cause of the failure.

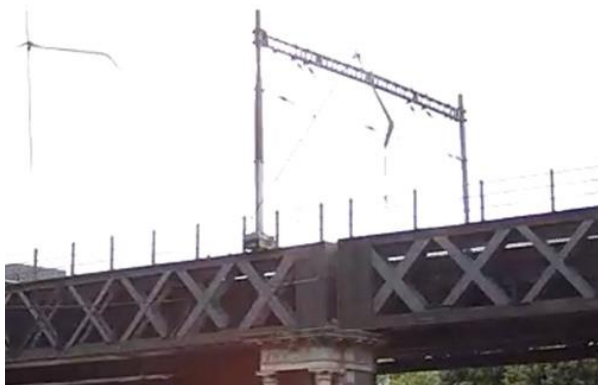
85 At approximately 01:16 hrs the parafile termination failed on the cross-span between the pole and the Strong Registration Arm attached to the Outbound line, cess side, at Beresford Place. The Strong Registration Arm and hangs down (see Figure 16, note, this image is taken from later in the morning, it is for illustrative purposes only).

Figure 16 – Hanging Strong Registration Arm

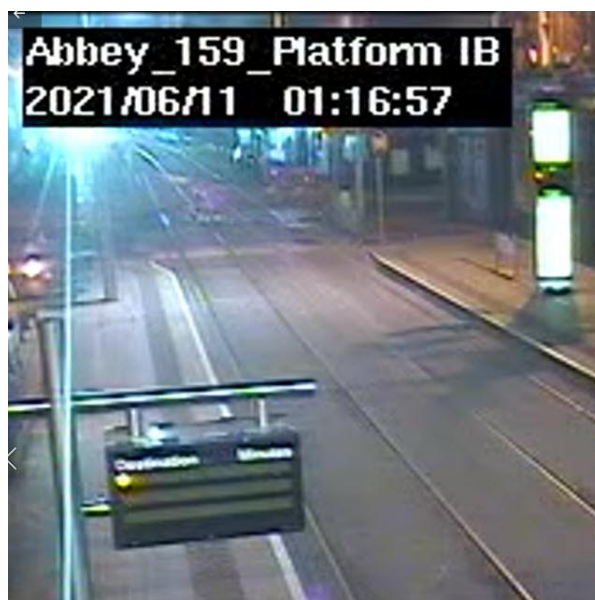
87 LNMC were alerted to the ESS trip-out on the console. The flash at O'Connell ESS from the trip-out was visible on the Abbey Street Platform CCTV, Figure 17.

Figure 17 – Flash at O'Connell ESS

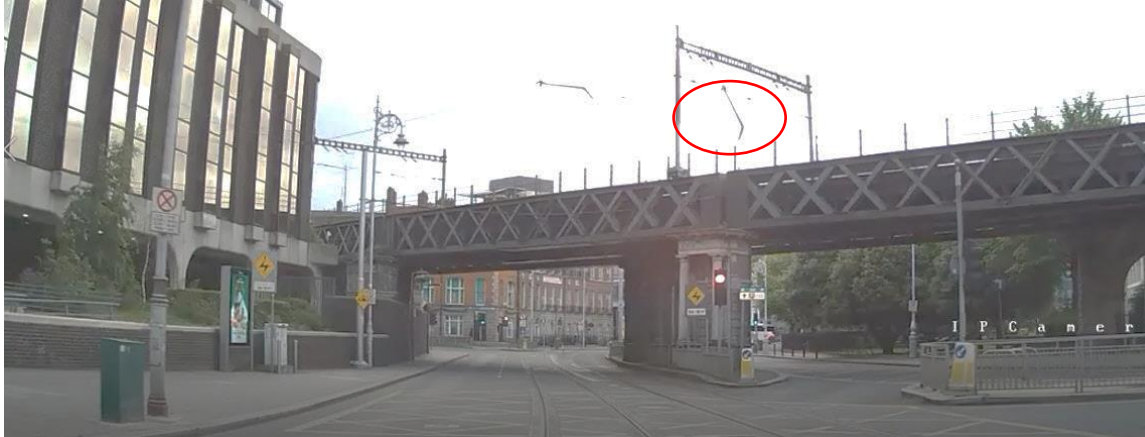
- 90 At 05:11:50 hrs, Sweep Tram 3016 stopped at Tram Signal C39. The FFCCTV shows the Strong Registration Arm on the Outbound line is partially detached, see Figure 18 (image taken from FFCCTV of Sweep Tram 3016). Driver 3016 did not see the Strong Registration Arm hanging down.

Figure 18 – Strong Registration Arm (circled) hanging (image from FFCCTV)

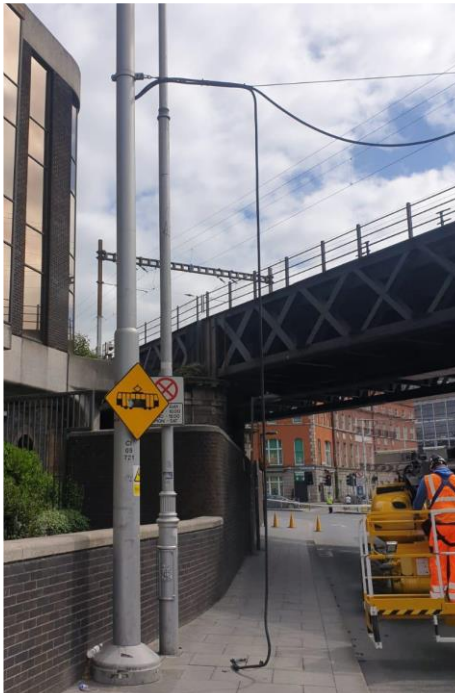
93 Sweep Tram 3016 continued forward, pulling down the feeder cable (Figure 19); with the pantograph colliding with the railway bridge, damaging the insulated plates (Figure 20).

Figure 19 – Feeder cable down

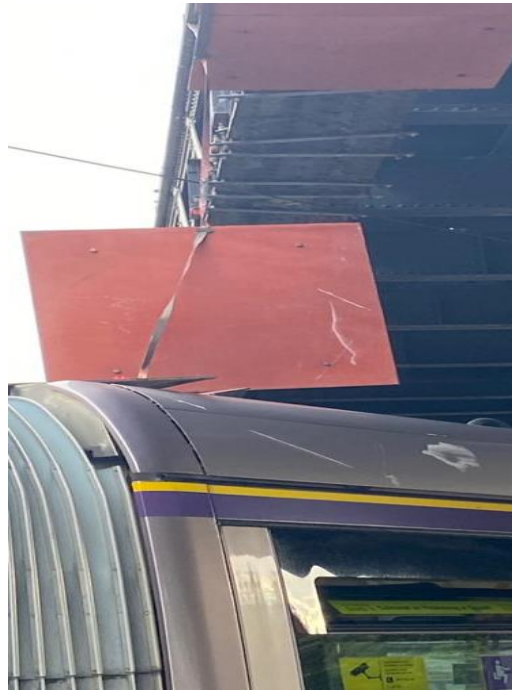
Figure 20 – Damage to insulated plates

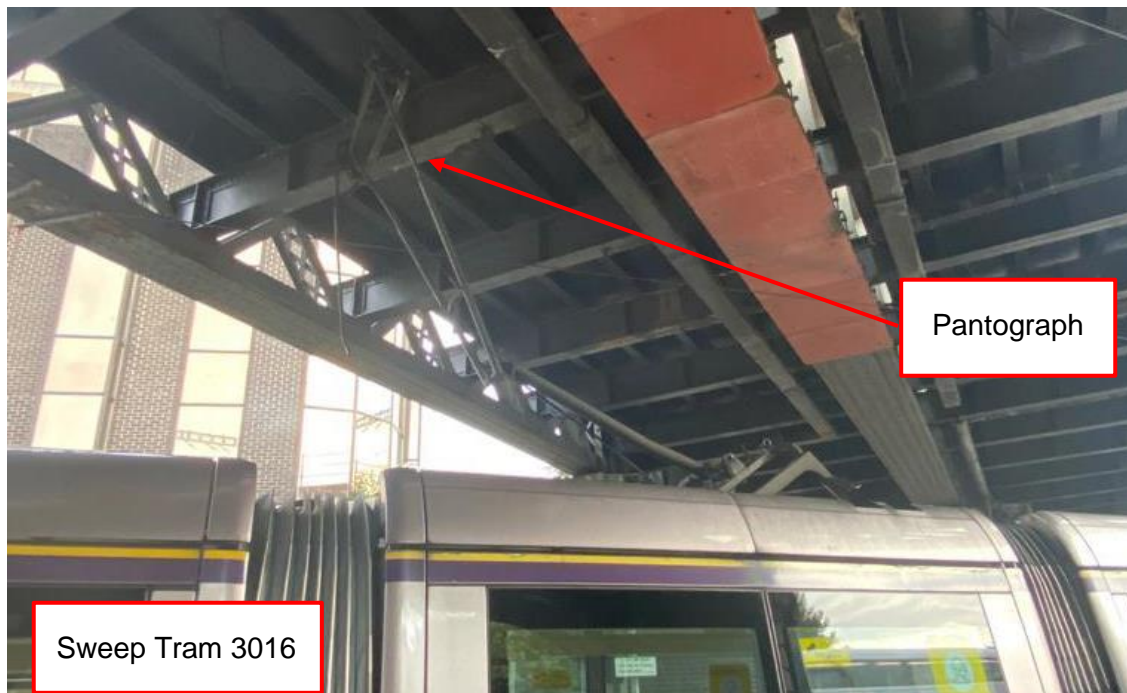
- 55 The pantograph of Tram 3016 was severely damaged in the collision with the Railway Bridge at Beresford Place. Transdev concluded that the pantograph was beyond economic repair at post-accident inspection and a new pantograph was fitted.
- 56 The damage to the pantograph of Tram 3016 prevented the checking of the pantograph uplift pressure.

94 The force of the impact causes the footings on the base of the pantograph to be torn back, see Figure 21.

Figure 21 – Pantograph of Sweep Tram 3016 in collision with bridge

21 The pantograph, pantograph base, wiring and other pantograph components were replaced along with the right side roof panelling.

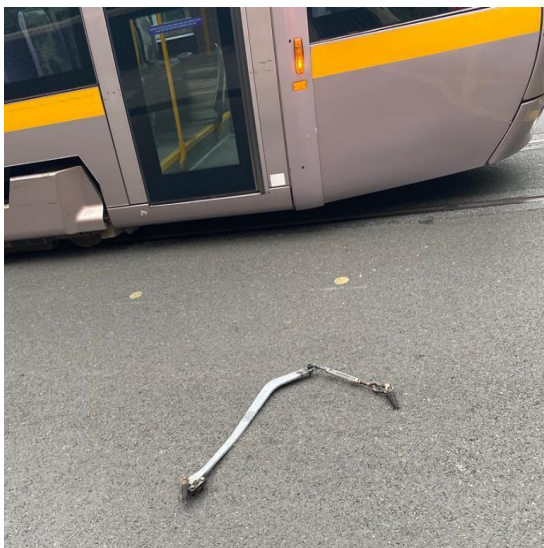
Figure 22 – Outbound Arm

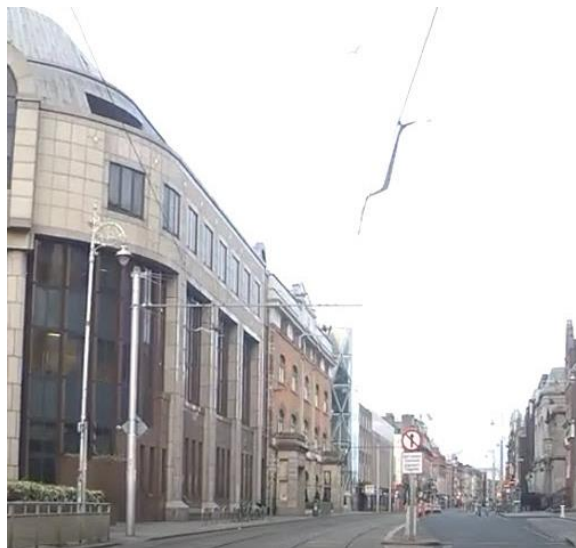
Figure 23 – Inbound Arm

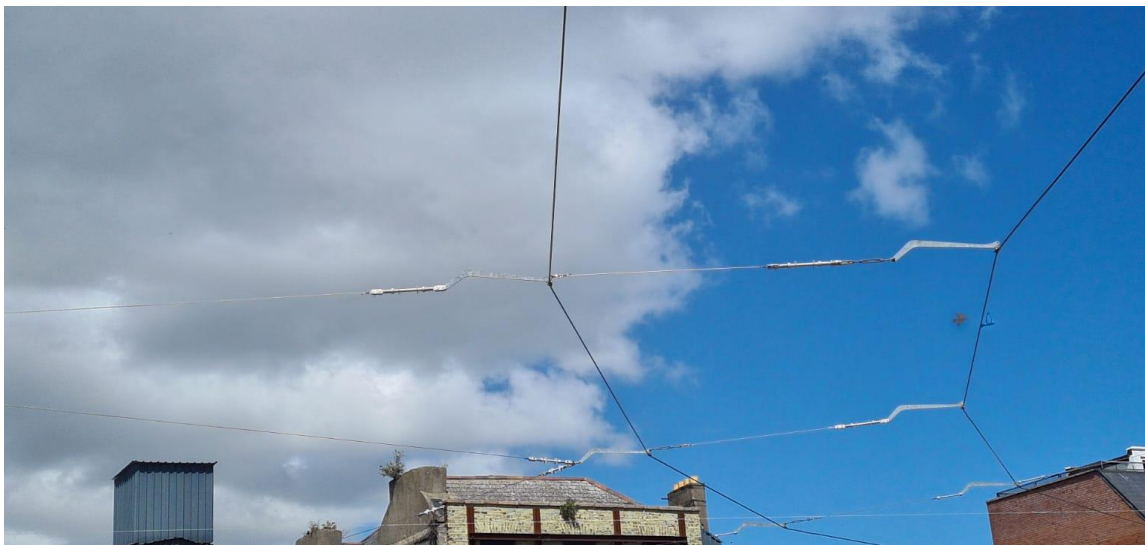
Figure 24 – Stainless Steel Wire Rope

134 In relation to the Kevlar parafil failures on the LUAS network, Pod-Trak have identified an alternative, namely the 6 mm diameter stainless steel wire rope and discreet insulators (see Figure 24), with works due to be completed by the end of 2022 (paragraph 126 - 128). Stainless steel wire rope is the preferred choice for all international light rail new build projects and extensions in recent years, with the maintainers of the Manchester Metrolink recording zero cases of stainless steel wire rope failure since installation began in 2010 (paragraph 109).
