**Railway Accident
Investigation Unit
Ireland**

INVESTIGATION REPORT

**Collision with track equipment between Newbridge
and Kildare,**

RAIU Report No: 2023 – R002

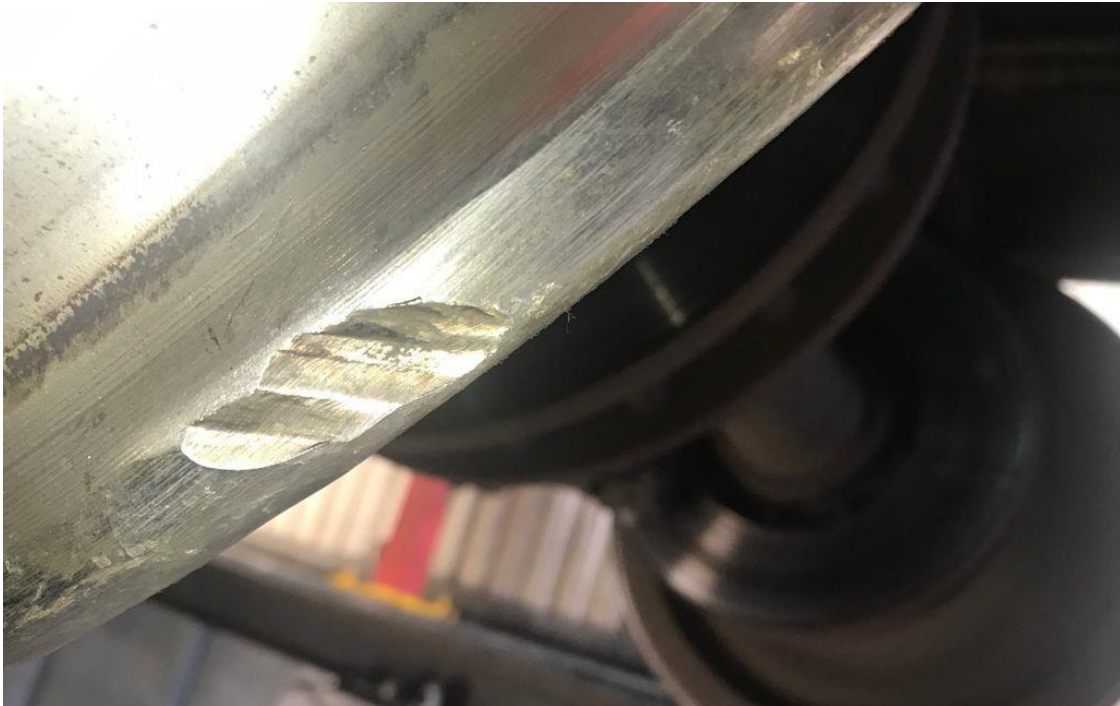
Figure 9 – Damage to wheel (4003)

48 Initial inspections and examinations (five in total) of Train J283 found no faults, however, on determination that the accident was more severe than initially reported, a more thorough examination was conducted by the CME Department on the 22nd September 2021 (three weeks after the accident); which found damage to a sander bracket and substantial damage to the front right wheel of control car 4003 (Figure 9). This is discussed in further detail in paragraphs 176 to 179.
