**Railway Accident
Investigation Unit
Ireland**

INVESTIGATION REPORT

**Dangerous occurrence involving a Double SPAD at
Clontarf Road Station,**

RAIU Investigation Report No: 2023-R001

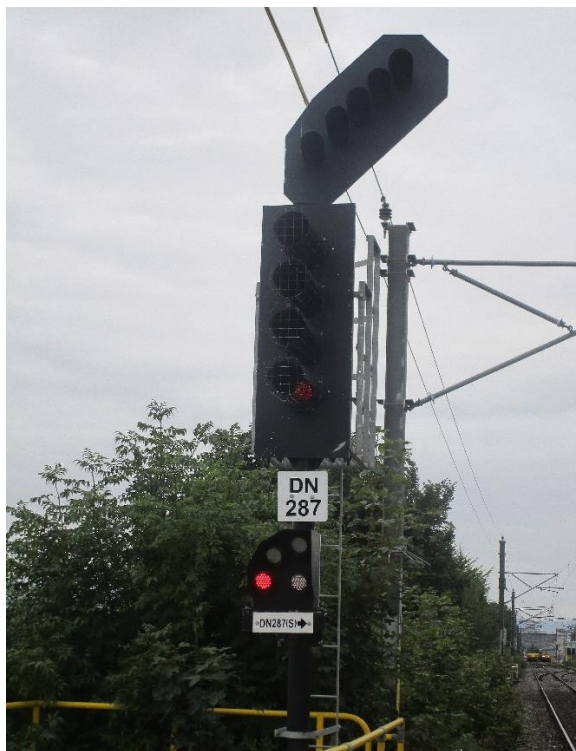
Figure 6 – Signal DN287

- 61 The signals passed at Stop were, Signal DN287 (Figure 6) located north of Clontarf Road Station and Signal DN295 (Figure 7) located at the southern end of Clontarf Road Station.

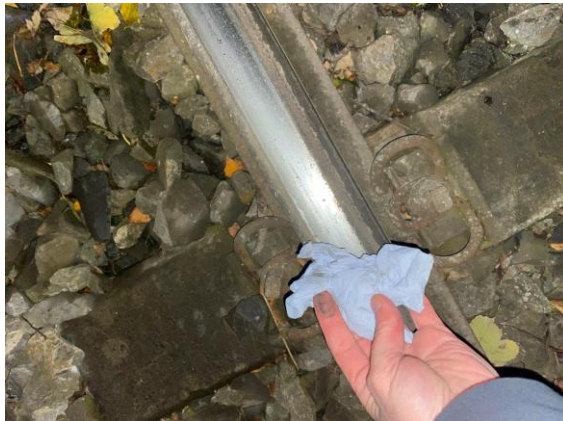
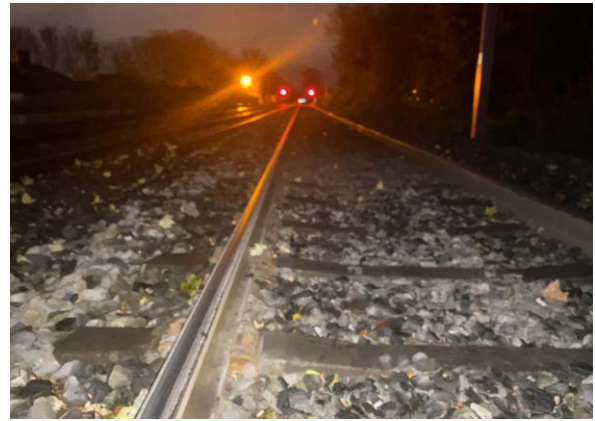
Figure 11 – Dry railhead prior to Clontarf Road Bridge

- 87 The CCE Department scrubbed the railhead when peak-time passenger rail services were over; the locations scrubbed were the Up Road between the 1 MP 550 yards to the 1 MP 233 yards; the process included applying orange cleanse to the rail followed by scrubbing the head of the rail with handheld rail scrubbers.
- 88 No contamination of the track was found prior to Clontarf Road Bridge (UBB5) 1MP 503 yards on the Up Road, see Figure 11.

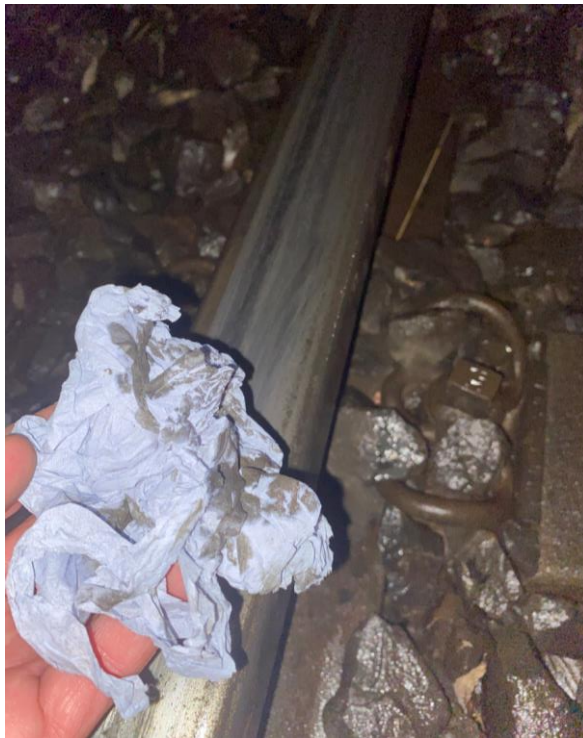
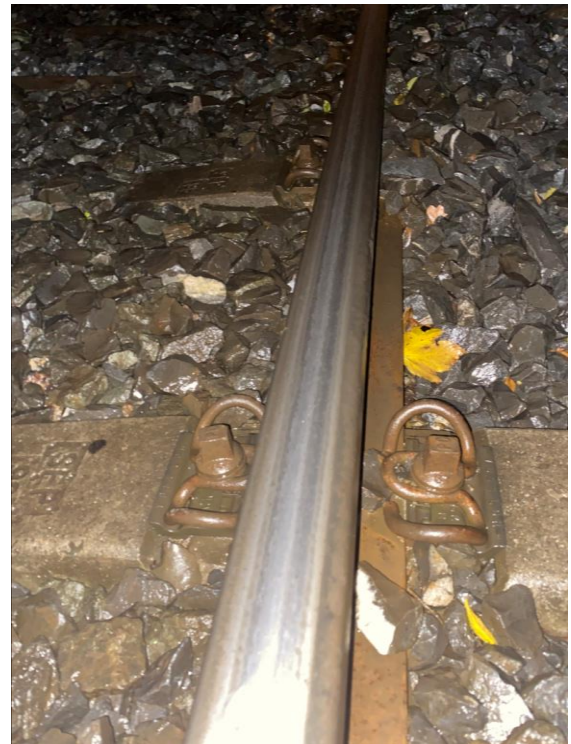
Figure 12 – Contaminated railhead on the Up Road

- 89 Track contamination was found on the Up Road past Clontarf Road Bridge and through Clontarf Road Station, see Figure 12.

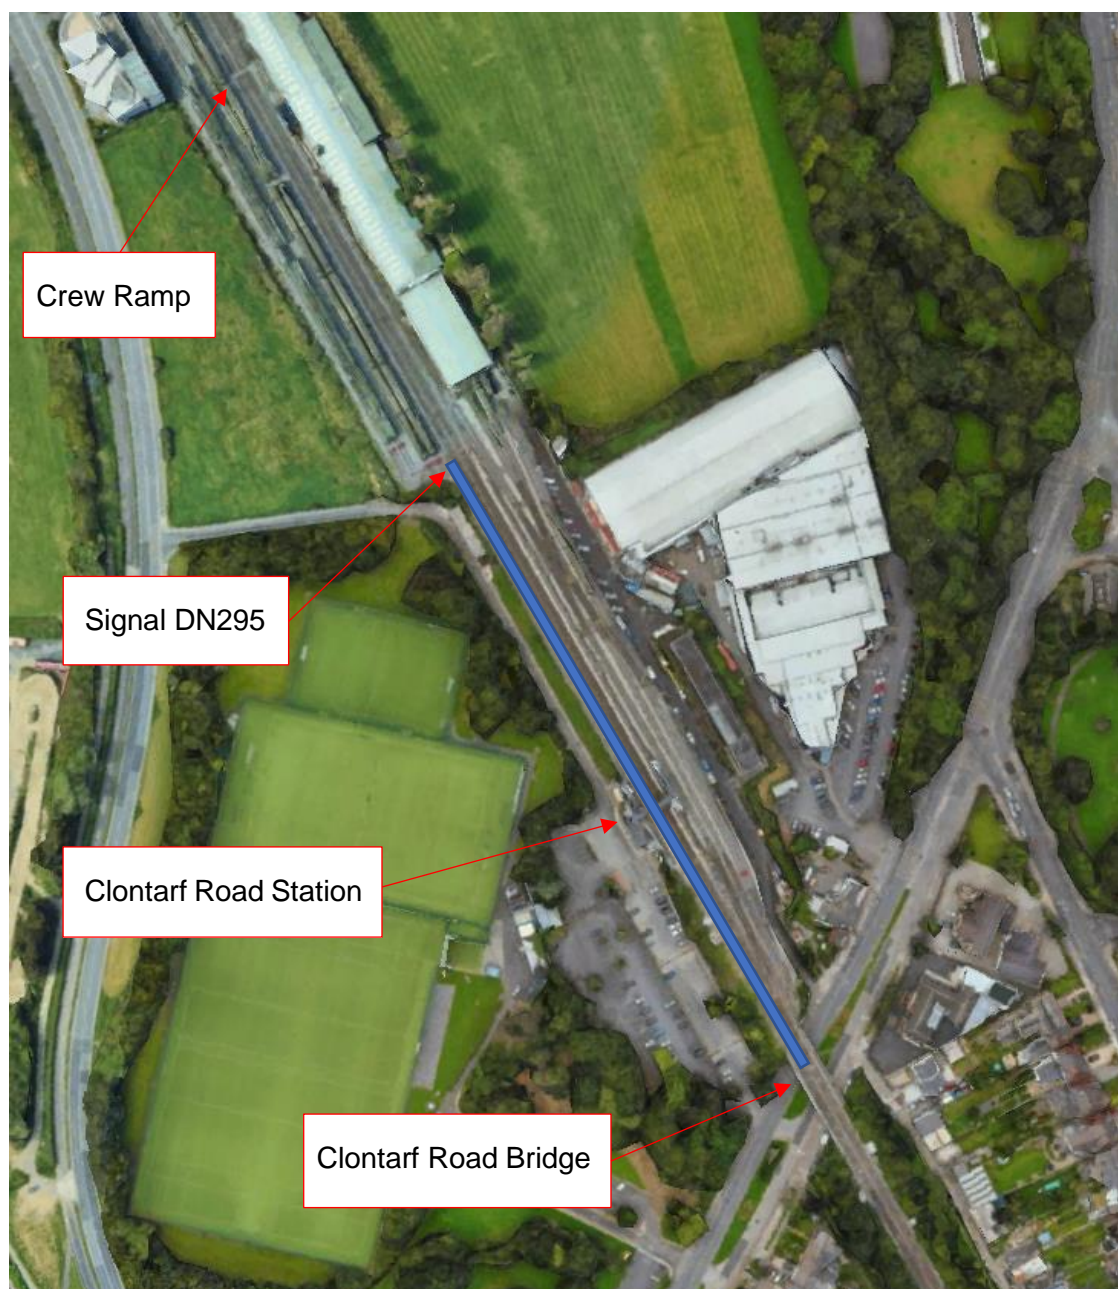
Figure 13 – LRA conditions identified post-incident

90 The following figure, Figure 13, indicates where the LRA conditions (blue line) were identified, post-incident.

91 The swabs taken were sent, by IÉ-IM, to be analysed by the Centre for Microscopy and Analysis, Trinity College, Dublin. The results of this analysis concluded that no organic residues were detected on the cloths. All of the sample residues were found to consist of silica and iron oxide.

- Safety Recommendation 2023001-05 – Iarnród Éireann Infrastructure Manager (IÉ-IM) Chief Civil Engineer (CCE) should consider, based on a risk-based approach, the introduction of *Traction Gel Applicators* (TGAs) at more locations.

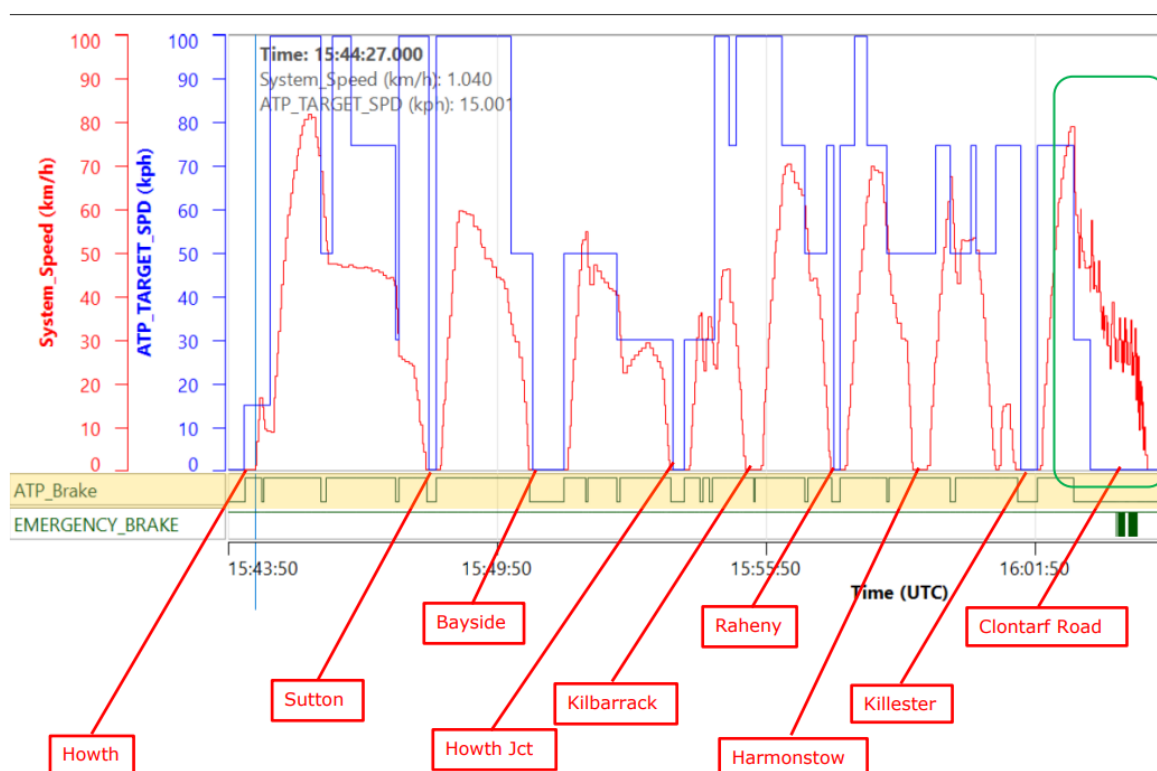
Figure 16 – Train E240 Actual Speed (Red Lines) and ATP Target Speed (Blue Lines)

140 A screen shot of the OTDR data, Figure 16, for Train E240's journey from Howth to Clontarf Road shows eighteen ATP penalty brake applications (highlighted orange, Figure 16) seven of which were at stations.

141 On eleven occasions the ATP penalty brake applied (highlighted orange, Figure 16)¹⁹, this was a result of the actual train speed (red lines, Figure 16) exceeding the ATP target speed (blue lines, Figure 16).

143 Driver E240 applied the emergency brake (green squares, bottom right of Figure 16) at the very late stages of the incident, note that the ATP was applying the emergency brake and the driver's intervention would have had no effect.

- Safety Recommendation 2023001-03 – IÉ-RU Chief Mechanical Engineer Department (CME) should upgrade the OTDRs on the 8500 Electrical Multiple Unit (EMU) fleet to the most up-to-date version, to ensure that digital signals are recorded for ATP penalty brake applications.

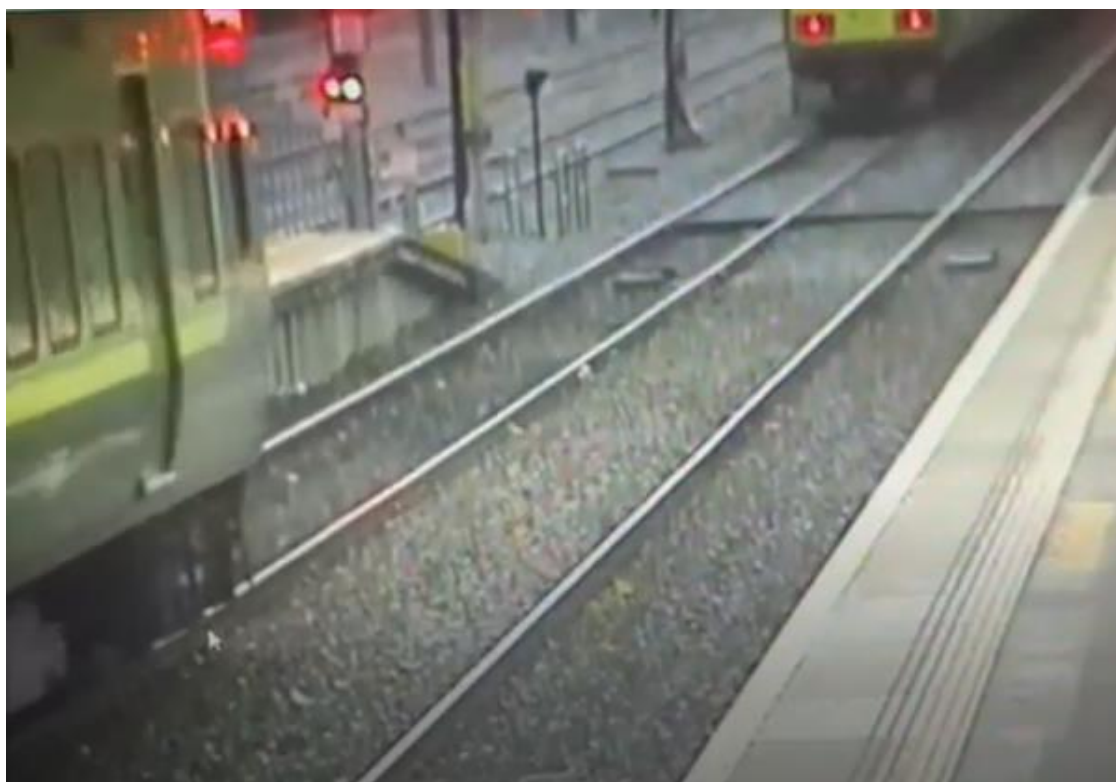
Figure 20 – Train E240 approaching Train E120

155 At 16:03:14 hrs Driver E240 rings the Central Signalman direct rather than making an emergency call through the Global System for Mobile Communications – Railway (GSMR)^{24,25} train radio. At 16:03:22 hrs the call connects and Driver E240 advises the Central Signalman that Train E240 had passed a signal (Signal DN287) at danger and was skidding towards the train that was at the Crew Ramp in Fairview (Train E120), Figure 20.

- Safety Recommendation 2023001-12 – IÉ-RU Ops should brief all drivers on the importance of making an open call in an emergency situation rather than calling the Signalmen direct.

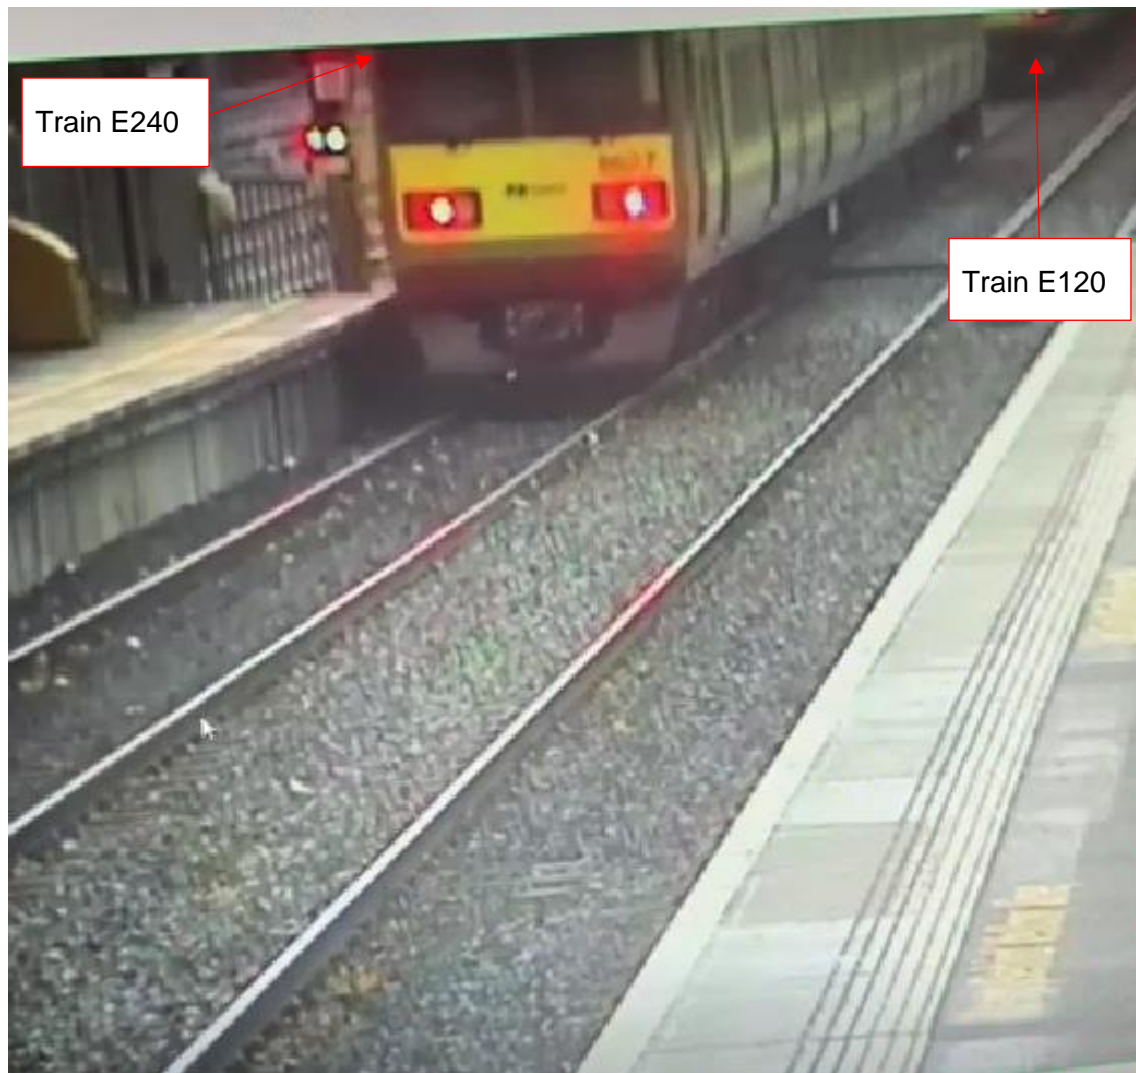
Figure 21 – Train E240 coming to a stop

- 156 The Central Signaller advised Driver E240 that he was going to hang up and contact the driver of the train (Driver E120b) at the Crew Ramp in Fairview; the Central Signaller hangs up at 16:03:56 hrs.
- 157 At 16:04:05 hrs the Central Signaller phones Driver E120b, the call connects at 16:04:11 hrs. Driver E120b confirmed that their train (Train E120) was moving, and the Central Signaller requested Driver E120b to keep moving.
- 158 Train E240 continued through Clontarf Road Station and also passed Signal DN295 (at the south end of Clontarf Road Station) at danger, travelled to within an estimated 5 m of Train E120, see Figure 21.

159 Train E240 came to a stop past Signal DN295, it is estimated that a collision with the rear of Train E120, was avoided by five seconds.
