**Railway Accident  
Investigation Unit  
Ireland**

## **INVESTIGATION REPORT**

**Collision of an RRV Dumper with a member of  
Iarnród Éireann infrastructure maintenance staff,  
Tivoli, Cork, 6<sup>th</sup> July 2022**

RAIU Investigation Report No: 2023-R003

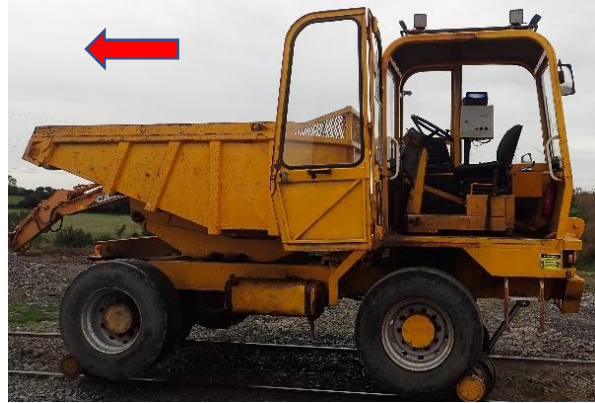
Figure 3 – Reverse driving configuration

50 Note how the view from the rear windscreen could become obstructed when the dumper is laden with materials in Figure 3. To compensate for this, there is a 120° angle camera (circled in Figure 4). The 120° angle (highlighted green in Figure 4) gives a 30° blind spot on both sides. The camera images are projected to a monitor situated at 90° to the RRVO's right-hand-side seated position while in reverse mode (circled and inset in Figure 5), the camera images only show live images and does not record i.e. the RRVO has to look to his right-hand-side to view the monitor.

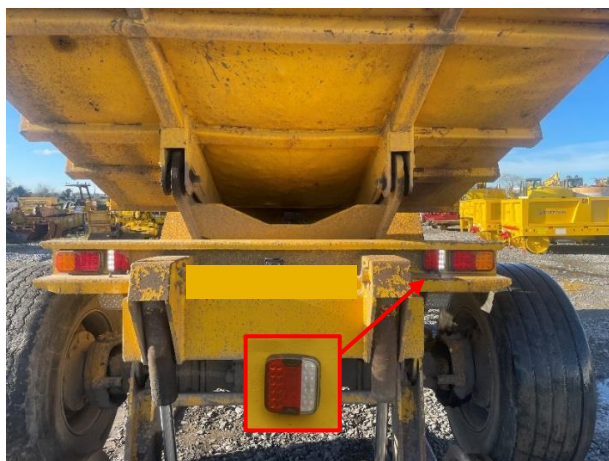
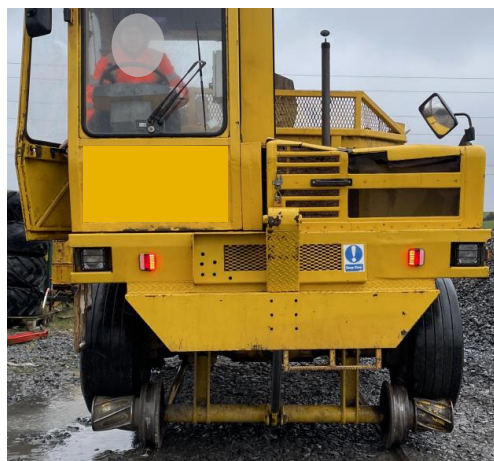
54 The RRVO configures the RRV's headlights and tail lights.

Note: The above would have been the configuration of the lights on the day of accident.

55 A post-accident inspection found the headlights and tail lights to be working.

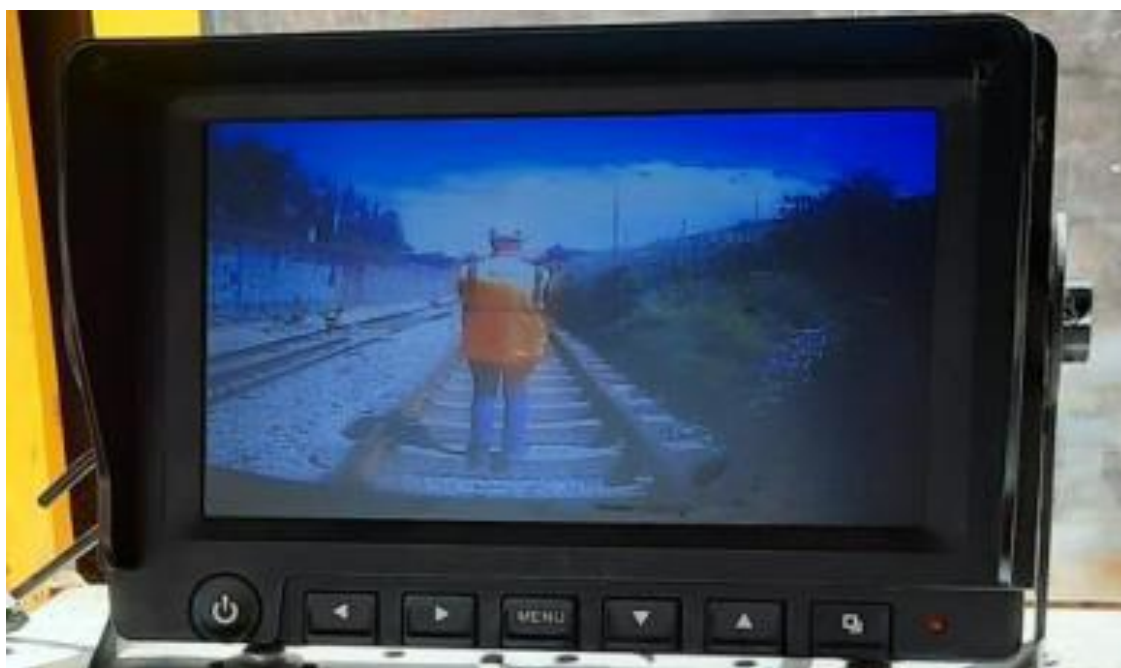
Figure 8 – Monitor view of person 3 m ahead (image taken by IÉ-IM)

56 The inspection also found the monitor to be working. The monitor gives a clear view of the five foot ahead of the RRV Dumper, while working in reverse.

57 Figure 8 shows the monitor displaying the view of a member of staff during an IÉ-IM re-enactment of the accident, in the five foot, 3 m ahead of the RRV Dumper. Note, the RRVO has to look to his right-hand-side to see the monitor (paragraph 50).

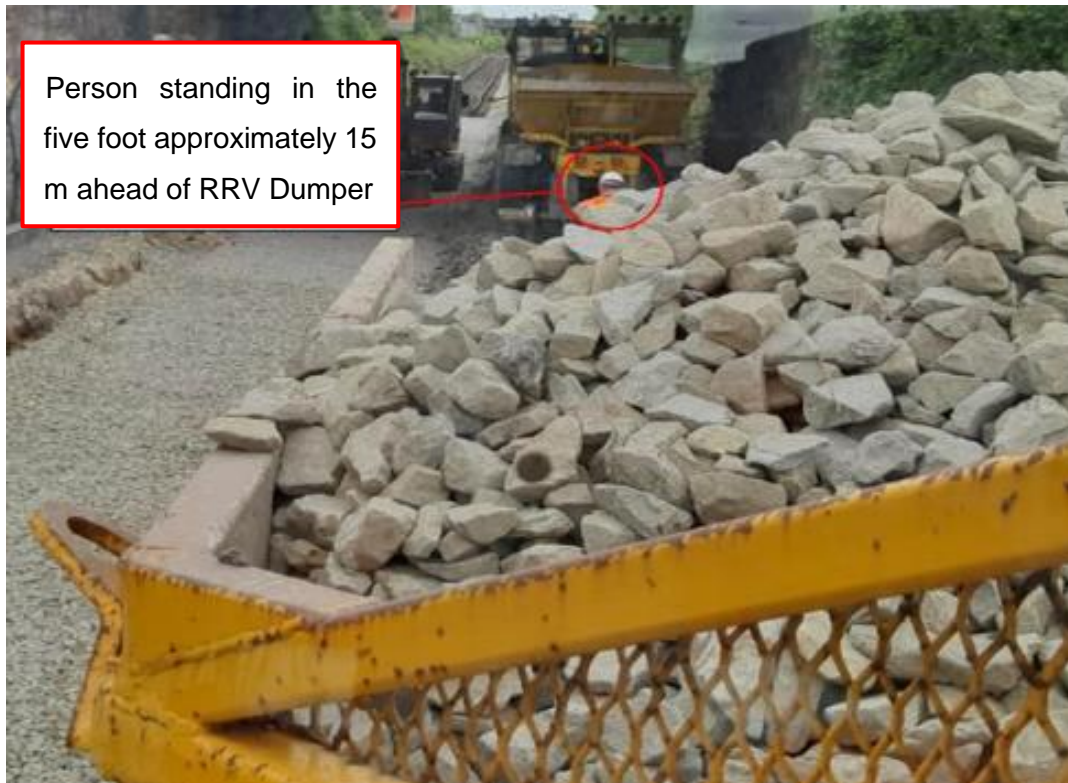
Figure 9 – RRVO's view looking out of the rear windscreen (image taken by IÉ-IM)

58 At the time of the accident the RRV Dumper was laden with stone ballast restricting the RRVO's view through the rear windscreen. The IÉ-IM re-enactment of the accident conditions identified that for the first 15 metres (m) the head of a person standing in the five foot could not be seen from the RRV Dumper cab in reverse mode over a bucket laden with stone ballast i.e. they become visible after 15 m (Figure 9).

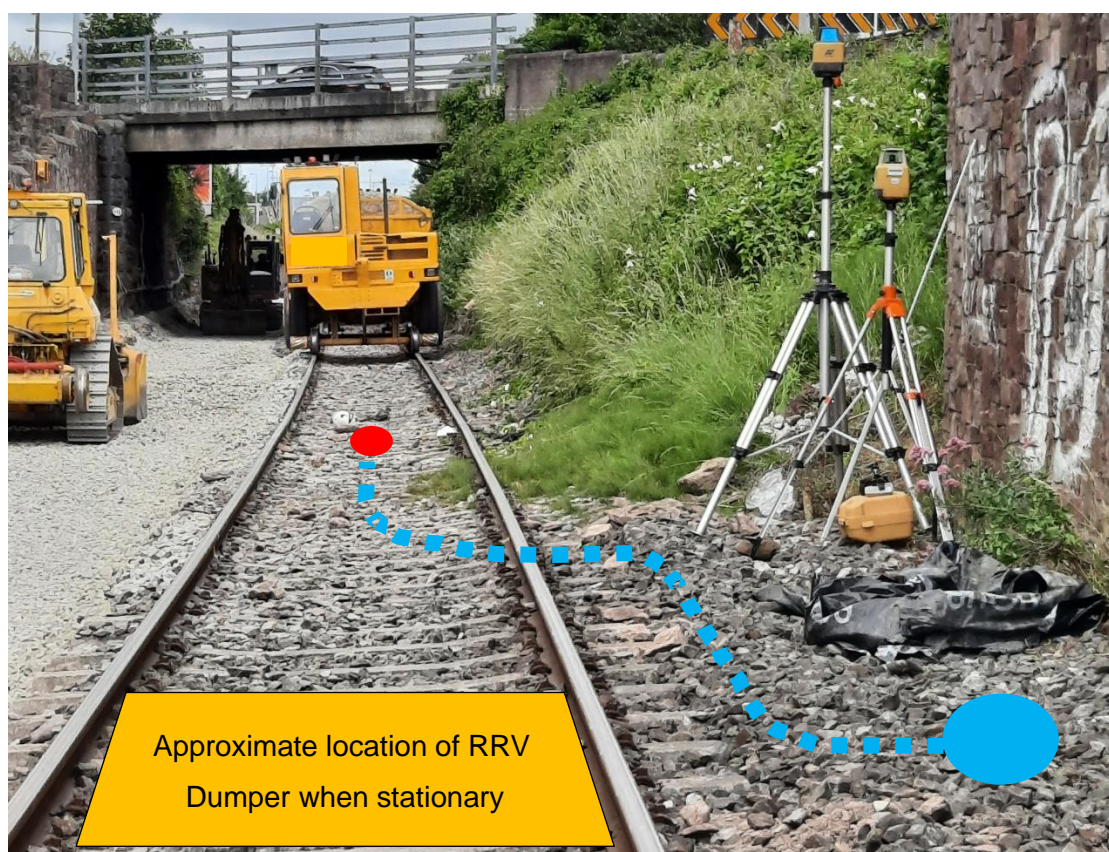
Figure 13 – Positions of Engineer 1 and RRV Dumper before and after collision (blue line indicates the route taken by Engineer 1, red dot indicates point of collision)

- 91 As the terrain in the cess became difficult, Engineer 1 looked around and behind to see if there was any movements of machinery and stepped into the five foot of the Up Line and continued walking with his back to the RRV Dumper (see Figure 13 for route taken by Engineer 1).
- 92 The RRVO moved forward slowly with the audible warning squawker sounding (paragraph 48, squawker sounds for reversing movement).
- 93 Engineer 1 could not hear audible warning squawker device over the noise of the other machinery (RRV Dumpers operating, and whacker plate operating nearby on the adjacent Down Line) and continued walking in the five foot unaware of the RRV Dumper approaching him from behind.

- 94 Engineer 1 walked for a few metres before feeling something striking his back, he turned around realised it was the RRV Dumper and instinctively decided to “go to ground” and lay as flat as possible in the five foot, knowing the RRV Dumper was going to travel over him. The RRV Dumper had travelled approximately twelve metres from its stationary position.

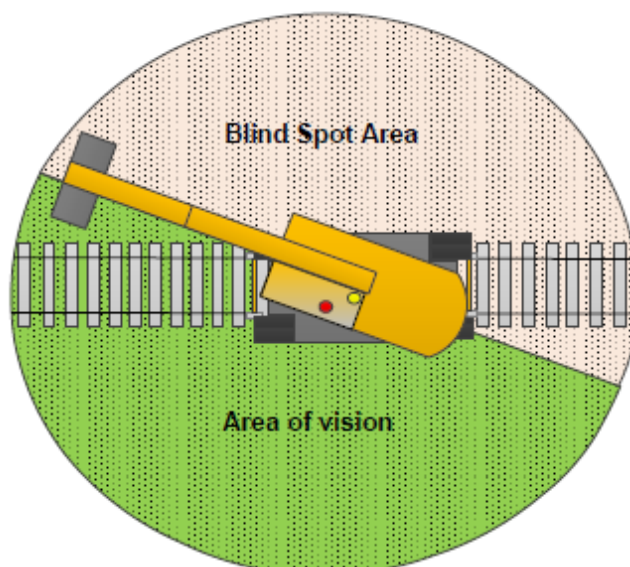
Figure 15 – Briefing Note IM.BN/02/2022 (Page 1)

Due to the size, weight and power of RRV's one major hazard is the operators restricted view of their surroundings and range of blind spots in which people and objects can be hidden from sight. Many RRV's have substantial blind spots, not only immediately behind the vehicle, but also alongside and immediately in front.

124 In terms of the issuing of Safety Notice including Briefing Note IM.BN/02/2022 on the 19<sup>th</sup> July 2022 (paragraph 117, Figure 15 and Figure 16). This document again highlights RRV blind spots and provides step-by-step instructions related to walking past and working in the vicinity of an RRV (in summary, permission must be sought from the PIC-RRV prior to making any movements). As a result, the RAIU does not consider a further safety recommendation is warranted in terms of staff movements where RRVs are on site (CaF-01 – CaF-04, paragraph 112).
