**Railway Accident
Investigation Unit
Ireland**

INVESTIGATION REPORT

Self-detrainment of passengers between Shankill & Bray,

RAIU Investigation Report No: 2023-R005

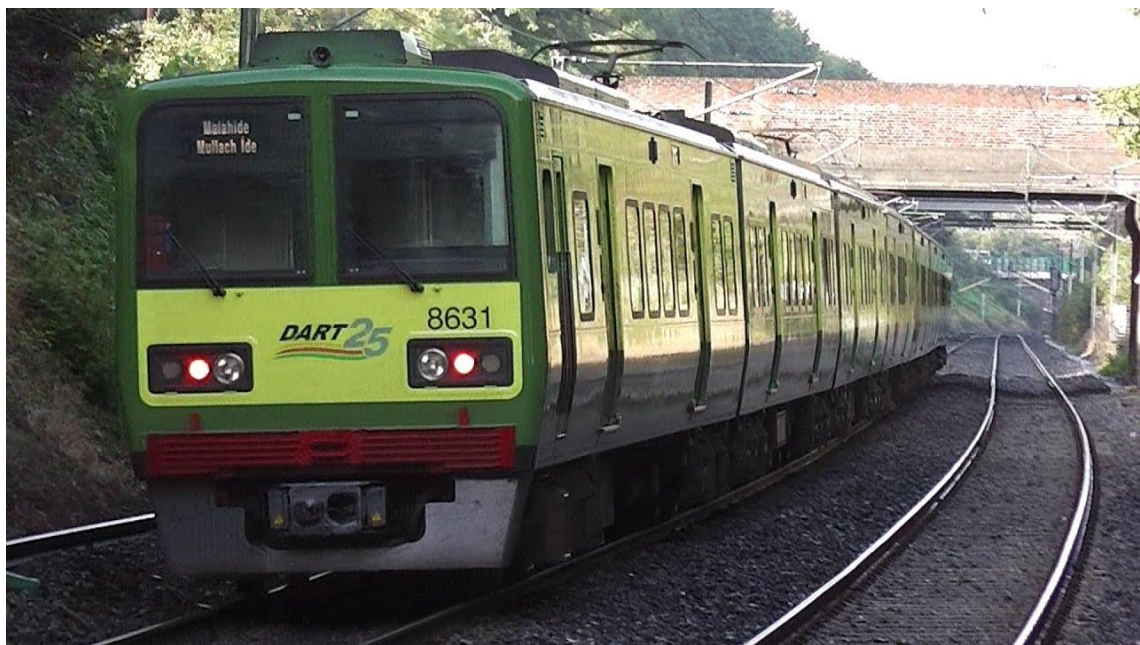
Figure 2 – Sealed windows

- 8 The air conditioning was off on Train E268 (unknown to the driver (Driver E268)), and as the windows were sealed (by design) there was no *forced* or *passive ventilation* on the

train, leading to increasingly uncomfortable conditions for passengers, with reports of some passengers suffering from symptoms of *heat exhaustion*.

- 76 Air conditioning is available on the 8520 EMU fleet only, with sealed windows which cannot be opened to ensure air conditioning efficacy, see Figure 2 for example of windows on 8520 EMU. Of the five trains involved in the occurrence only one train, Train E268, was fitted with air conditioning.

- Safety Recommendation 2023005-02 – IÉ-RU Head of Health & Safety should include a check that the heating, ventilation and air conditioning systems are operational in the train preparation instructions;

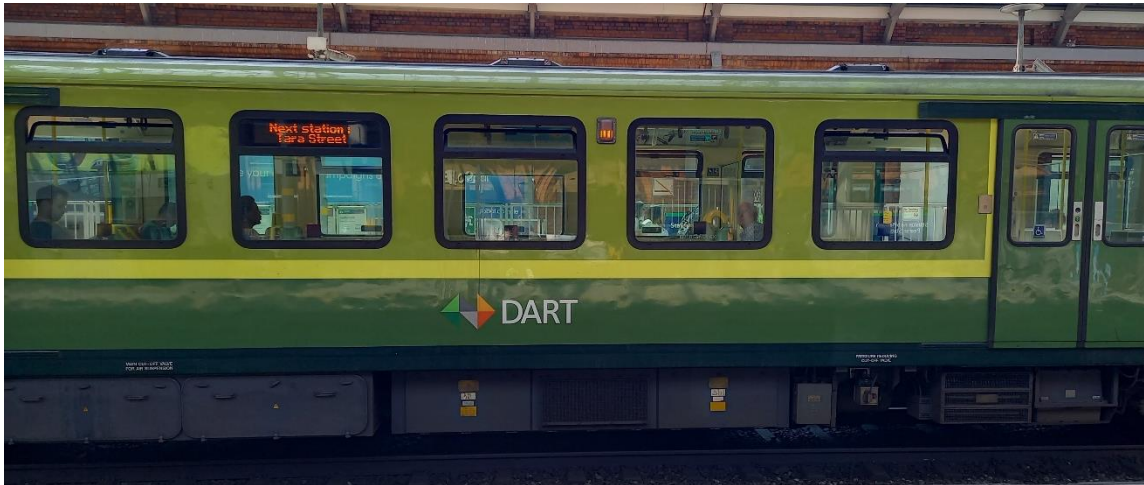
Figure 3 – 8100 hopper windows

- 77 All other EMU trains have conventional heating and openable windows (hopper windows) in the saloon. Not all windows are openable.

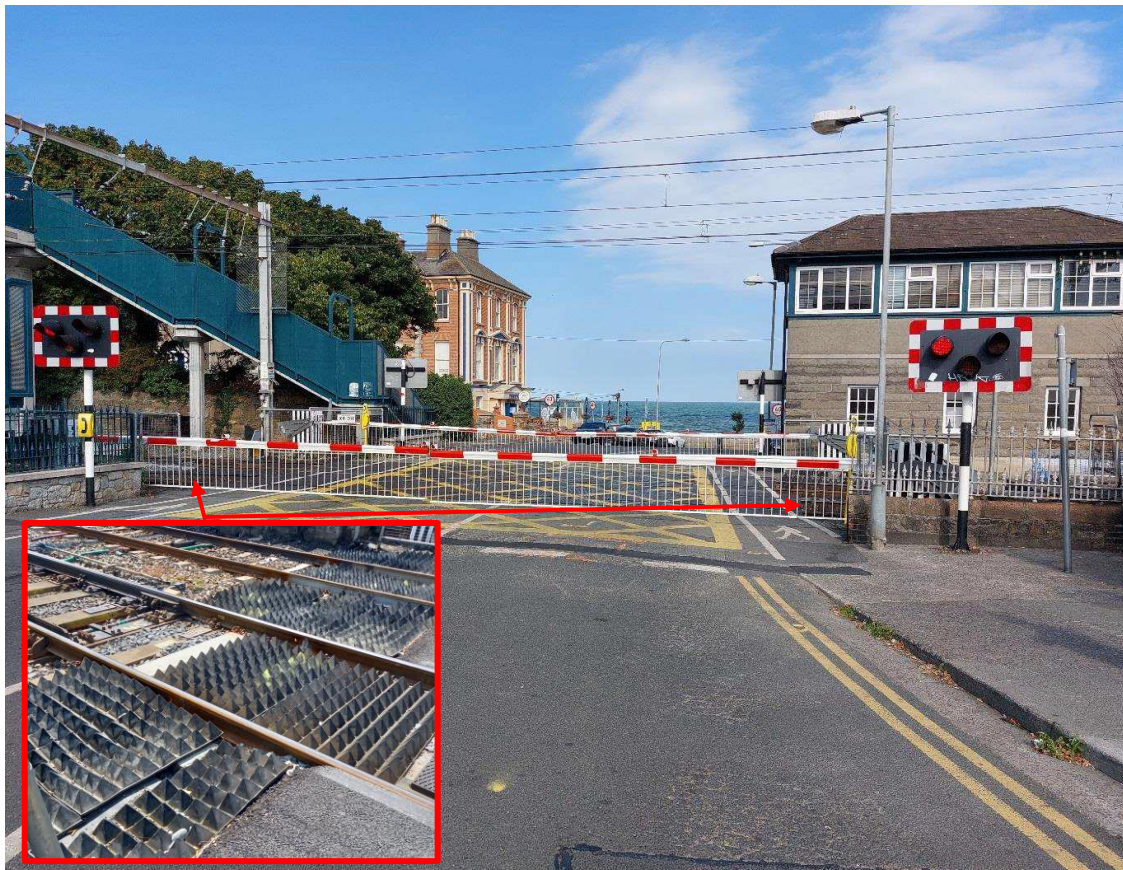
Figure 5 – Trespass guard locations at Level Crossing XR011

92 Level Crossing XR011 is a CCTV type crossing located at the north end of Bray Station (see Figure 4), on Quinnsborough Road. Level Crossing XR011 is normally controlled from CTC. A local control panel is provided in the former signal cabin adjacent to the level crossing (see Figure 4), the level crossing was in local control on the day of the incident (paragraph 101). Level Crossing XR011 has trespass guards, on the edges of the road to deter people from walking onto the railway line (see inset in Figure 5).

- Safety Recommendation 2023005-18 – IÉ-IM should develop procedures for the evacuation of passengers over trespass guards, these should then be included in the Train Evacuation Briefing Notes and other relevant documents which reference evacuations;

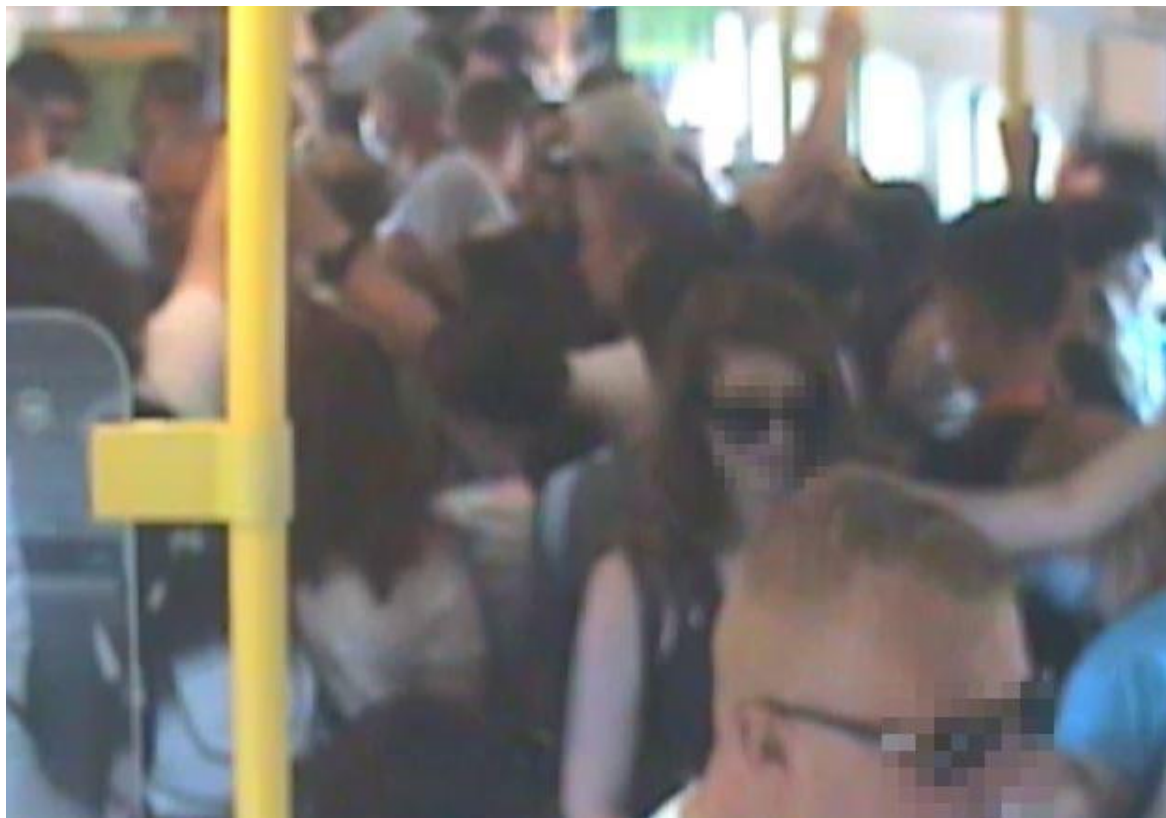
Figure 10 – Still from carriage where first door was opened
Image taken from IÉ internal CCTV

- 189 The air conditioning Train E268 was off and with windows sealed there was no forced or passive ventilation on the train. Train E268 was close to maximum capacity.
- 190 The majority of passengers had travelled from Connolly and were on the train for sixty-two minutes (the scheduled time for Connolly to Bray is forty-six minutes) when the train came to a stop at Signal BR28.
- 191 Driver E268 did not make any passenger announcements as he believed this was not a requirement if the delay was less than five minutes (an “ice-breaker announcement was required within two minutes and a more detailed announcement after five minutes).
- 192 The following events are what can be determined by the RAIU as to what likely happened in the carriage where the first doors were opened (see Figure 10 for still of saloon CCTV of carriage involved).

193 At this stage Train E268 was stopped at Signal BR28 (Figure 9) for approximately five minutes³¹. On the carriage, the heat was so great that condensation built up on the carriage ceiling and began to drip onto passengers³². A teenager, who was feeling faint with the heat, began to vomit (both symptoms of heat exhaustion), and due to the crowding was vomiting over other passengers, some of whom tried to disperse, and others tried to come to her assistance. In the commotion, a baby began screaming and turning red, and the baby's father, Pax 1³³, in a "distressed", "agitated" and "frustrated" state (irritability is a symptom of heat exhaustion), opened a passenger door by means of the emergency opening device, forcing open the door, and passengers began self-detraining.
