**Railway Accident
Investigation Unit
Ireland**

**Failure of a Current Return Cable on a Luas Tram,
Connolly Stop,
25th October 2022**

RAIU Investigation Report No: 2023-R004

Published: 13th October 2023

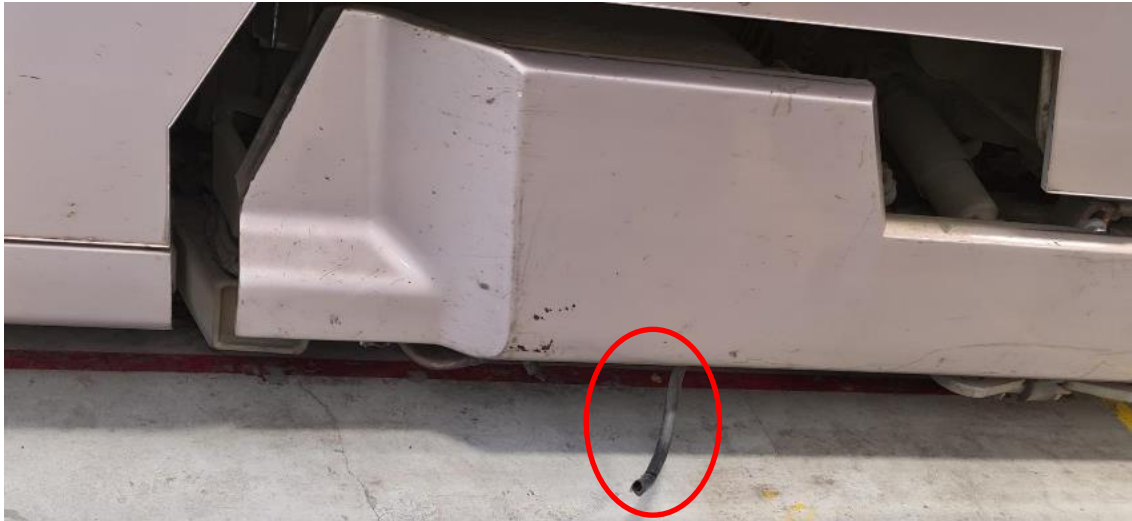
Figure 9 – S1 Current Return Cable

66 On inspection of Tram 3012 on return to the Red Cow Maintenance Depot, the S1 Current Return Cable was found to be severed and was protruding from the underframe of Tram 3012 (on Bogie 176DU), see Figure 9.

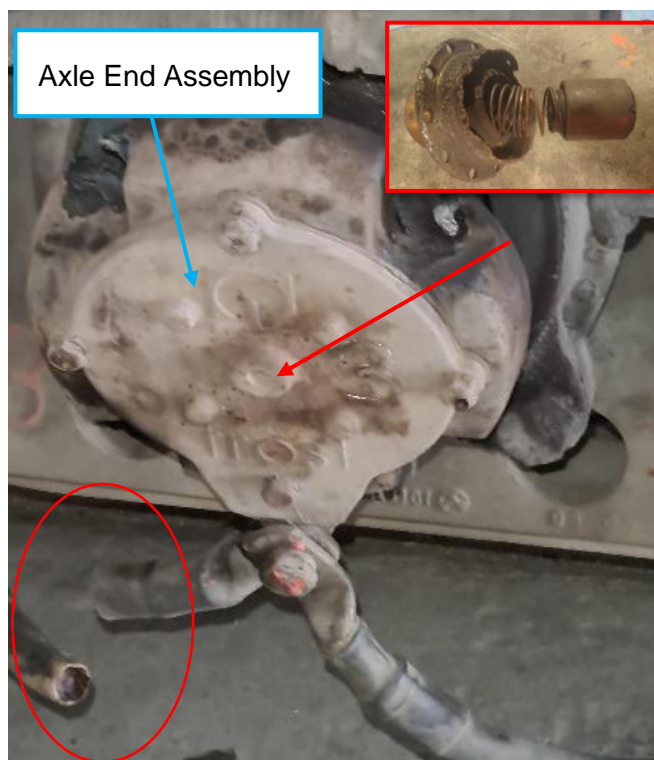
Figure 10 – S3 Earth Shunt Cable & S3 Axle End Assembly

67 Further inspection on Bogie 176DU identified the failure of S3 Earth Shunt Cable (circled, Figure 10) and heat damage to the S3 Axle End Assembly (inset red, Figure 10).

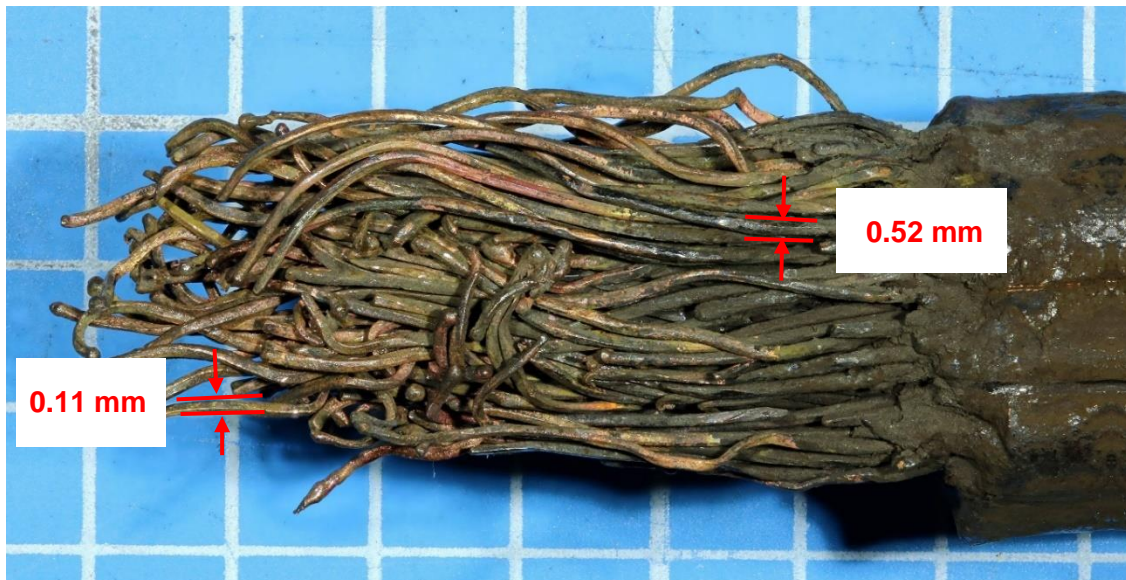
Figure 12 – Failed Current Return cables strands

- 73 Close to the failure, the cable strands were much thinner and more angular in cross-section indicating the cable strands had been mechanically stretched, thinned and deformed against adjacent cable strands, prior to the failure (see Figure 12). Many of the cable strands showed a “chisel edged” form at their points of fracture, consistent with tensile overloading. Many cable strands showed a globule (small round particle of substance) of previously molten and re-solidified material at the point of fracture (Figure 12).

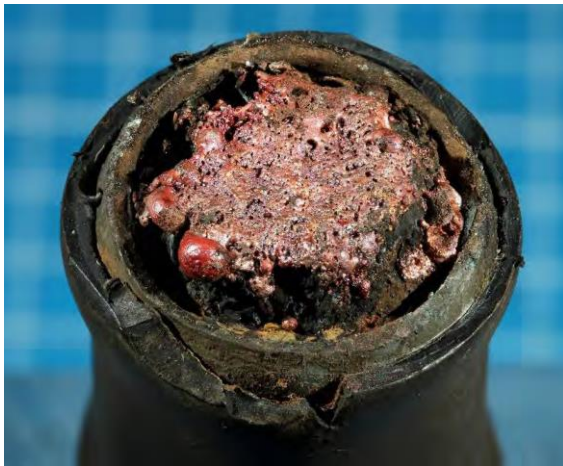
Figure 13 – Lug side fused cable strands

- 74 On the Lug side of the S3 Earth Shunt Cable, the cable strands had fused together across almost the entire cross-section of the cable (see Figure 13).
- 75 On the opposite side, fusing of the cable strands was evident in the central region but much less on the outer regions (see Figure 14), with the cable strands failing at different lengths with evidence of stretching and deformation before failure (similar to S1 Current Return Cable failure). The fusing indicated that *arcing* had taken place between the two sides.

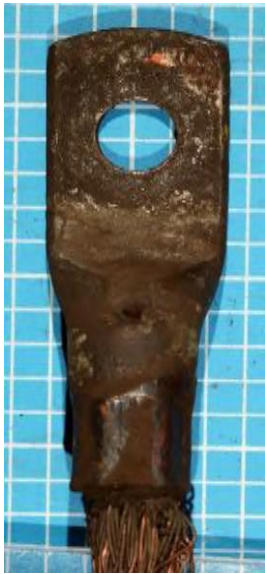
Figure 15 – S1 Current Return Cable Lug closest to the failure

77 The Lugs associated with the S1 Current Return Cable (Figure 15) and S3 Earth Shunt Cable (Figure 16) closest to the failed ends were significantly more soiled and oxidised than those away from the failure (Figure 17); suggesting that there may have been higher than normal electrical resistance through the connections at the failed ends of the cables; which in return resulted in a degree of resistive heating.

- Safety Recommendation 2023004-01 – TDLR should develop supporting guidance documentation to WI-00814, Preparation before and after wheel turning, to include information on possible defects e.g. photographs of unacceptable levels of corrosion on the Current Return and Earth Shunt cable Lugs;

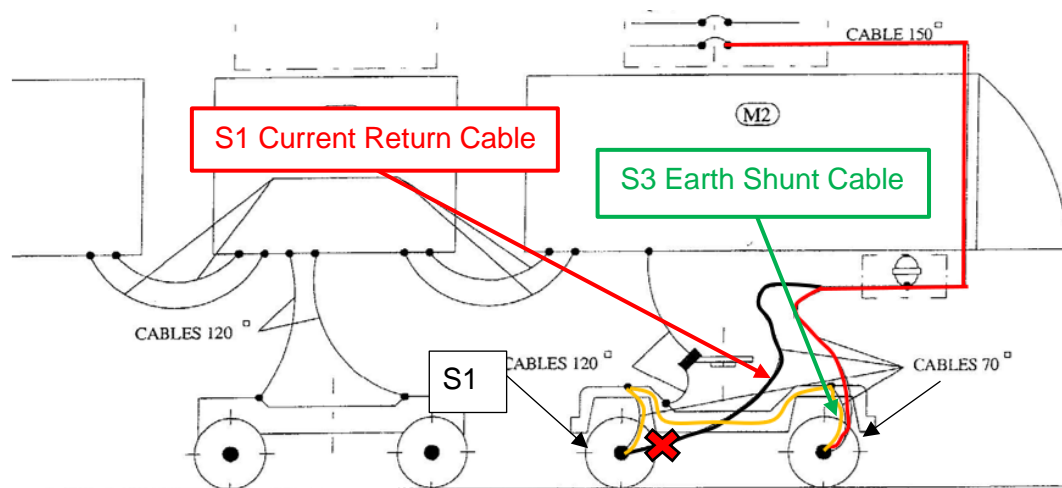
Figure 18 – Electrical path after the S1 Current Return Cable failed (yellow)

81 Separation of the S1 Current Return Cable (red X in Figure 18) caused the electrical load on the S3 Earth Shunt Cable to instantaneously increase significantly as there was no path for the current to flow through and the current found an alternative path (from that set out in paragraph 44 and Figure 3) through the S3 Earth Shunt, through Bogie 176DU and into the S1 Axle End Assembly via the S1 Earth Shunt Cable (see new path coloured yellow in Figure 18).

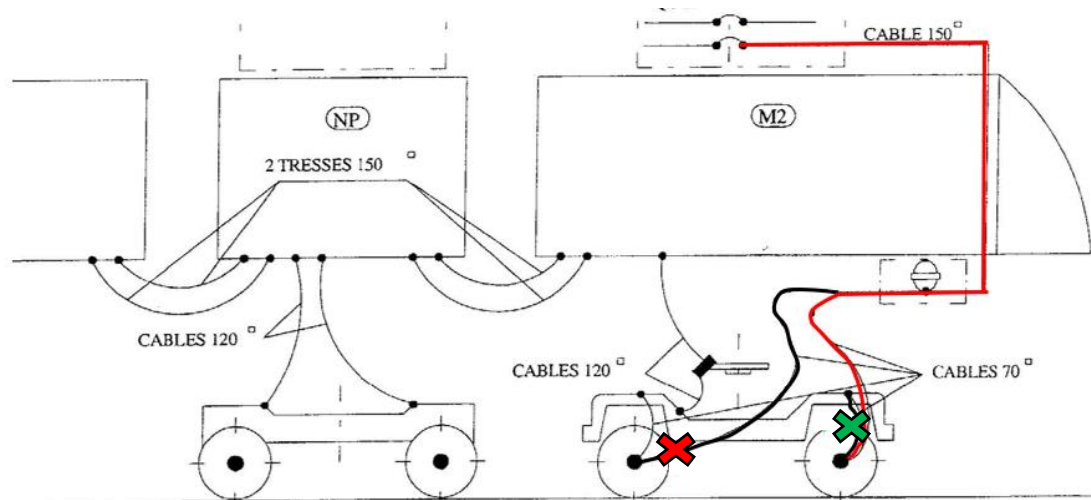
Figure 19 – Electrical path after the S3 Earth Shunt Cable failed

83 When the S3 Earth Shunt Cable failed (green X in Figure 19), the only alternative was for all the current to return through the S3 Axle End Assembly which resulted in an overload of S3 Axle End Assembly and extensive heat damage to the assembly.
