**Railway Accident
Investigation Unit
Ireland**

INVESTIGATION REPORT

**Broken Rail near Emly,
County Tipperary, 22nd February 2023**

RAIU Investigation Report No: 2024-R002

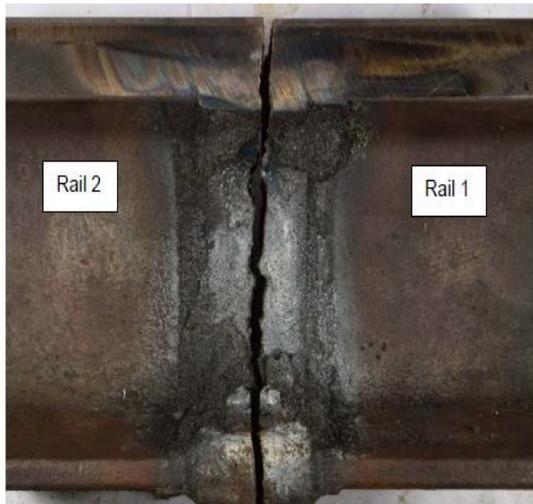
Figure 9 – Transverse failure through the centreline of the weld

87 A visual inspection indicated that the weld suffered a complete transverse failure through the approximate centreline (see Figure 9) with a pronounced hollow in the foot of the rail which was partially filled with luting sand (see Figure 10).

- 94 The Serco Report concluded that the weld broke rapidly from defects introduced during Thermit SoW-5. Their position within the last areas to solidify combined with the appearance indicated that the defects were likely to be either a hot tear or *shrinkage*¹¹. Both are similar in appearance.

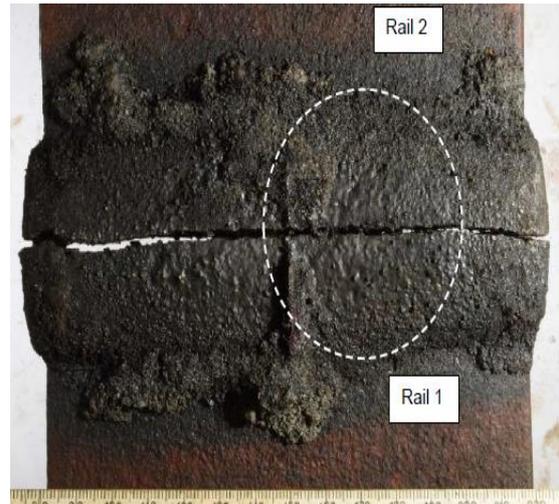
Figure 10 – Underside hollow partially filled with luting sand

- 95 The Serco Report states that “it appears some difficulties¹² had been experienced obtaining a good fit between the mould and the rail, as copious amounts of luting sand had been applied especially around the underside of the foot where an unusual ‘hollow’ had been created in the final weld. There is no evidence to suggest that this had become a leakage path for hot metal during the welding”.

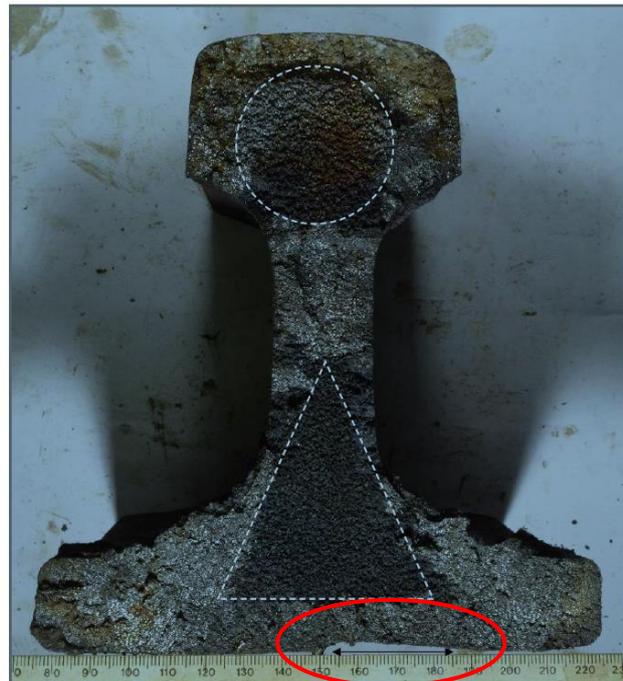
Figure 11 – Fracture face

88 There were two darkly oxidised regions found on the fractured face of the weld. A triangular shaped area at the foot/web transition and a circular area occupied most of the head area (see Figure 11). The remainder of the weld showed signs of a recent rapid *overload*. And a “hollow” was present across the bottom of the foot (circled red in Figure 11).

89 The oxidised region at the web/foot transition were described in the report as consisting of a multitude of sharp “peaks” with dendritic areas in the “valleys” although towards the apex, entirely dendritic regions were also identified in the web indicative of shrinkage. This was distinctly different to the surrounding fracture that was crystalline in nature.

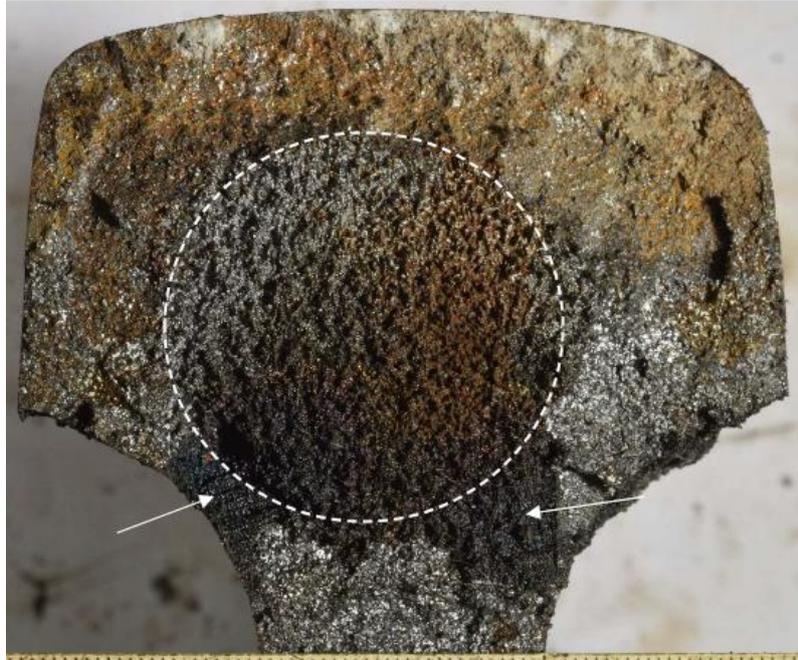
Figure 12 – Fracture face in the head

90 The defect in the head (see Figure 12) had a similar appearance to the triangular feature in the web/foot (sharp peaks and dendritic valleys). Unlike the triangular feature only a proportion of the surface was darkly oxidised with the remainder either being lightly oxidised or relatively free of oxidation.

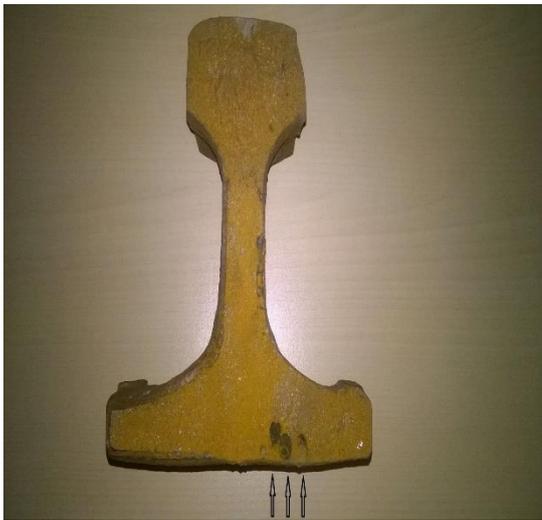
Figure 13 – Rail foot defects

133 On the 14th January 2015, there was a broken rail on the Heuston (Dublin) to Cork line on the Down Line located at 89 miles and 445 yards from Heuston. The Thermit SoW-5 weld failed due to gas entrapped within the metal forming holes. The break was from the porosity holes (see arrows in Figure 13) in the weld at the base of the rail foot. There was no sign of any crack propagation from any of the inclusions and it was a fast break. The rail was stressed and welded on the 11th November 2009 and tested by the Ultrasonic Operator on the same night and no defects were found. *Sperry Vehicle Testing* carried out Ultrasonic testing on the 2nd of April 2014 and no defects were found.

134 The conclusion of the broken rail report on the 14th January 2015 was that the proximity of the defects that broke the weld in the foot area would be outside the ultrasonic range of the Sperry Vehicle Testing equipment and the inclusions in the web (see arrows in Figure 14) and head areas would most likely be undetectable, or too small.
