**Railway Accident
Investigation Unit
Ireland**

INVESTIGATION REPORT

Operational Irregularity, Clontarf Road, 1st May 2024

RAIU Investigation Report No: 2025-R001

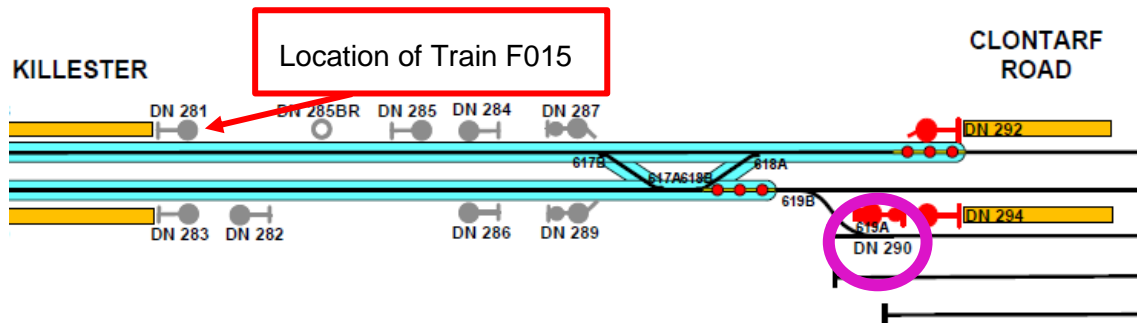
Figure 12 – 01:08:14 hrs to 01:08:16 hrs

- 111 At 01:08:14 hrs the Signaller commenced the process of granting the T3 Possession by applying the reminder appliance on Signals DN290, leading out of the north end of Fairview Depot (see Figure 12). Two seconds later, at 01:08:16 hrs, Train F015 passed Signal DN281 at Killester, see Figure 12.

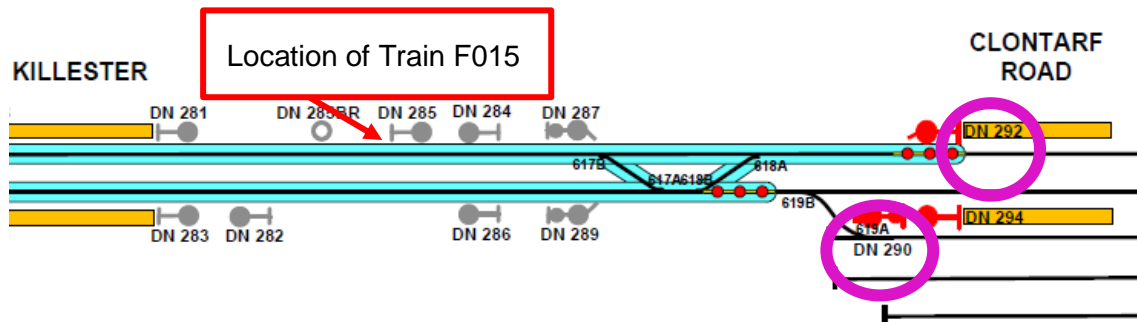
Figure 13 – 01:08:26 hrs to 01:08:38 hrs

- 112 At 01:08:26 hrs, reminder appliance placed on Signal DN292, on the southbound line, Clontarf Road Station, see Figure 13.

- 113 At 01:08:38 hrs, Train F015 was on the *berth track* of Signal DN285, see Figure 13.

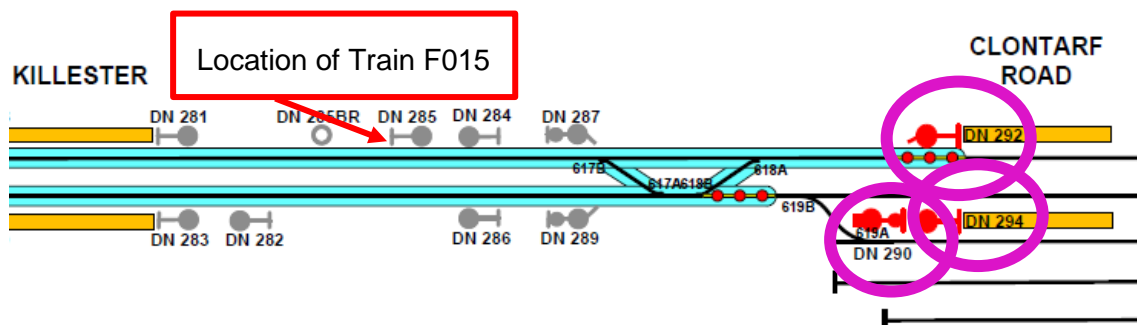
Figure 14 – 01:08:41 hrs

- 114 At 01:08:41 hrs, a reminder appliance is placed on Signal DN294, northbound line, Clontarf Road Station, see Figure 14.

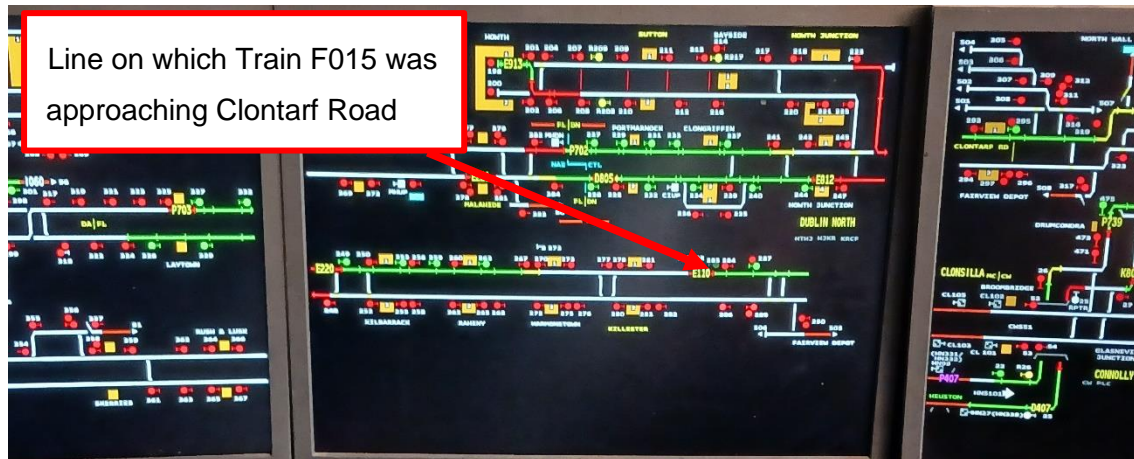
Figure 15 – Train F015's approach to Clontarf Road station on the overview screen

- 115 This was the last reminder appliance to be placed by the Signaller, track blocks were not applied to act as a reminder of the extent of the T3 Possession¹⁰ (paragraph 38).
- 116 Train F015 would have been continuously visible on the overview screens, see Figure 15, whilst these tasks were performed.

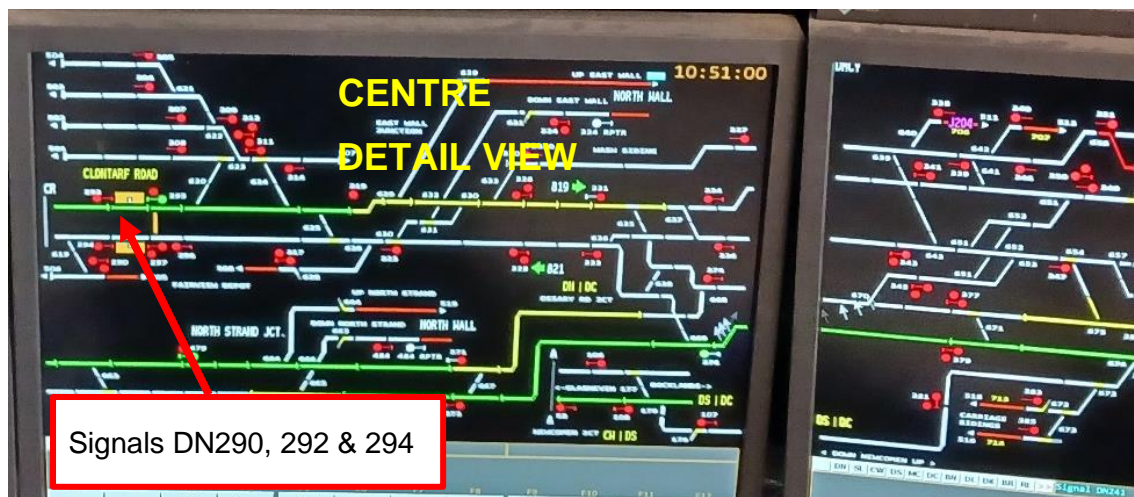
Figure 16 – Possible screen view for the Signaller

- 117 At the time of the last reminder appliance being placed for Signal DN294 (paragraph 114), assuming that this interlocking area was selected to do this, the Signaller's attention would have been centred on the middle of the three lower screens (see Figure 16). At this time, Train F015 would have been visible, but only on the lower part of the left-hand side detail view screen i.e. the Signaller would have to look at the screen on the left to see Train F015.

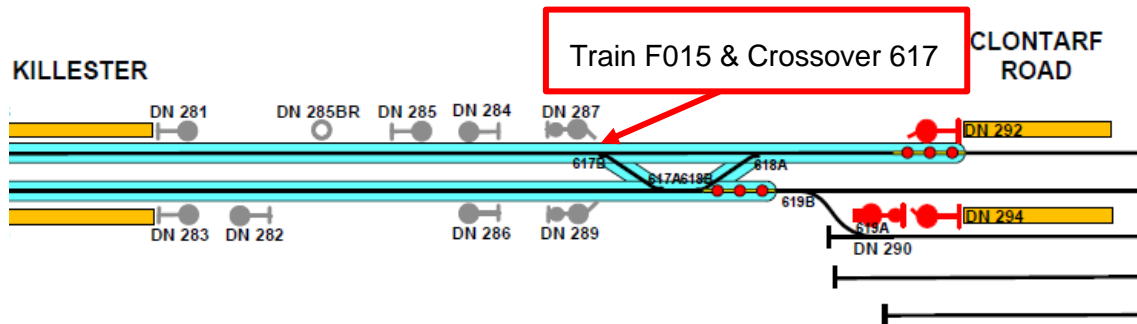
Figure 17 – 01:09 hrs

120 During the time of the call, Train F015 passed Signal DN285 and Signal DN287 and was now approaching crossover 617 (see Figure 17).

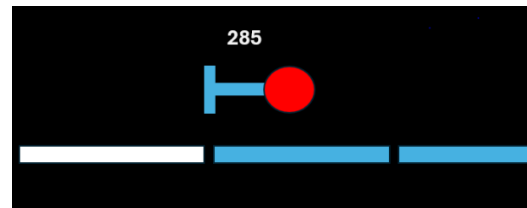
Figure 18 – A reminder appliance icon and track block and track block applied.

141 The key features of the Central Workstation relevant to arranging T3 Possessions are reminder appliances and track blocks (paragraphs 38 and 40); with reminder appliances used on the night of the incident (paragraphs 111, 112, 114), see Figure 18 for how this would be displayed on the Central Workstation.

142 Had the Signaller used the track block function, the Signaller would have had to select and block each track section of the lines under T3 Possession, meaning, the Signaller would have had to click on the track section Train F015 was on, and so would have been very likely to have seen Train F015, and so stopped the process of arranging signal protection.
