**Railway Accident  
Investigation Unit  
Ireland**

## **INVESTIGATION REPORT**

**Signal Passed at Danger, Keellogues Level Crossing,  
13<sup>th</sup> August 2024**

RAIU Investigation Report No: 2026-R002

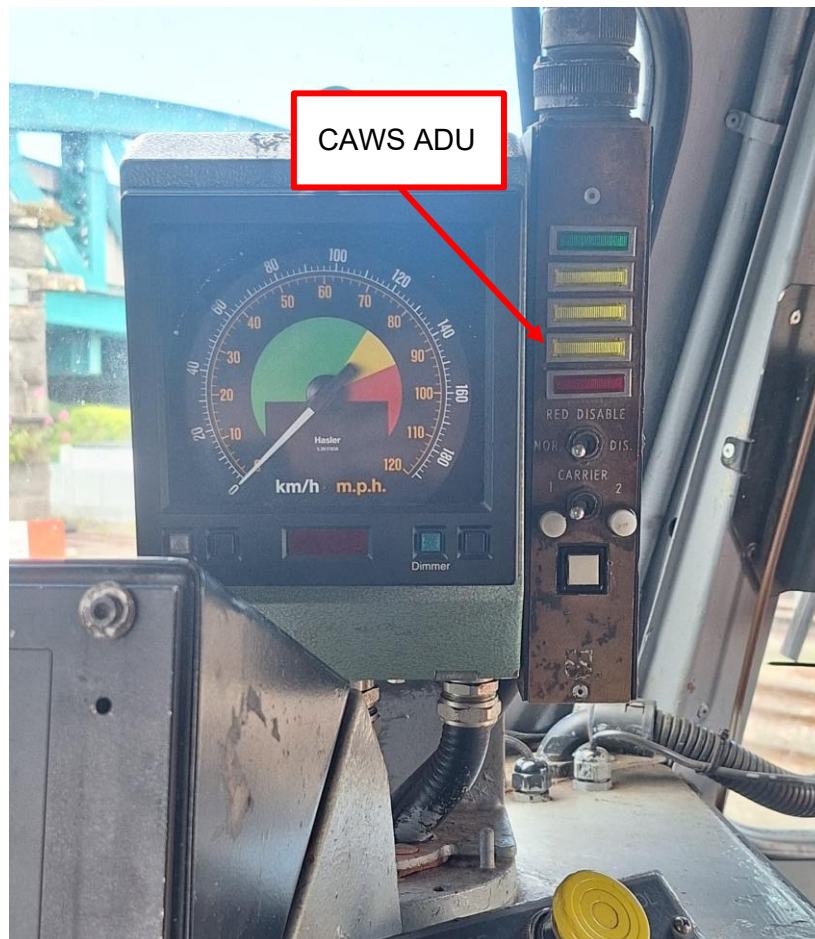
Figure 3 – CAWS ADU in a Class 071 locomotive

26 The CAWS works by repeating the aspects shown by the lineside colour light signals on an Aspect Display Unit (ADU) inside the driver's cab (see Figure 3). The ADU continuously displays the aspect that was shown by the previous signal until updated approximately 350 m before the next signal. The ADU then displays the aspect shown by that signal. Each time a signal showing a restrictive aspect (double yellow, single yellow or red) is encountered on a fitted route, an audible warning is sounded which must be cancelled by the driver.

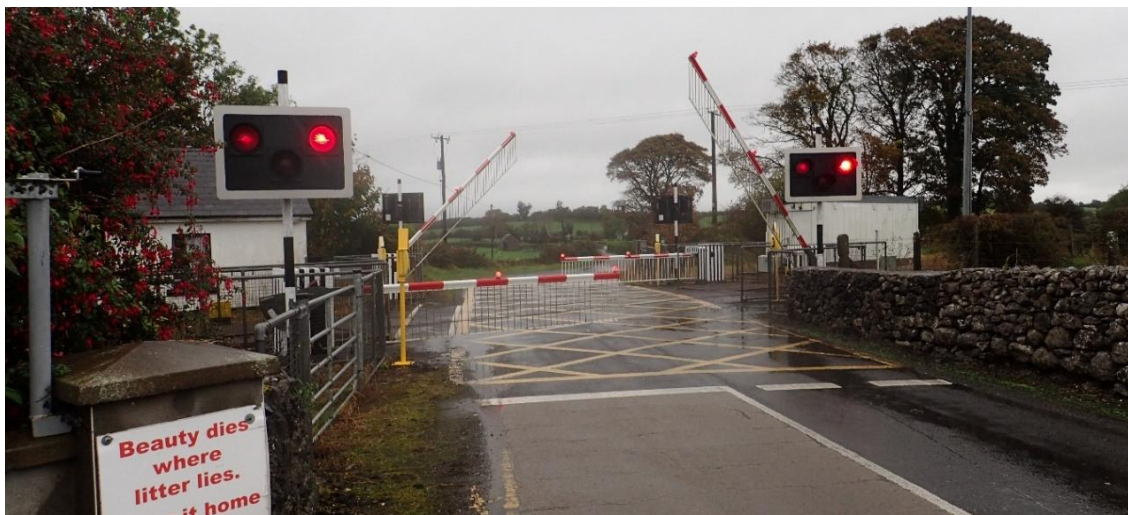
Figure 4 – LC XX011

- 32 LC XX011 (see Figure 4) is a *mid-section closed circuit television (CCTV) crossing* located at 148 3/4 MP<sup>4</sup>.
- 33 LC XX011 is on a regional road where the road speed limit is 80 km/h.
- 34 LC XX011 is protected by traffic light signals, audible warning devices and full barriers.

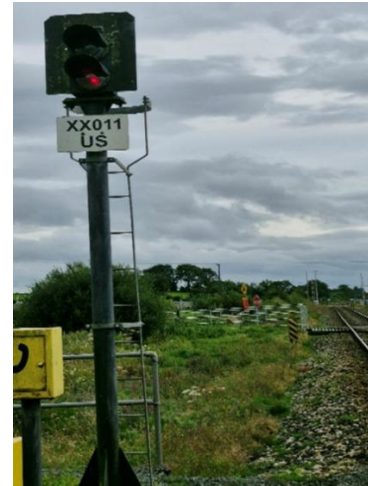
Figure 5 – Signal XX011 US

41 Signal XX011 US is visible for a distance of approximately 650 m on approach. The required reading distance for the signal was also calculated to be 286 m.

42 The position of the signals was not contributory to the incident.
