**Railway Accident
Investigation Unit
Ireland**

INVESTIGATION REPORT

Investigation into two near miss events involving track workers at Bray Tunnels

RAIU Investigation Report No: D2026-R003

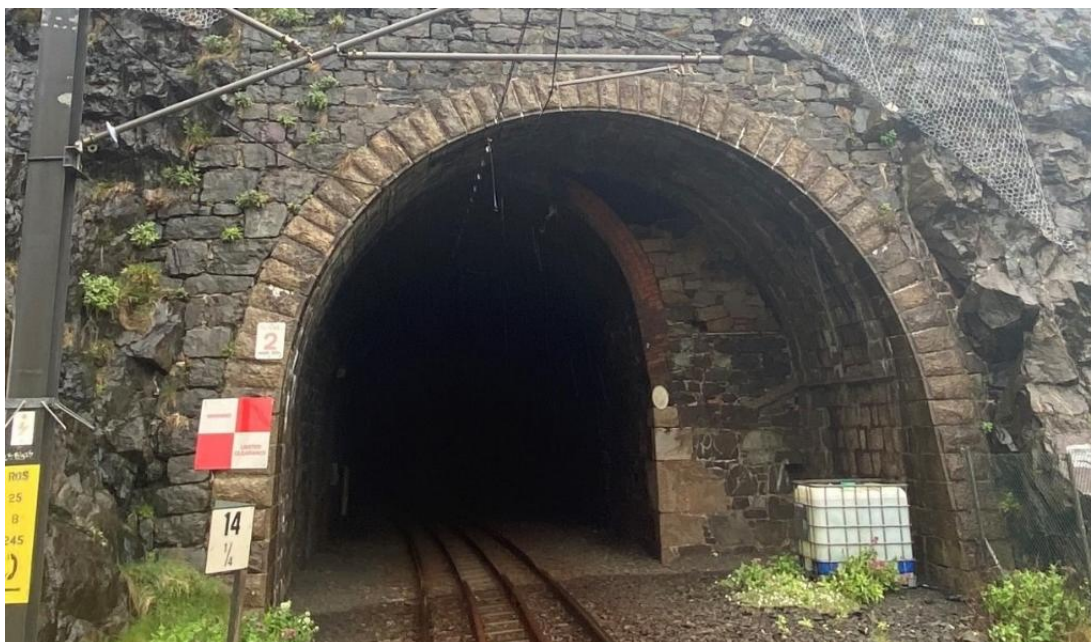
Figure 2 – Bray Tunnel No. 2 viewed from the southern *portal*

- 36 Bray Tunnel No. 2 is located on the single-track railway between Bray and Greystones where the railway runs along the cliff face through a series of four tunnels; Bray Tunnel No. 2 is 135 metres (m) long, see Figure 2.

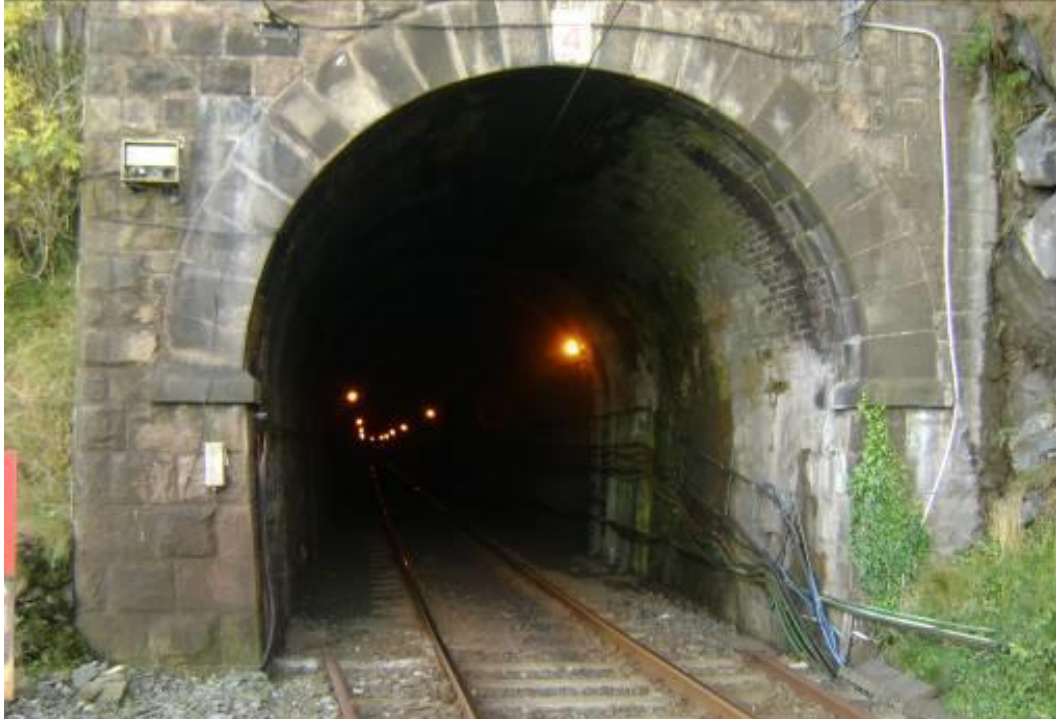
Figure 3 – Bray Tunnel No. 4

- 37 The line runs above the cliff face through a series of four tunnels with Bray Tunnel No. 4 being located nearest to Greystones.
- 38 Bray Tunnel No. 4 is a single bore tunnel and is 992 m with limited clearances, refuges are provided at regular intervals.

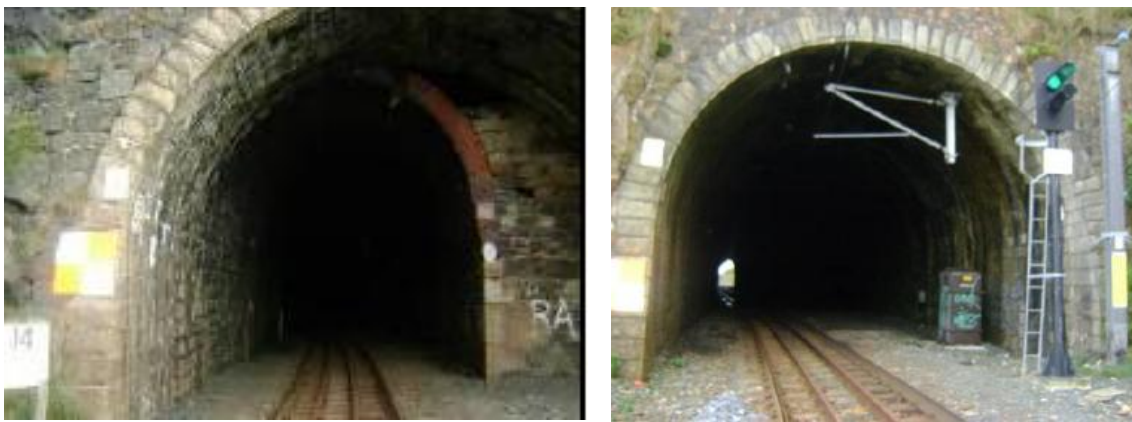
Figure 6 – Tunnel No. 2 portals (note the difference in bore widths)

65 The Patrol Length Features Form includes photographs for each portal of the Tunnel No.2, see Figure 6.

66 For Bray Tunnel No. 2, the Patrol Length Features Form states “do not enter any tunnel unless fully equipped which must include sufficient lighting”. Of note, for track patrolling and when working, it states that “You must attempt to set up green zone as per Section B Part 6 of the Rule Book; if green zone is not available set up red zone for lone working”.

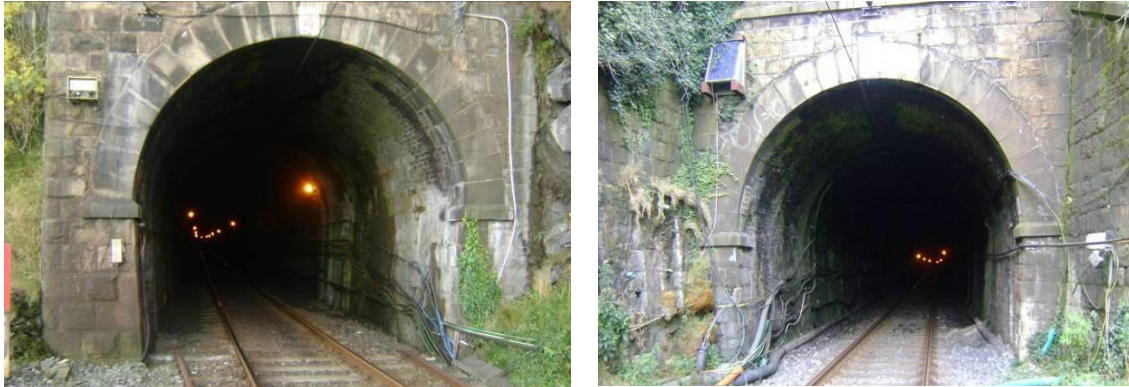
Figure 7 – Tunnel No. 4 portals

67 At Bray Tunnel No. 4, the Patrol Length Features Form includes photographs of each portal, see Figure 7.

68 The Patrol Length Features Form identifies the safe system for entering Bray Tunnel No. 4 by identifying the hazards associated with the locations and making some notes in relation to track patrolling and working. The hazards are identified, for entering the tunnel, are as follows: severe curve; public interface overhead; trespassers; train strike; slip, trip and fall; fall from height onto cliff face; broken fencing; OHLE; overhead hazards from public throwing objects onto track; and overhead hazards from debris falling from cliff face.

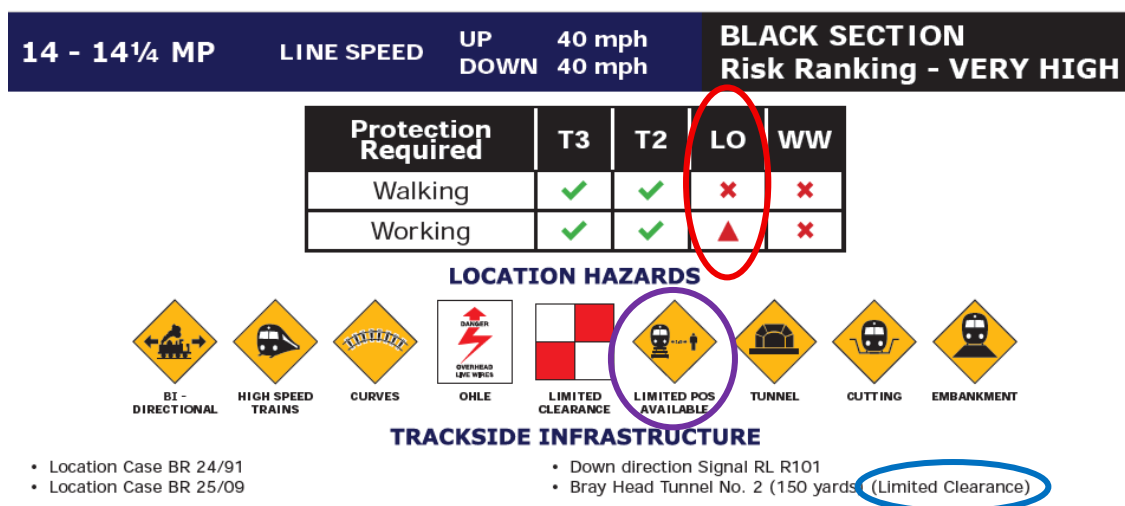
Figure 9 –TAI section for Bray Tunnel No. 2

78 The quarter mile section including Bray Tunnel No. 2 is illustrated in Figure 9, identifying location, line speed, risk ranking, protection required for the location, locational hazards and trackside infrastructure.

79 The risk ranking for the location is very high risk; noting limited clearance is a location hazard and that that the tunnel is specifically identified as having areas of limited clearance (circled in blue in Figure 9) and area of limited positions of safety (circled in purple in Figure 9).

80 In terms of protection requirements, it identifies that a T3 Possession, T2 Protection and Lookout Protection (LO) are permitted when working (circled in red in Figure 9) but must only be undertaken with the requirements/ elements of IÉ Rule Book (last bullet, paragraph 75).

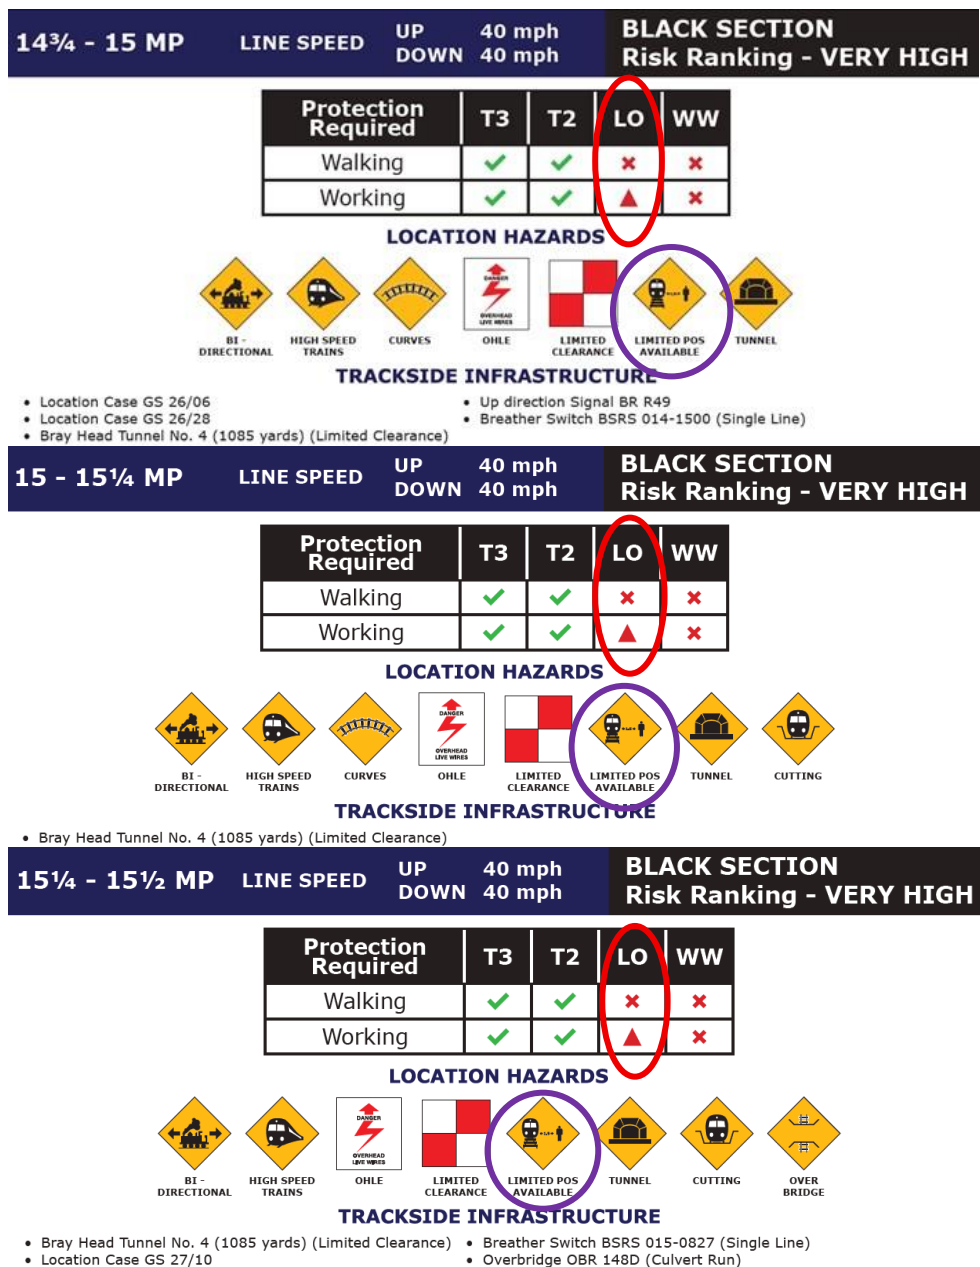
Figure 10 – TAI sections for Bray Tunnel No. 4

81 The quarter mile sections which reference Bray Tunnel No. 4 are illustrated in Figure 10.

82 The risk ranking for the location is very high risk; noting limited clearance is a location hazard and the tunnel is specifically identified as having areas of limited clearance (circled blue in Figure 10) and limited positions of safety (circled purple in Figure 10).

83 In terms of protection requirements, it identifies that T3 Possession, T2 Protection and LO are permitted when working (circled in red in Figure 10) but must only be undertaken with the requirements/ elements of the IÉ Rule Book (last bullet, paragraph 75).

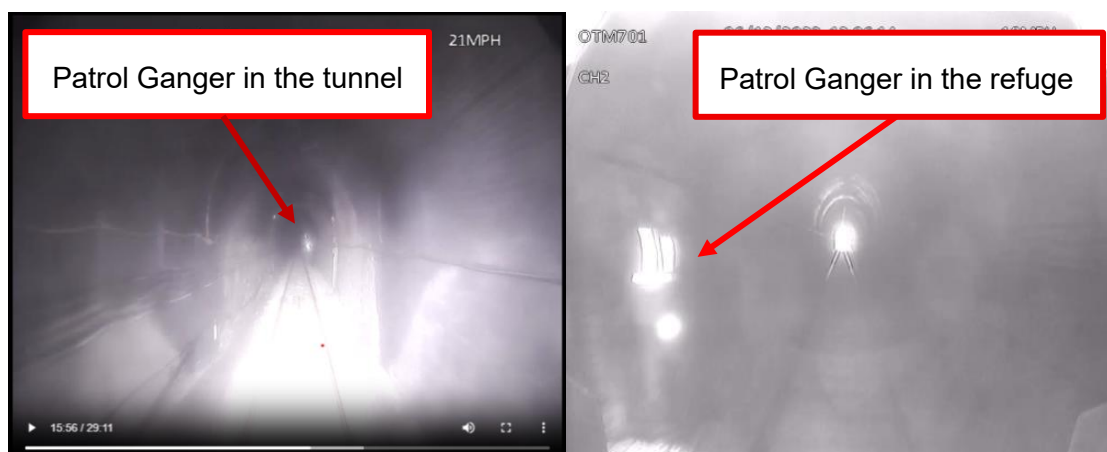
- 119 On seeing Train Y683, the Patrol Ganger moved to a nearby refuge inside the tunnel between eight and ten seconds before the train arrived, see Figure 13. The Patrol Ganger acknowledged the driver of Train Y683.

Figure 13 – FFCCTV and rear facing images showing the Patrol Ganger in the refuge (Note the image recording was inverted left to right at the time).
