Railway Accident Investigation Unit

Report

**Report into the Collision at Level Crossing XN 104 between
Ballybrophy and Killonan on the 28th of June, 2007**

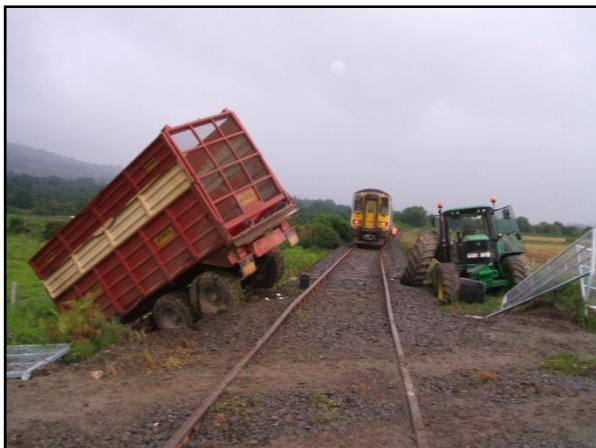
Figure 3 – Location of Tractor, Trailer & Train

The tractor and trailer uncoupled. The tractor struck the crossing fencing and came to a stop on top of the adjacent signalpost, parallel to the railway line on the same side as the field from which the grass was being harvested, facing towards Ballybroughy. The trailer came to a stop in the ditch on the opposite side of the railway line, at an angle of approximately 60° to the railway line. The train was not derailed and came safely to a stop 81 m beyond the crossing. The trailing door leaf of the leading left side door of carriage 2753 was detached from the train and was located in the ditch beside the trailer. There was a train driver, ticket checker and 11 passengers on board the train at the time of the incident. The positioning of the train, tractor, trailer and door leaf can be seen in figures 3 and 4.

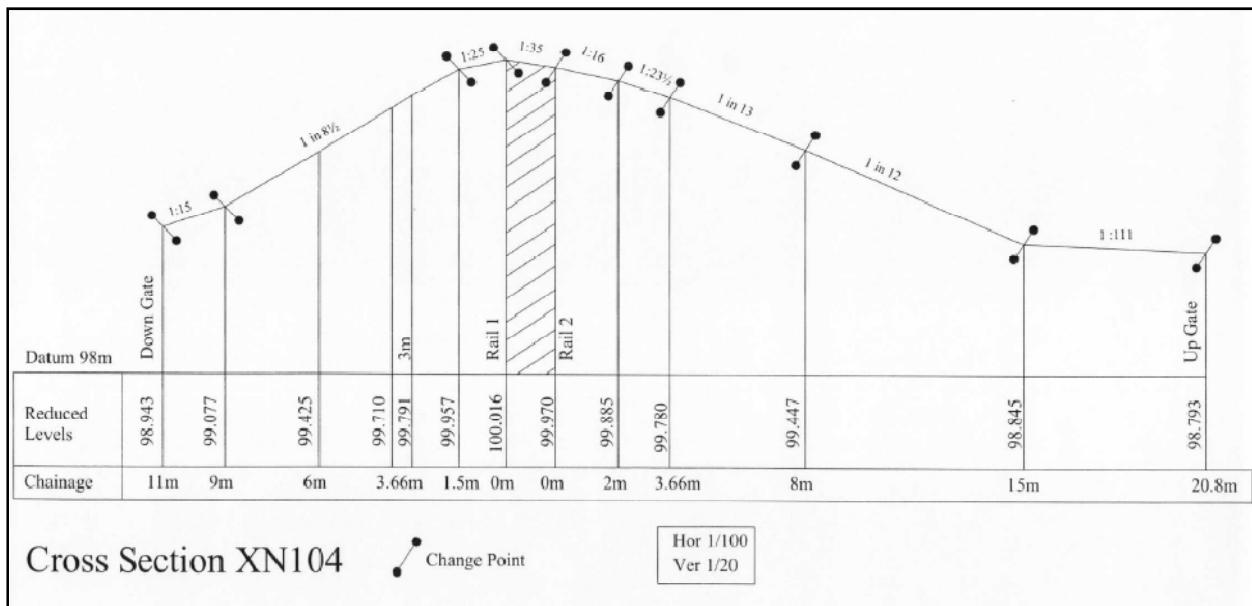
Figure 5 – Gradient Profile of XN 104 (Iarnród Éireann, 2007)

The gradient profile of the crossing can be seen in figure 5, this shows the rising gradients on both approaches to the crossing. On the Killonan side of the crossing there are deep ditches on either side. The approaches from the public road and the field can be seen in figures 6 and 7 respectively.

The 1990 report (Iarnród Éireann, 1990) identifies the desirable gradient for the approach to crossings from a distance of 5 m. This recommends a gradient of 1 in 10. The gradient on the approach to the crossing on the Down side is in excess of this.

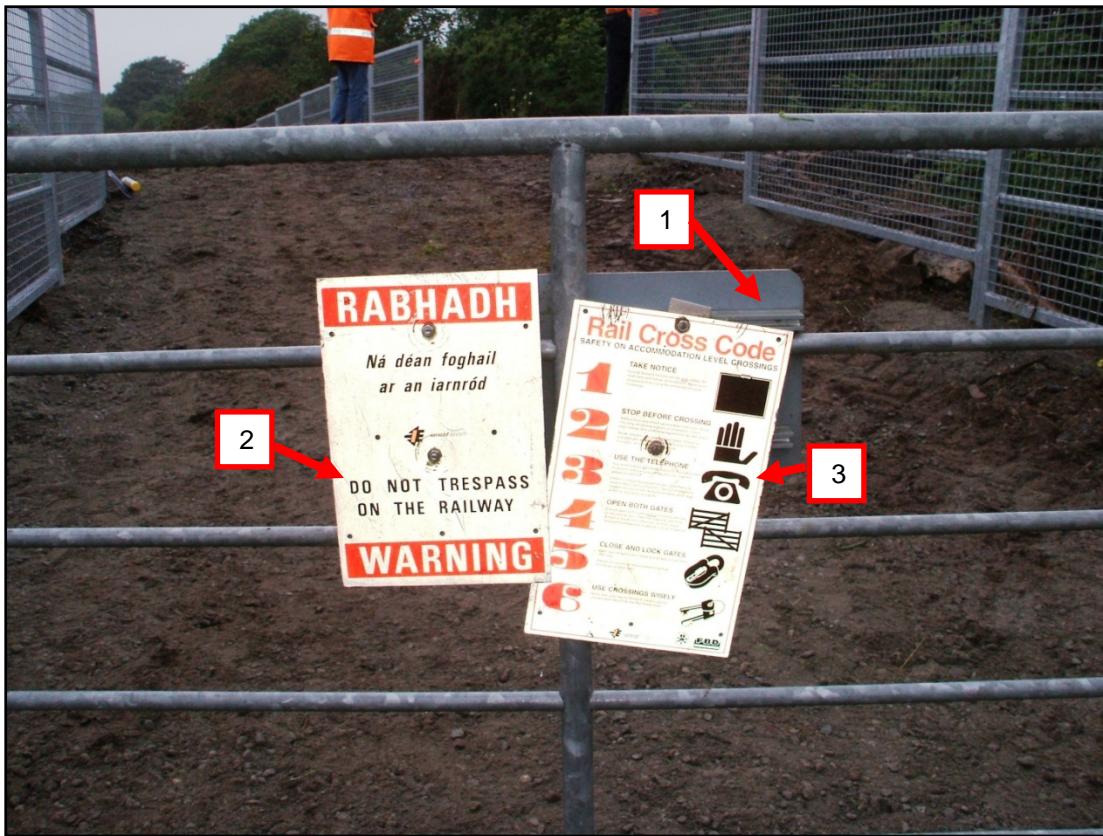
Figure 8 – Signage on Gate of XN 104

The signage at the crossing was attached to the gates, see figure 8. The signage consisted of:

1. Crossing number (fixed to back of gate);
 2. Do Not Trespass on Railway;
 3. Rail Cross Code.

There were no marker boards on either side of the crossing indicating the safe stopping point clear of the railway for crossing users.

Currently there is no company standard that clearly identifies the specification and signage required at crossings. I-PWY-1307 prompts staff to check for missing signage but gives no reference to a list of signage that should be fitted. A list of signage for Accommodation Crossings was provided by Iarnród Éireann (see appendix 1). In addition, the Maintenance of Way Technical Information Sheet MW50, dated 01/01/1983 (MW50) (Iarnród Éireann, 1983) identifies a list of signage to be fitted as does the Report of Committee of Inquiry into Accommodation Level Crossing Safety, dated 13/07/1990 (Iarnród Éireann, 1990). The signage at the crossing was inconsistent with all three lists of required signage for this type of crossing. The signage that was present was attached to the gate and hence when the gate is open there is no visual reminder of the crossing ahead. Following a short audit of several crossings in the local vicinity it was observed that signage also varied between crossings.

2. The review of signage requirements is ongoing and a number of internal meetings have taken place to discuss this and other issues relating specifically to level crossings.

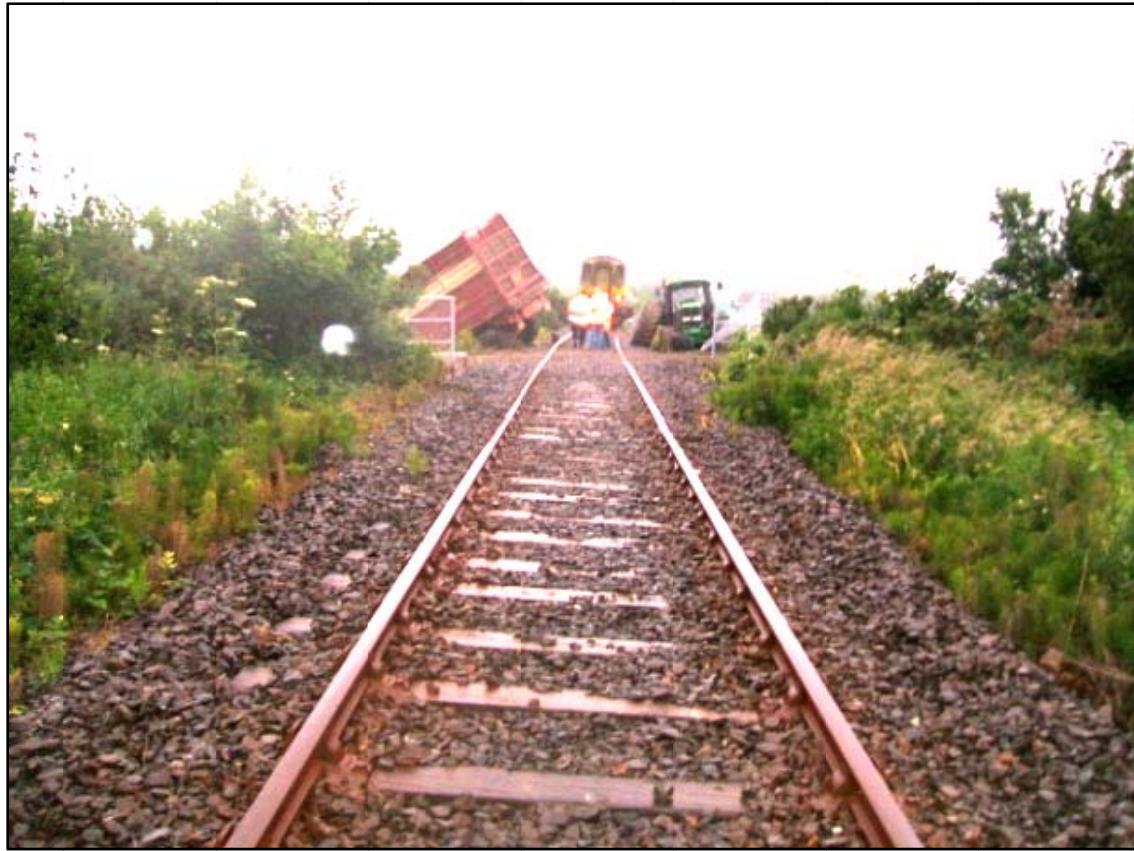
Figure 9 – Approach from Ballybropy

Vegetation lined both the Up and Down sides of the railway at the crossing on the approach from Ballybrophy, restricting views of approaching trains from Ballybrophy for crossing users. This vegetation measured in excess of 3 metres (m) in height on the Down side and in excess of 2 m in height on the Up of the railway, see figure 9. On the approach from Killonan there was low level vegetation on the Up and Down sides of the railway at the crossing.

The view from the crossing was restricted by vegetation. Unfortunately, it was not possible to measure the viewing distances accurately as the vegetation was accidentally lowered by the on-track machine that

was assisting with the recovery of the vehicles. However, from the photographs taken on site it is evident that the views were restricted. The combination of the rising gradient and vegetation meant that it was not possible for the train driver to see the tractor and trailer or the tractor driver to see the train until the tractor was fouling the railway line.

Based on the information above, it can be established that the viewing distance at the time of the incident was below the Iarnród Éireann requirements, which could have been achieved had the vegetation been cut back to improve visibility.

Comparing the viewing distance measured following the incident of 21 m with the Iarnród Éireann required distance of 125 m and the Railway Safety Commission's guidance of 178 m, it can be established that the viewing distance was considerably restricted.

1. The vegetation at XN104 has been cut back and the views are in excess of 300 m for both views on the up and down side of the crossing. Ongoing upgrading work, which had commenced at the time of the incident, was completed by the end of April, 2008.

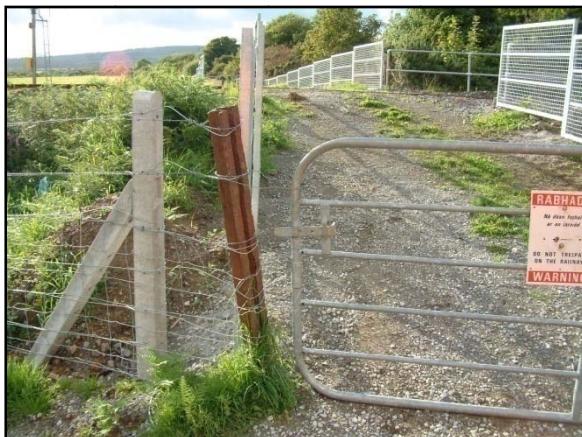
Figure 10 – Gatepost on public road side

There are 12 foot wide gates on both sides of the railway, these were fitted with bolts that did not align with the gate posts and wire was being used to maintain the gates closed, see figures 10 and 11. New fencing had been erected on both sides of the approach from the public road and the field.

It was not possible to securely close and padlock the gates at the crossing as per section 7.4 of “The SAFE use of Unattended Railway Level Crossings” (Iarnród Éireann, 2006) due to the position of the gates and gateposts.

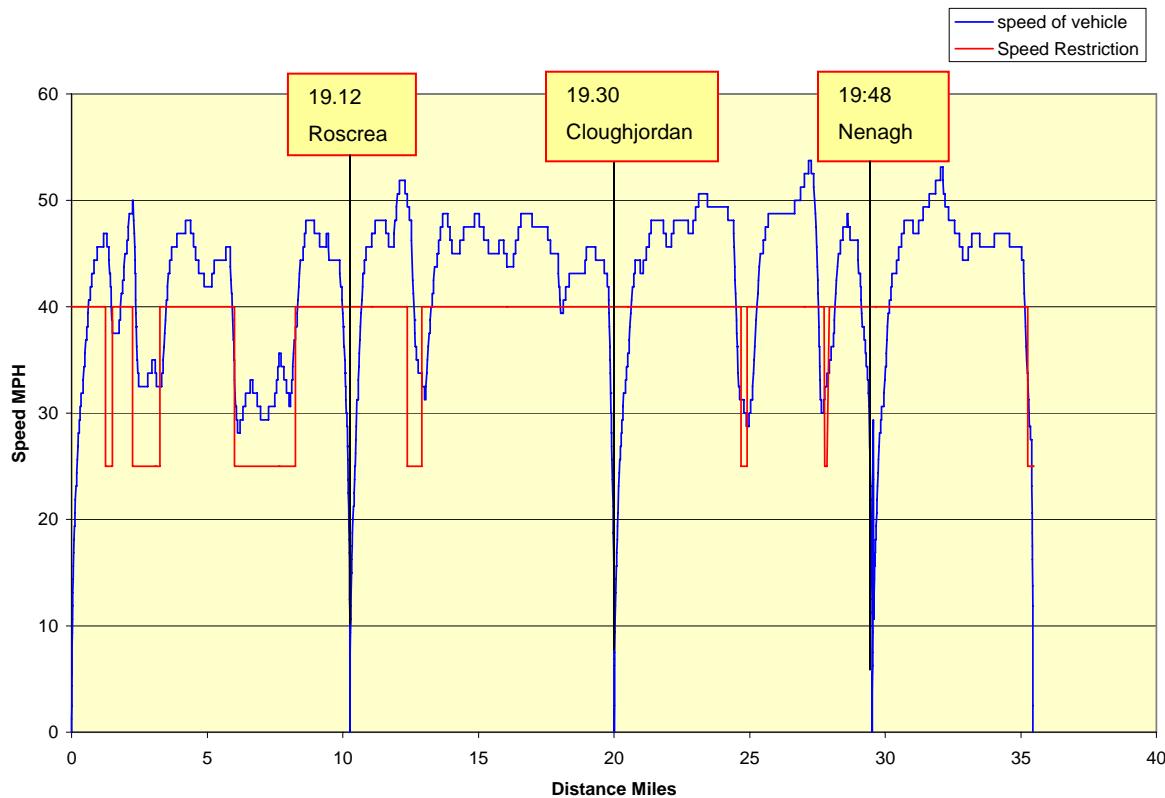
Graph 1 – Speed Profile for Journey from Ballybrophy to Incident

Graph 1 shows the speed check for the journey from Ballybroyphy to the crossing. The speed of the vehicle as recorded by the event recorder is shown in blue. The speed restrictions as outlined in the working timetable and weekly circular week ending 01/07/2007 are shown in red. The timetabled stops are indicated. The speed of the train was regularly above the permanent and temporary speed restriction permitted. Monitoring the speed of trains is carried out in accordance with Iarnród Éireann's standard RSS2-1 'Checking the Speed of Trains' (Iarnród Éireann, 1998). This provides for monitoring train speed by: using the information in Signal Cabin Train Register Books or CTC; downloading the data recorder of the train; radar speed guns; and on-board checks using stop watches and mileposts. The monitoring of train speeds in the Ballybroyphy to Killonan section was found to be heavily reliant on the Signal Cabin Train Register Books. This is not always an effective way to monitor the speed of trains. In 2007, only 25% of the planned radar monitoring was carried out. In the same period from 24 planned monitors by means of downloads from on board data recorders only 2 were carried out and both of these were post incident downloads.

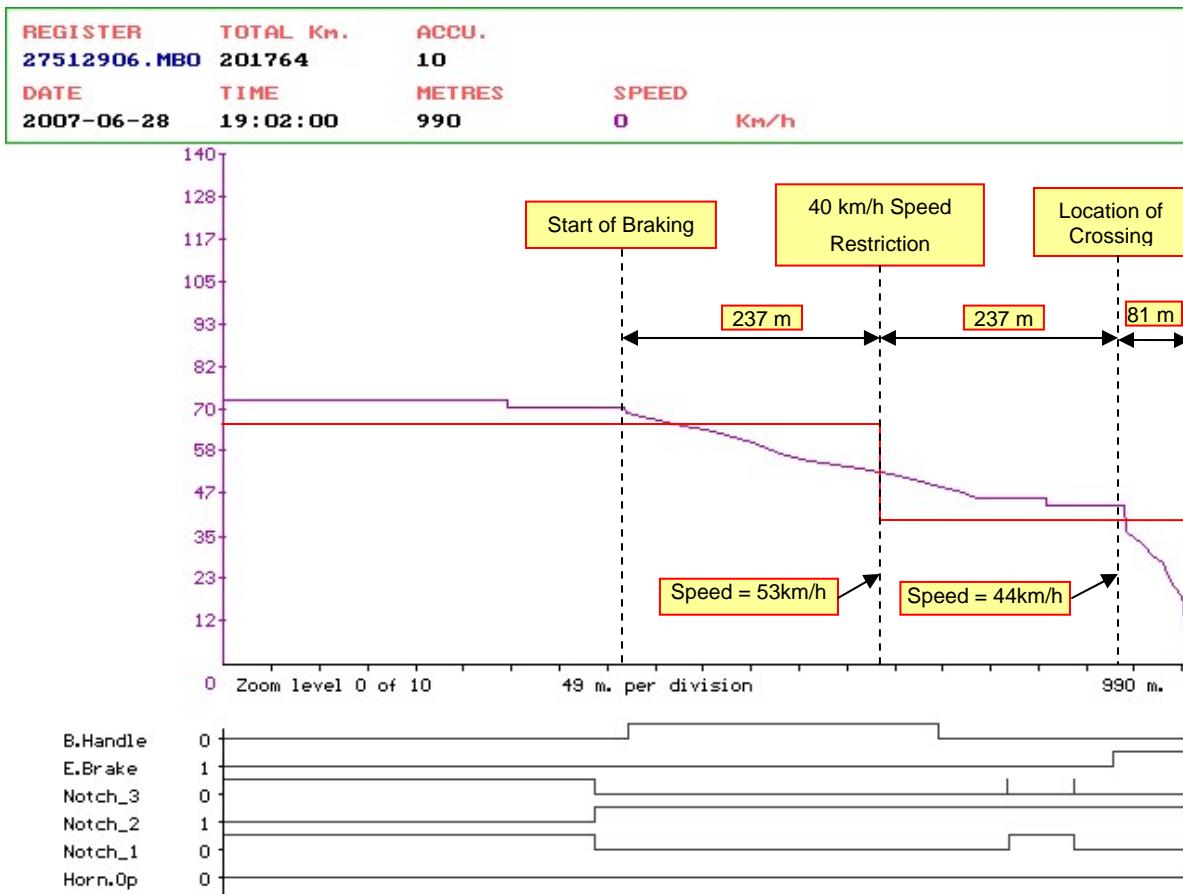
Graph 2 – Lead up to incident

The location where the train came to a stop was measured as 81 m beyond the crossing. Graph 2 shows information from the event recorder for the last 990 m before coming to a stop. The event recorder from unit 2751 does not record the activation of the horn from unit 2753. The purple line indicates the speed of the train while the red line shows the temporary and permanent speed restrictions as outlined in the Working Timetable and Weekly Circular for the week ending 01/07/2007.

At approximately 510 m from the crossing, approaching the TSR, the driver applied the brake and the train speed can be seen to reduce. At the commencement of the TSR, 237 m from the crossing, the train speed was 53 km/h. Brake application was maintained until the train slowed to approx 46 km/h. The driver applied the emergency brake whilst travelling at a speed of 44 km/h and the train came to a stop 81m beyond the crossing. The collision with the tractor and trailer would also have contributed to this deceleration.
