**Near miss at Ballymurray level crossing on the 14th of June 2008
between Athlone and Westport**

Report 08061401 (issued 11th of May 2009)

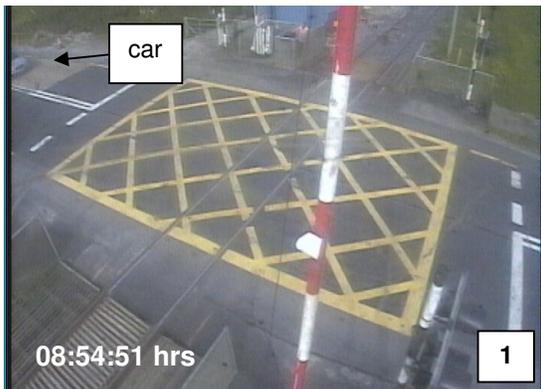
A car approaches the crossing

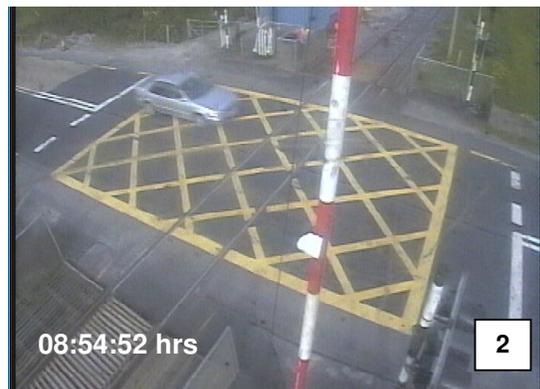
The car drives through the crossing

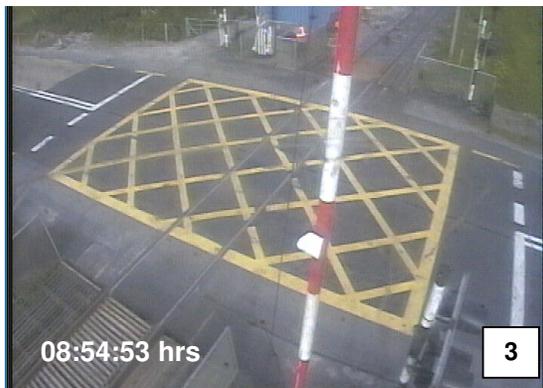
The car clears the crossing

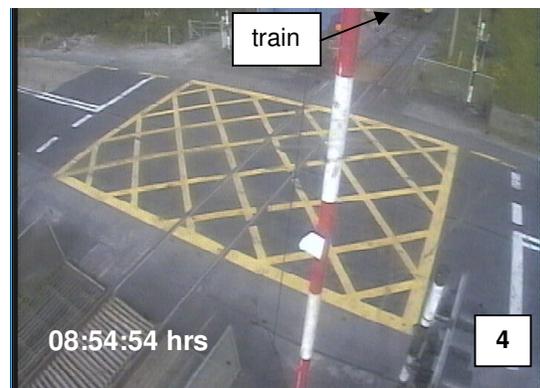
- The barriers were raised to road traffic while maintenance works was being carried out, as a train approached.

A train approaches the crossing while the barriers are raised

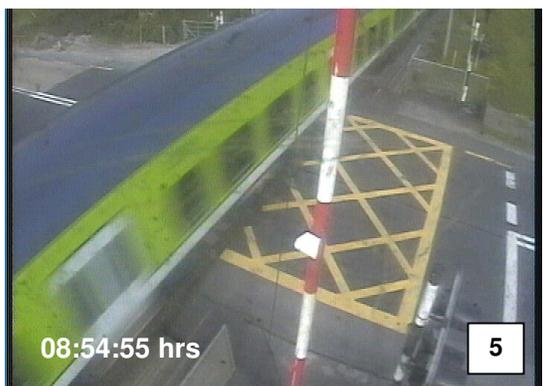
The train drives through the crossings while the barriers are raised

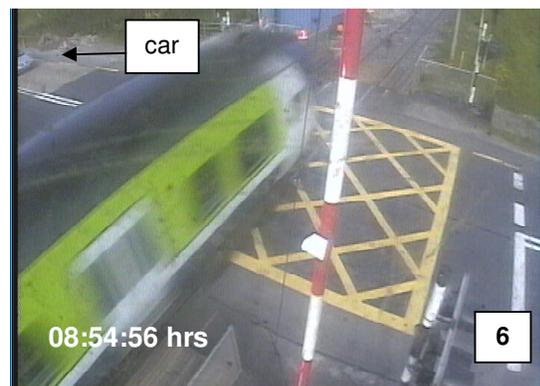
A car approaches, but stops, at the crossing while the barriers are raised and the train is crossing

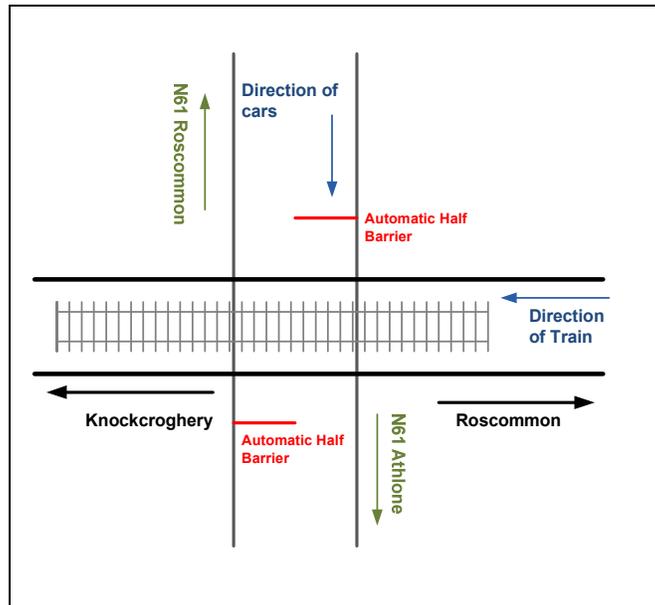
Figure 2 – Site map of Ballymurray AHB

The level crossing, XM075, is an AHB type crossing. This type of crossing prevents access by means of two half-barriers that block the flow of road traffic, but not the exits (see figure 2). The level crossing is protected by traffic light signals, audible warning devices and the half-barriers. The operation of the lights and sirens followed by the lowering of the barriers is initiated automatically as the train approaches the crossing. The barriers raise automatically once the train has passed. The crossing equipment is supervised from a manned location (in this case Athlone).

Telephones are provided for public use and connected to the supervising point in Athlone. The level crossing meets the Railway Safety Commission's 'Guidelines for the Design of Railway Infrastructure & Rolling Stock', Section 5, Level Crossing. The road traffic activity at the level crossing is recorded by CCTV and a signal post telephone is provided at the crossing for direct communication with the controlling signalman. Calls on this telephone are recorded.
