## **Investigation Report 2011-R004**

**Gate Strike at Buttevant Level Crossing (XC 219), County Cork,  
on the 2<sup>nd</sup> July 2010**

<b>Title</b>	Gate Strike at Buttevant Level Crossing (XC 219), County Cork, on the 2 <sup>nd</sup> July 2010
<b>Document type</b>	Investigation Report
<b>Document number</b>	2011-R004
<b>Document issue date</b>	27/06/2011

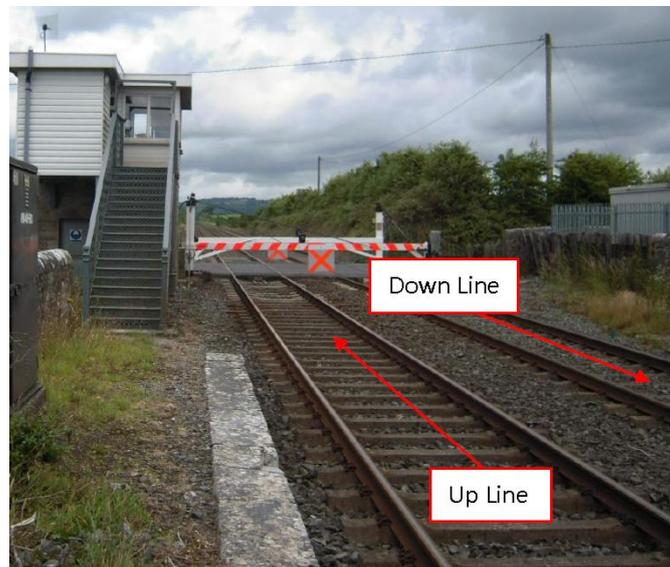
Photograph 1 – Line directions relative to the raised cabin

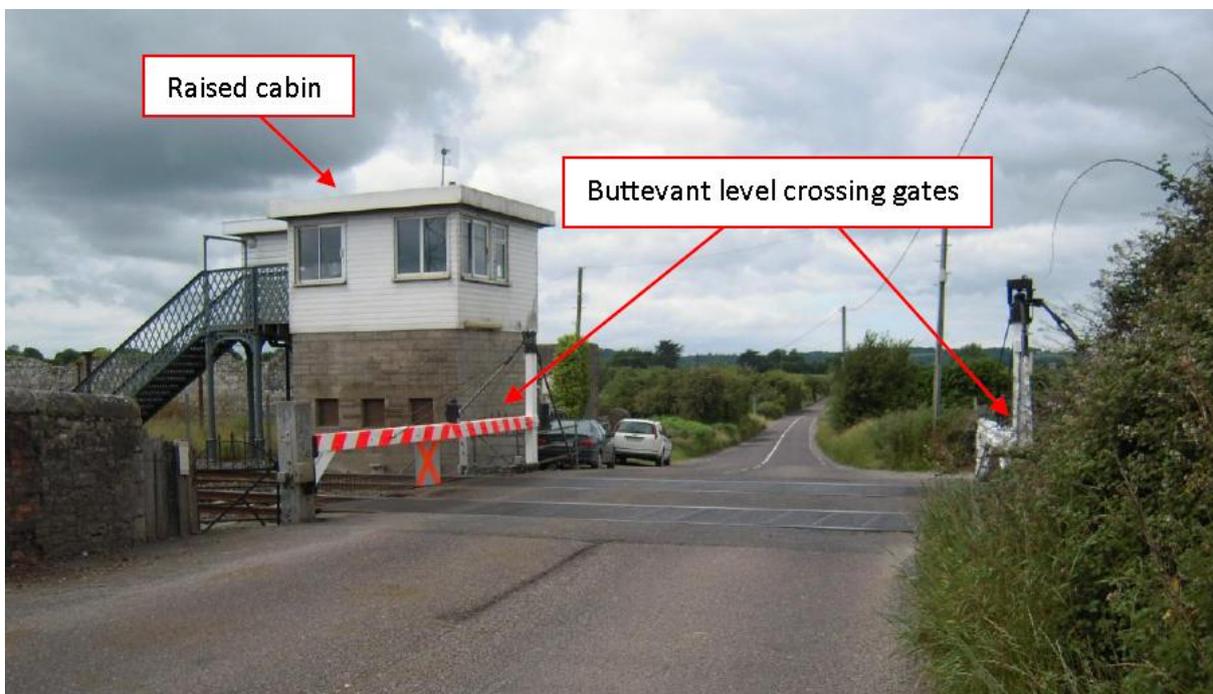
The Level Crossing, asset identification number (no.) XC 219, is a Gate Keeper attended 'CX' type crossing, which means that the default position of the Level Crossing gates is open to the public road (and closed across the railway line). The Level Crossing gates are opened and closed by the Gate Keeper who is located in the raised cabin adjacent to the Level Crossing where he has clear views of the railway line and public road, see Photograph 2.

Photograph 2 – Buttevant Level Crossing with raised cabin

A *risk assessment* exists in relation to the occupational safety of the Gate Keepers at the Level Crossing. However, no formal risk assessment in relation to the Level Crossing equipment design was created for the Level Crossing at the installation stage, or since its installation. IÉ have advised that, risk assessments would not have been customary at the time of installation, and a more informal approach to risk assessment was likely to have been adopted.

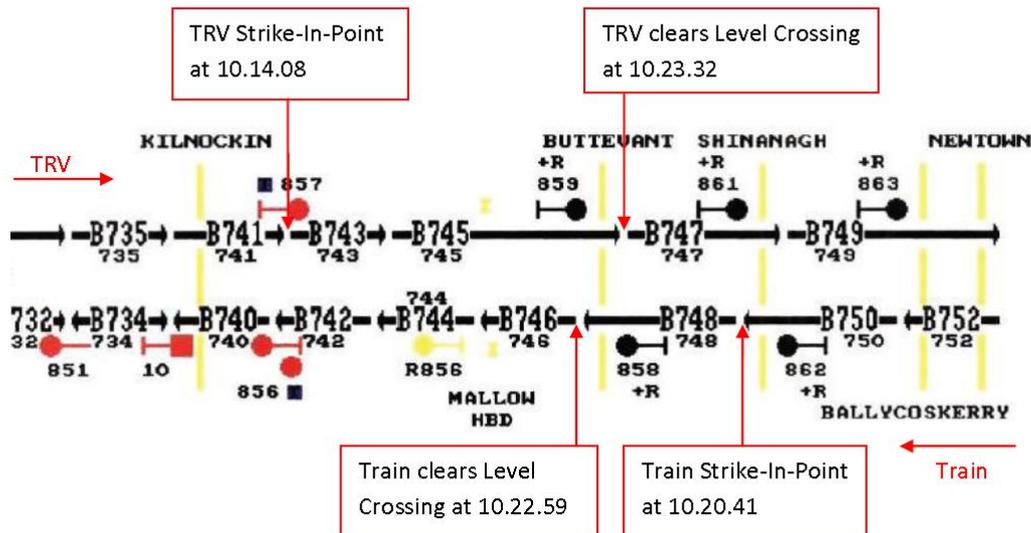
When the train/trains *clears* the track circuits associated with the Level Crossing the gate keeper can then begin the process of closing the gates to the railway. In the case of the Up and Down direction, the track circuits are B745 and B748, respectively.

Figure 2 – Signalling system download

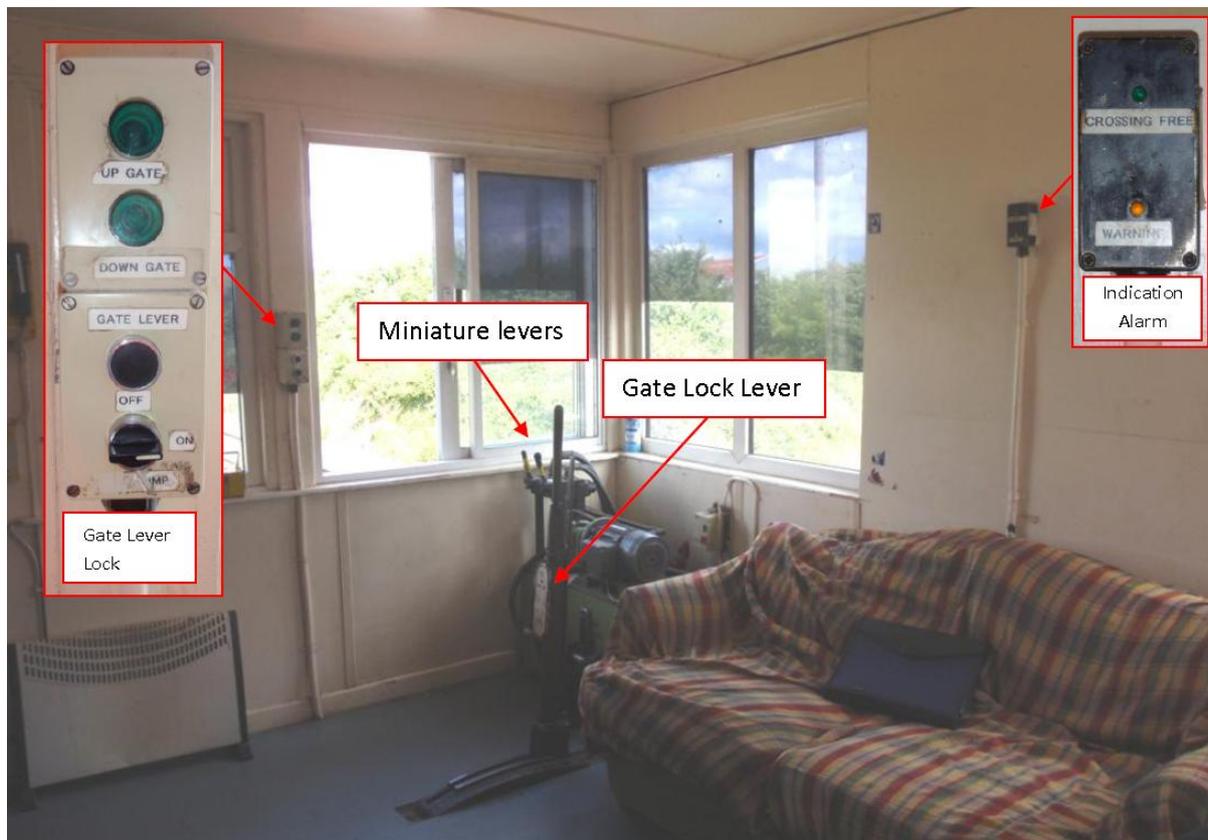
Photograph 3 – General arrangement of signalling equipment

It can be seen from Photograph 3 that all the above equipment is positioned in close proximity to each other, allowing the Gate Keeper to operate the equipment in a quick sequence from a single standing position, while maintaining a clear view of the Level Crossing.

IE staff, under the supervision of the RAIU, tested the Level Crossing equipment post accident, including the Indication Alarm and associated audible alarm, Gate Lock Lever and Gate Lever Lock. No faults were found with any of the Level Crossing equipment, and no faults have been recorded at the Level Crossing since the accident.

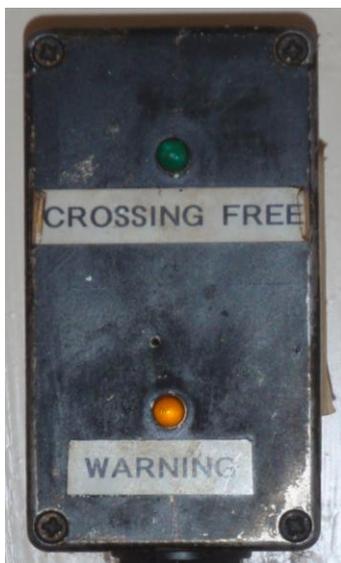
As a train approaches the level crossing, striking the Strike-In-Point, the yellow “Warning” lamp becomes illuminated, the audible alarm sounds, and the green “Crossing Free” lamp becomes extinguished on the Indication Alarm illustrated in Photograph 4.

Photograph 4 – Indication Alarm

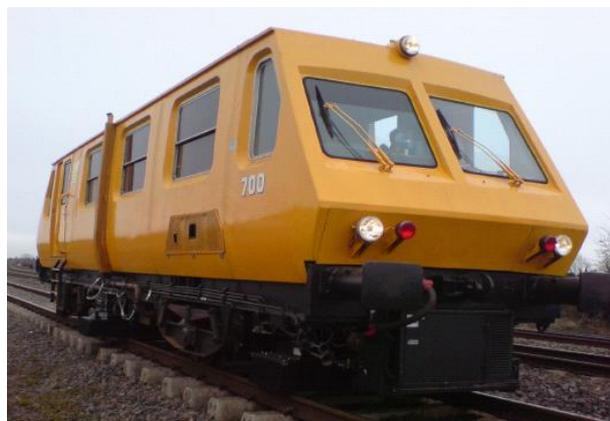
The TRV involved in the incident is vehicle no. 700, train identification no. Y261, see Photograph 7. The TRV was not in recording mode at the time of the accident. The length and weight of the TRV are 12.8 m and 23 tonnes, respectively. The TRV does have a forward facing camera, however, this only operates when the TRV is recording, and therefore was not recording at the time of the accident. The TRV does not have an event recorder fitted. The *maximum permissible speed* for a TRV is 64 km/h. The TRV is not equipped with CAWS receiving equipment.

Photograph 7 – Track Recording Vehicle

The impact from the train striking the level crossing gate resulted in some minor damage to the TRV.
