**Inquiry into the
Derailment of a Freight Train
at Cahir Viaduct on
7th October 2003**

Interim
Railway
Safety
Commission

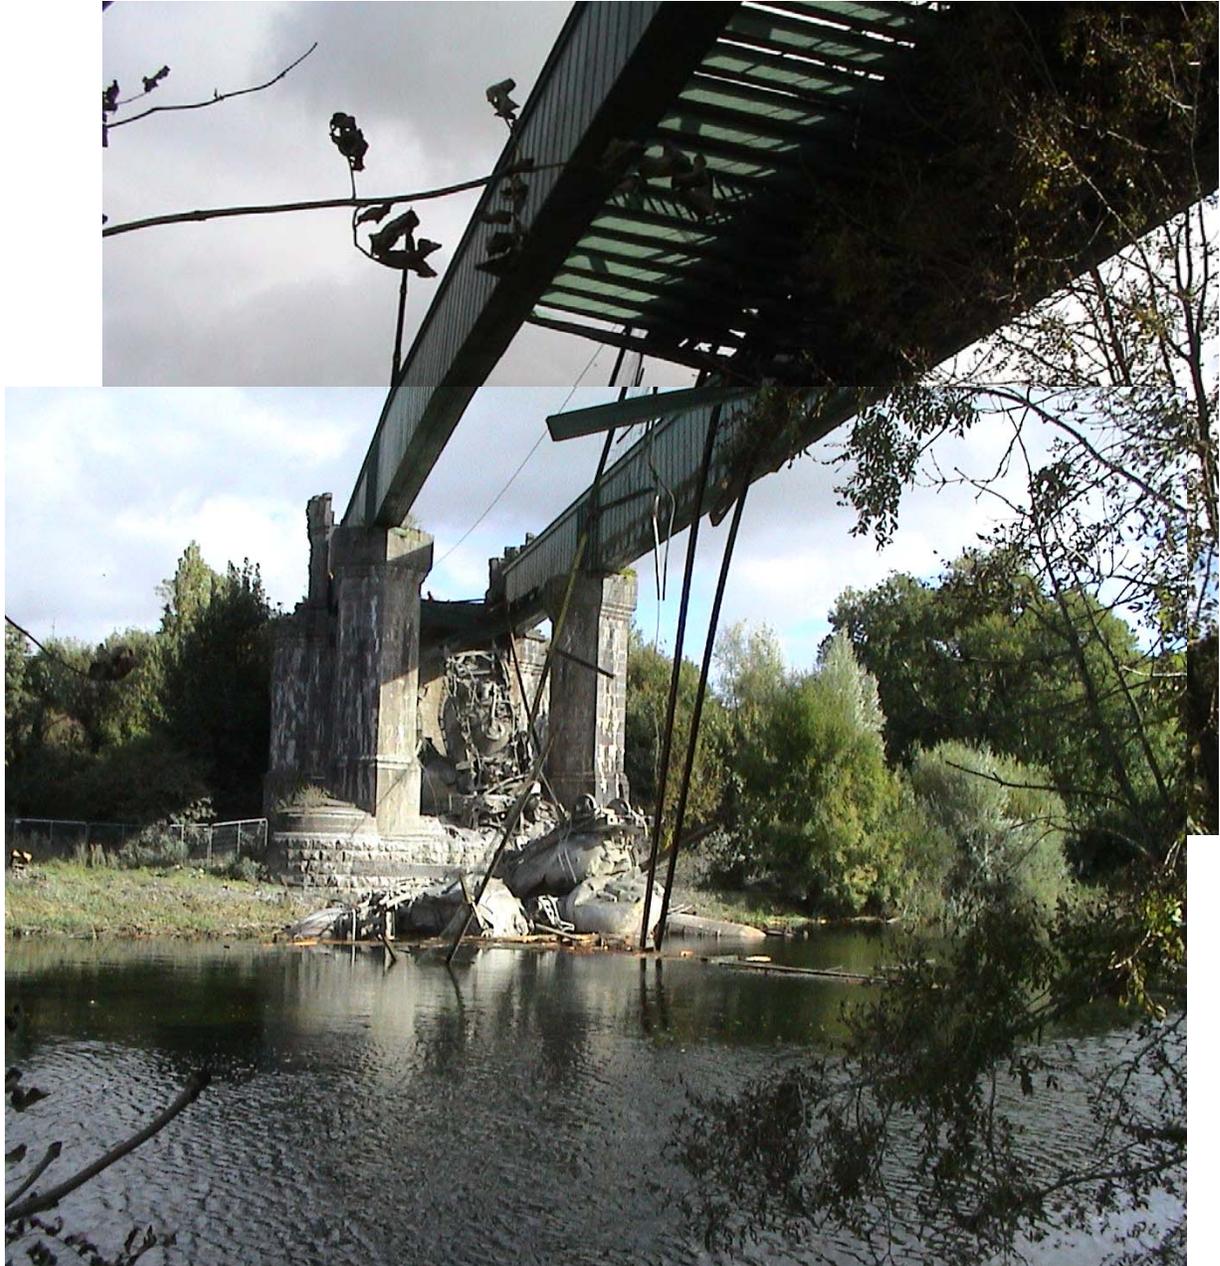
Figure 7 Viaduct from Limerick bank, showing collapsed deck and wagons

- On the upper flanges of the transverse girders and beams in the area of the collapsed deck there was varying amounts of damage indicative of their having been struck by one or more wheel flanges. On the fully-collapsed transverse girders these marks tended to be clustered approximately 300mm outside the gauge on the Down rail and, correspondingly, 300mm inside the gauge on the Up rail. Over approximately the last 15m of the deck approaching the Waterford abutment there was a gradual shift in the clustering of the wheel-flange strike marks of approximately 100mm to the Down side.
- Wagon 11 came to rest on top of wagons 12 and 13, with wagons 14 and 15 adjacent at the bottom of the Waterford abutment and wagons 18 to 20 against the plinth of the Waterford pier (see figure 7).

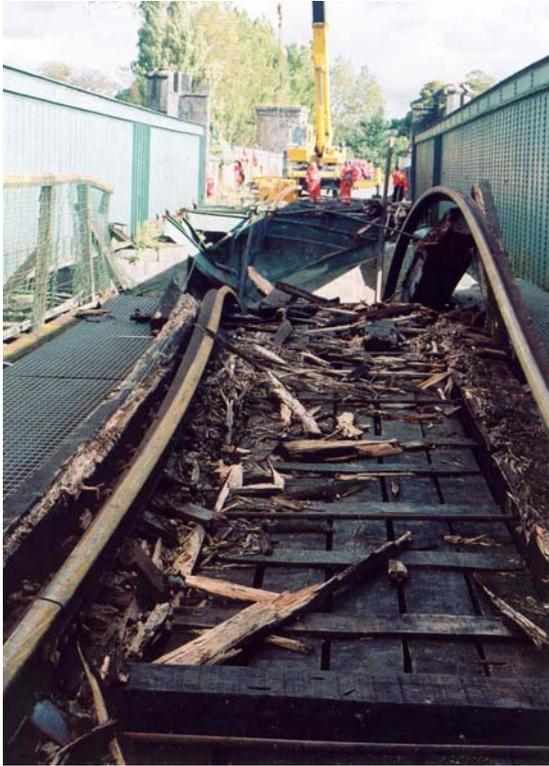
Figure 12 View of collapsed deck from Limerick side of Viaduct

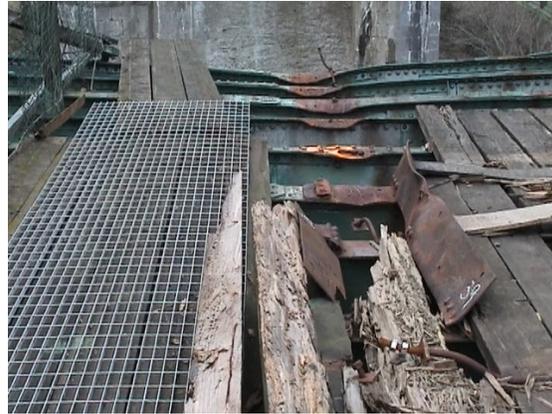
Figure 13 Detail of Down side after debris was removed

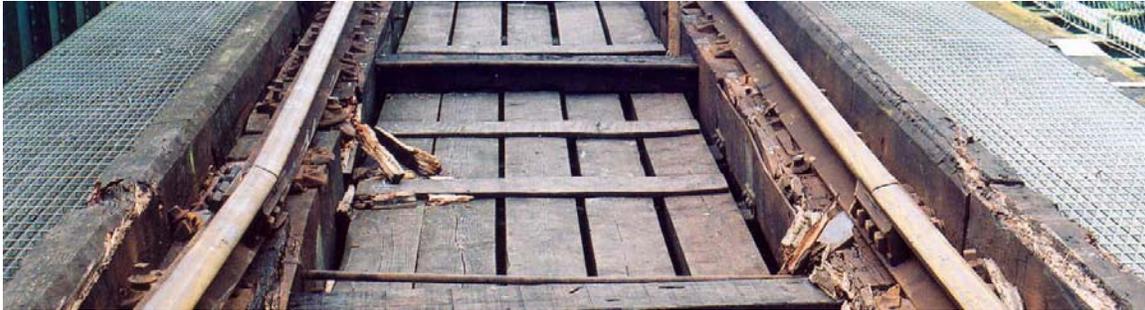
Figure 14 View of secondary deck, looking back toward point of original derailment

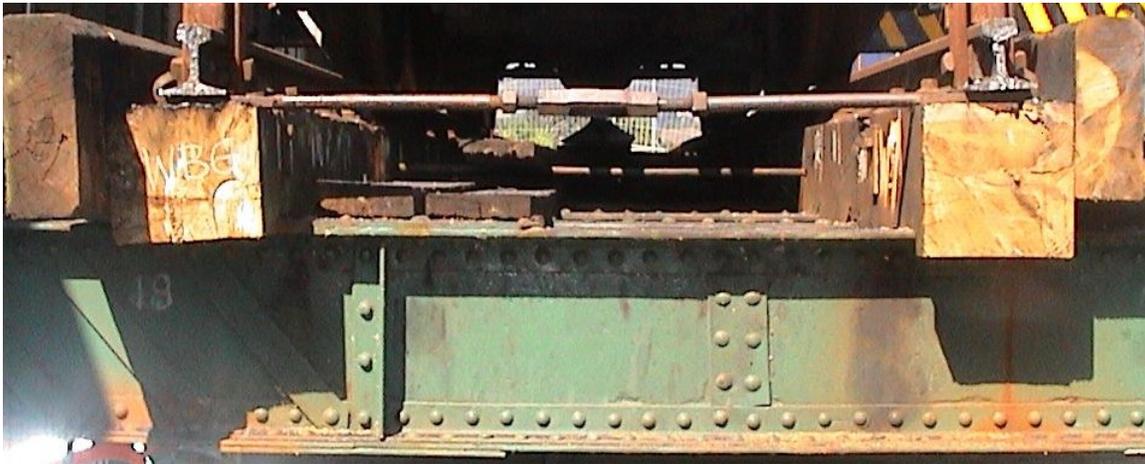
Figure 15 View of secondary deck at transverse girder 18, with way-beam 6 at left

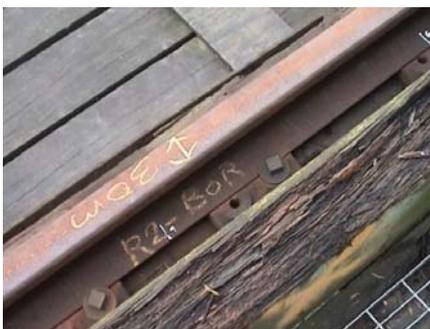
Figure 16 Rail mounted on way-beam 6, with adjacent guard-beam 6 in poor condition

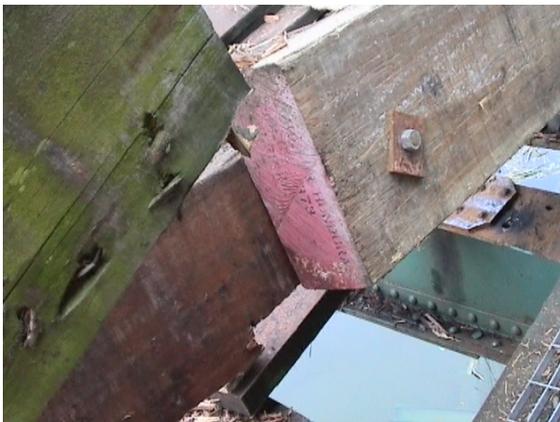
Figure 18 Old guard-beam abutting new guard-beam on Up side: way-beam behind has deep notching at its base

In some instances, way-beams appeared to have been notched over transverse girders the top flanges of which had not been reinforced. When and why this more extensive practice of notching developed is not clear. If, at the time of construction of the bridge, there had been variance in the level of the tops of the transverse girders, it is likely that this would have been minor, requiring only minimal notching of some way-beams to compensate. On the intact portion of the deck however both Up and Down way-beams were notched over all the transverse girders, in some instances to a depth of 90mm which is approximately 30% of the overall depth of the beam (see figure 18).

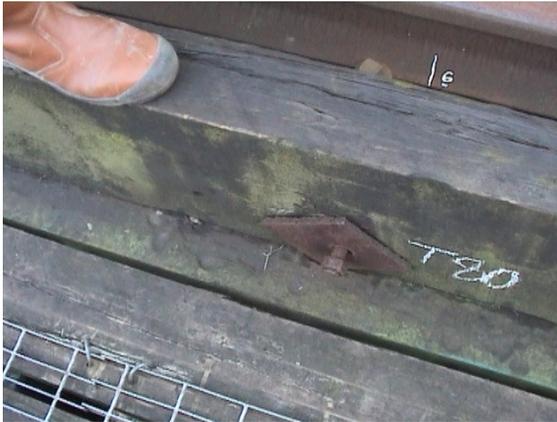
Figure 19 Down guard-beam and decking arrangement

As illustrated by the 1911 drawing, it was clearly intended that the 75mm walkway timbers would extend under the guard-beams and support them. On the section of deck that remained intact after the accident this was the case for the Down guard-beams only (see figure 19).

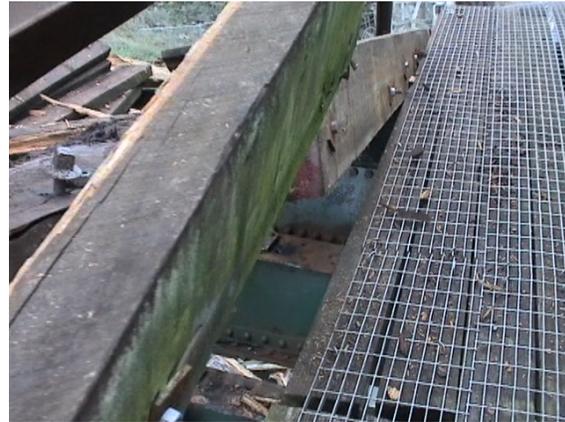
Figure 20 Up guard-beam and decking arrangement

The walkway timbers did not extend under the Up guard-beams which were either seated directly on top of the transverse girders or supported only by the lateral bolts securing them to the associated guard-beams (see figure 20). In the case of way-beam 6 for example, the guard-beam was 25mm above the transverse girder 18 (Figure 21). Any guard-beam mounted in this way would not only have failed to help counter any rotational force applied to the way-beam through the rail by a train but also would have acted with this force.

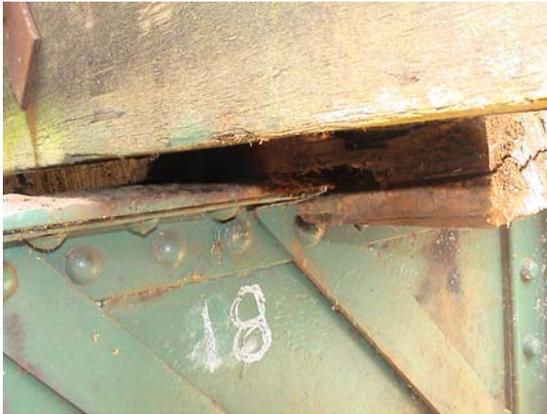
Figure 21 Up guard-beam suspended over transverse girder 18, at way-beam 6

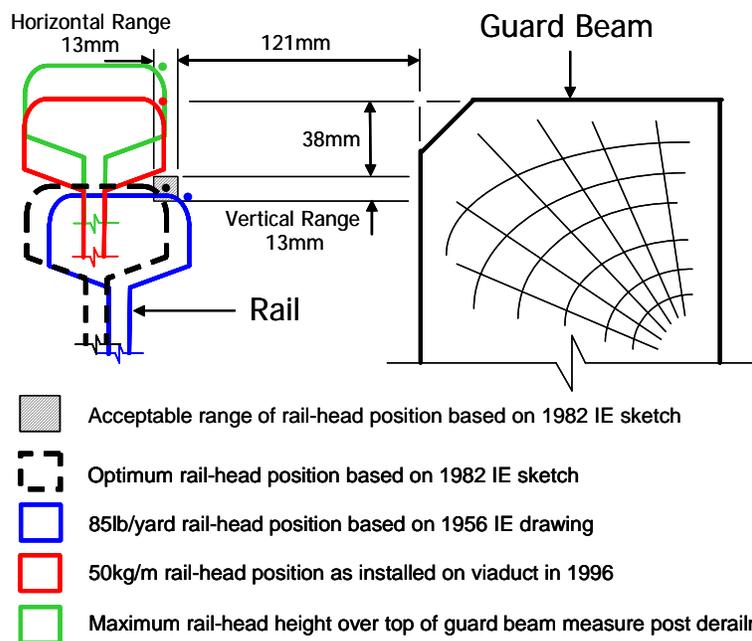
The 50kg/m rail installed on the Viaduct in 1996 was mounted on sole plates, giving it a rail-head height of approximately 179mm above the top of the way-beam. This raised the rail height by 50mm, leaving the guard-beam 2mm below the top of the rail rather than the required 38mm to 51mm above the rail. With the sole plate mounted centrally on the way-beam, and allowing for the 1:20 inward inclination of the rail, the horizontal guard-beam gap would have been within the required tolerance range.

Figure 22: Sketch showing acceptable range, expected position and actual position of rail-head, relative to Up guard beam

Following the accident, the height of the rail-head relative to the top of the guard-beam was measured at the Up side over the intact section of the deck. At all points, the top of the guard-beam was less than the indicated minimum height of 38mm over the rail-head. Over the last 12m of rail that was undisturbed in the accident the guard-beam was found

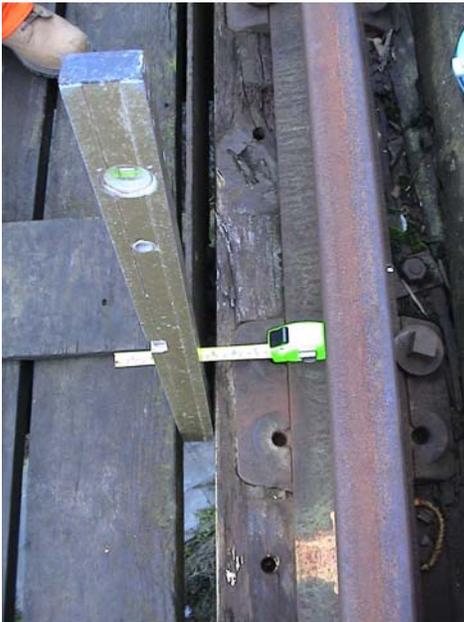
Figure 23 Outward tilt of way-beam 6

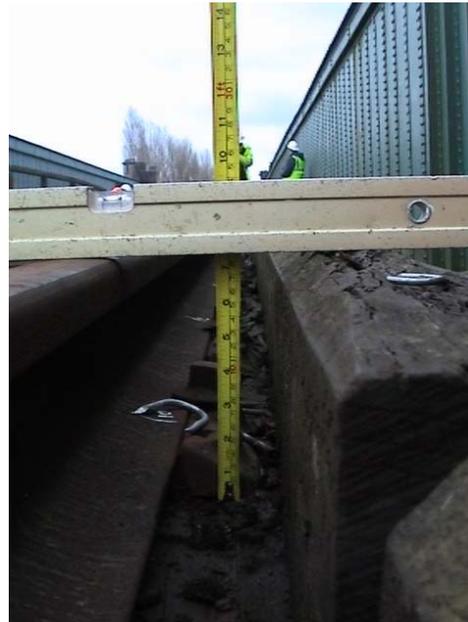
Figure 24 Height of rail above guard-beam at Way-beam 6

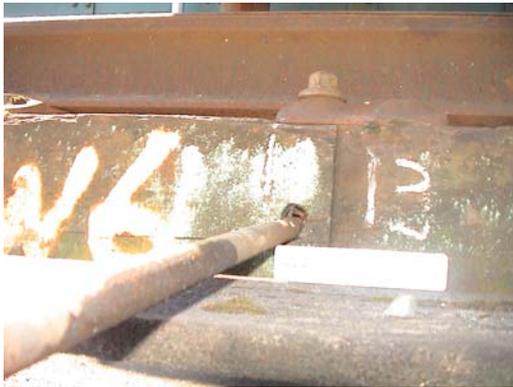
- g) Significant vertical elongation was noticed in a hole drilled through the way-beam to accommodate a tie-rod suggesting that rotational movement had been occurring for some time prior to the accident (Figure 25). In addition, and in contrast with the adjacent way-beams 4 and 8, the four vertical bolts securing this way-beam to the transverse girders were all loose, with in excess of 25mm of the bolt shank visible between the bolt-head and the underside of the girder top flange (Figure 26).

Figure 25 Tie-rod hole elongation on way-beam 6, between transverse girder 15 & 16

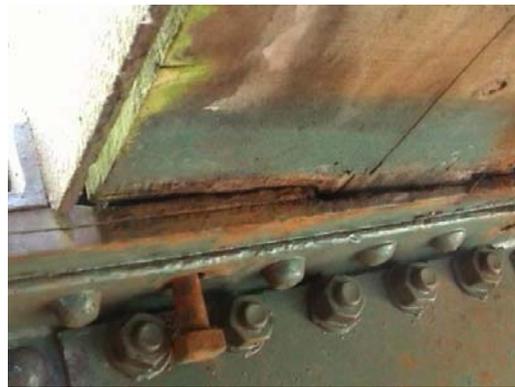
Figure 26 End of Way-beam 6 at transverse girder 21

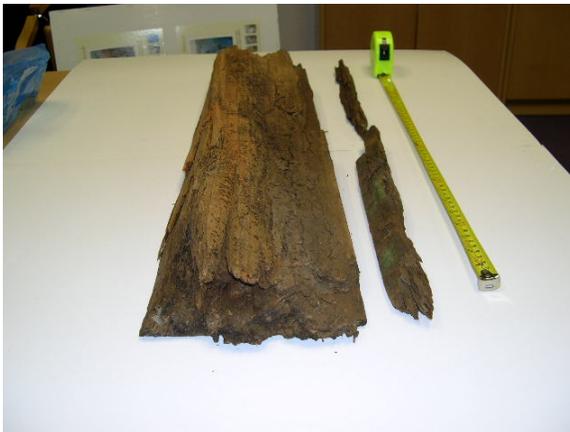
- h) IÉ's post accident survey data indicated significant track cant of about 1:68 in the area of way-beam 6, with the Up rail-head as much as 23.5mm lower than the Down rail-head. While data from two such surveys show the same pattern of cant over the intact deck there are variances in the values, again indicating that track movement had occurred between the surveys.
- i) The impact of the adverse gauge and cant was illustrated during the load test in that the flange of the Up-side wheel of one axle seated over way-beam 6 was hard against the gauge-face of the rail while the outer edge of the corresponding Down-side wheel was located approximately centrally over the rail-head (Figure 27).
- j) An approximately 600mm x 200mm x 50mm section of the outer underside of the way-beam between transverse girders 16 and 17 came away easily under hand pressure (Figure 28).

Figure 28 Badly deteriorated timber removed from underside of way-beam 6
