REPORT OF THE INVESTIGATION

THE ACCIDENT ON THE CIE RAILWAY

CHERRYVILLE JUNCTION, CO. KILDARE

21st AUGUST, 1983

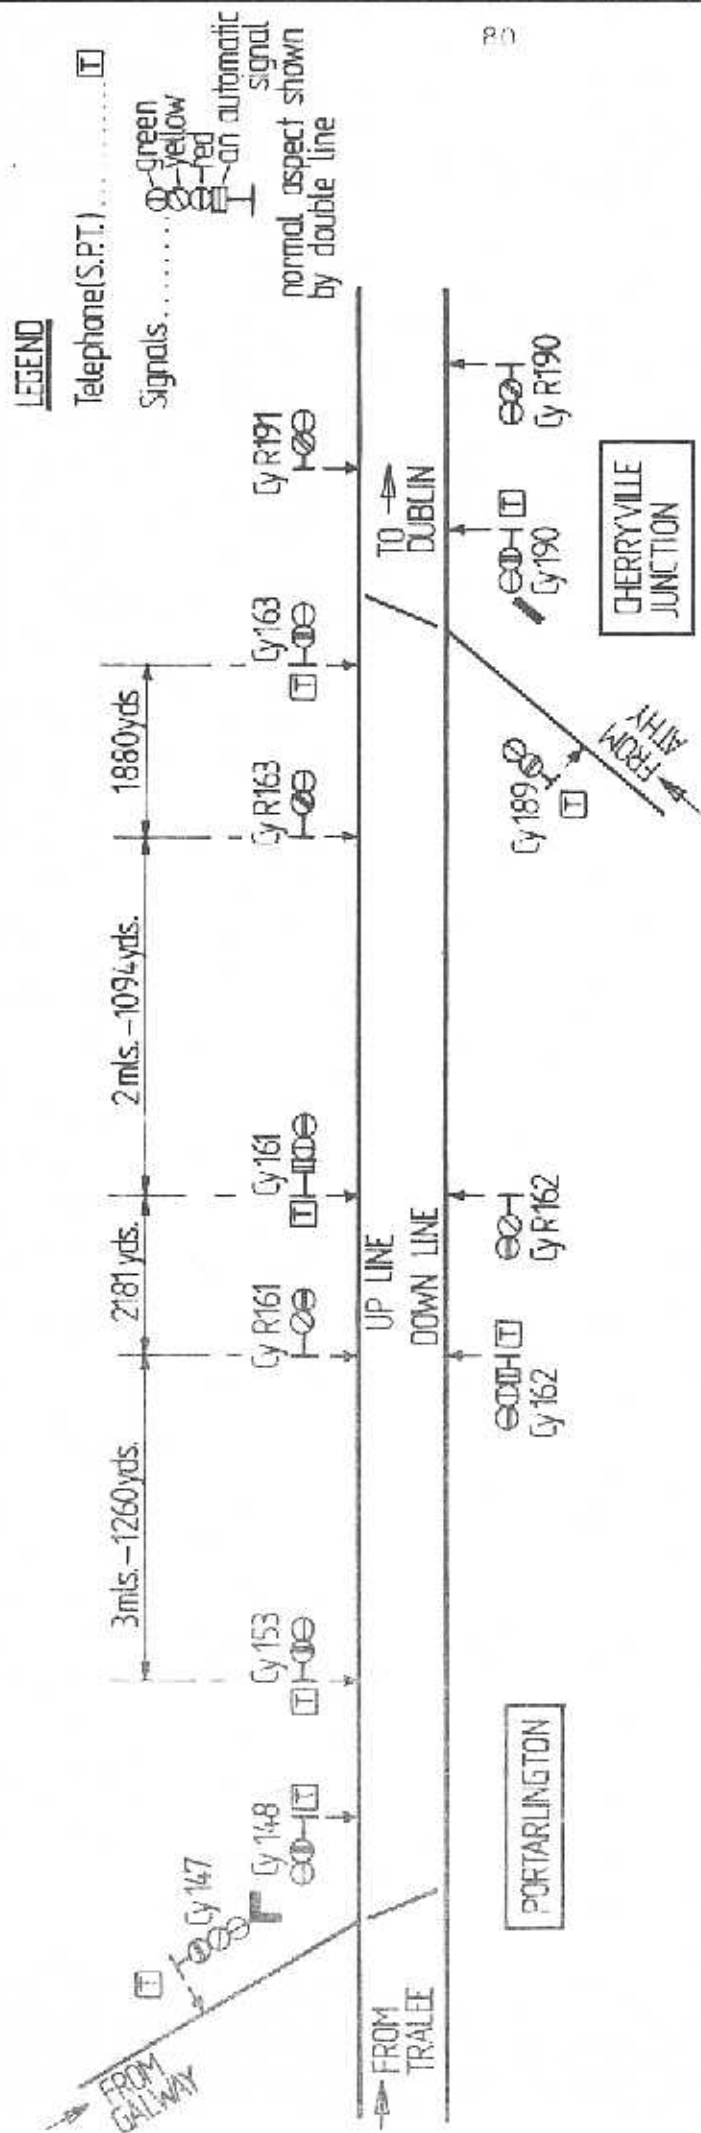
DIAGRAM SHOWING RELEVANT SIGNALS BETWEEN PORTARLINTON AND CHERRYVILLE JUNCTION (Not to scale)

A diagram of the accident site showing relevant signals is at Appendix IV. The accident site is between signals CYR 163 and CY 163. The published maximum permitted line speed at that location was 75 m.p.h. and there is a rising gradient of 1 in 180 for traffic travelling towards Dublin.

52.1 The accident on 21 August, 1983 occurred because the 18.50 hours Galway to Dublin passenger train having proceeded past automatic Stop signal CY 161 at Danger, (when the driver could not contact the signaller), was running at such speed that allowing for visibility, condition of the rails and gradients of the line, the driver, when he became aware of an obstruction on the line ahead, could not stop his train before it was in collision with the 17.15 hours Tralee to Dublin passenger train which was stationary.
