Investigation Report 2011-R002

Secondary suspension failure on a train at Connolly Station

7th May 2010

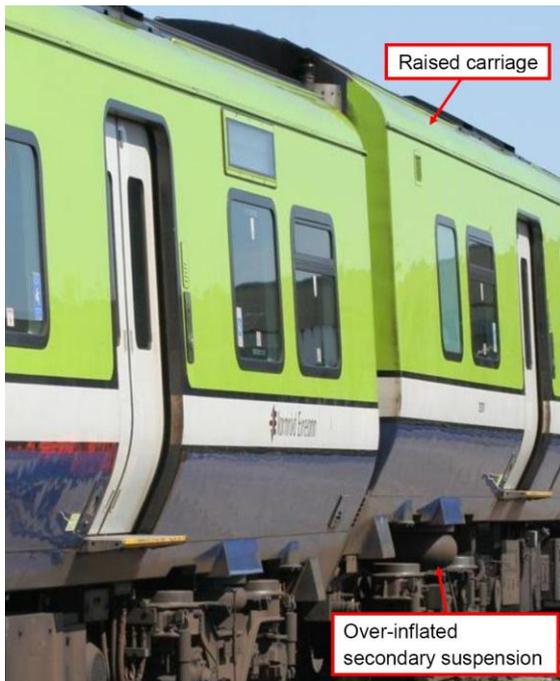
Photograph 1 – Raised carriage

The leading end of the second carriage, carriage 29310, was raised relative to the first carriage, carriage 29410, see Photograph 1. Upon examination it was observed that the *secondary suspension* on the leading *bogie* on carriage 29310 was over-inflated and the underframe of the carbody was no longer held in place on the bogie by the *centre pivot pin* as the *bogie centre retaining plate* bolts had failed, see Photograph 2.

Mounting the levelling valve on the incorrect side of the bogie led to the valves remaining open constantly due to the downward curvature of the levelling valve arms when fitted correctly. Once the train was powered up and the air compressors were functioning, a continuous feed of air from the main reservoir passed through the open valves, allowing the airbags to continue to fill until the pressure in the airbags reached that of the main reservoir, 7.8 bar. As the pressure increased, the volume of air in the airbags increased and the height of the airbags increased relative to the bogie frame, raising the height of the carbody, see Photograph 1.

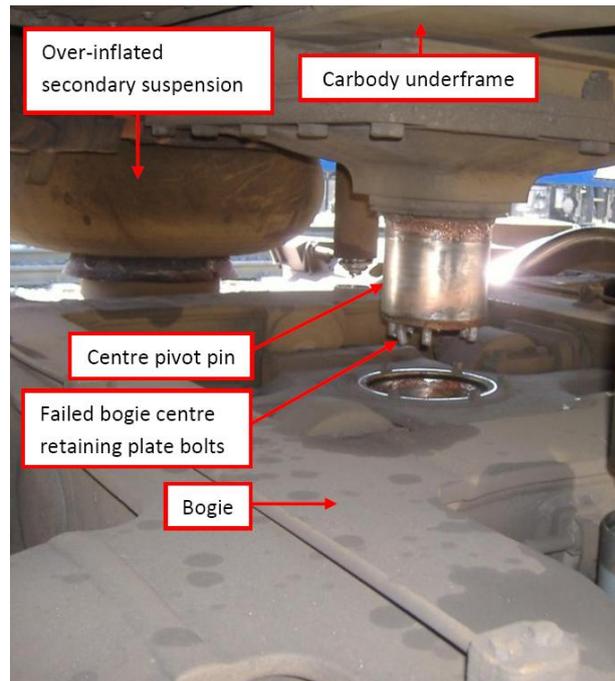
Photograph 2 – Bogie to carbody connection

The damage was isolated to carriage 29310. The centre pivot pin was raised out of the bogie centre. The eight bogie centre retaining plate bolts were stretched and broken in two. The upper and lower sections of the two vertical dampers on the bogie had separated. The mounting points of the levelling valve control rods suffered minor damage.

The failure of the centre pivot retaining plate bolts was a result of fatigue and overloading as a consequence of over-inflation of the secondary suspension, this then allowed the centre pivot pin to be raised out of the bogie centre thus preventing it from performing its intended function and permitting the train to enter an unsafe state. The physical failure of the centre pivot pin was addressed in the hazard log and this demonstrated the potential consequence and resultant accident for the failure of the centre pivot pin to perform its function.

IÉ should evaluate the risks relating to failure of the centre pivot pin to perform its function due to over-inflation of the secondary suspension and determine if any design modifications are required to avoid future failures.

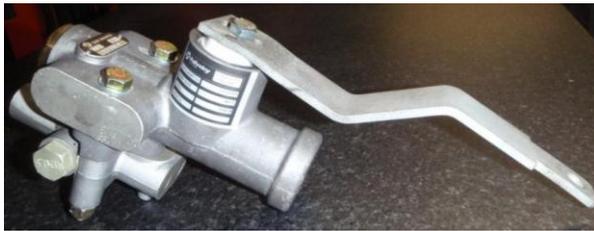
Photograph 3 – Levelling valve, part no. 82662

The secondary suspension airbags on the trailer bogie of carriage 29310 were found to have over-inflated due to the mounting of the levelling valves upside down on the incorrect side of the bogie. The design of the secondary suspension permits the levelling valves to be fitted to either side of the bogies. The levelling valves for each side of the bogie are mirror images of each other and have few distinguishing features, see Photographs 3 and 4. They have the same part name and are distinguished by different part numbers written on them as shown in Photograph 4, which were not visible due to a build up of dirt in service as seen in Photograph 5. The slight downward curvature of the levelling valve arms is the main visible difference between the valves, see Photograph 5.

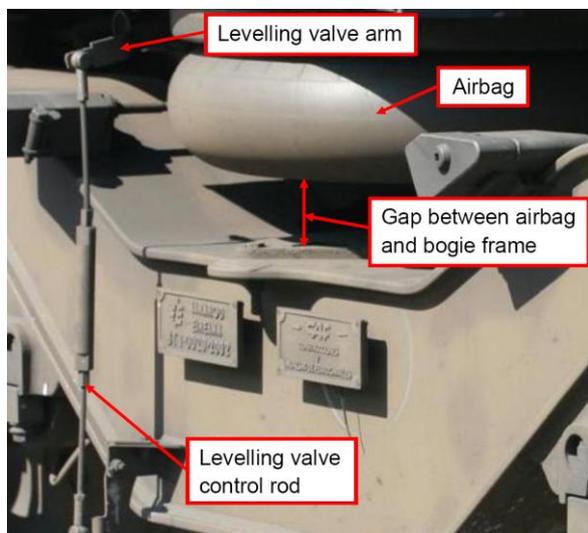
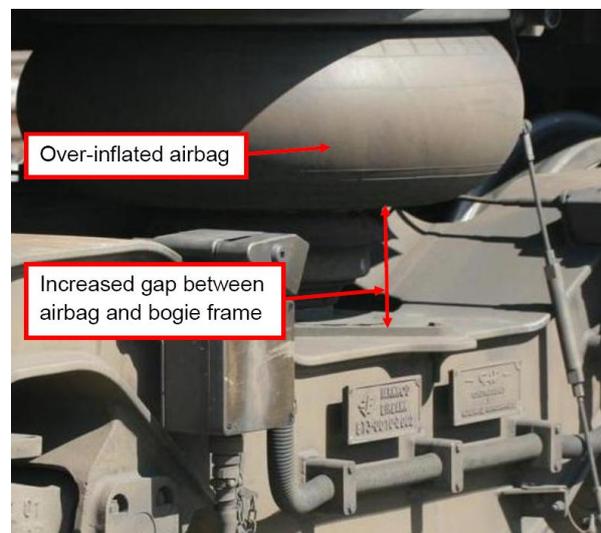
The pressure in the airbags created a vertical load on the centre pivot retaining plate bolts. The combination of the load from the pressure in the airbags and the load due to the movement of the carriage on the track led to the failure of the centre pivot retaining plate bolts, see Photograph 2. Once the bolts failed, the volume of air in the airbags was allowed to increase further. A normally inflated airbag and the over-inflated airbag after failure of the centre pivot retaining plate bolts are shown in Photographs 6 and 7.

Photograph 6 – Normal suspension inflation

Photograph 7 – Over-inflated suspension

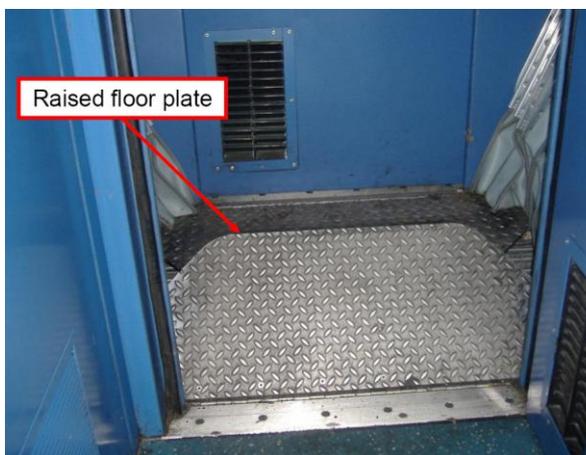
Photograph 8 – Raised gangway floor plate

Over-inflation of both airbags on a bogie causes a slope in the level of the carbody from one end of the carriage to the other. This may be apparent at a platform due to the gap between the carriage and the platform at a station depending on the normal gap between the platform and the carriage. It would not be apparent walking through the train due to the height difference being between the bogie centres prior to the failure of the bolts. Once the bolts failed, the fault would have become apparent when walking through the train as the plates of the floor of the gangway were no longer laying flat over the coupling due to the difference in the height of the carriages, see Photograph 8.

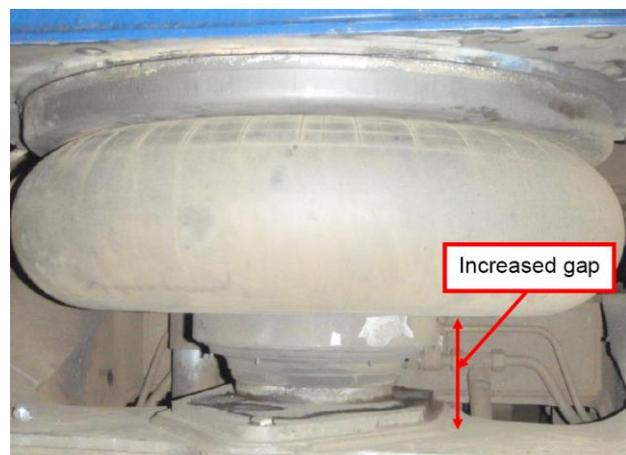
Photograph 9 – Over-inflated airbag

A test was carried out following the accident to determine the extent of the visibility of the over-inflated secondary suspension. The secondary suspension was over-inflated to 6.8 bars. The floor plate between the carriages did not raise. The gap between the bottom of the airbag and the bogie increased by 35 mm to 320 mm, see Photograph 9, however, the airbag did not appear inflated beyond normal inflation, see Photograph 6.
