DEPARTMENT OF INDUSTRY AND COMMERCE,
IRISH FREE STATE.

REPORT ON ACCIDENT TO
DRUMM BATTERY TRAIN.

MERZ AND McLELLAN

24th July 1935.

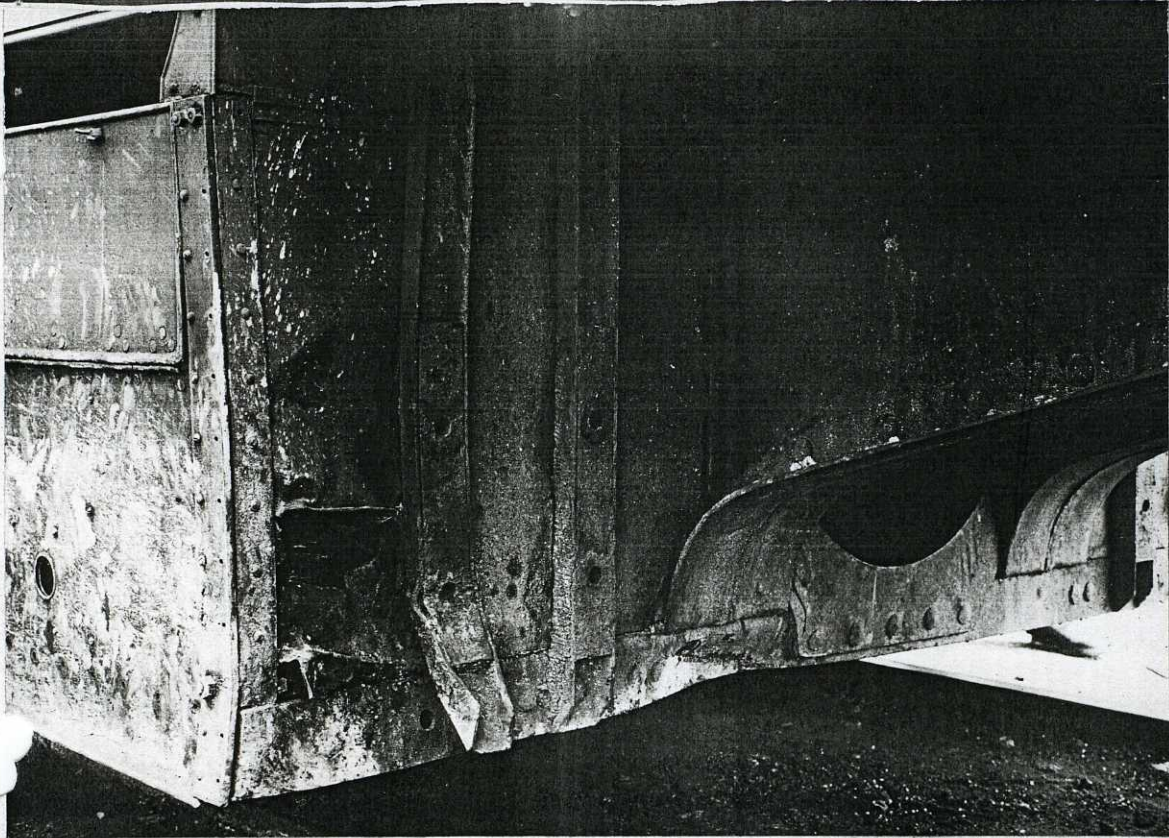
(1) Offside leading corner of leading coach.

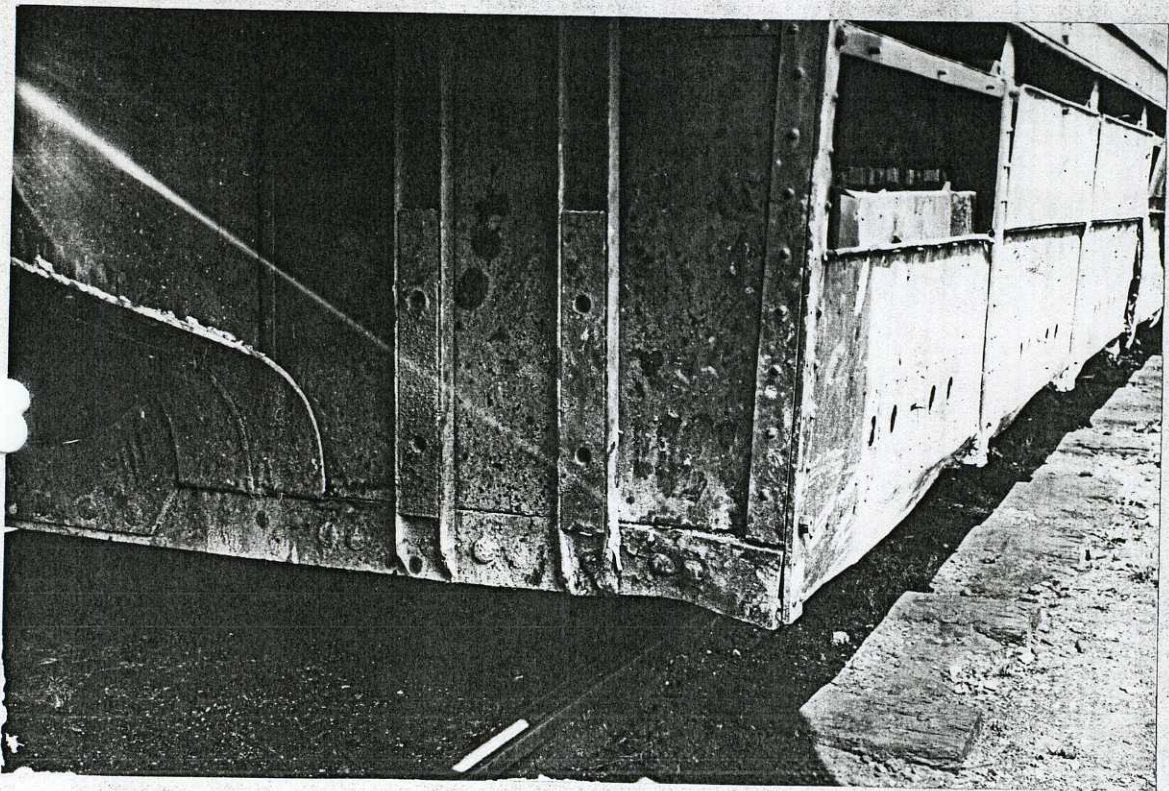
(2) Near side leading corner of leading coach.

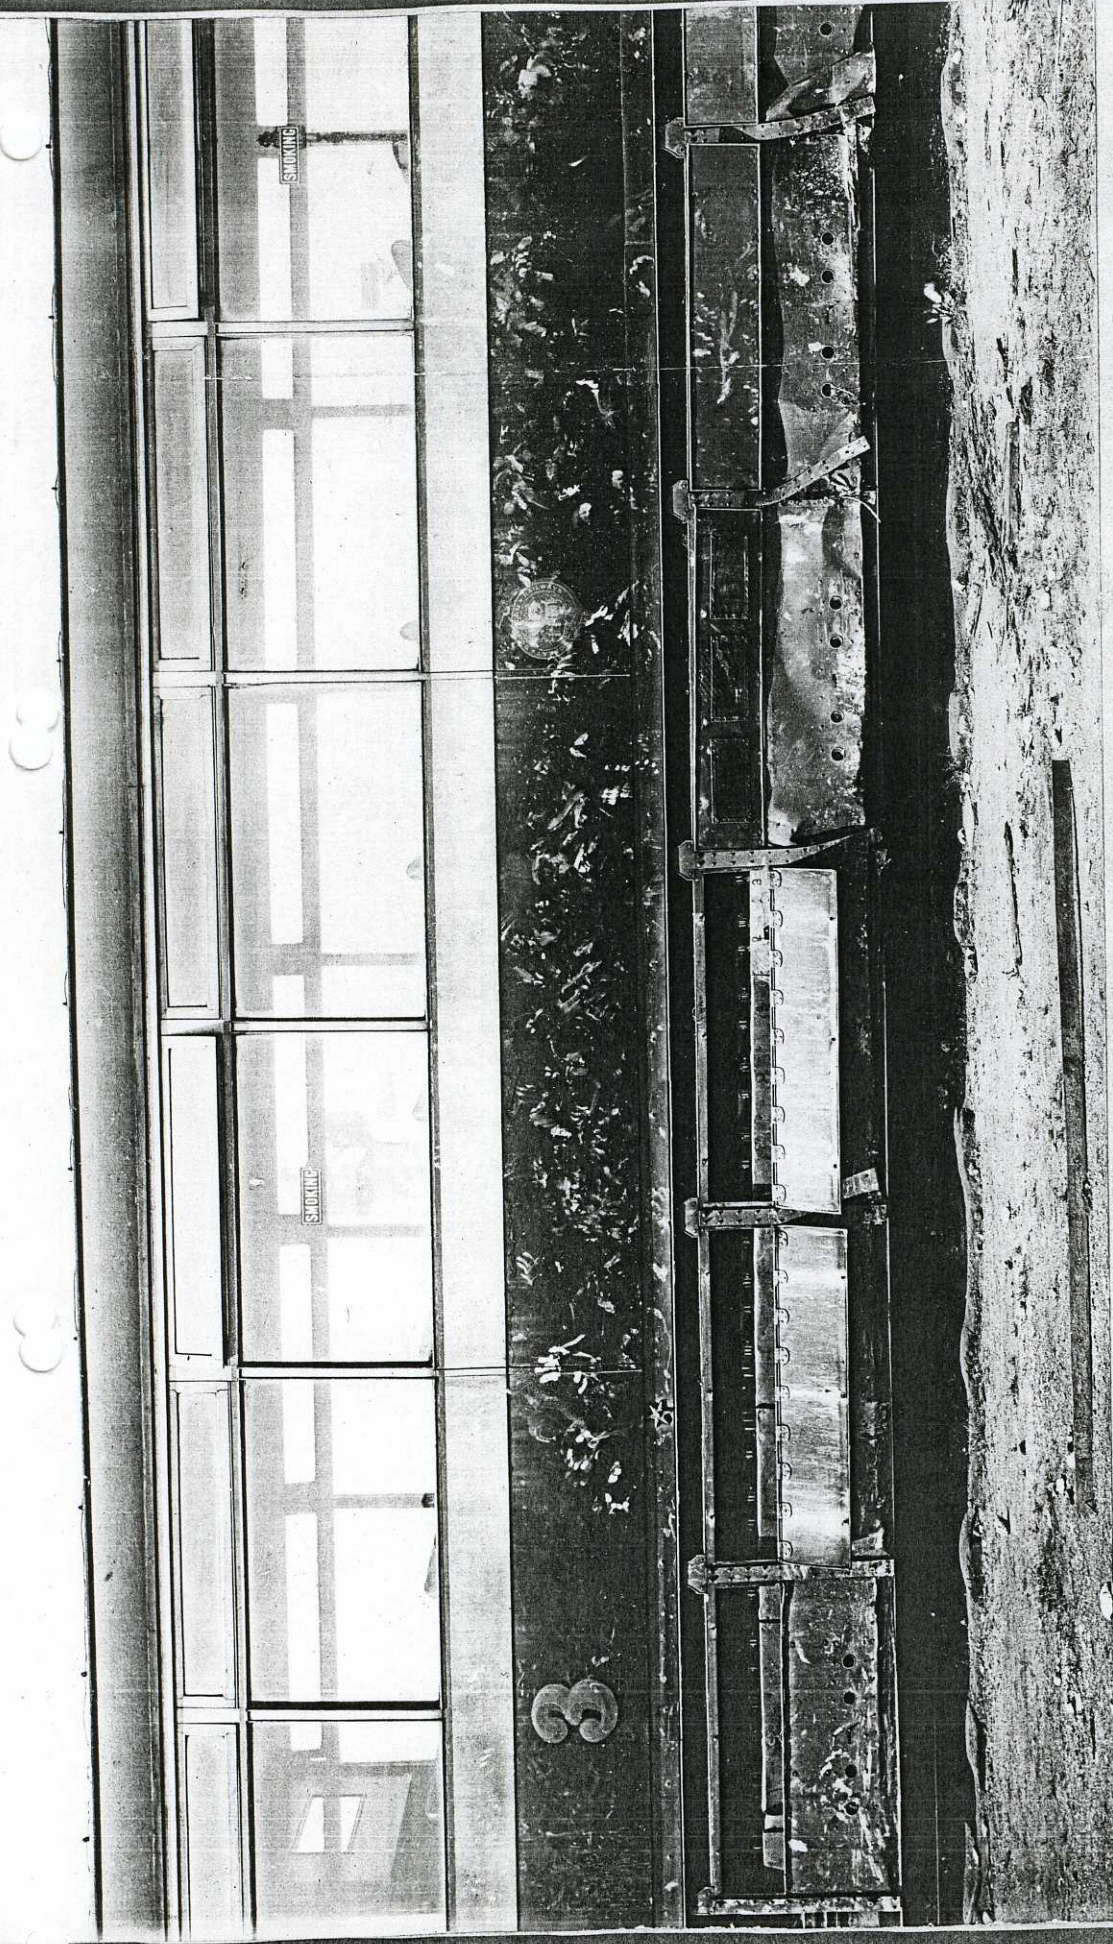
The front bogie truck mounted the debris and was brought to rest before the remainder of the train, and forced about 3 feet 6 inches back under the leading coach, raising the front end 3 feet before the train came to a standstill. The train travelled through the debris for some 20 feet, and the impact with the debris bent and distorted the channel iron members at the lower outside edge of both battery chambers in the leading coach (Photo.3).

(3). Cells 1 to 24. Bay 4.

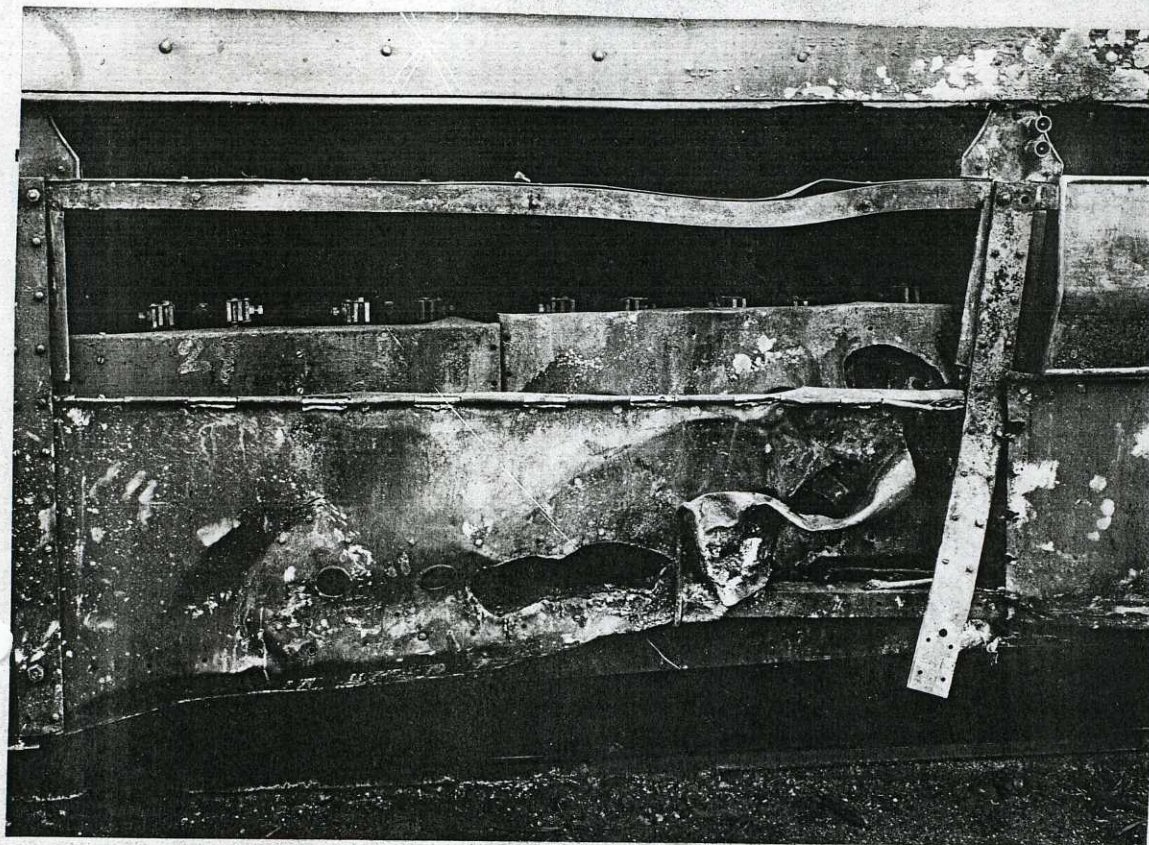
As the result of the derailment the channel iron sections at the bottom edges of the battery chambers were bent, and in the case of the offside chamber of the leading coach were pressed against the steel sides of the crate and forced the steel sides into contact with the containers of the adjacent cells. This point, which is marked "X" on the diagram, is about 24 feet from the leading end of the offside chamber. (Photo. 4).

At point "X" severe arcing and burning had taken place and a very heavy current had evidently passed to the coach underframe.

very heavy current from the battery through the short circuit, estimated at 3000 to 4000 amperes, continuing for 3 or 4 minutes, which generated sufficient heat to burn the insulation on the cables, and char the adjacent woodwork of the floor and sides of the coaches and the wood barriers in the crates.

(4). Cells 28 to 25. (Left to Right) Bay.3.

(1) In our opinion the first essential precaution is to eliminate the possibility of accidental connection between the cell containers and the coach underframe by constructing the sides of the crates of hard wood or other suitable insulating material. (This has already been done in train "B", and is provided for in the specification for new trains.)

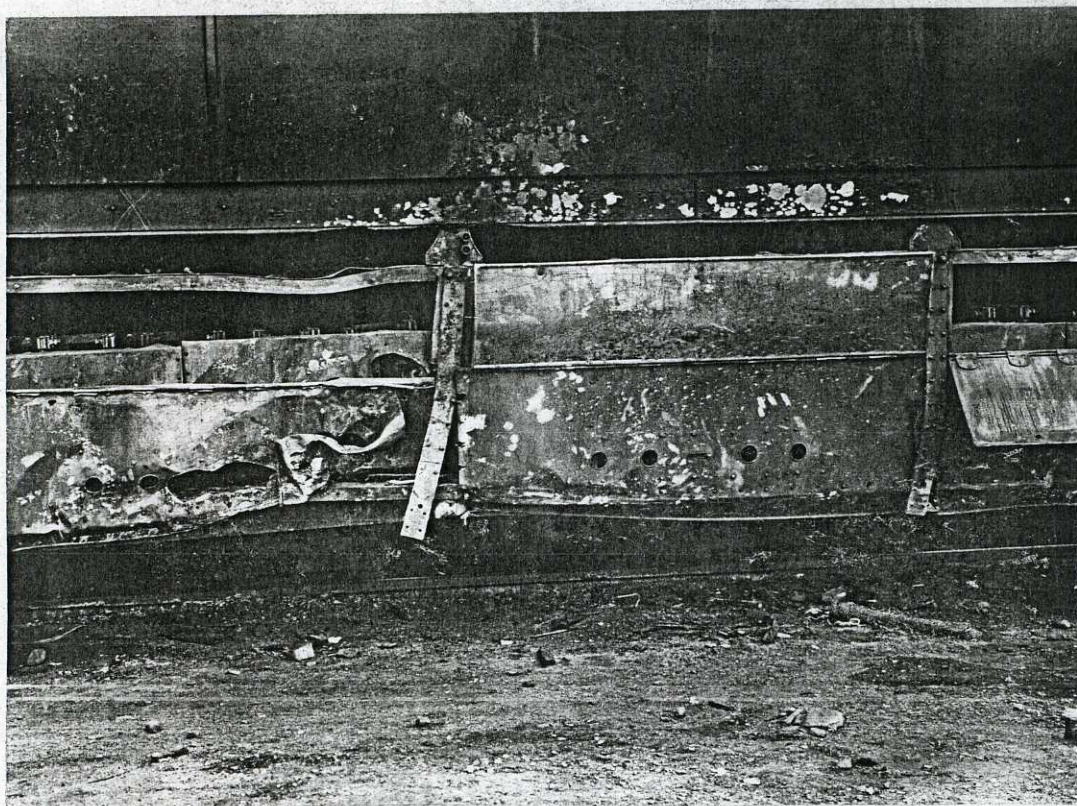
(5) Cells 26 to 21 (Left to Right). Bay 3.

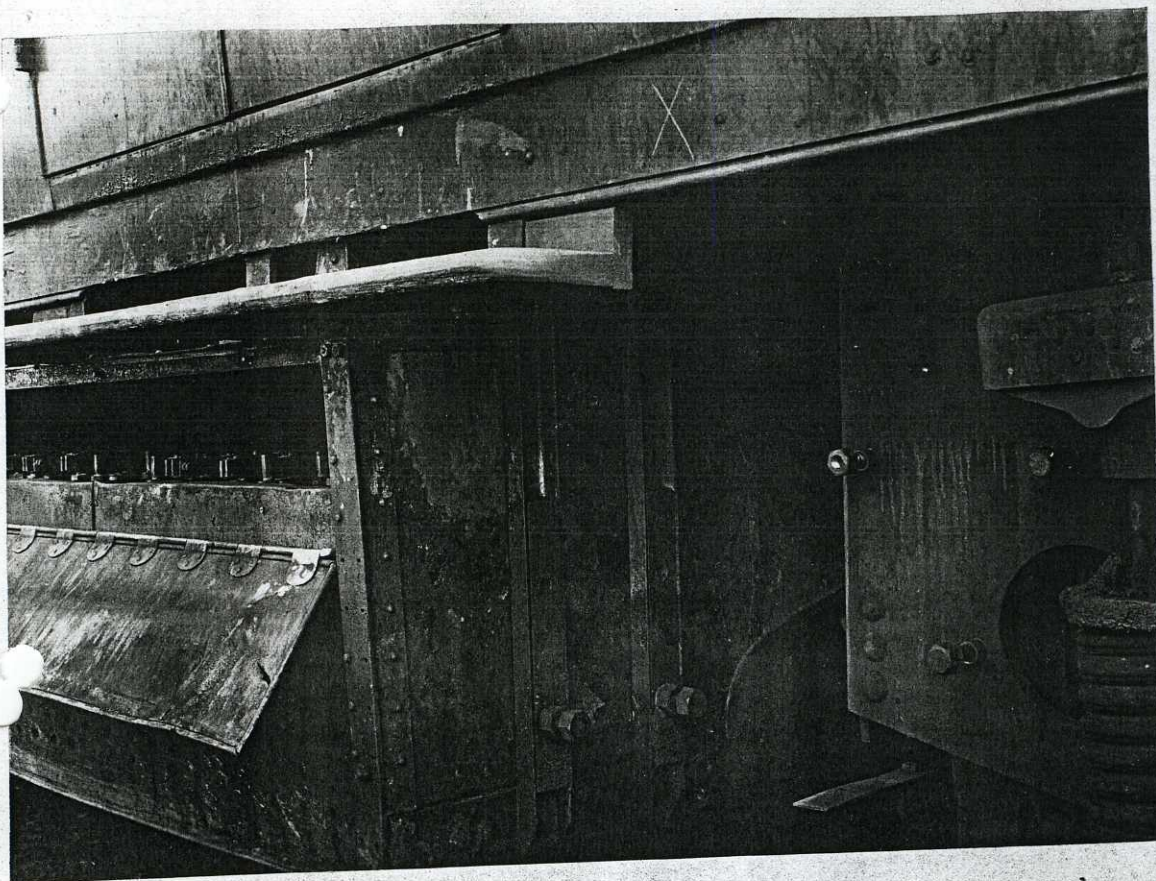
(6). Leading offside corner of trailing coach.

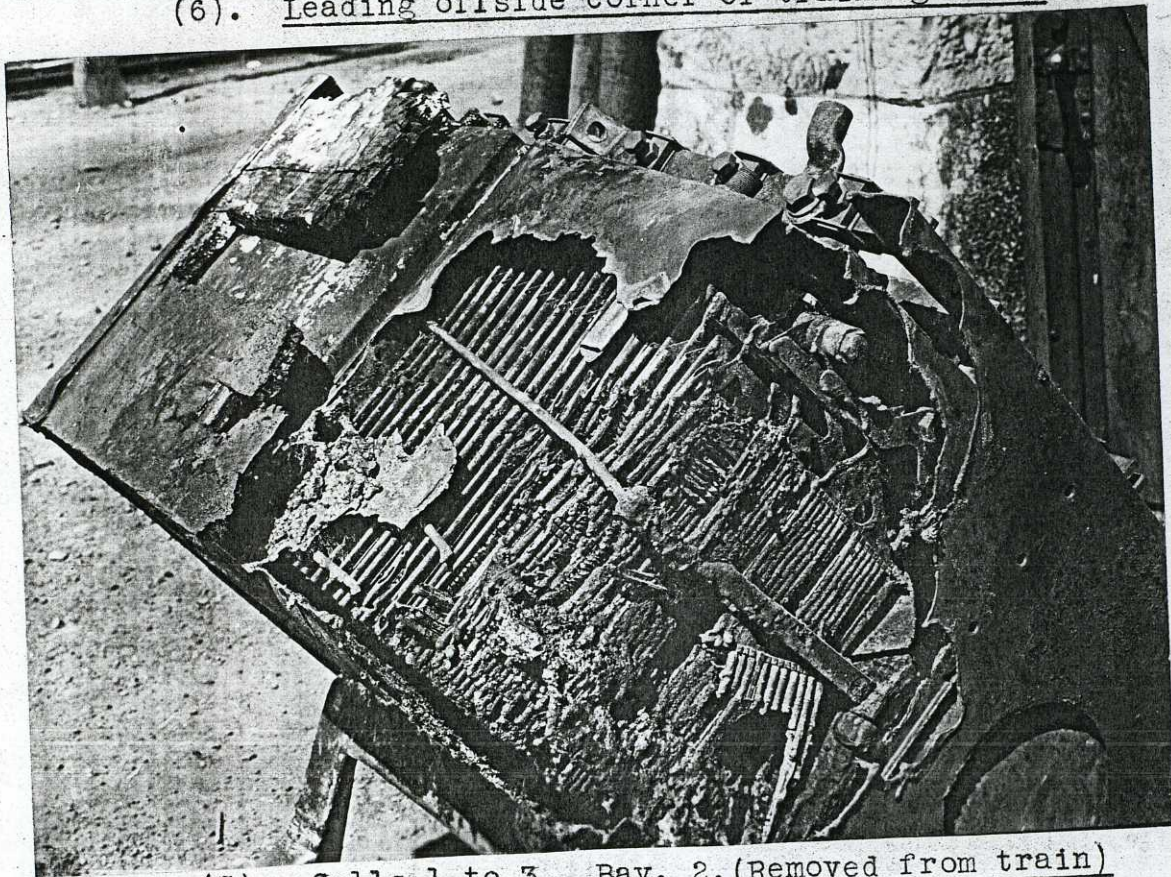
(7). Cells 1 to 3. Bay. 2. (Removed from train)

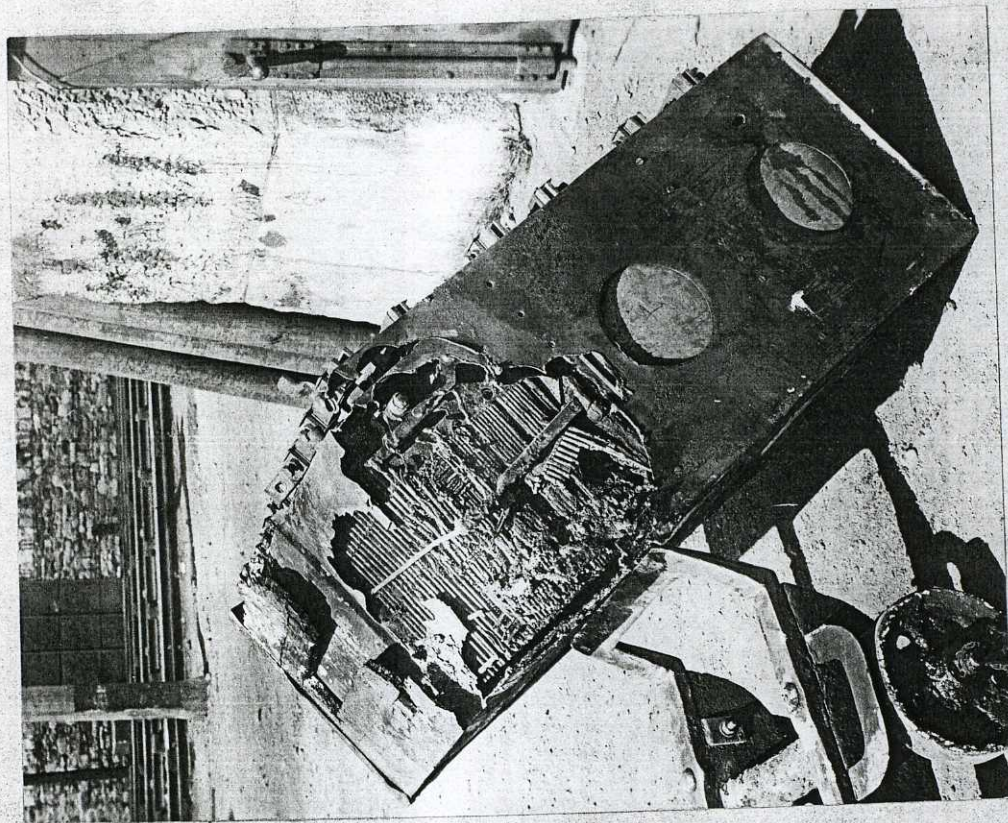
(8). Cells 1 to 3. Bay 2. (Removed from train).

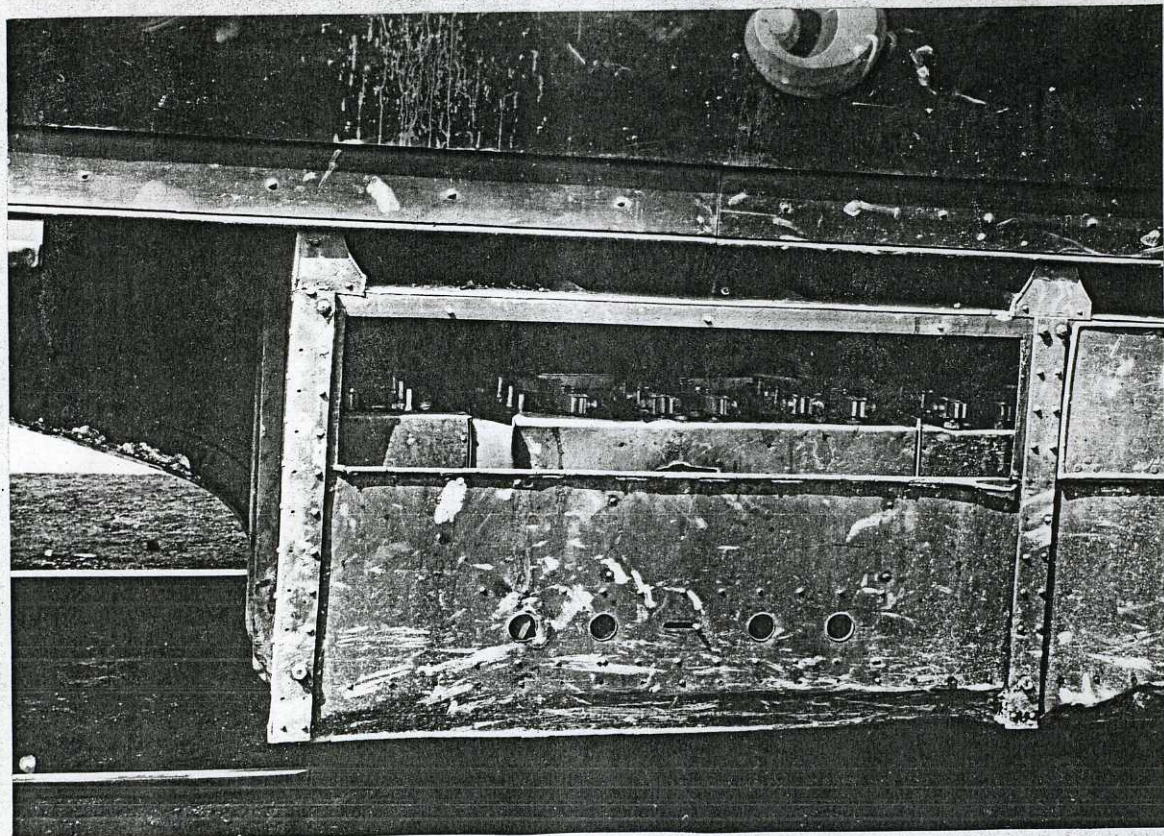
The general distortion of the battery chamber similarly forced parts of the metal structure into contact with steel containers at other points in the leading coach, causing local short circuits between these containers via the coach frame, but these local short circuits may be regarded as of secondary importance in the present

(9). Cells 1 to 5. Bay 4.
