Investigation Report 2011-R001

Laois Traincare Depot Derailment

20th January 2010

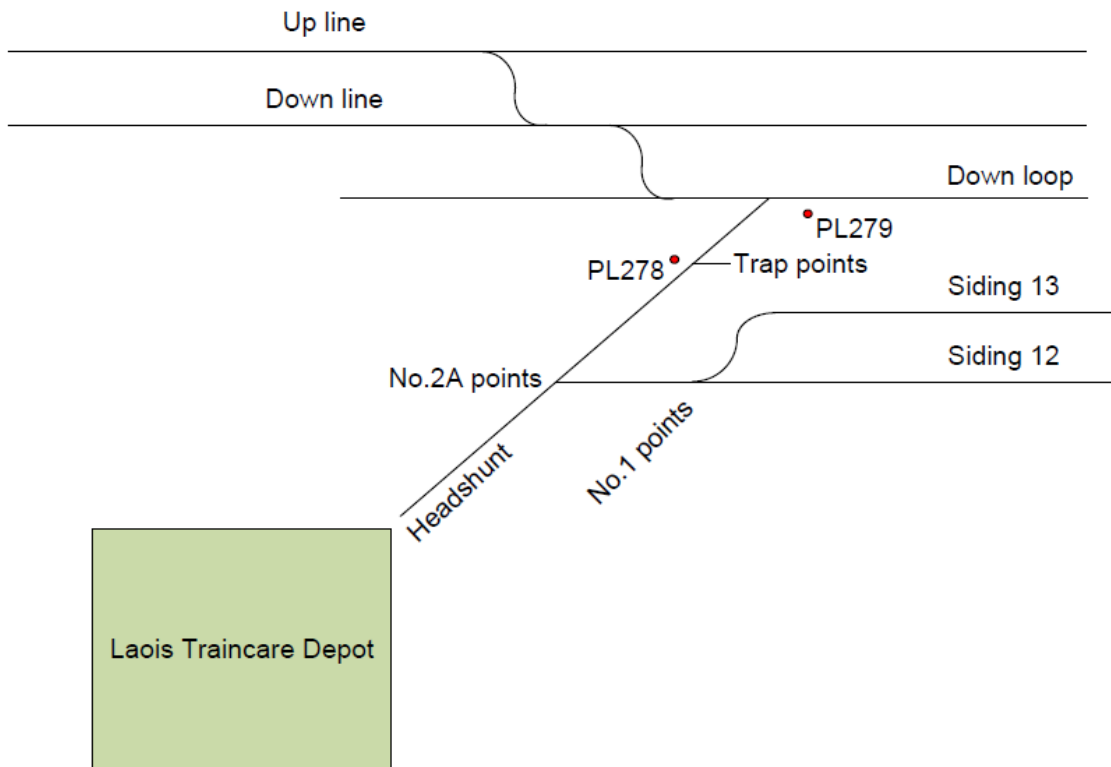
Figure 2 - Depot layout

Signals PL278 and PL279 authorise movement between the Depot and the down loop, these are controlled by CTC. Signal PL279 controls entry to the Depot and signal PL278 controls exit from the Depot onto the down loop, see Figure 2. When leaving the Depot trains remain stationary at signal PL278 until a proceed aspect is given to join the down loop.

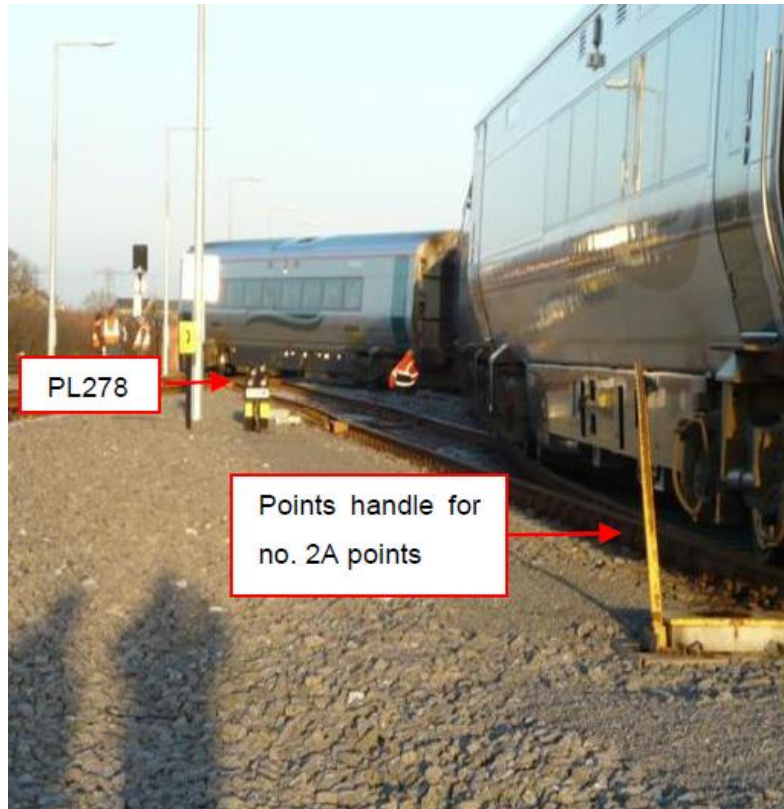
Photograph 1- Signal PL278 with 2A points in the foreground

The immediate cause of the accident was the movement of the number 2A points as the train was passing over them causing the carriages to take diverging routes and carriages three and four to derail.

On approaching the number (no.) 2A points the Shunter moved the *points handle* setting the no. 2A points for travel in the direction of the down loop. The train then moved forward to signal PL278, see Photograph 1. The Train Driver was unable to read the *signal aspect* due to sunlight shining on it.

The Shunter then walked back alongside the train to the no. 2A points, a distance of approximately 30 metres (m), in order to return them to their normal position, for movements on the *headshunt*. He operated the points handle changing the direction of the points as the train was still moving over them. The Shunter realised his mistake immediately but was unable to rectify the situation. This led to the train taking divergent paths resulting in the derailment of the third and fourth carriages. See Photograph 1.

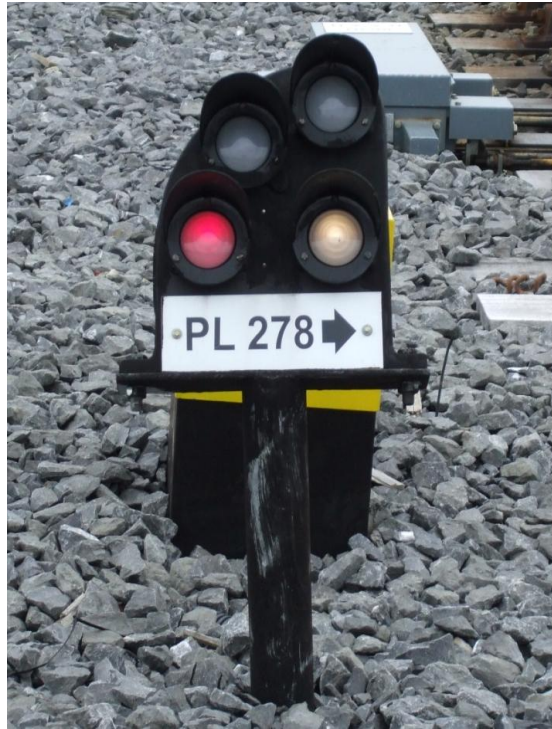
Photograph 2 - Signal PL278 illuminated by filament lamps

At the time of the accident signal PL278 was illuminated by filament lamps, see Photograph 2. Train drivers had voiced concerns over visibility of this signal through the Operations Department prior to the accident. Initially these concerns were raised verbally, however, on the 9th Sept 2009 a written request was made to the SET Department to upgrade the signal from a filament lamp to a brighter LED signal. The Depot Manager was unaware of the train drivers concerns with the signal.

Signal Sighting Committees are convened, as required, to determine the most suitable and safest positions for all new and altered signals. Their remit also includes convening to consider problems or alleged problems with an existing signal. The SET Department did not inform the Signal Sighting Committee of the reported issue with signal PL278. The SET Department adjusted the orientation of the signal head. There was no evidence to show that the SET Department checked the effectiveness of this change.

Concerns had been raised in relation to visibility of the filament lamps in signal PL278. This did not prompt the SET Department to inform the Signal Sighting Committee in accordance with section 2.1.5 of I-SIG-2043, instead the positioning of the signal head was adjusted by the SET Department. The effectiveness of the change was not verified and as a result of this the need for shunters to assist train drivers with the reading of the signal continued.

The filament lamps in signal PL278 were difficult to read in sunlight. A Signal Sighting Committee was not convened to consider the problem and the measures taken by the SET Department to resolve this issue were found to be ineffective. The change was not verified for effectiveness, allowing the problem to remain. This has led to the recommendation:

- Signal PL278 has been upgraded to an Light Emitting Diode (LED) display;
- Shunters have been briefed regarding this accident and of the need to remain focused on their task.

- IÉ should ensure that the Signal Sighting Committee is informed when train drivers report difficulties viewing a signal and the Signal Sighting Committee should verify that the reported difficulties are addressed effectively.

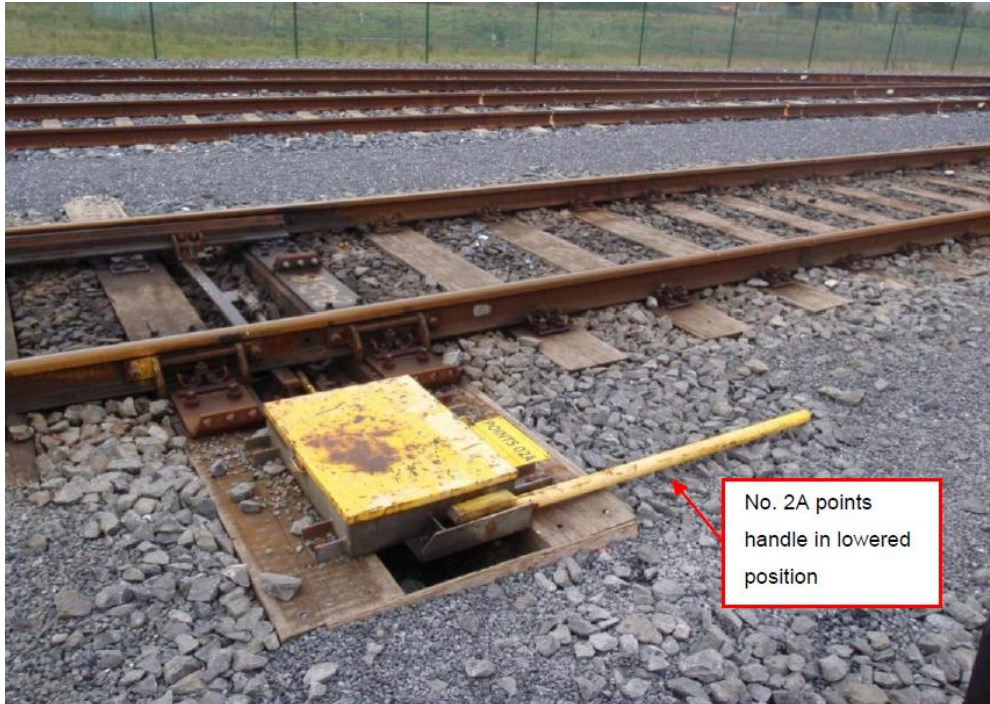
Photograph 3 – No. 2A points with points handle disengaged

The points mechanism installed at no. 2A points are spring assisted and require minimal force to operate them. They require two actions to operate the points, these are:

- Engaging the points handle by lifting the points handle from its stored position, laid horizontally on the ground, and connecting it to the points gearing, see Photograph 3;
- Moving the points by moving the points handle.

When not in use the points handle is to be stored in the disengaged position, see Photograph 3. There are only two sets of this type of points mechanism on the IÉ network.

When the no. 2A points are not in use shunters are instructed to disengage the points handle to prevent accidental activation of the points. This instruction is not documented as part of the operating procedure and implementation of this verbal instruction was found not to be strictly enforced.

No risk assessment was found to exist in relation to the no. 2A points. In addition, the CME instruction 'Laois Traincare Depot Safe System of Work and Operating Instruction' (IÉ CME, July 2009) did not identify the requirement to disengage the points handle when not in use, which mitigates the risk of accidental operation of the points. The requirement to disengage the points handle was found to be covered as part of the training of shunters but there was no enforcement of this verbal instruction. This led to the points handle being left in the engaged position on the day of the accident. Once this occurred the minimal effort required to move the points handle allowed the Shunter to operate the points inadvertently whilst walking past.

The necessity to disengage the points handle for the no. 2A points when not in use was not addressed in the operating instructions for the Depot and the verbal instruction to disengage the points handle was not enforced. As a result, the risk of accidental operation of the points due to their ease of use was not adequately controlled. Hence, it is recommended that:

- IÉ should ensure that the risks relating to use of spring assisted manual points are identified and that appropriate control measures are implemented based on the risks identified.
