Investigation Report No. 2010 – R004

August 2010

**Malahide Viaduct Collapse on the Dublin to Belfast Line,
on the 21st August 2009**

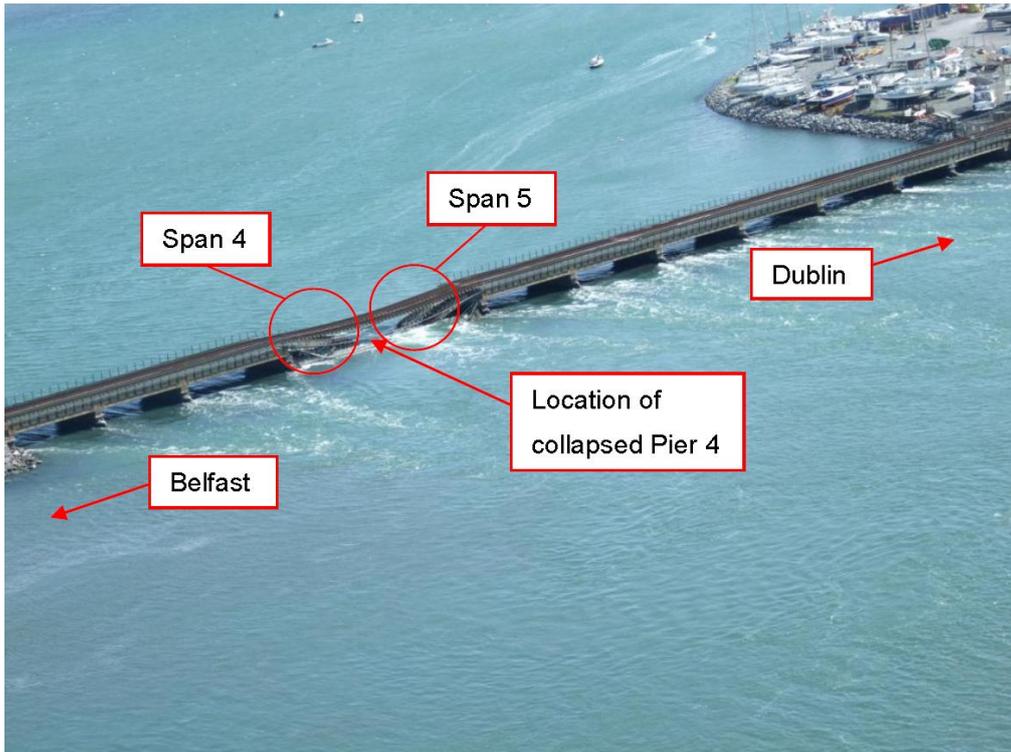
Photograph 4 – Collapsed Malahide Viaduct

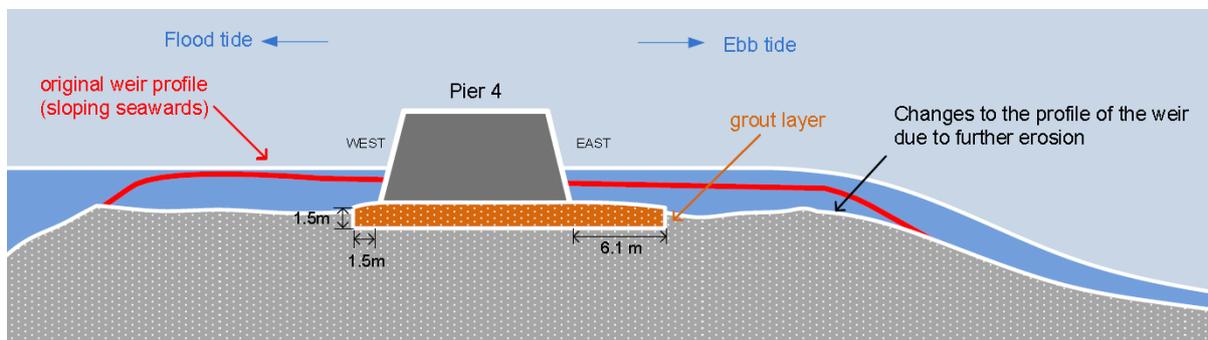
However, the grouted rock armour began to break down as a result of degradation of the grout (the grout on the west side remained semi-intact). This led to further transport of cobble and grout from the weir crest. However, with the non-replacement of materials to the crest of the weir further erosion resulted under the eastern side of the pier, (see Figure 16).

Figure 16 – Erosion of the eastern side of the weir

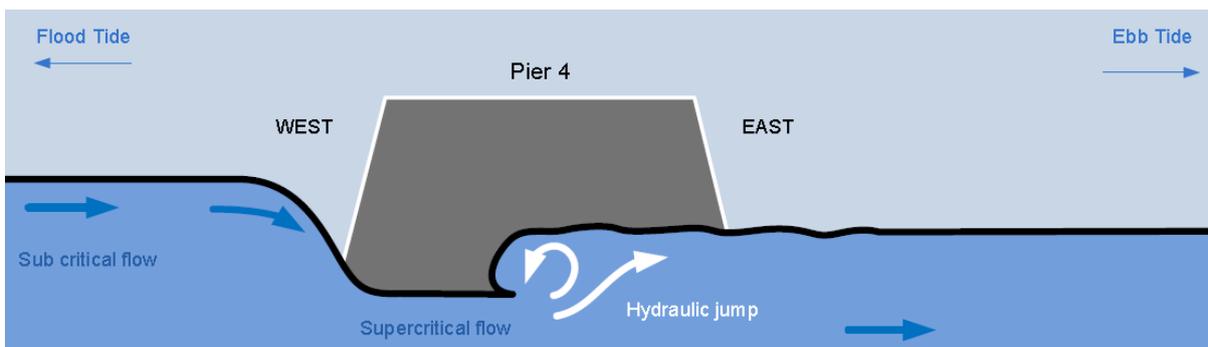
However, the 3-D 1:80, simulating the high spring *ebb tide* flowrate, showed that when the tide reached certain critical levels on the eastern side, a hydraulic jump formed between Pier 4 and Pier 5, the location of the collapsed pier (see Figure 18 and Photograph 8). Velocity measurements were taken from the model at the mid-point of the pier to the downstream side of the weir. These measurements were recorded in the model and scaled to the prototype giving values in the range of 4m/s to 5.5m/s.

Figure 18 – New position of hydraulic jump, between piers 4 and 5

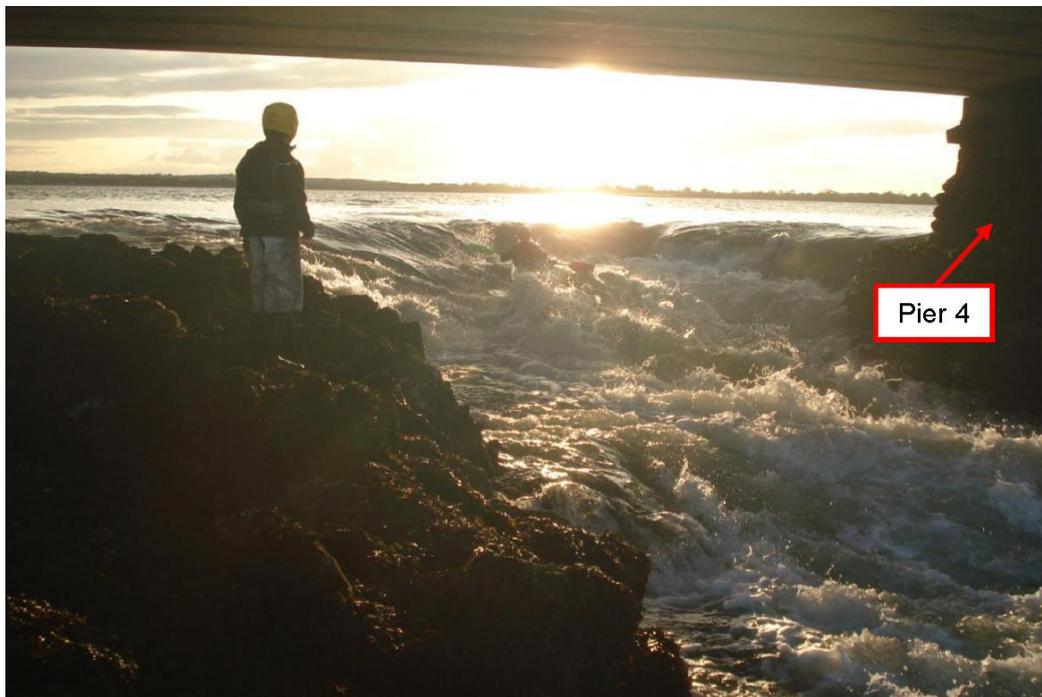
This erosion resulted in the area between Pier 4 and Pier 5 to deepen forming a channel (see Photograph 9). This resulted in changes to the water flow under the structure, with the flow of water no longer being evenly distributed through all twelve spans.

Photograph 9 – Deepened channel between Pier 4 and Pier 5

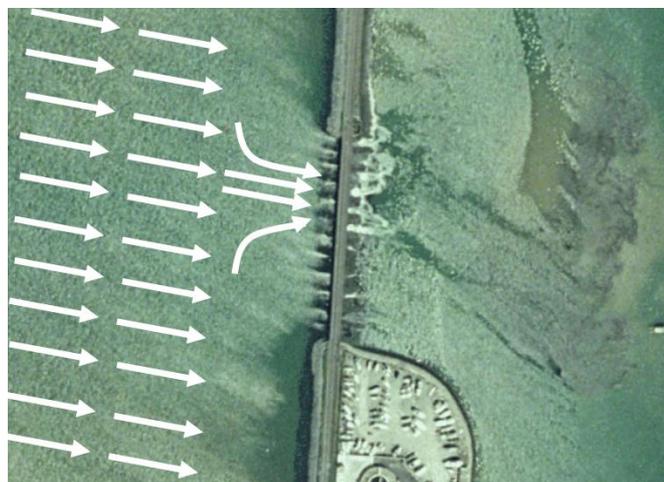
As a result of the deepened flow path, through Pier 4 and Pier 5; and the increased hydraulic gradient resulting from the erosion of the crest of the weir, the potential for the winnowing of smaller stones from the weir was increased.

Photograph 10 – Majority of water flow between Piers 4 and 5

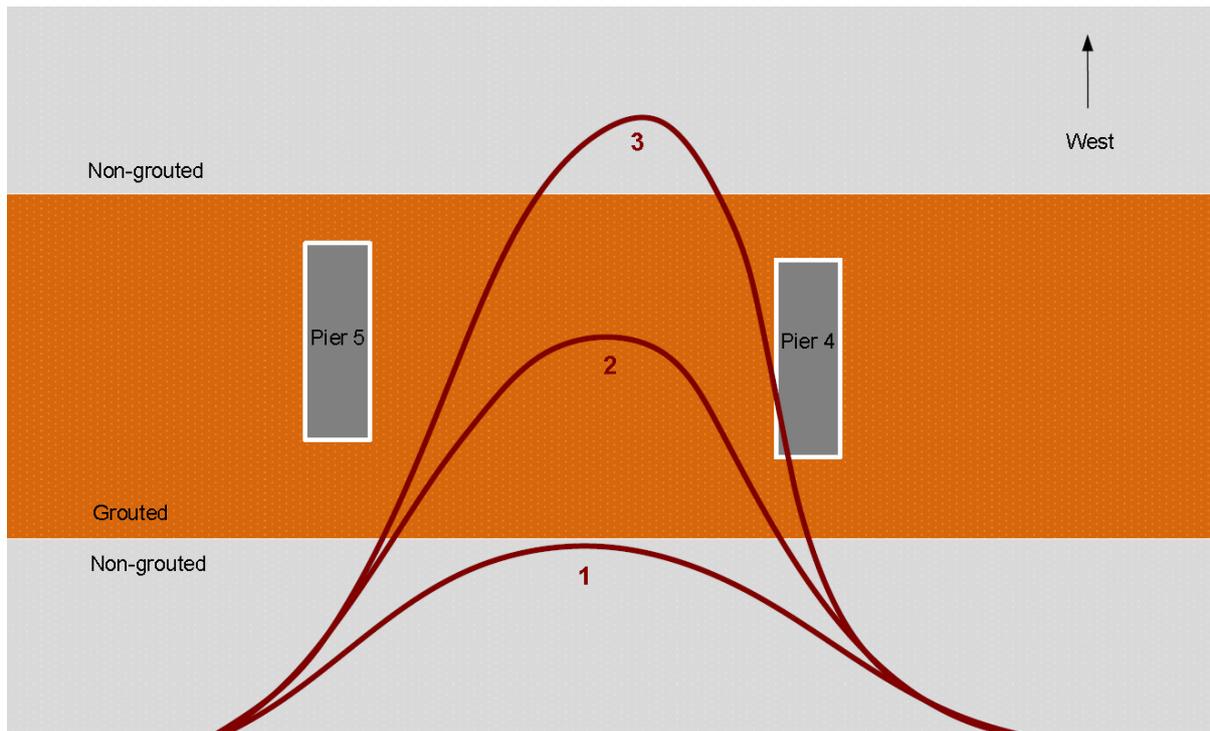
Figure 19 illustrates the grouted and un-grouted zones of the weir, as well with the red lines indicating the general westward propagation of the hydraulic jump where the grouted and non-grouted weir material has been removed by the scour action.

Figure 19 – Westward propagation of the hydraulic jump and erosion due to scour action

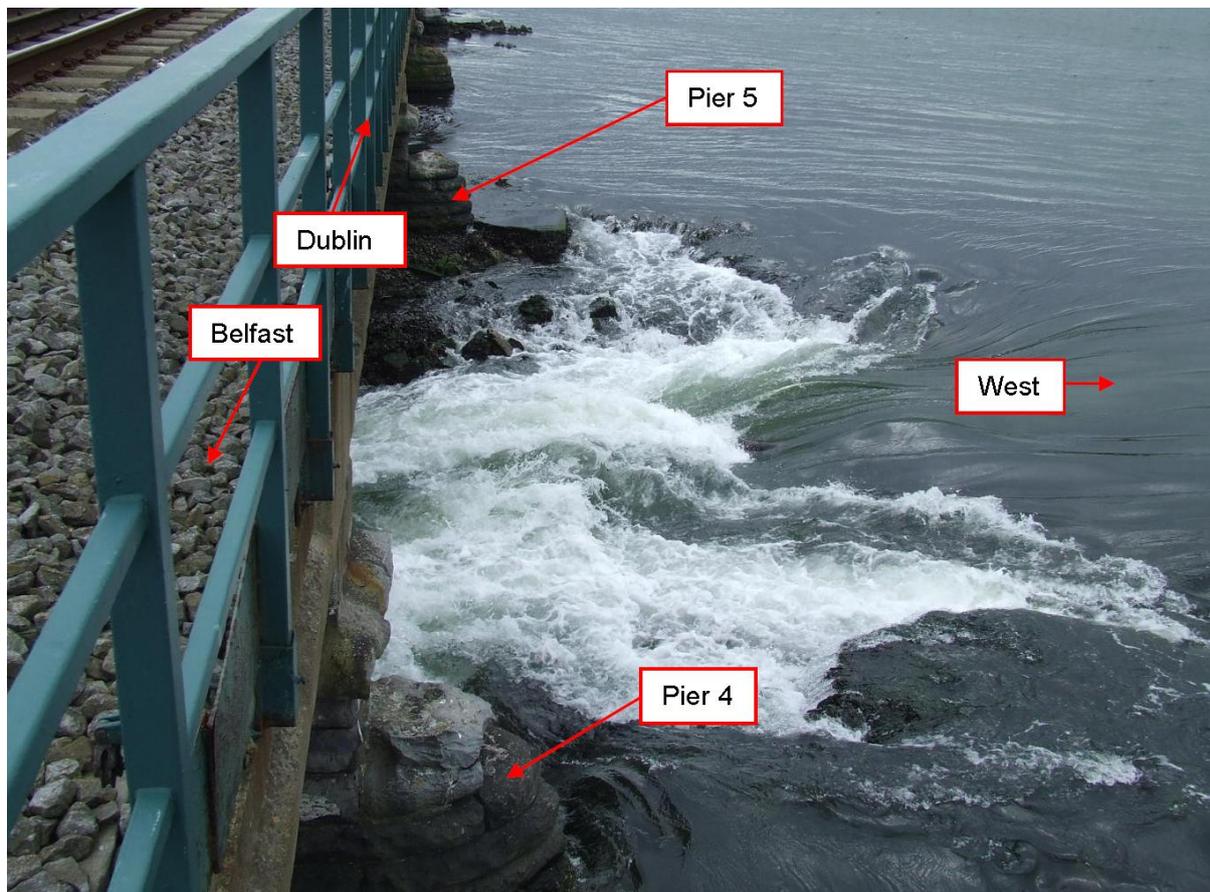
The reported washing away of 'stones' would indicate that the erosion mechanism had accelerated and the stones close to the foundations of Pier 4 had started to be displaced on the western side of the weir. This can be verified from the photograph taken by IÉ during the structural inspection on the 18th August 2009 (see Photograph 11). It can be seen, from the photograph, that the ebb flow hydraulic control point had moved further west at Piers 4 and 5. This suggests that serious erosion was occurring in the months leading up to the collapse of the viaduct, confirming the flow was accelerating over the crest, resulting in high velocities upstream of the western foundations of Pier 4.

Photograph 11 – Photograph taken during inspection of Viaduct on the 18th August 2009

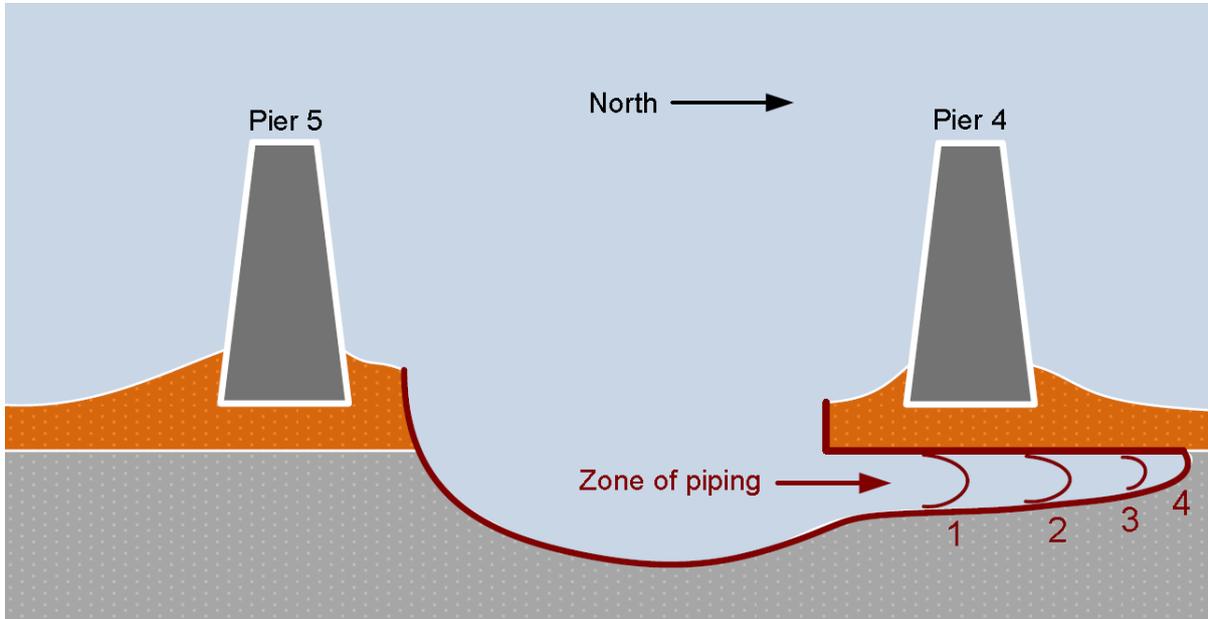
The narrowed flowpath and the remaining semi-intact grout rock armour on the western side meant there was an increased potential for *piping*. Piping occurs when there is a sub-surface formation and progression of a continuous ‘pipe-like’ tunnel. The material is eroded by the flow of water through the tunnel, which then carries away these eroded particles, (see Figure 20).

Figure 20 – Piping under Pier 4.

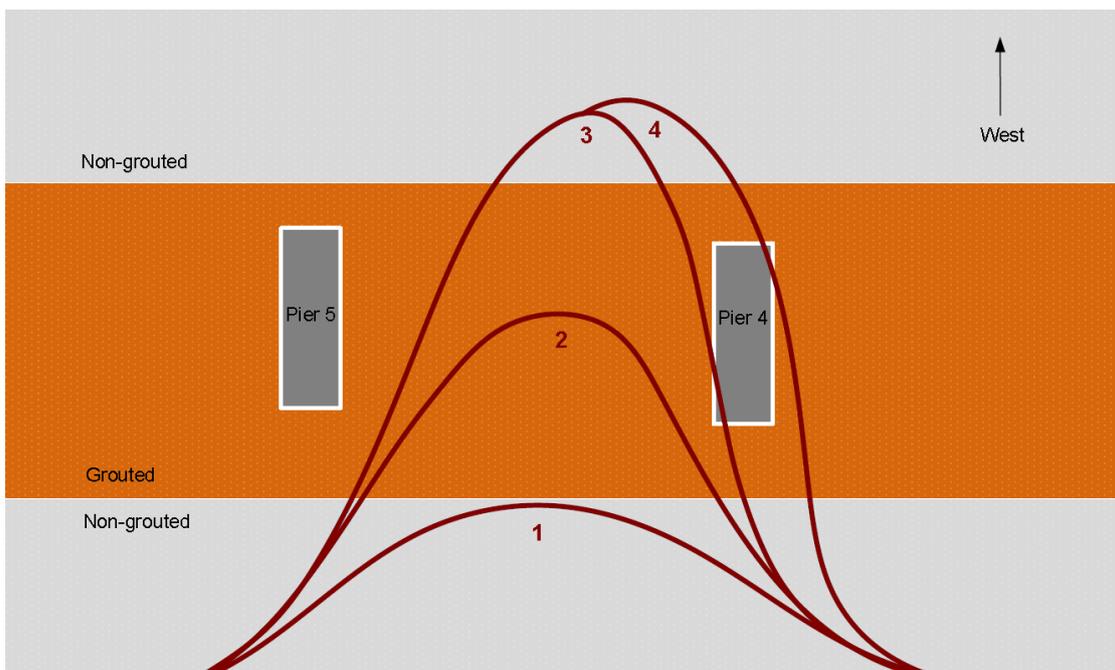
The piping flowpath was under the remaining grout layer on the west side of the weir with the grout layer acting as an upper boundary to the flow pipe, causing undermining of Pier 4 (see Figure 21).

Figure 21 – Undermining of Pier 4 as a result of piping

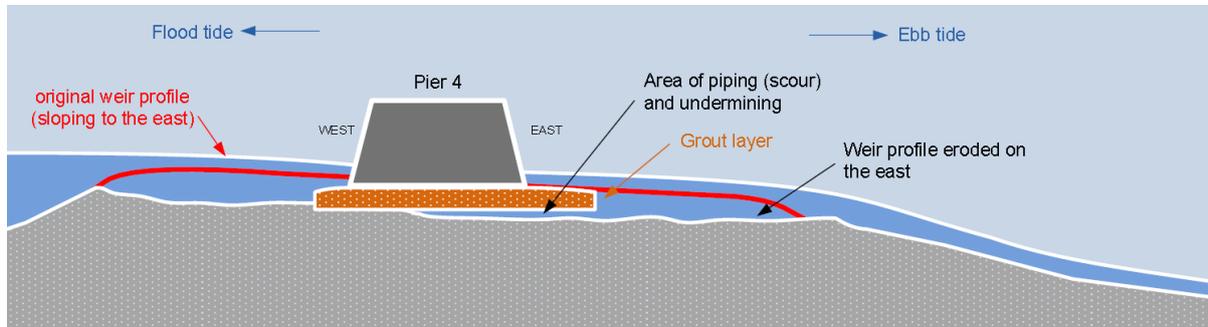
The red lines 1 – 3 in Figure 20 and 21, illustrate the general westward propagation of the hydraulic jump where the grouted and non-grouted weir material has been removed by the scour action (as occurred in the medium term events), the addition of red line 4 indicates the post collapse zone of the 'piped' scour that undermined the grout apron. Figure 22 clearly illustrates this undermining.

Figure 22 – Transport of materials after the movement of the hydraulic jump

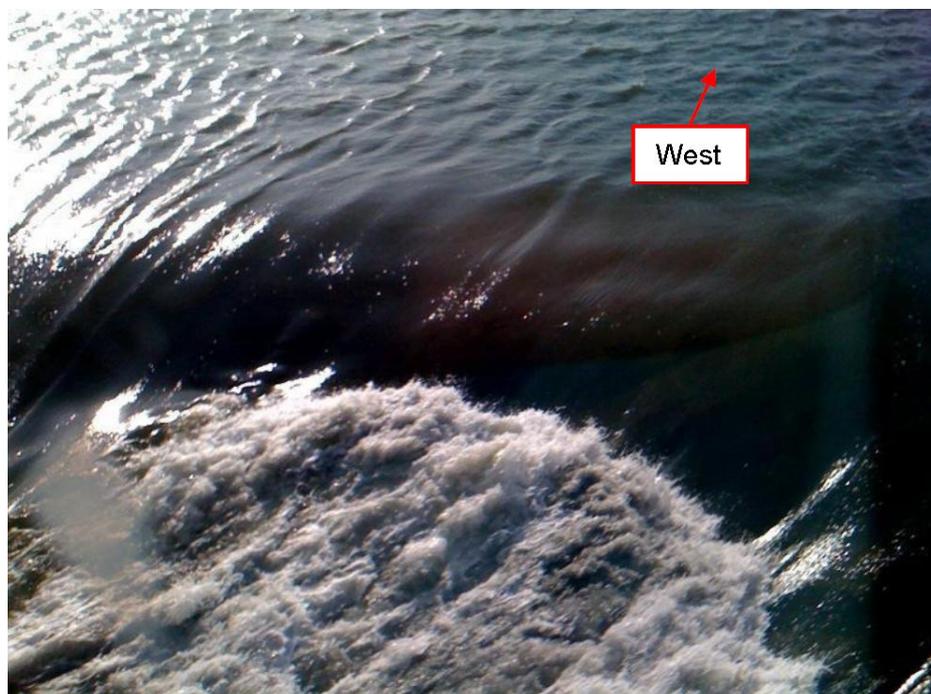
This has been verified by a photograph taken by a passenger travelling over the viaduct at 9.35 hrs on the 21st August 2009, the day of the collapse. He observed a whirlpool of approximately 3 m diameter on the western side of the viaduct. From the passenger's position on the train, the whirlpool would have been located approximately 4 – 5 m from the viaduct. The passenger again observed and photographed this whirlpool at approximately 17.55 hrs, (see Photograph 12). This passenger's travel over the viaduct coincided with the ebb tide flow for the day.

Photograph 12 – Vortex, photograph taken 30 minutes before the collapse

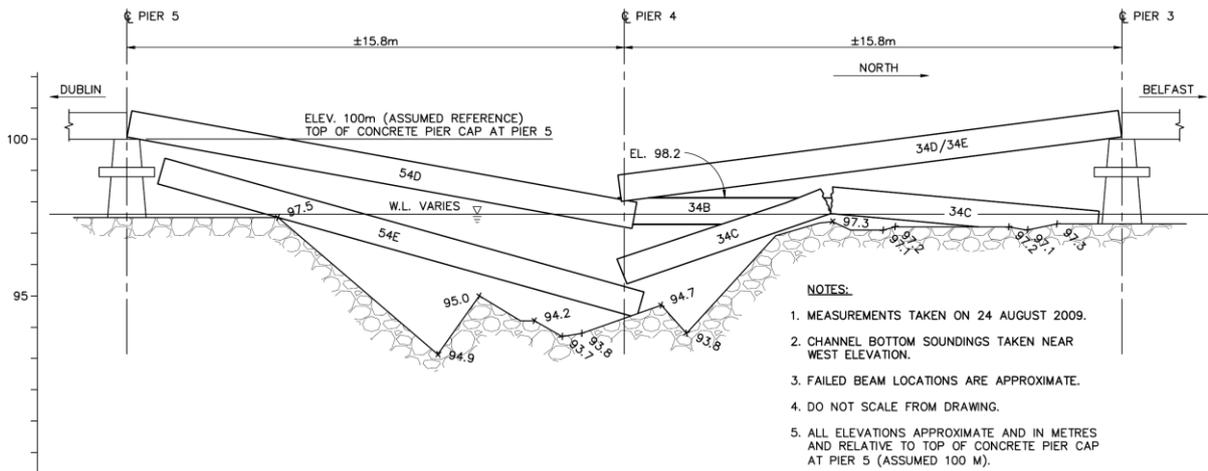
From a post accident survey (see Figure 23) an asymmetrical form can be observed. The significance of this observation is that the cause of scour is unlikely to be solely a result of 'local scour', further reinforcing the cause of the undermining to be as a result of piping scour.

Figure 23 – Post accident survey illustrating asymmetrical scour hole

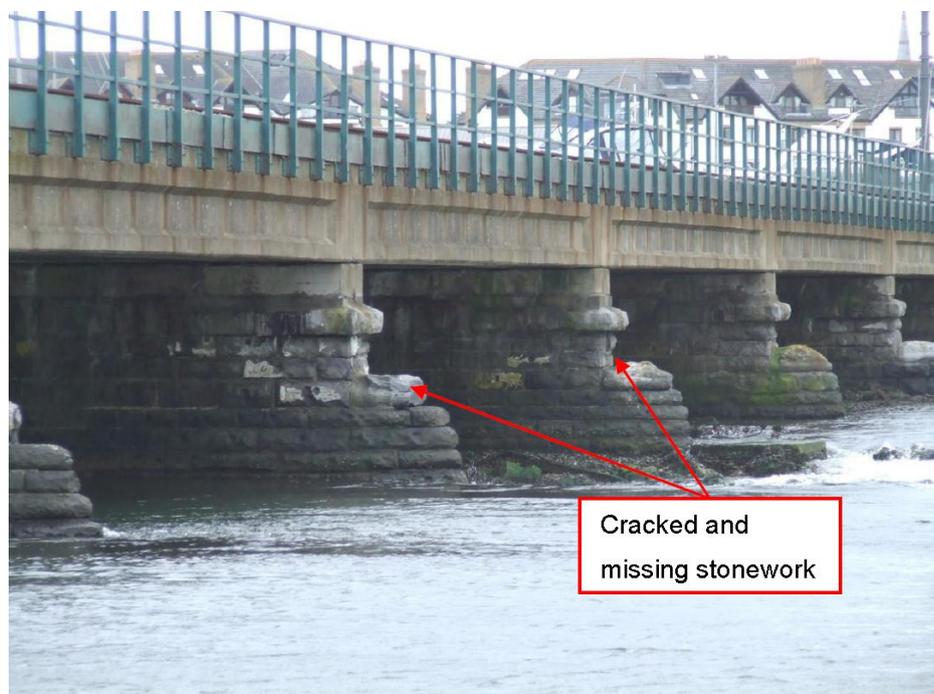
Prior to the AE carrying out an examination of Malahide Viaduct at 14.10 hrs on the 18th August 2009, the AE had not carried out an inspection of the Malahide Viaduct and was not familiar with the structure or the tidal conditions of the Broadmeadow Estuary. The AE recorded the examination with photographs and found defects in the piers' stonework, such as the piers' required repointing and found that some of the stones on a number of the piers were cracked or missing, (see Photograph 15).

Photograph 15 – Photograph taken by the AE on the 18th August 2009, showing defects to piers' stonework

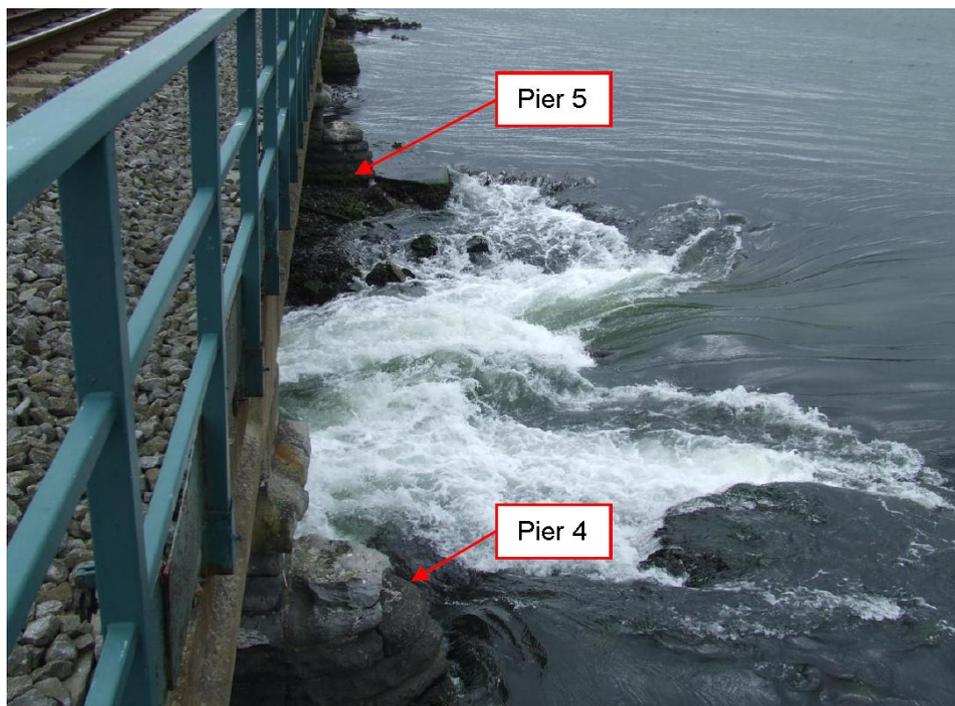
The AE also photographed (see Photograph 16) the base of the piers on the fifth span of the Malahide Viaduct (i.e. the span reported by the Malahide Sea Scouts group leader to IÉ as the span with the erosion at the base of the piers) and determined that there were no indications of erosion at the base of the piers.

Photograph 16 – Span 5 (between Pier 4 and Pier 5) of the Malahide Viaduct

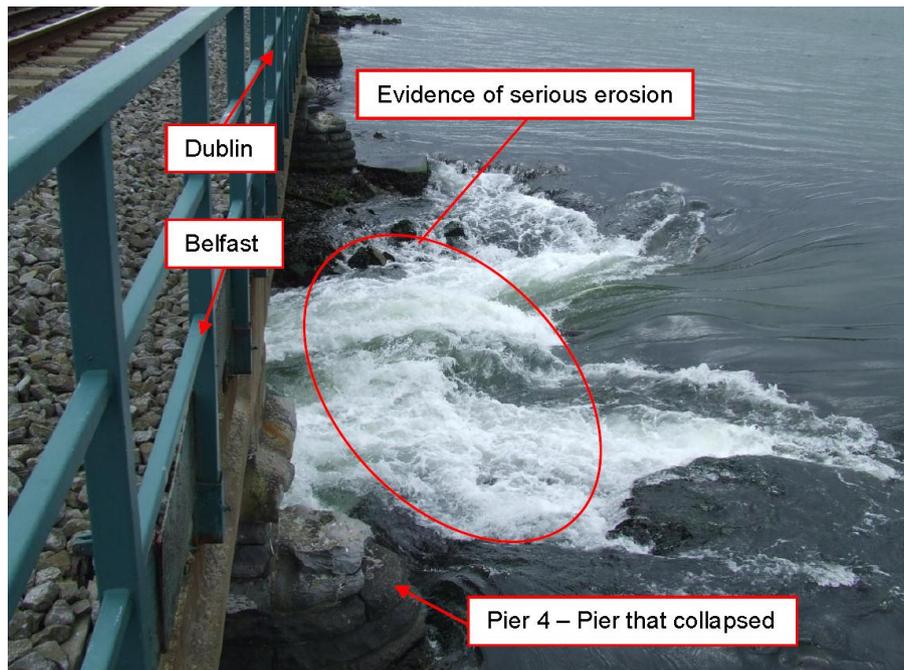
Reviewing the photograph (Photograph 18) taken by the AE, there is evidence of serious erosion, however, the AE, being unable to recall any information from the training, unable to decipher the training notes provided, and not experiencing any practical element to the training, did not conclude that there was any evidence of scouring at Malahide Viaduct. Reviewing the condition ratings, provided in the training notes, Condition Rating 4 illustrates where undercutting of the rock armour had occurred, similar to the failure mechanism of the collapse of Pier 4.

Photograph 18 – Photograph taken during inspection of Viaduct on the 18th August 2009
