Investigation Report 2011-R007

Car Strike at Knockaphunta Level Crossing (XM250),

County Mayo,

24th October 2010

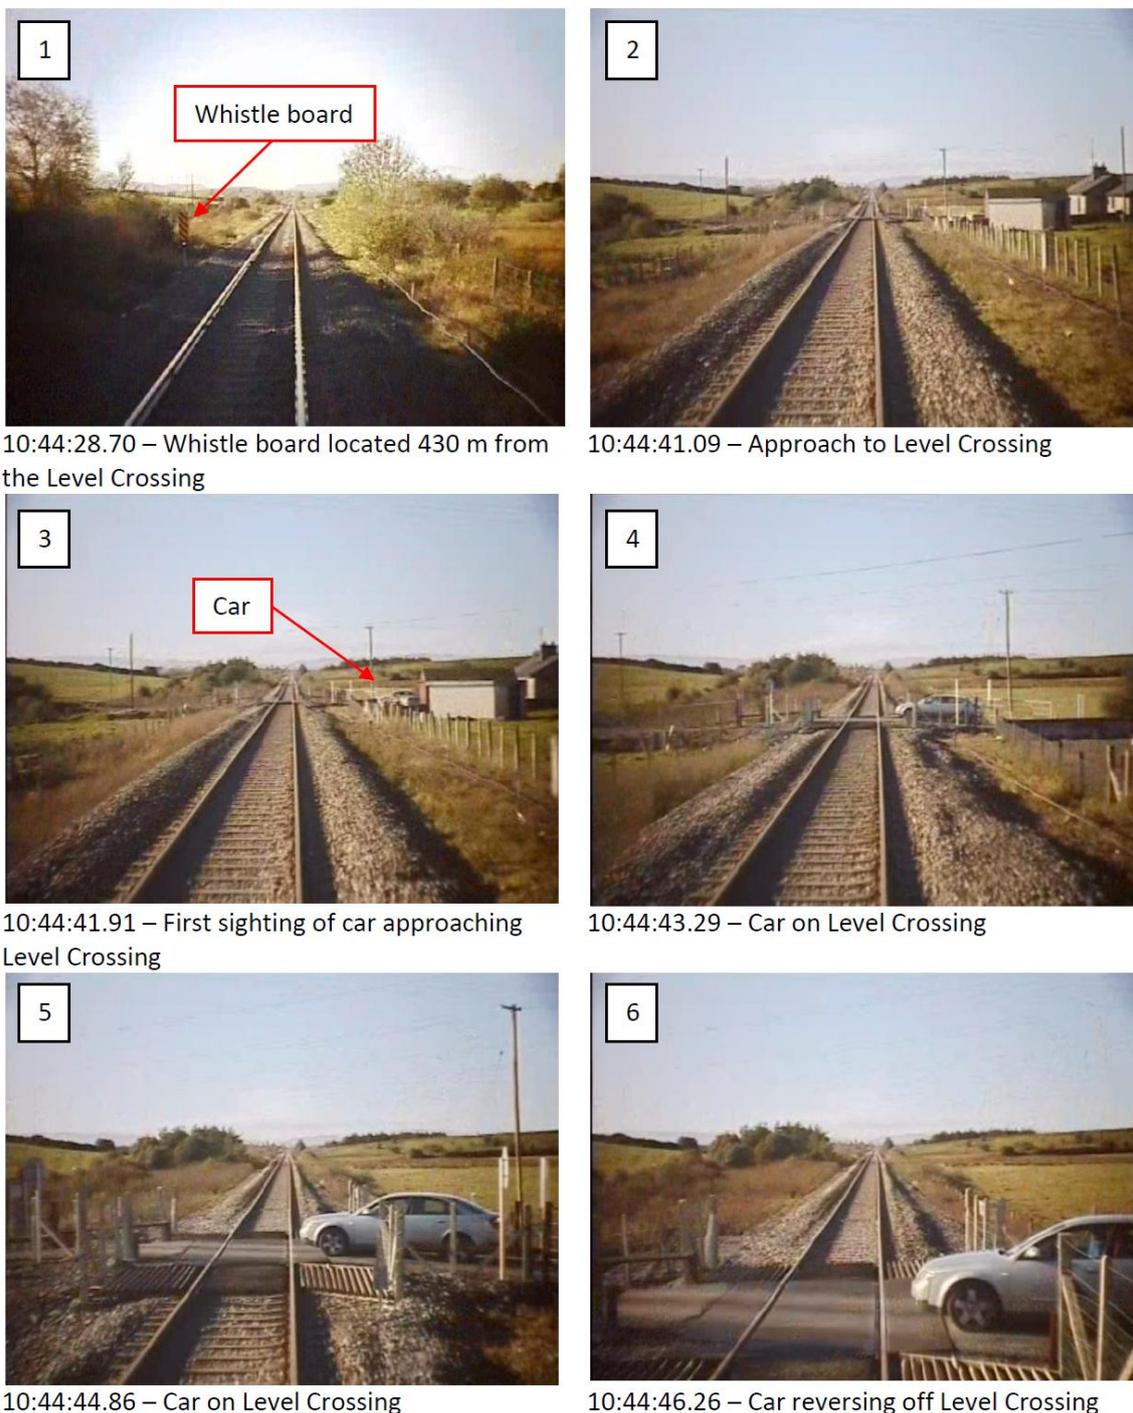
As the Train continued to approach, a car travelled from the *Up* side of the Level Crossing and stopped at the Level Crossing. The Train Driver immediately re-sounded the horn and applied the emergency brake. The car then started to reverse off the Level Crossing, however, it did not clear the Level Crossing in time and was struck by the Train.

Figure 2 – CCTV snapshots of the Train's approach to the Level Crossing

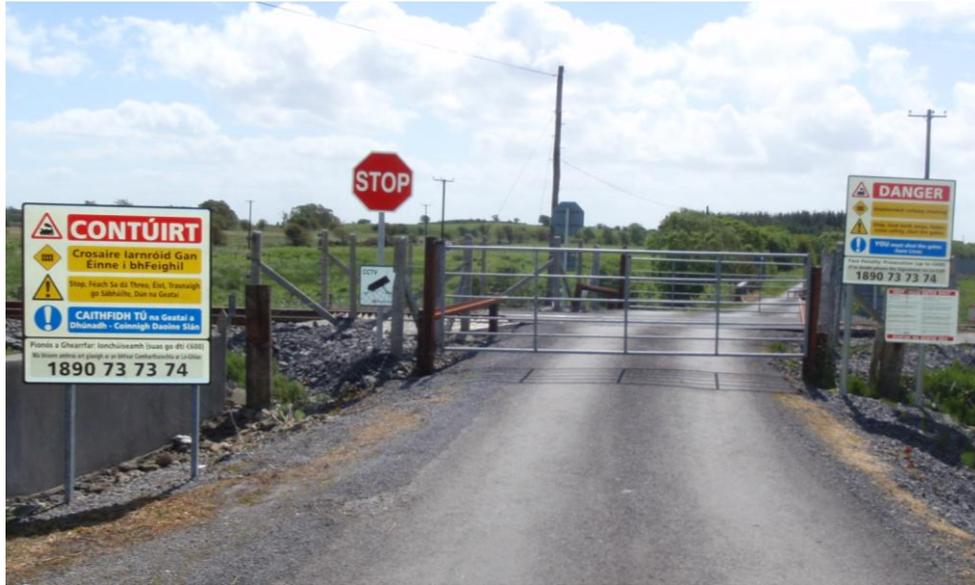
The Level Crossing is located on the Mayo Line at 151 miles 1141 yards from Broadstone Station, County Dublin. IÉ have designated the level crossing as an 'Occupational on Public Road' (OP) type crossing and is identified as asset number (no.) XM250, see Photograph 1.

Photograph 1 – Knockaphunta Level Crossing, approaching the Up side

IEÉ danger and warning signage is erected on the approaches to the Level Crossing, on both sides, see Photograph 1.

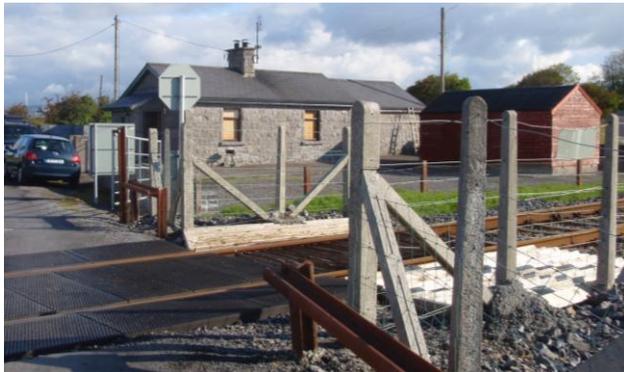
The metal gates positioned on each side of the Level Crossing are approximately 4.3 m wide and open away from the railway. The surface of the intersection of the road with the track is covered in rubber ‘Strail’ units, which gives a level surface over the track. Cattle grids are installed on each side of the roadway, where it crosses the track to prevent cattle straying onto the railway line. There is concrete post and wire fencing running between the gates and the boundary hedges, see Photograph 2. There is a residential house (an old railway building) and shed positioned 15 m and 20 m, respectively, from the Up side of the Level Crossing, see Photograph 2.

Photograph 2 – Residential house and shed

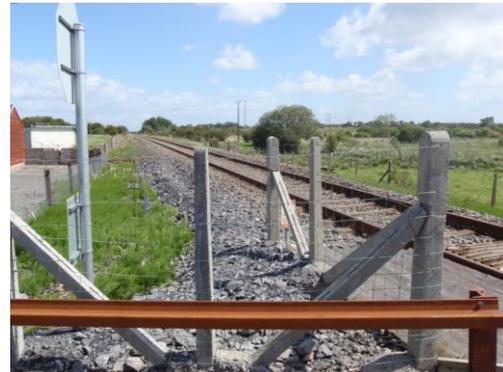
Photograph 3 – View from the Up side of the level crossing

An upright 'Stop' sign is present on both approaches to the Level Crossing, on the public road within the railway boundary which indicates to the road users that they must come to a full stop. In the case of this Level Crossing, the 'Stop' sign is in line with the Level Crossing gates, see Photograph 3.

Apart from the 'Stop' sign, there are no other signage or road markings, such as the continuous white 'Stop' line sometimes associated with the 'Stop' sign, on the approaches to the Level Crossing.

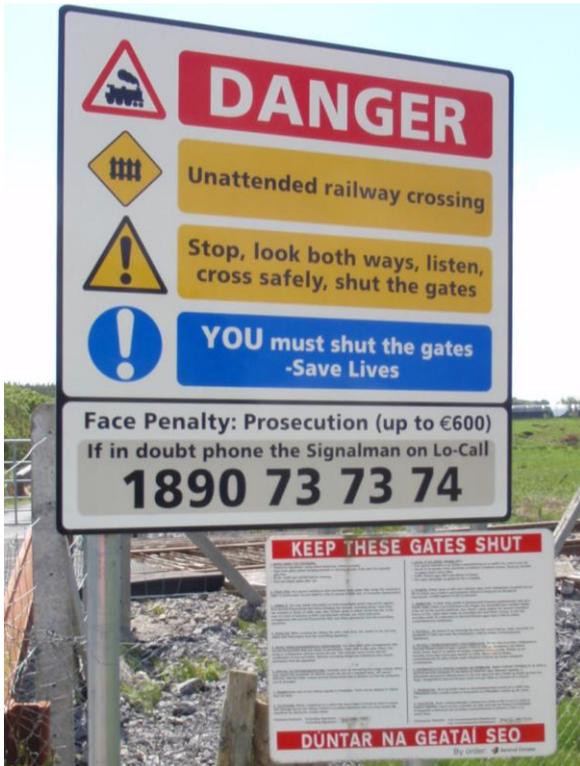
Signage, in relation to the closure of the gates, is also present on the approaches and exits of the Level Crossing. See Photographs 4 and 5 for photographs of the signage at the Level Crossing.

Photograph 4 – Danger, warning and “keep these gates shut” signage, entering the Level Crossing

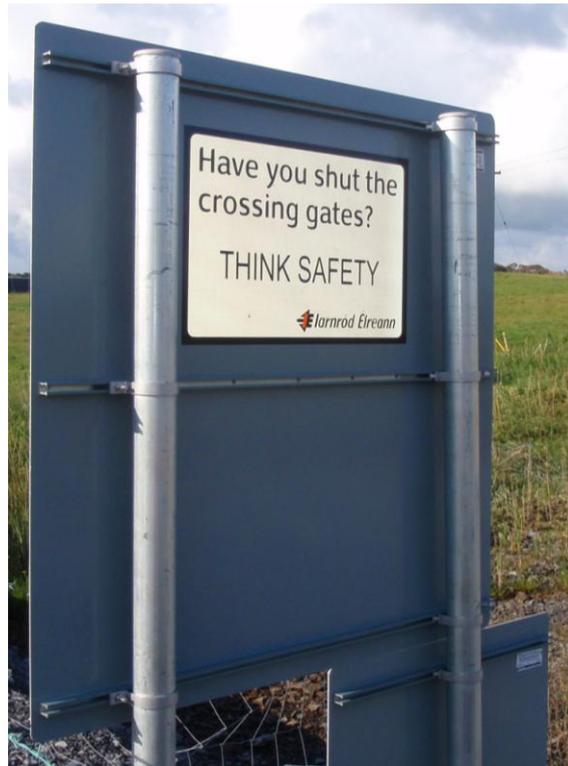
Photograph 5 – Signage in relation to the closure of the gates, exiting the Level Crossing

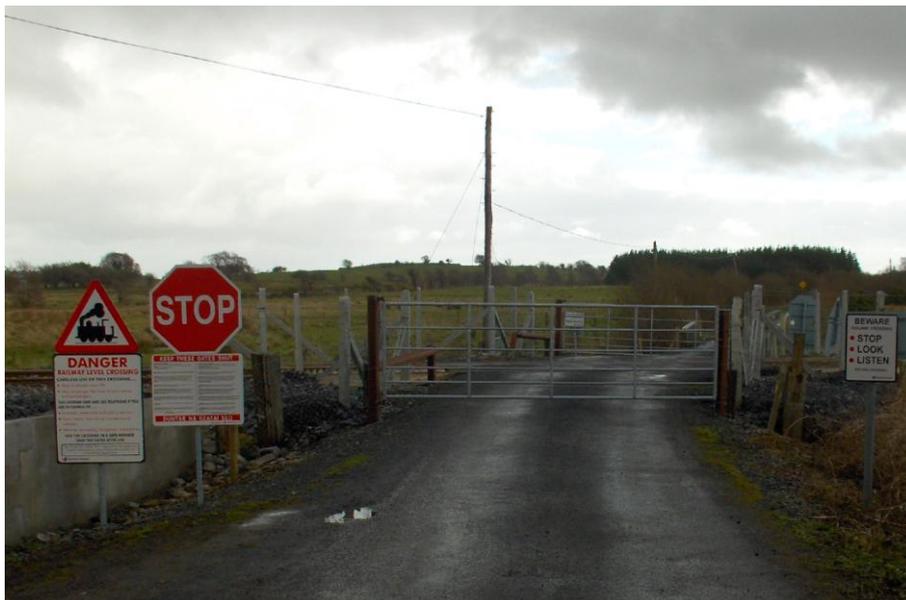
Upgraded signage, present at the time of the accident, was erected in June 2010, four months prior to the accident. Previous to this signage being erected, the old type warning signs had been located at the Level Crossing in accordance with MW50, see Photograph 6.

Photograph 6 – Old signage at the Level Crossing
