Investigation Report 2011-R006

**Road vehicle struck at level crossing XM096,
County Roscommon,
2nd September 2010**

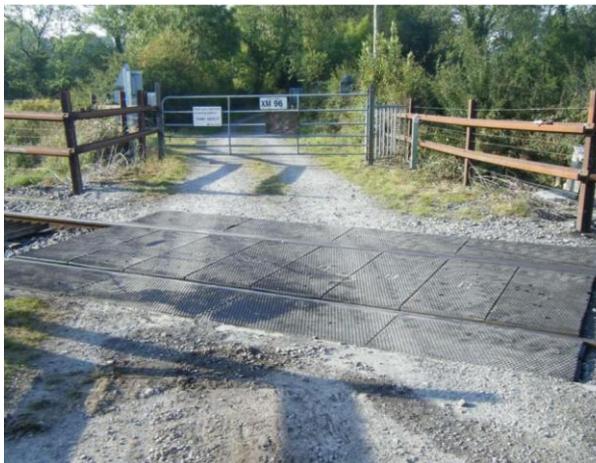
Photograph 2 – XM096 from Up side

XM096 is shown in Photograph 2, photographed from the Up side and showing the Down side of XM096, which is the side the tractor approached.

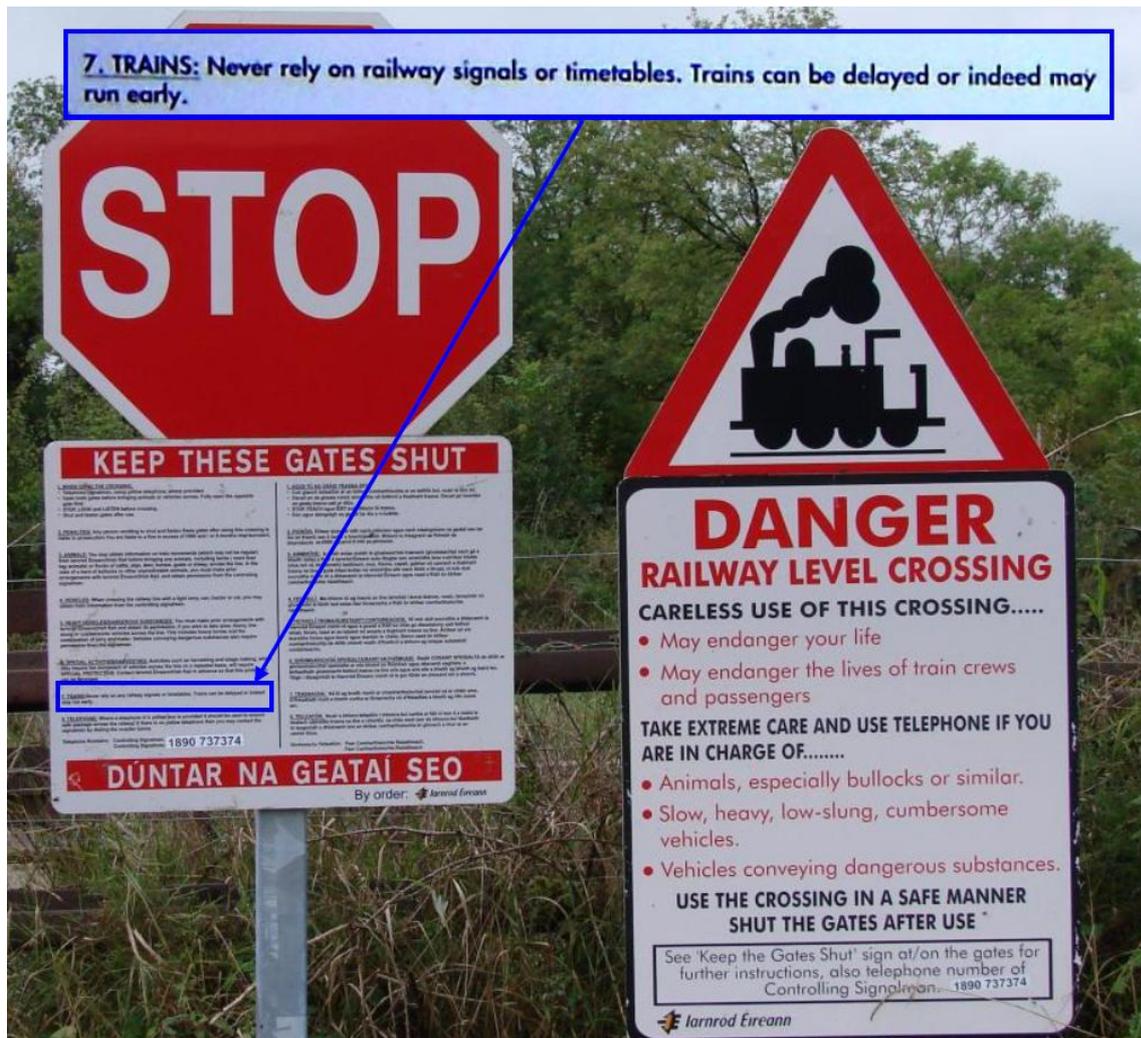
Photograph 4 – Signage at XM096

The 'Danger level crossing' sign at XM096 and the 'Keep these gates shut' sign both include instructions on how to cross the railway, see Photograph 4. None of the signage was found to cover the action an LC user should take in case of difficulty crossing the railway line.

The 'Keep these gates shut' sign also advises LC users 'Never rely on railway signals or timetables. Trains can be delayed or indeed can run early', see Photograph 4. Although this does state that LC users should not rely on railway signals, it does not state that signals are provided for the control of trains and that trains can approach regardless of the aspect displayed. This information is a single point out of eight on the sign, which contains the information in both English and Irish.

Information on what to do in case of difficulty when crossing the railway line was found to be addressed in the IÉ LC user booklet, the RSC guidance for third parties and the rules of the road. However, it was found that the signage at XM096 did not advise LC users of what to do in case of difficulty when crossing the railway.

- Iarnród Éireann should review the effectiveness of its signage at user worked level crossings, and amend it where appropriate, taking into account the information provided in the level crossing user booklet. The review should include the information on the use of railway signals, what to do in case of difficulty when crossing the railway and ensuring the signage is illustrated in a clear and concise manner, taking into account current best practice and statutory requirements.

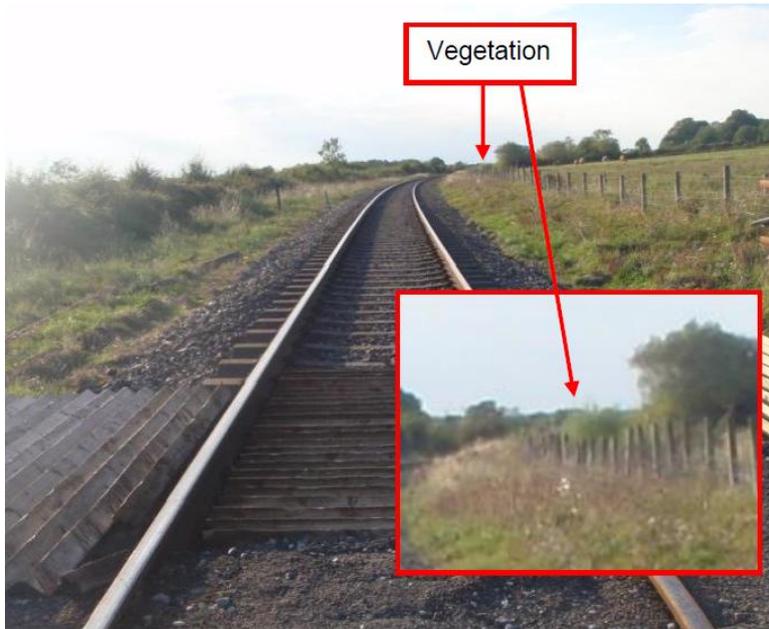
Photograph 5 – Vegetation on the Up side of the track

The Farmer had passed the viewing position on the Down side of the track when the train came into view, hence, the view from either side of the track was not relevant to his actions. There is no viewing requirement for the centre of LCs. However, it was noted that there was vegetation present on the Up side of the track positioned less than 200 m from XM096 that may have obscured the Farmer's view of approaching trains, see Photograph 5.

It was observed as part of the investigation, although not contributing to the accident, that IÉ had identified the viewing distances as being restricted by vegetation prior to the accident as shown in Tables 2 and 3. The risk register contained an entry relating to the risk of collision at XM096 for which the mitigations are outlined in Table 1. Table 1 shows that the risk relating to the substandard viewing distances was considered by IÉ to be high. Mitigating measures were identified to address the risk however these had not yet been implemented. No interim measures were put in place as a temporary control to manage the risk although the mitigating measures were due for completion by the 31st December 2010. The RSC guidance for new LCs advises that where the required warning time cannot be achieved that it may be necessary to reduce the speed of trains, this was not done. IÉ standard MW50 does not mention reducing the speed of trains to achieve the required warning time, it does mention the addition of whistleboards to address this, however, a whistleboard had not yet been installed for XM096.

The vegetation at XM096 was found to have provided restricted views that could have been improved through vegetation management, leading to the reiteration of the following safety recommendation from RAIU investigation report 'Report into the collision at level crossing XN 104 between Ballybrophy and Killonan on the 28th of June, 2007' published in June 2008 (RAIU, 2008) based on AO-02:

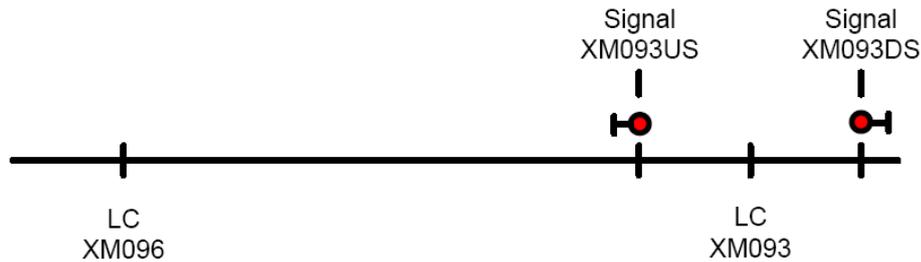
Figure 3 – XM093 clear for road traffic

Signal XM093US shows a red aspect if the gates at XM093 are across the railway line, see Figure 3.

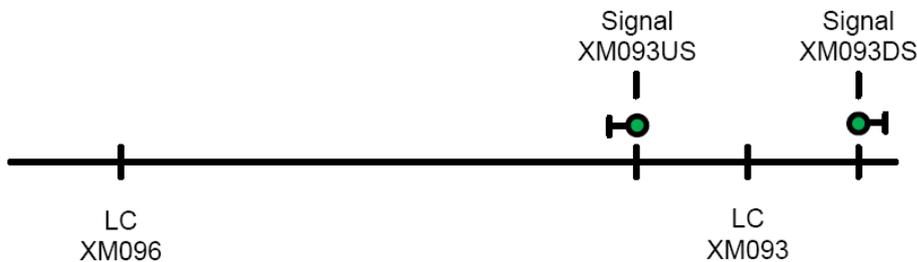
Figure 4 – XM093 clear for railway traffic

When the gates at XM093 are positioned across the road by the gatekeeper located at XM093 and the gatekeeper sets the green proceed aspect, signals XM093UD and XM093US both show a green aspect, see Figure 4.

It was found by RAIU that at the time of the accident that LC users at XM096 were still reading a green aspect at signal XM093US for XM093 as an indication that there was no train approaching.

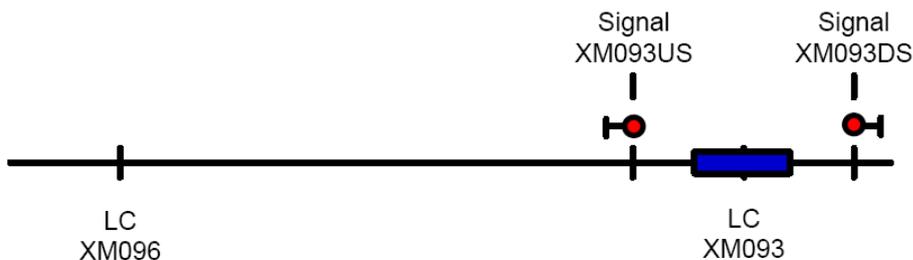
Figure 5 – Train between signals XM093US and XM093DS

Once a train enters the section between the XM093US and XM093DS signals travelling in either direction, both signal aspects display a red stop aspect, see Figure 5.

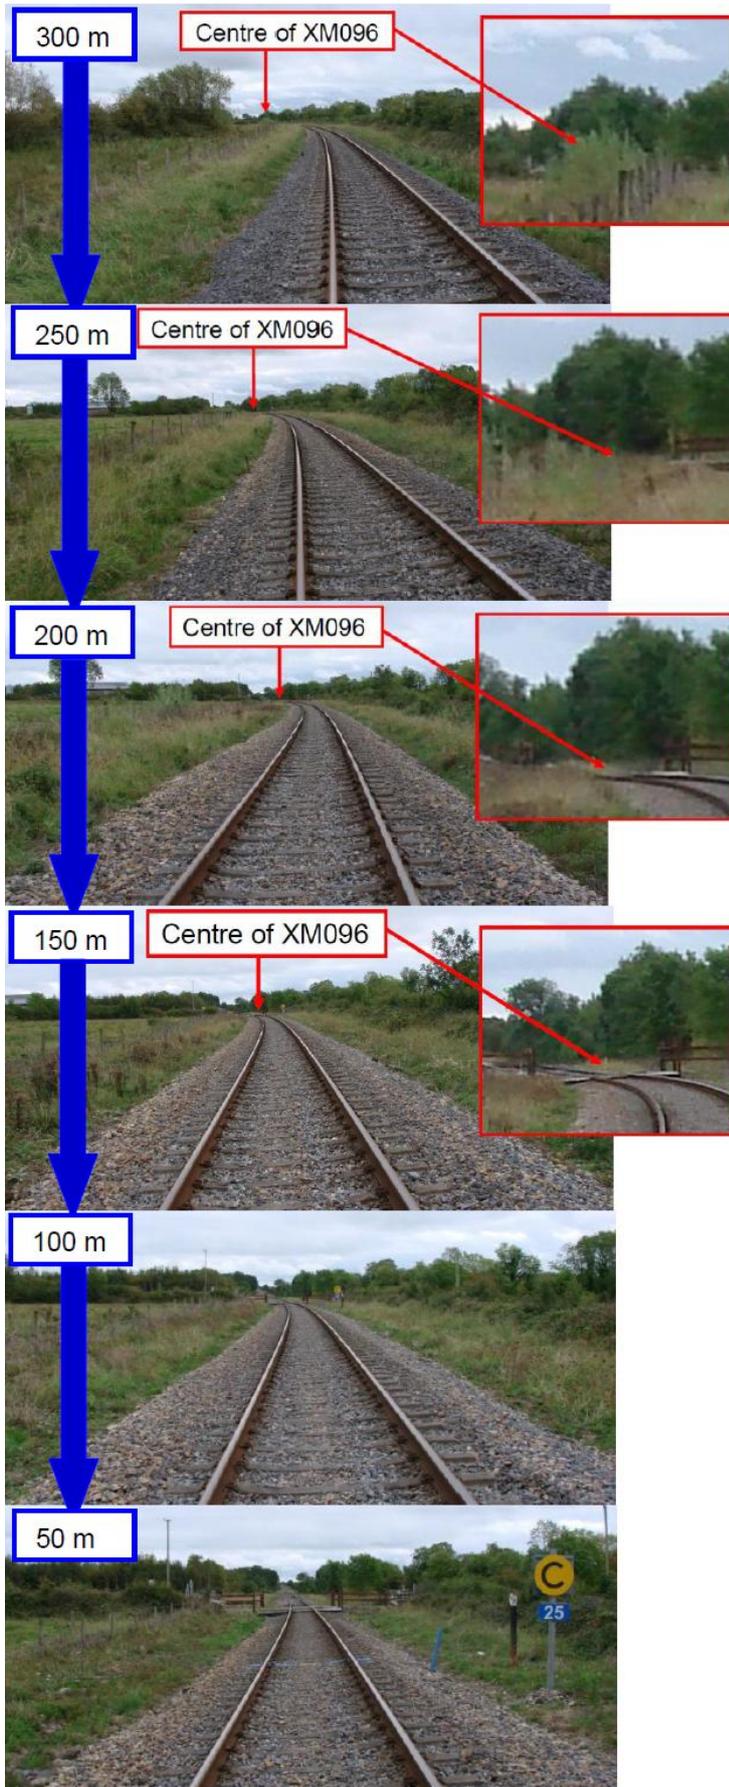
Figure 6 below shows the approach to XM096 along the railway line and gives an indication of the view the Train Driver would have had. It should be noted that these photographs were taken the day after the accident when signs were put in place for a temporary speed restriction following repairs to the track. The photographs were not taken at the same height as a train driver positioned in the driver's seat of a 201 locomotive.

Approximately 13 s before the accident
The Train Driver may not have had a clear view of the centre of XM096 as it was obstructed by vegetation.

Approximately 11 s before the accident
The view of the centre of XM096 was not obstructed.

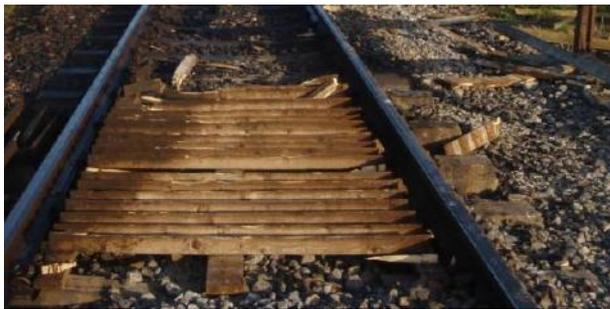
Photograph 7 – Damage to cattle grids

There was damage to the cattle grids, primarily on the down side of the track at XM096 and between the rails. This is consistent with impacts from the front wheels of the tractor between the rails and impacts from the rear wheels on the Down side of the track, see Photograph 7.

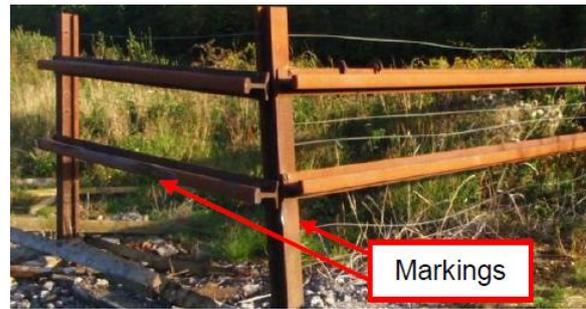
Photograph 8 – Damage to fencing

There were markings on the corner post of the fencing at XM096 consistent with having been struck by the bale handler and markings on the horizontal part of the fencing consistent with having been struck by the rear tyres of the tractor, see Photograph 8.

The fencing at XM096 was made up of disused rail. It sustained damage in the collision, however, as shown in Photograph 8, it did not break away due to the impact. Although its effect in the accident cannot be determined, the robust nature of this fencing could increase the severity of a collision between a train and a road vehicle by not allowing the vehicle to be pushed out of the path of the train or by creating a *pinch point* between the fencing and a train in which a road vehicle could become caught leading to increased damage to the road vehicle, train or the occupants of either.

IÉ should review its use of disused rail as fencing at user worked LCs to ensure it cannot potentially increase the severity of a collision and where this is the case, replace the disused rail with appropriate fencing.
