**Report into the derailment of a Tara Mines freight train at Skerries on the**

**10<sup>th</sup> of January 2008**

**Report Number 08011001**

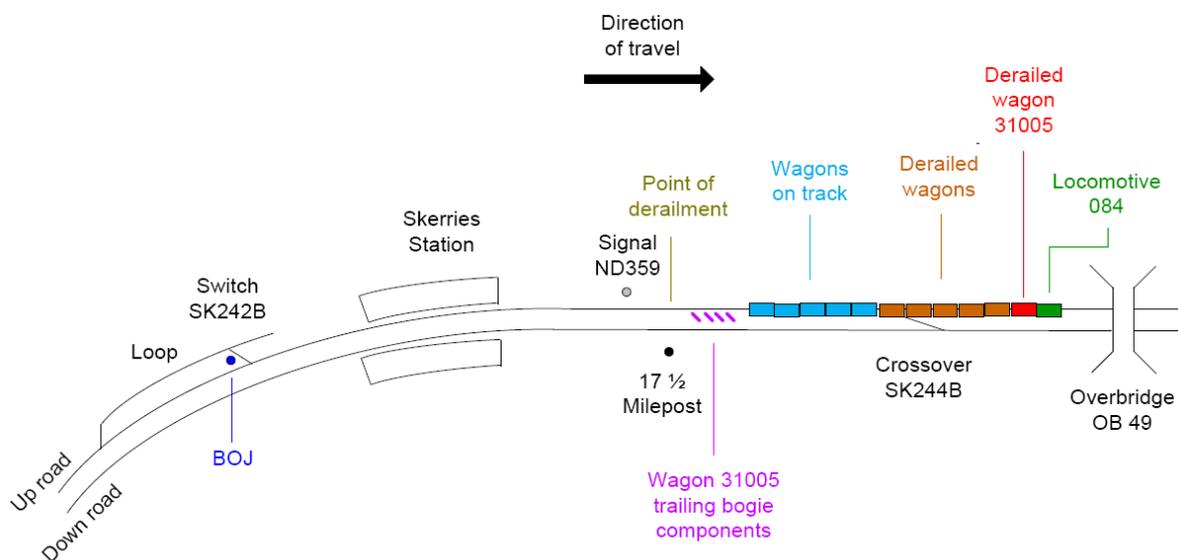
Figure 2 – Site Map

Train M107 suffered a catastrophic bearing failure leading to failure of the axle, this is commonly referred to as a Burnt Off Journal (BOJ). The train derailed and came to a halt at 17 miles 585 yards, north of overbridge OB 49, at 22.53 hrs, see figure 2. The derailment occurred on a section of double track on the Dublin Connolly to Belfast line. The train was travelling south on the Up road when the first six wagons in the train derailed, all wagons remained upright. The first wagon behind the locomotive, 31005, suffered a BOJ on the leading axle of its trailing bogie and the bogie was derailed. Wagons 31023, 31020, 31002 and 31017 had both bogies derailed and wagon 31027 had the leading bogie derailed with the trailing bogie still on the tracks just short of points for crossover SK 244. The wagons 31019, 31003, 31012, 31014 and 31007 did not derail.

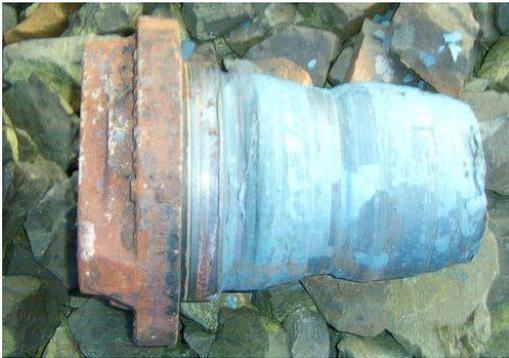
Photo 1 – Burnt Off Journal

The BOJ was found with the end cap and end cap screws, locking plate and ½ inch pipe plug in place in between the Up road and the loop at the nose of switch SK242B at 18 miles 607 yards, see photo 1. The train travelled approximately ½ a mile with the axlebox of the leading wheelset on the trailing bogie on wagon 31005 leaning on the axle journal. The wheelset with the failed axle then derailed and damage could be seen on the sleepers starting at the 17 ½ milepost. Components from the trailing bogie of wagon 31005 were found in the six foot after the 17 ½ milepost. The failed bearing had fused to the axlebox, see photo 2. The remaining wheelsets derailed at crossover SK244B facing points, located at 17 miles 707 yards.

The diameter of the axle narrowed to 90 mm before it failed.

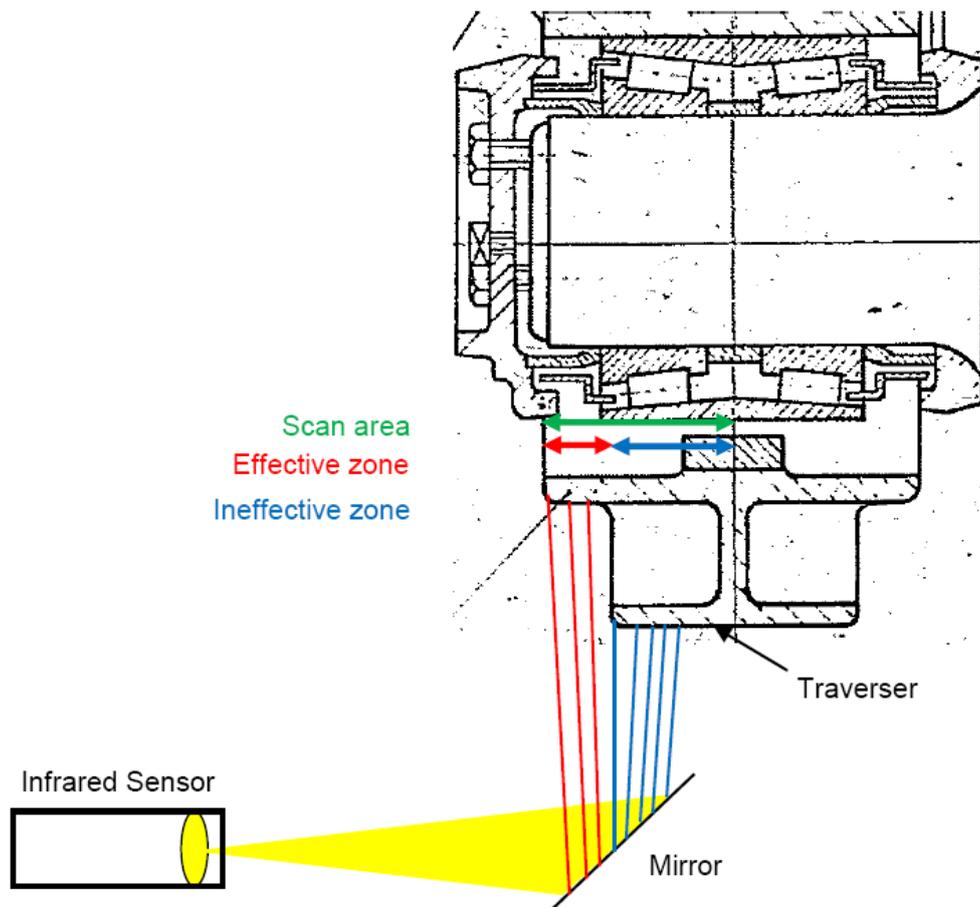
Figure 3 – HABD Scanning

In the case of the Y23 bogies because of the presence of the axlebox traverser only the three points at the outboard edge of the bearing measure effectively and the temperature readings at the remaining five points, including those towards the centre of the bearing cup that give a more accurate bearing temperature, are affected by the underside of the axlebox, see figure 3. Therefore, the true temperature reading of a bearing enclosed in a Y23 axlebox would be greater than the measured temperature.

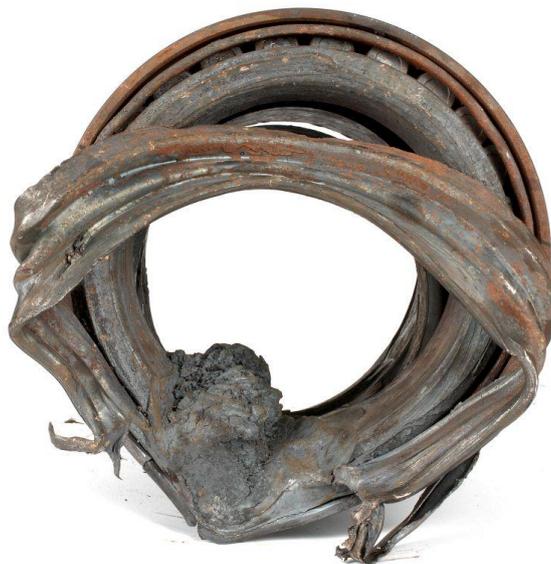
Photo 3 – Failed Bearing

The failed axle was manufactured in November 1981. There were no markings on the wheel fitted at the failed end to indicate its date of manufacture or the manufacturer, only the press on force was marked and based on this it is believed that the wheel was pressed on by IÉ. No wheel flats were observed on the wheel.

The failed components along with the four bearings from the trailing bogie of wagon 31005 and the axlebox the partner bearing was supporting were examined by the Health & Safety Laboratory in Derbyshire, United Kingdom<sup>3</sup>. The BOJ stub fracture appearance was consistent with the axle failing at a high temperature, under torsion loading. This indicates that the axle journal failure was probably a consequence of the heat generated and increased torque resulting from the bearing failure. The axle failed in line with the inboard cone of the bearing. The failed bearing had plastically deformed into a pear shape at the inboard side (see photo 3). The high temperatures caused by the bearing failure resulted in significant plastic deformation of the cup, cones and rollers. The principal cause of the high temperatures appears to have been frictional heating resulting from the rotation of the inner cone around the axle surface. There was no evidence of rolling contact fatigue, spalling, corrosion or wear on the internal surfaces of the failed bearing. The cone assemblies were seized with the rollers skewed in a herringbone pattern. A roller in the outboard cone had suffered a brittle fracture primarily in the longitudinal direction (see photo 4). There was no evidence that the fractured roller had indented the adjacent rollers suggesting that it may have been a consequence of the bearing failure rather than the cause. The inboard cage had failed in the area of the peak of the pear shape and two adjacent rollers had moved out of their relative position in the cage (see photo 5).
