Investigation Report 2010-R001

Collision of a Locomotive with Passenger Carriages at Plunkett

Station in Waterford on the Limerick to Rosslare Line

29th of March 2009

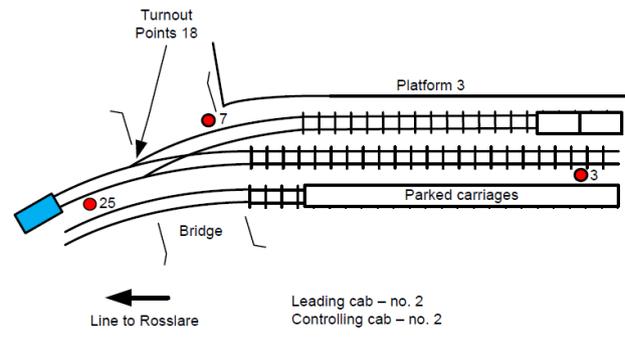
Figure 4 – Second movement of locomotive

The locomotive then travelled over a set of *points* moving from the Platform Line onto the *Up Main Line* where it stopped, see figure 4. The train driver tried to take cab no. 2 out of service in order to drive the locomotive from cab no. 1 at the opposite end, by operating a cut in/cut out valve. Several attempts were made to operate the valve but this was unsuccessful. The train driver remained in the cab no. 2 and waited for the proceed aspect on the no. 25 signal to continue the movement. Once this was given the locomotive proceeded in reverse with the train driver in cab no. 2.

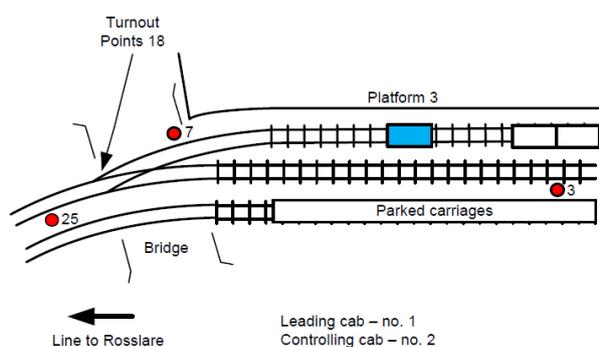
Figure 5 – Train driver applies brakes

The locomotive took the wrong route and started to travel back onto the Platform Line at 18 km/h. The train driver applied the locomotive brakes 43 m before the collision, see figure 5. The *brake reaction time*, which is the time for the brake pressure to build up and react to a train driver brake application, was 6 seconds. The locomotive was travelling at 28.6 km/h at the time of the collision, see figure 6.

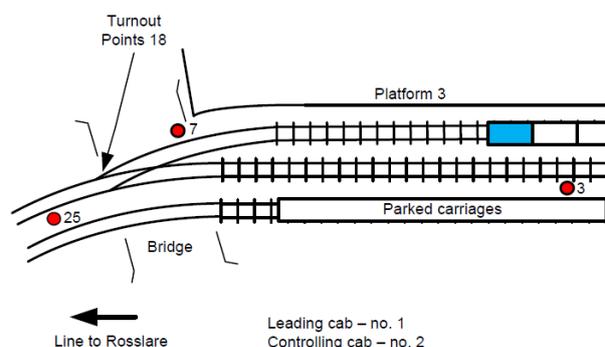
Figure 6 – Collision

The train driver could not see the next signal, no. 3, directly but observed the proceed aspect at signal no. 3 reflected in the windows of passenger carriages parked on the *Down Main Line*. The train driver continued the movement and then observed that the locomotive was travelling on the Platform Line instead of the Up Main Line. The train driver applied the locomotive brake, see figure 5, but the locomotive collided with the carriages, see figure 6.

The rear carriage of a train is normally fitted with *tail lights* indicating the rear of a train. While the train driver was moving the locomotive, the shunter had climbed onto the track at the rear end of the carriages and was removing the tail lights from the carriage. The shunter observed that the locomotive was travelling towards the carriages on the Platform Line and turned to move away from the carriages but was struck by the rearmost carriage and fell forward onto the track. Two members of staff who were on the carriages fell over. There were no passengers on the carriages at the time of the collision. The carriages moved approximately 3.4 m and all four wheels of the second bogie on the carriage struck by the locomotive derailed.

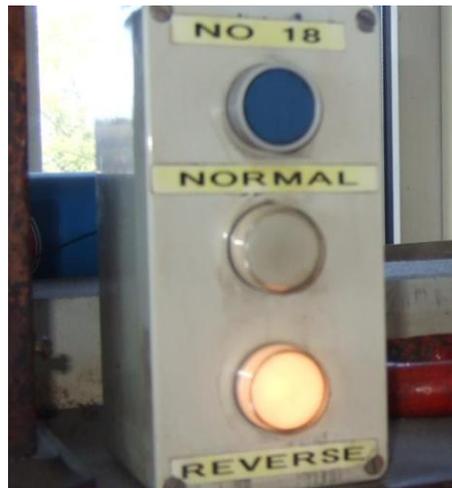
Photo 4 – Turnout direction release button

While setting the route for the locomotive on the night of the 29th March 2009 the signalman omitted to press the control button and move the lever to change the turnout direction at the no. 18 points for the movement, see photo 4.

The direction the turnout at the no. 18 points is set for is indicated by the lighting of the turnout release button light, see photo 4. Signal no. 25 does not indicate if the route is set to travel on the Up Main Line or the Platform Line, it simply indicates if the train driver has permission to proceed past the signal or not. When setting a route past signals no. 25 and 3 over points no. 18, the signal panel will display the track circuit indicators and the signal indicators as green if the route is clear regardless of whether or not the no. 18 points are set for the intended direction. The panel was showing green indications for the track circuits and signals along the route on the Up Main Line, meaning that the track was clear of other trains and the signals were showing a proceed aspect for the locomotive.

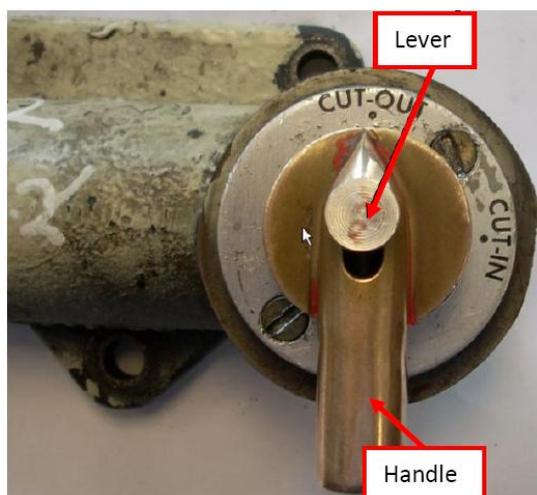
Photo 5 – MU-2-B1 Valve

Each cab of the 201 locomotives has an MU-2-B1 valve. In order to drive a locomotive from one of the cabs the MU-2-B1 valve for other cab must first be cut out and then the MU-2-B1 valve for the cab being used to drive must be cut in. This allows the brakes to be released in order to move the locomotive. The valve is operated by pulling on the spring loaded lever which lifts a pin inside the valve allowing the train driver to turn the handle between the cut in and cut out positions, see photo 5. No operating instructions are available to the train drivers for the valve.

Each locomotive has a log book for train drivers to record faults for the attention of maintenance personnel. The MU-2-B1 valve in cab no. 2 was recorded in the log book for locomotive 232 as not cutting out on the 24th of February 2009. The detent pin inside the valve, which allows the valve to be cut in and out, was found to be broken. The handle, lever and shaft as well as the associated components including the detent pin were replaced on the 24th of February 2009.

There is no written requirement to maintain the MU-2-B1 valve or carry out pre-service inspections on it. IÉ advised that the valves are overhauled every four years during the heavy locomotive maintenance. Following the accident, examination of the MU-2-B1 valve revealed that the detent pin inside the valve was bent, see photo 6. This would have required the train driver to manipulate the lever in order to turn the handle.

The MU-2-B1 valve was found to be defective following the accident. The component had been replaced 1 month prior to the accident. There was no formal maintenance requirement for the MU-2-B1 valve and its operation was not part of the daily or weekly pre-service checks. The lack of pre-service checks of the valve meant that it was possible for a locomotive to enter service with a faulty valve.

IEÉ should ensure procedures are put in place for the operation and maintenance of the MU-2-B1 valves.

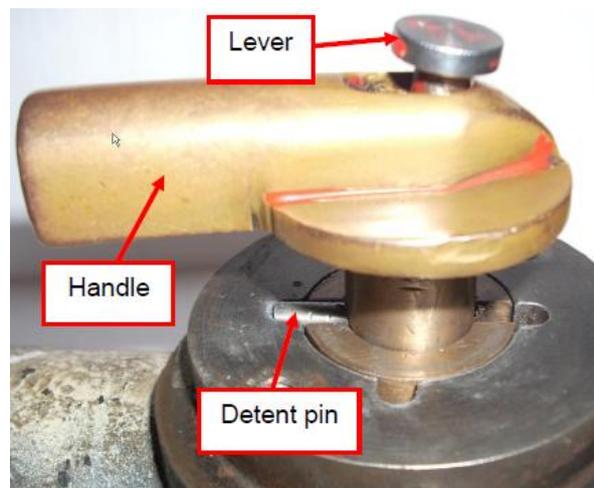
Photo 6 – Damaged detent pin

The MU-2-B1 valve was found to be defective resulting in the train drivers having to manipulate the lever in order to operate the valve. The testing of MU-2-B1 valves is not part of the pre-service checks, which are intended to ensure locomotives are functioning correctly when they enter service. In addition, train drivers were not instructed in the correct operation of the MU-2-B1 valve, which led to unintentional damage to the detent pin of the valves, leading to the recommendation:
